## **Addendum #2**

### **Greenway Farms New Conference Facility**

**CONTRACT NO. R-17-004**

**Subject: NESHAP Inspection – Greenway Farms Residence Building  
5051 Gann Store Road  
Hixson, Tennessee**

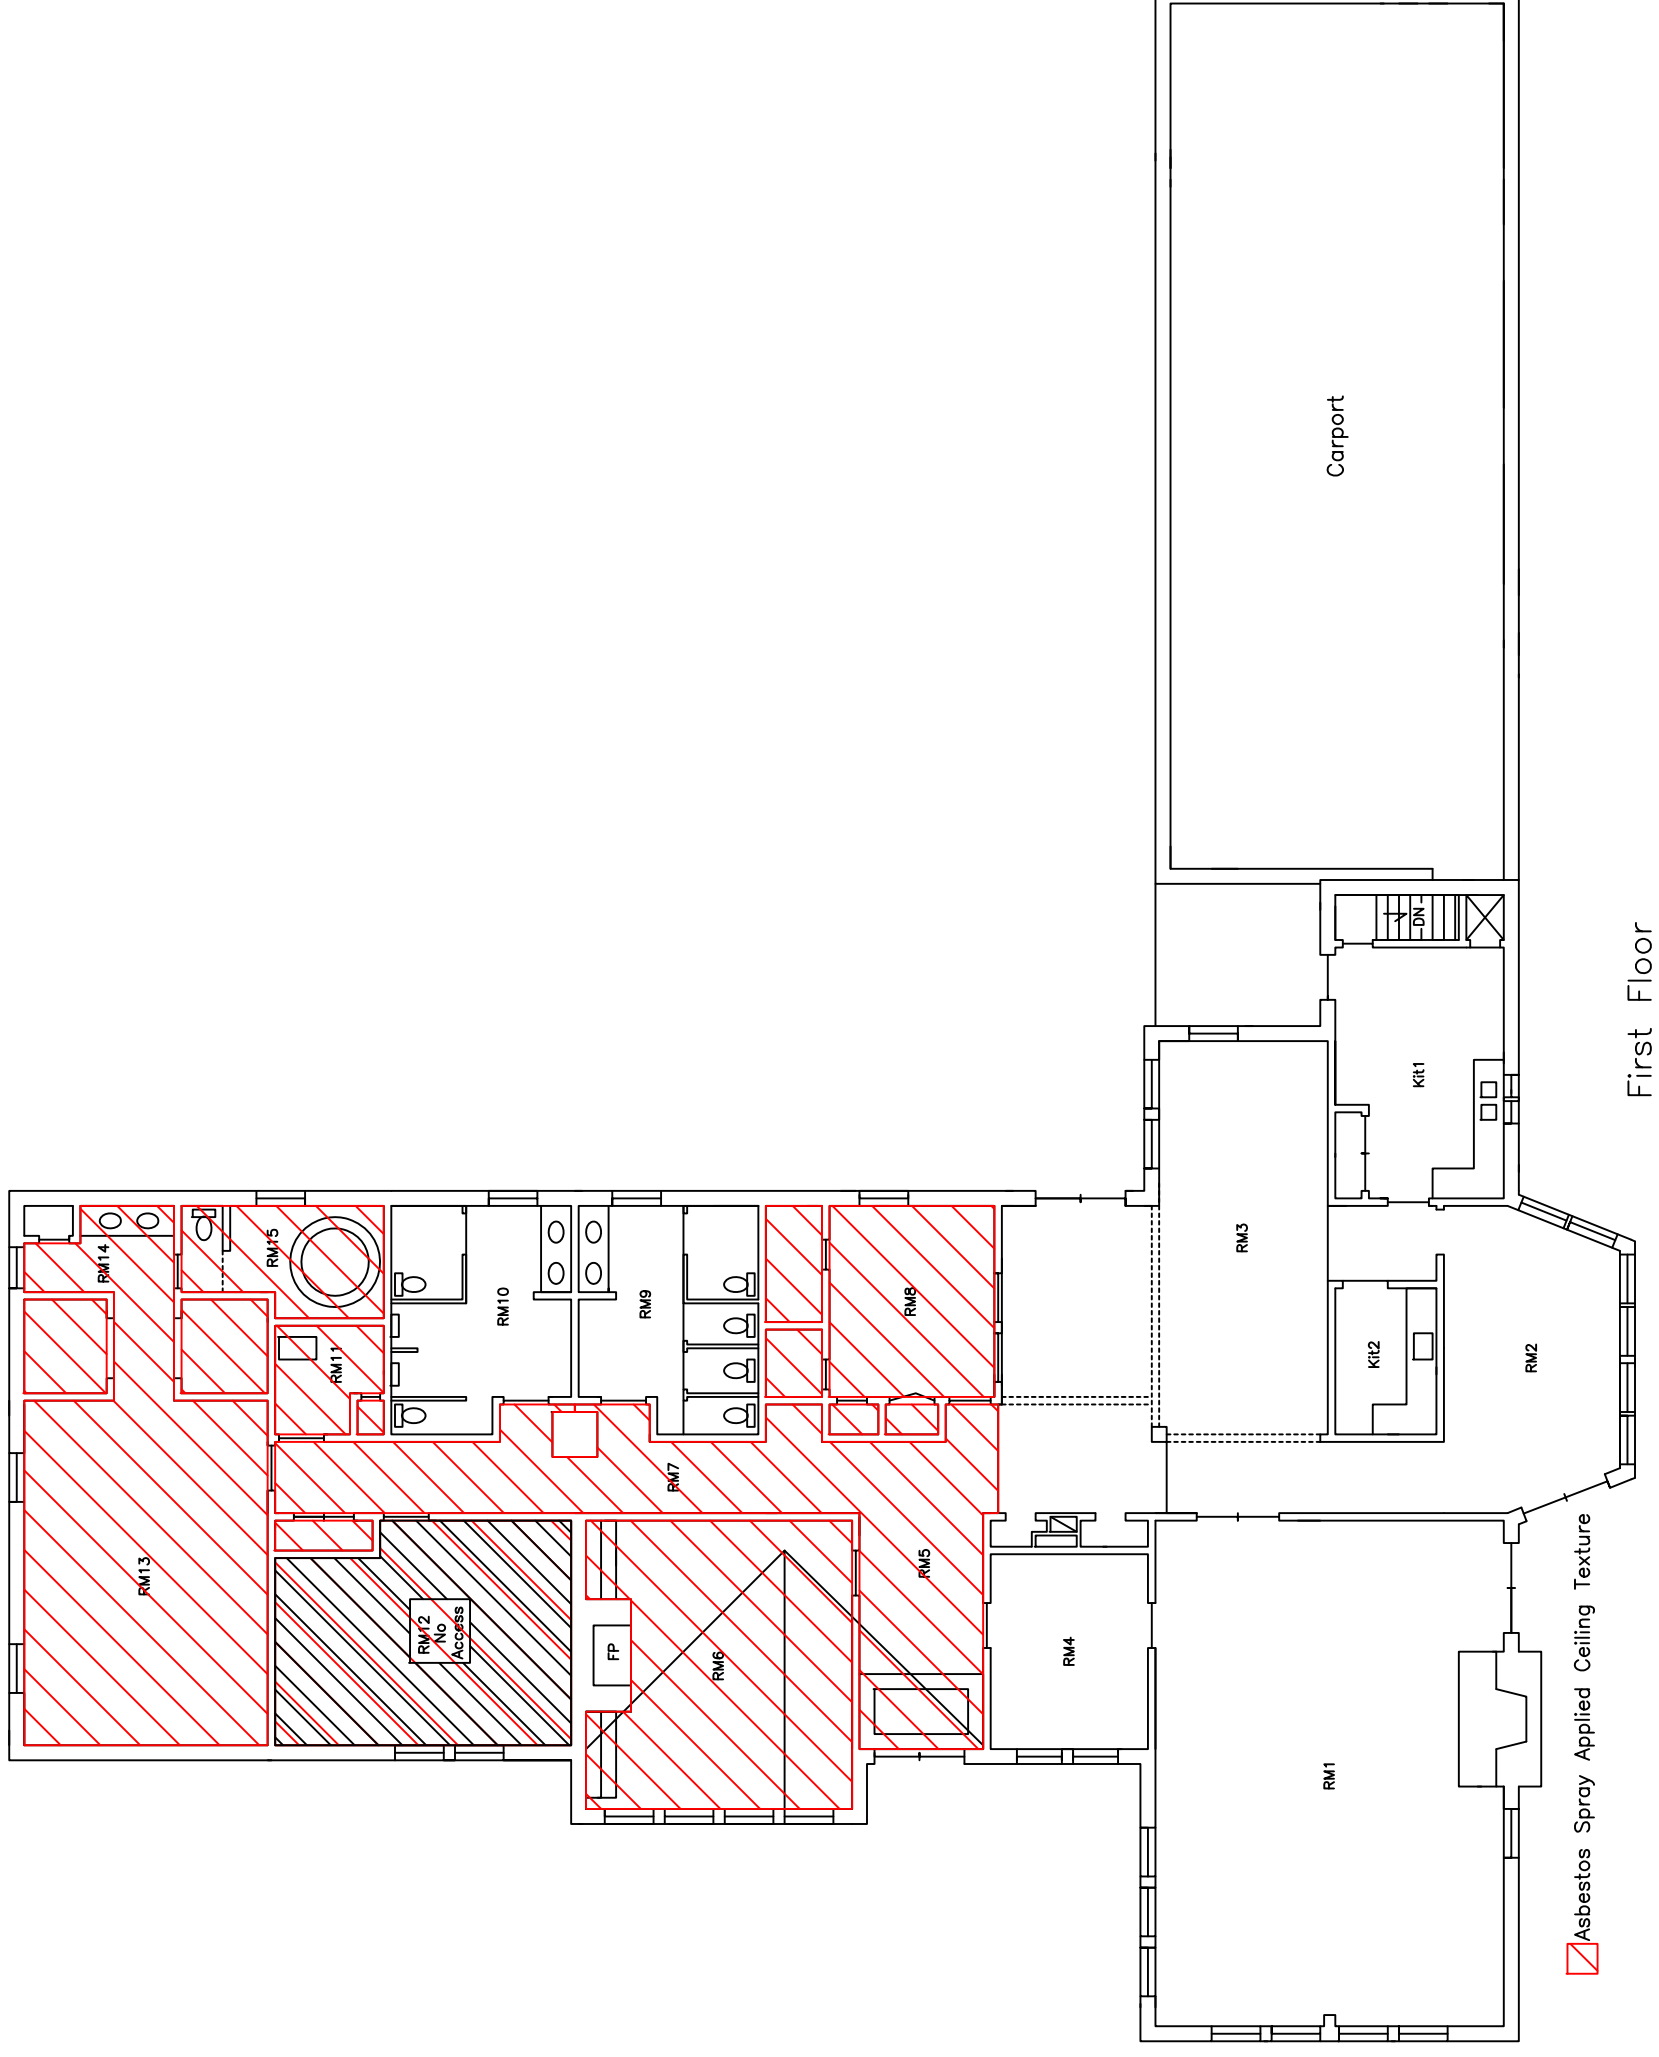
Asbestos Locations  
Greenway Farms Residence Building  
5051 Gann Store Road  
Hixson, Tennessee

Asbestos Spray Applied Ceiling Texture

***Asbestos Spray Applied Texture*** – Asbestos spray applied texture is considered to be a Regulated Asbestos Containing Building Material (RACBM) by Federal NESHAP Regulations. The disturbance and removal of this material is regulated by both EPA and TOSHA. The removal, repairs or encapsulation of the spray applied texture should be made by an asbestos contractor with accredited supervision and workers. All material and debris must be properly disposed of at an approved sanitary landfill. EPA and TOSHA require special training and other requirements for anyone disturbing any asbestos material. OSHA also has procedural requirements pertaining to asbestos removal and handling. Contractor must comply with State of Tennessee Asbestos Program requirements and TOSHA.

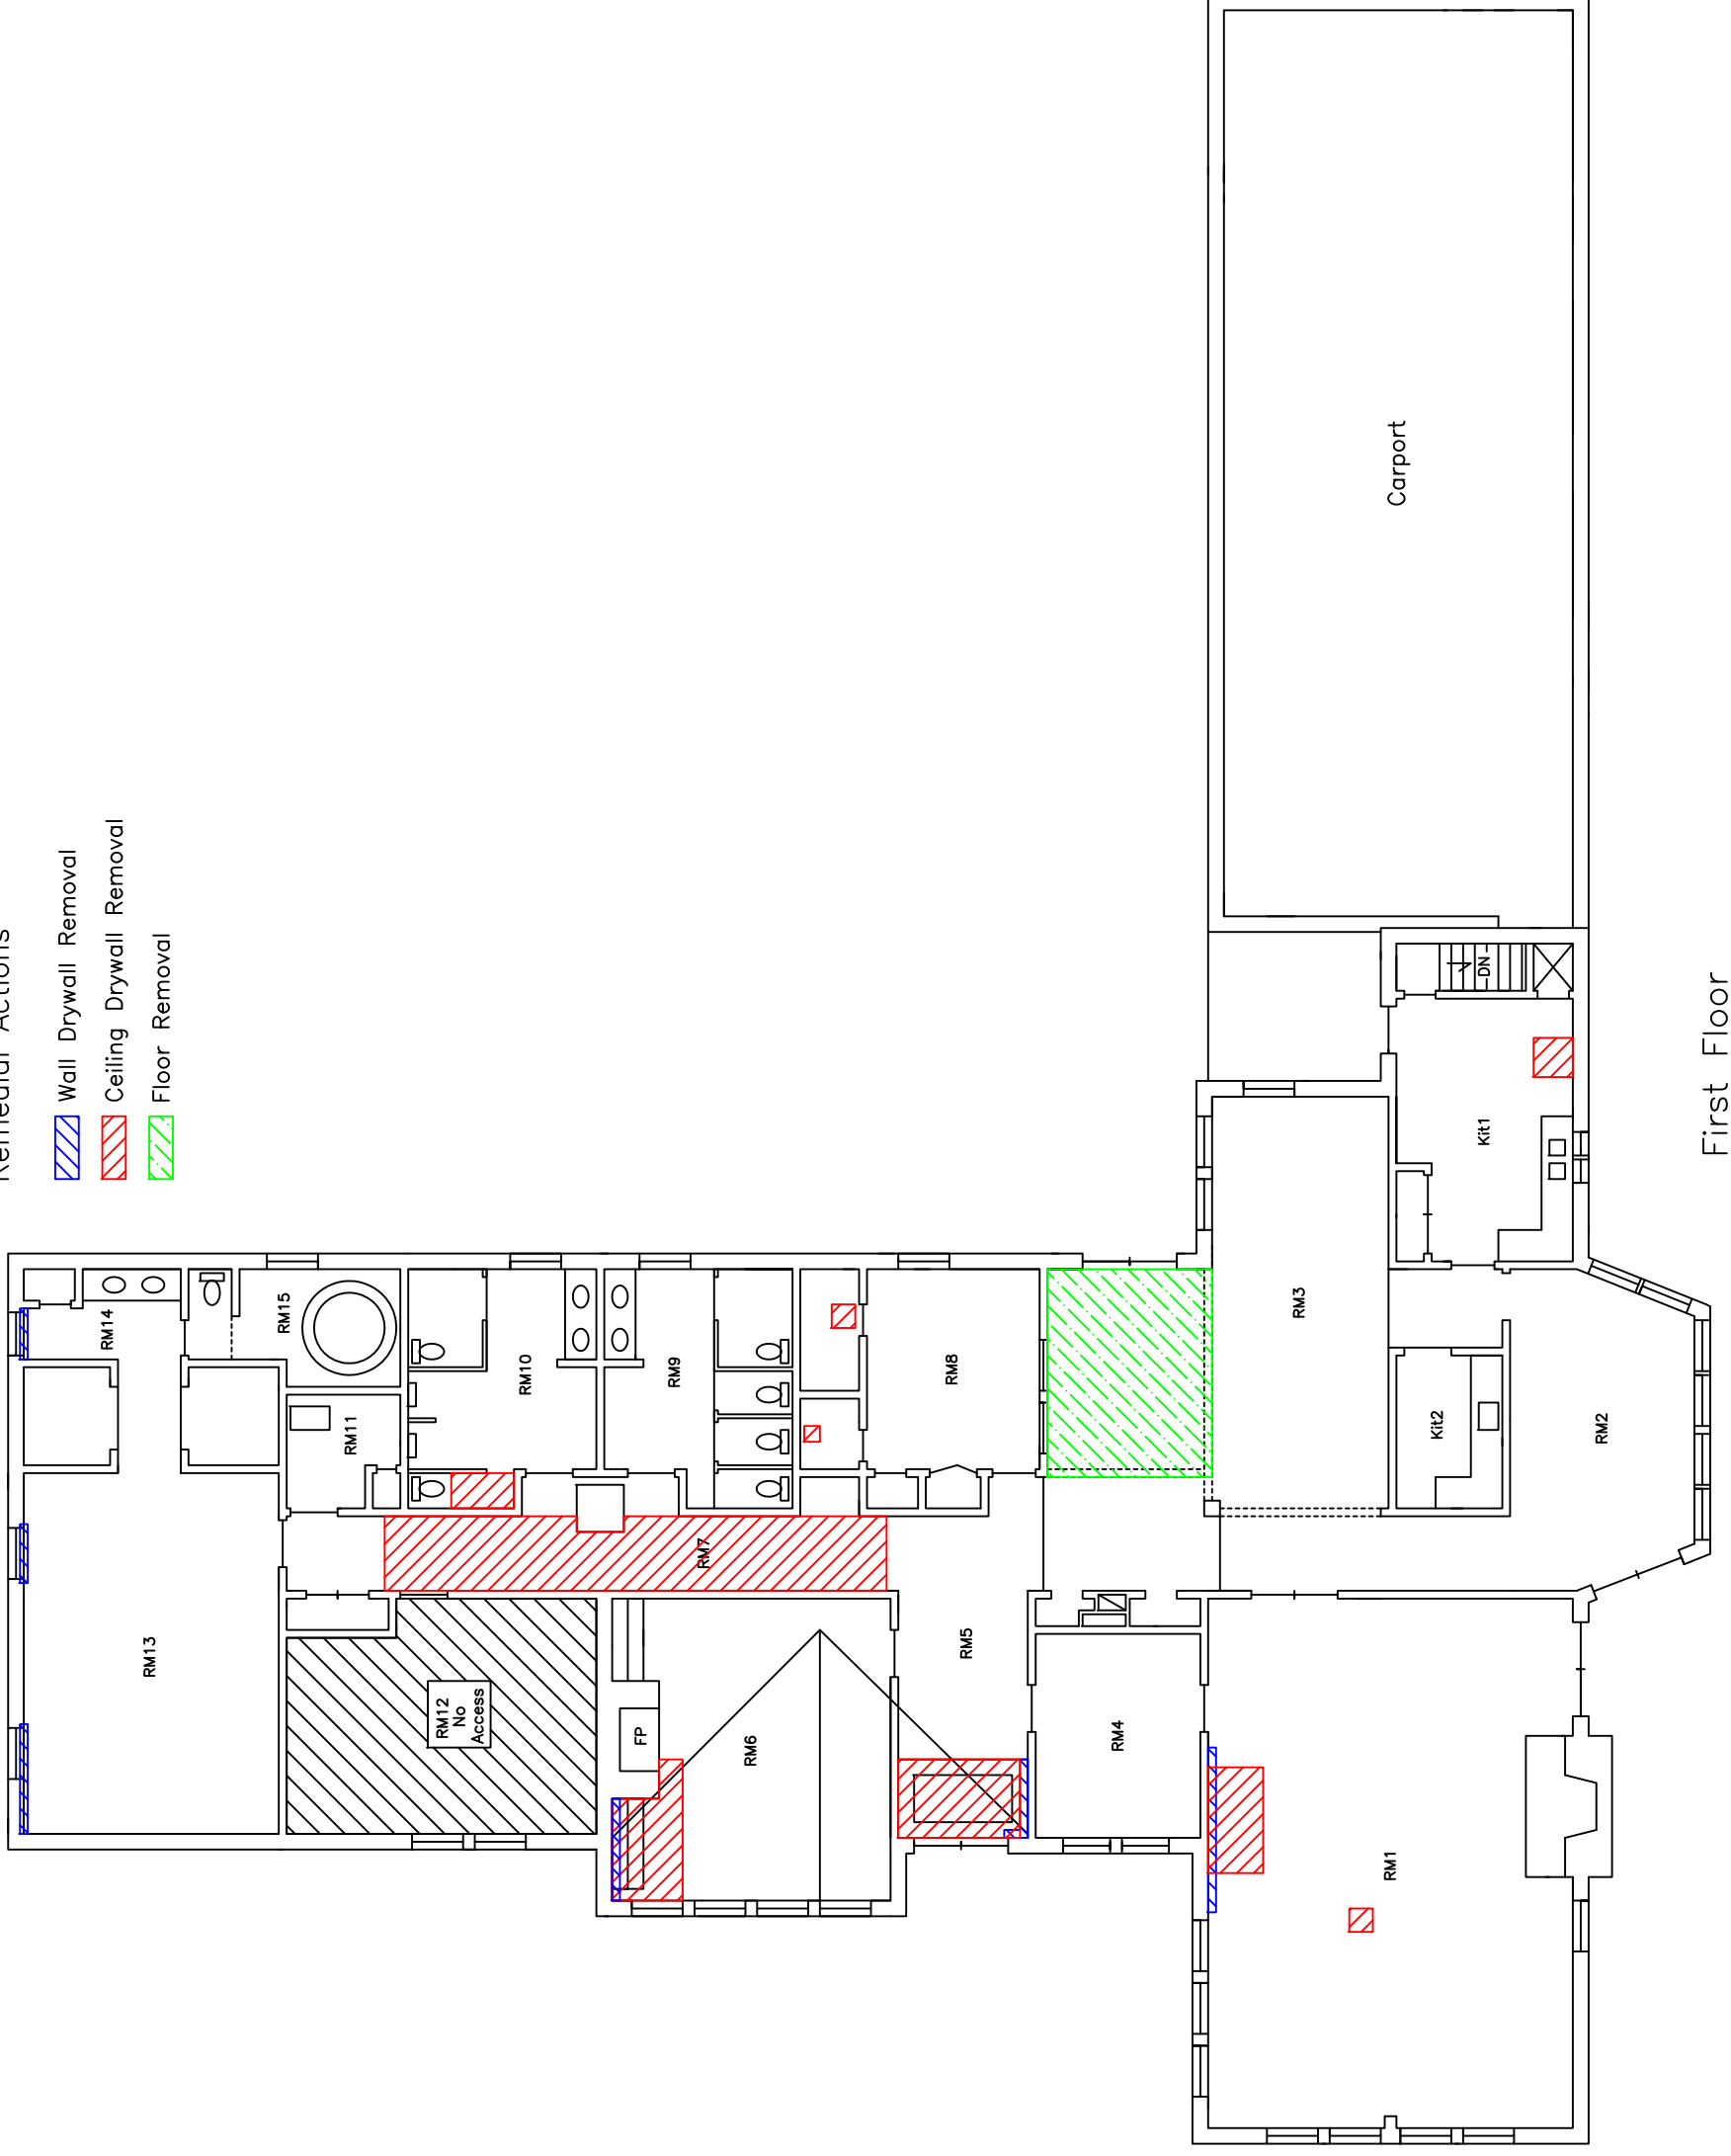
Remedial Actions

- Wall Drywall Removal
- Ceiling Drywall Removal
- Floor Removal

- 4) Clean all framing and remaining finishes in the area using HEPA vacuums and an approved biocide. Stained wood will need to be sanded to new wood finish to remove embedded microbial growth. Water damaged wood should be cut out and replaced. Do not use any form of a sealant.

- 5) Check moisture content of all remaining framing or finishes left in work area. All materials will need to be dried, if necessary, to a moisture content of 12% or less.

- 6) The rectangular area in front of the rear double doors will need to be removed as noted on the attached drawing. This area will need to be isolated from other areas within the building. Debris can exit out the rear double doors. Once the flooring and subflooring is removed, evaluate the framing, box beam and door threshold for water damage, rot and microbial growth. Dry or replace framing as necessary. Framing components will need to be dried to 12% moisture content or less. Clean framing using HEPA vacuums and an approved biocide.

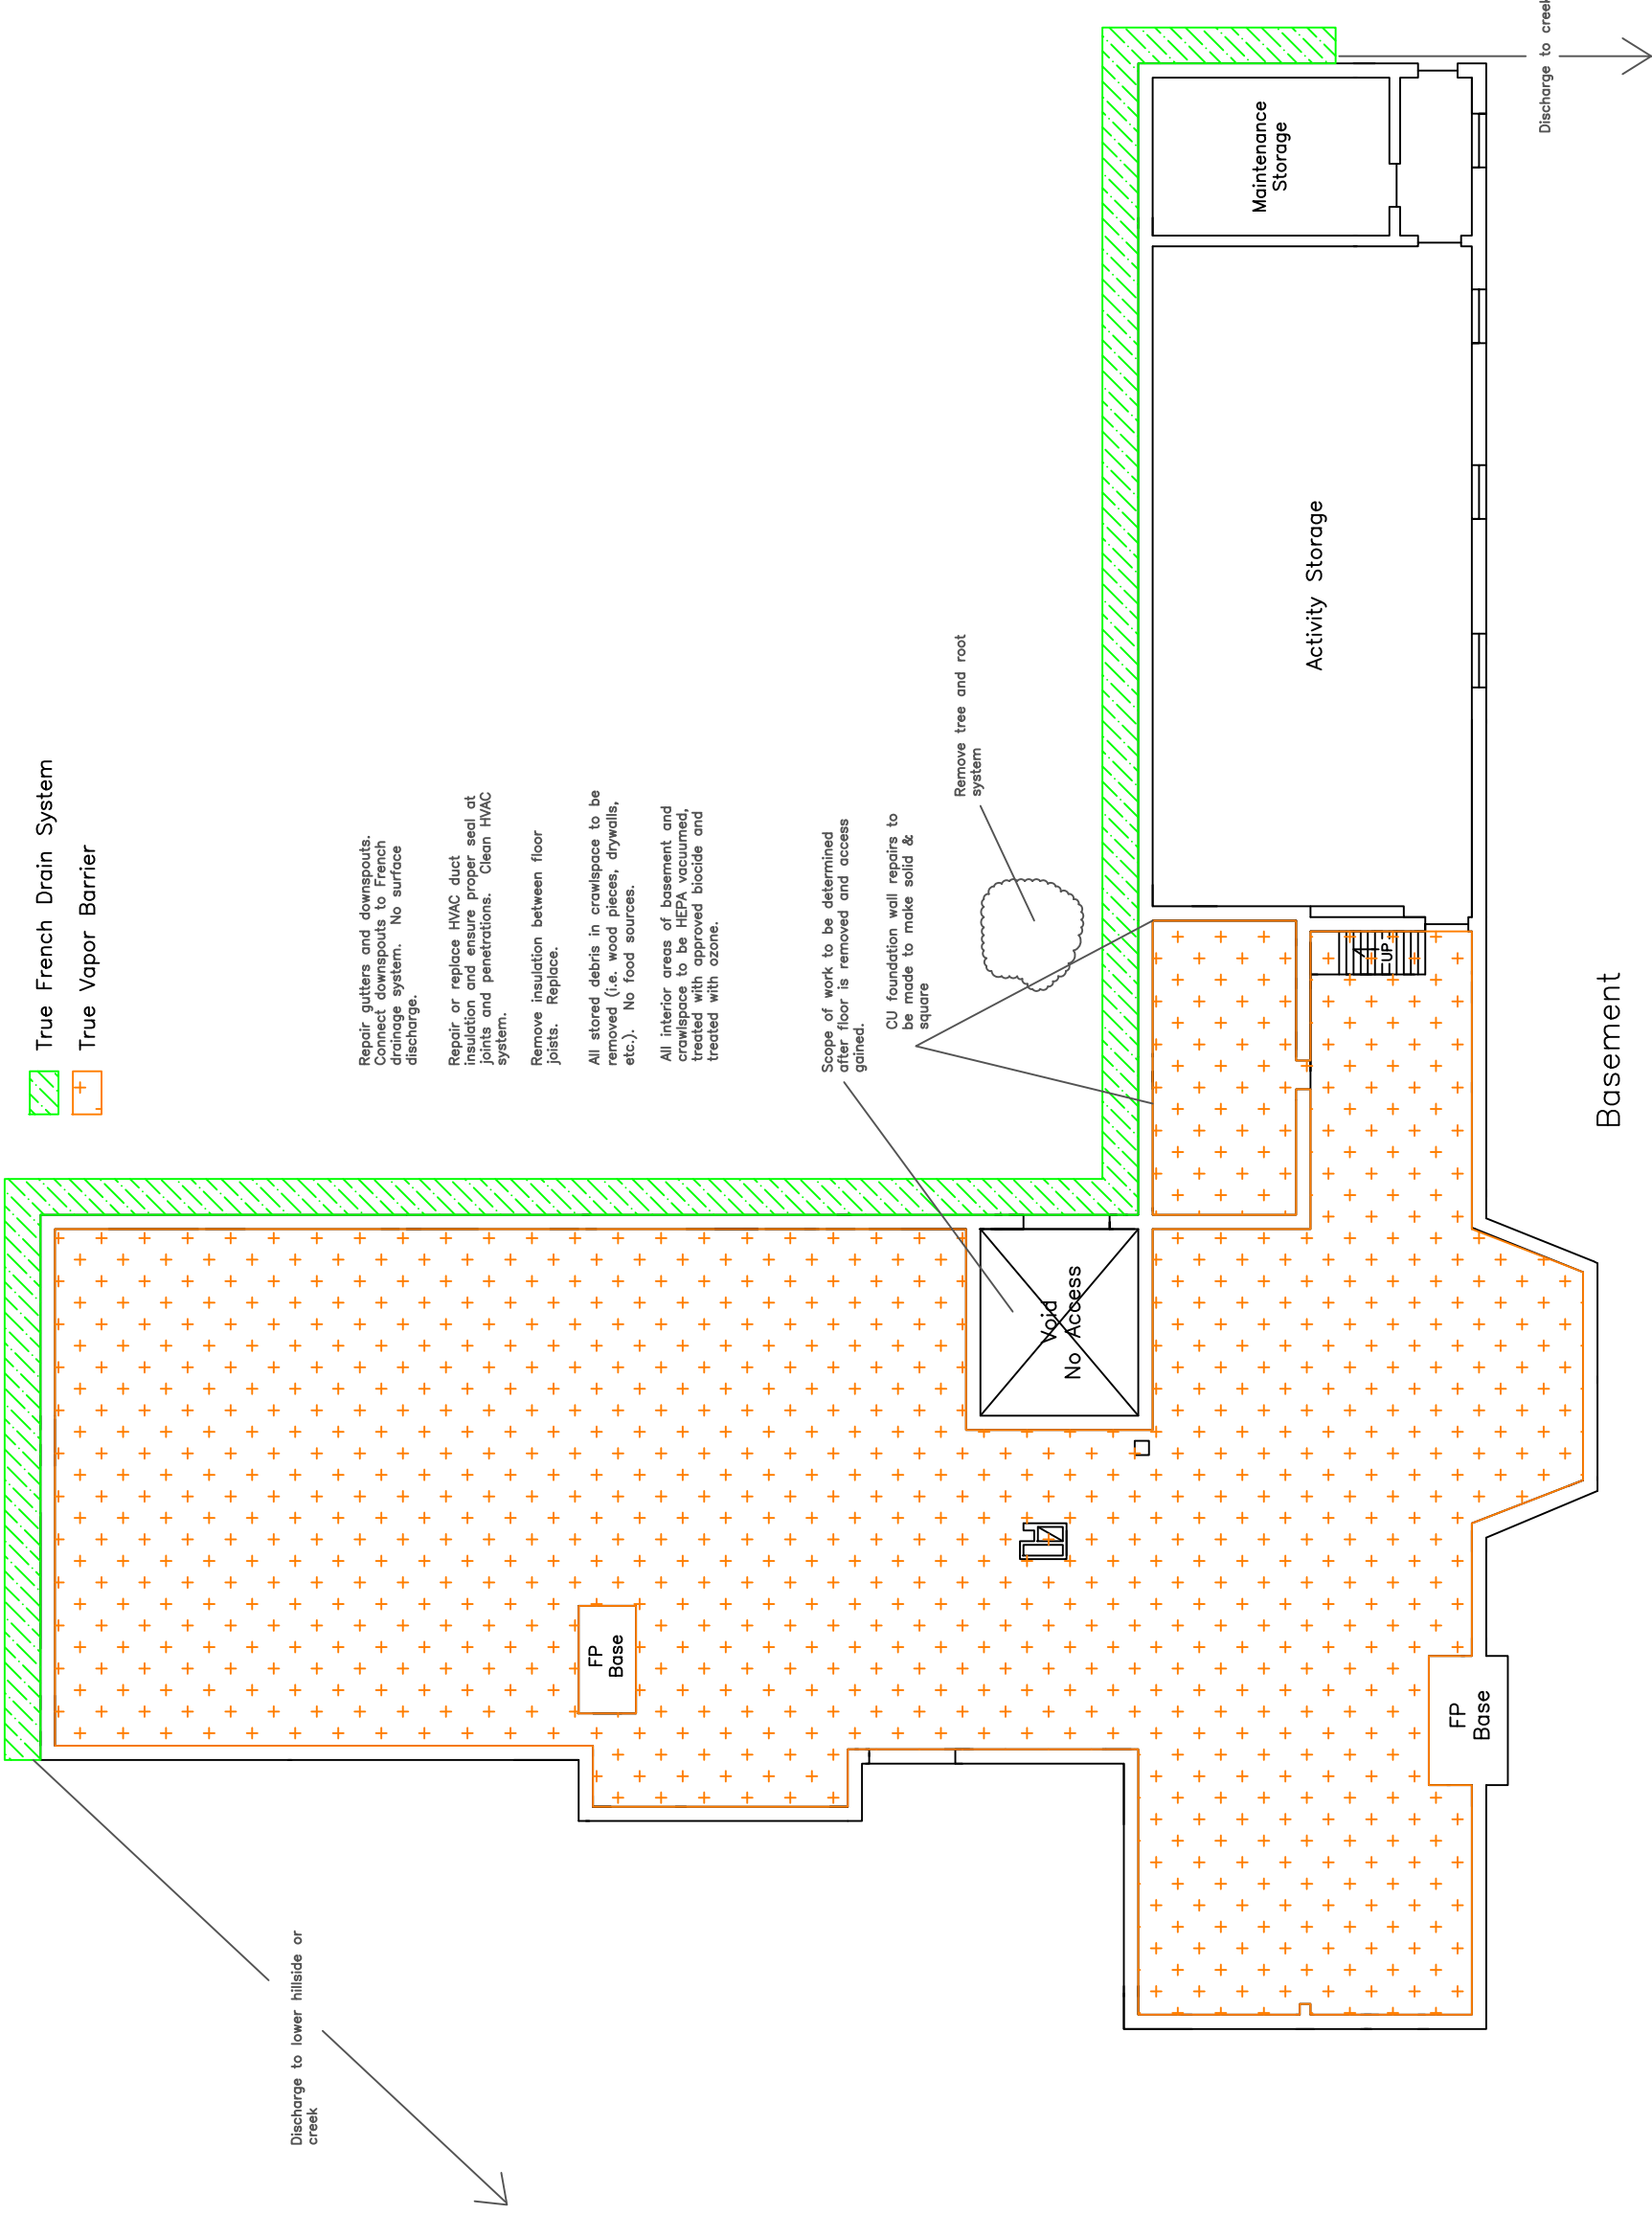
Basement

A section of foundation wall near the kitchen has been pushed by hydraulic water pressure and possibly tree roots. This is a structural issue. It will need to be corrected to stop water intrusion and protect the structure. This repair needs to be performed at the same time as the installation of the French drain.

Repair gutters and downspouts. Connect downspouts to French drainage system. No surface discharge.

Repair or replace HVAC duct insulation and ensure proper seal at joints and penetrations. Clean HVAC system.

Remove insulation between floor joists. Replace.

CU foundation wall repairs to be made to make solid & square

Remove tree and root system
