Asbestos & Lead Based Paint Assessment

City of Spartanburg
100 Georgia Street
Spartanburg, South Carolina 29306

Project Number: 0118-14

September 4, 2018

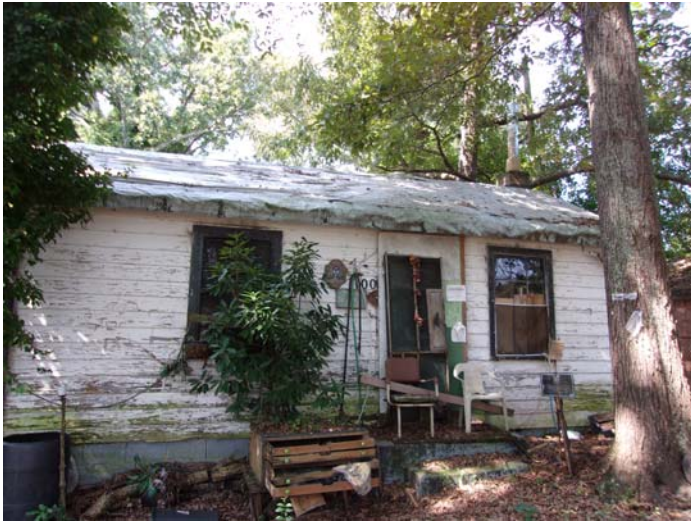
Photo 1 – 100 Georgia Street in Spartanburg, South Carolina

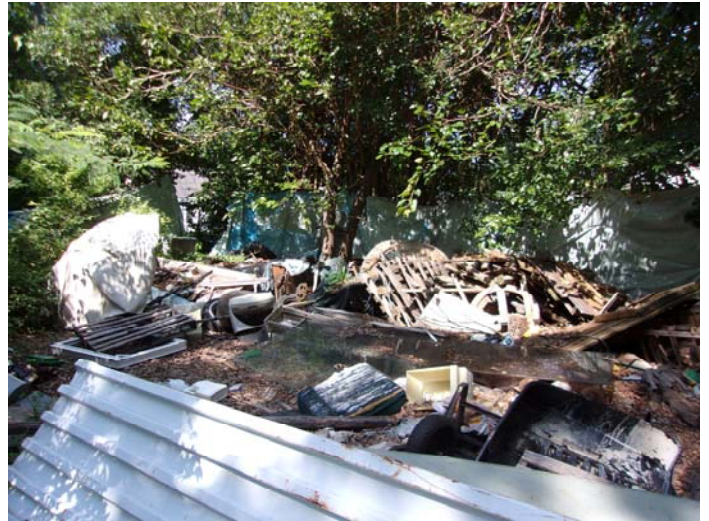
Photo 2 – Large amount of debris in the back yard

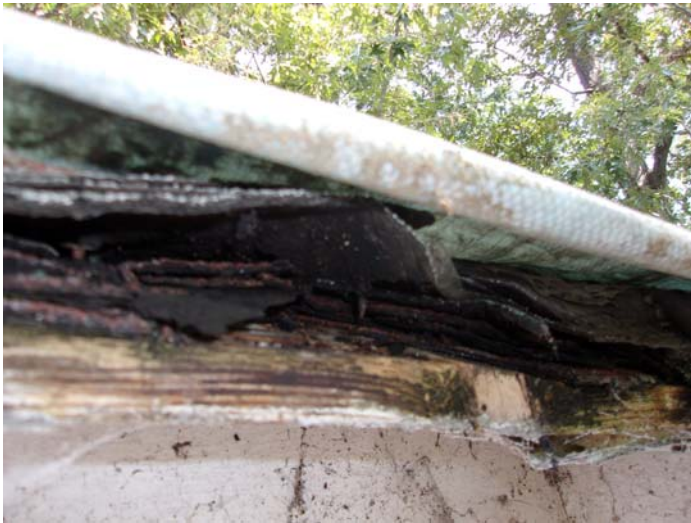
Photo 3 – Roof shingles with no felt

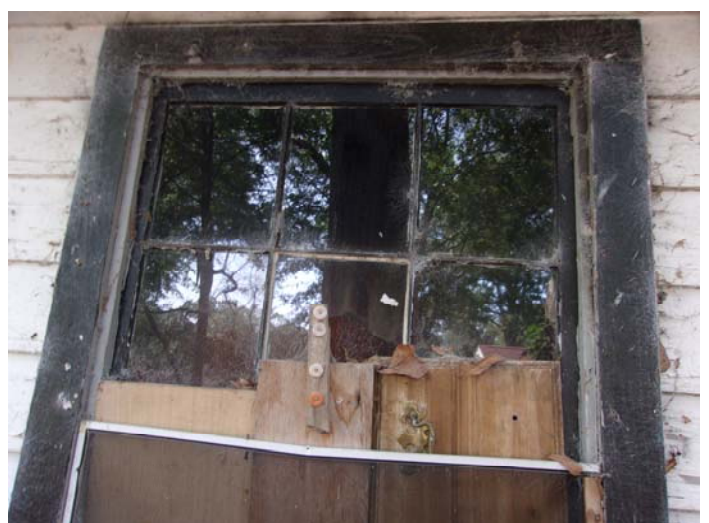
- Approximately 5 wooden windows with glazing.
- Approximately 6 LF of mastic/tar on 1 chimney – assumed positive.

4 A84959	Window Glazing	Heterogeneous	2%	Cellulose	5%	Paint	2% Chrysotile
		Black/Gray	3%	Talc	88%	Binder	
		Fibrous Bound

Photo 4 – Wooden windows with glazing

1. Abate the asbestos containing materials in the structure prior to renovation or demolition.
2. Follow applicable asbestos regulations during renovation or demolition of the structure. You should be aware that stringent requirements are imposed upon anyone renovating or demolishing a structure in which ACM will be disturbed. This work must be performed in accordance with OSHA asbestos regulations, 29 CFR 1910 & 1926, and NESHAP asbestos regulations 40 CFR 61, subpart M. South Carolina regulations require the accreditation of personnel who work in the asbestos field and notification and permitting fees for asbestos removal projects. There is a 10 working day notification period required prior to abatement of asbestos in a facility. Failure to take proper precautions and actions to protect human health and the environment can result in penalties, danger to personnel, and construction delays.

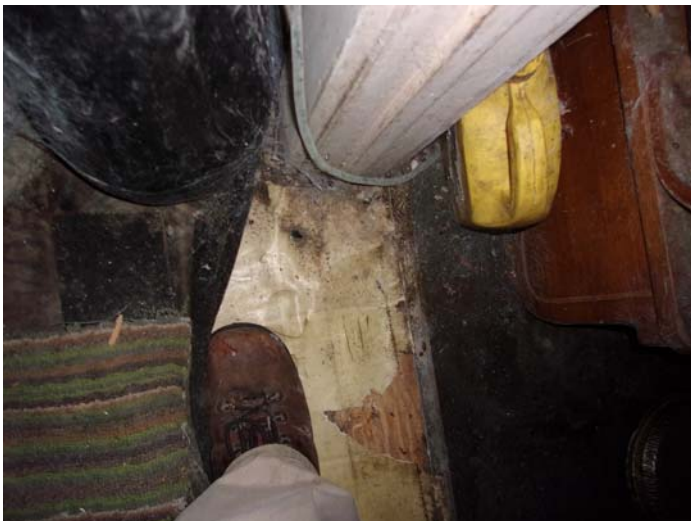
Photo 5 – Tan square pattern roll vinyl floor with no mastic in the bathroom

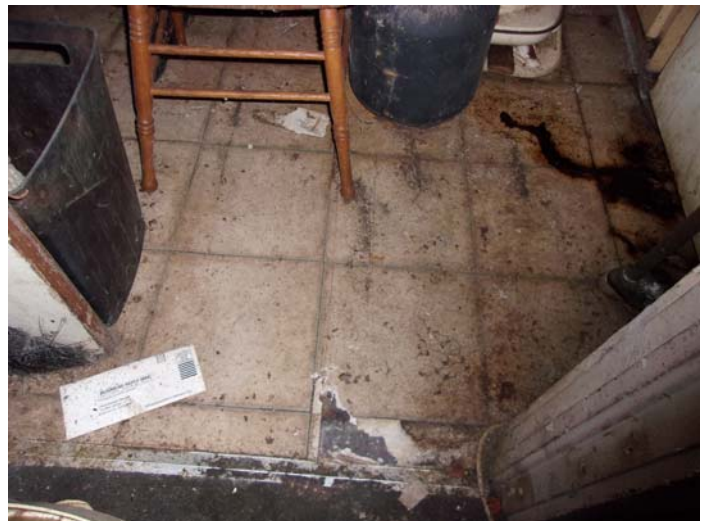
Photo 6 – 12" x 12" beige square pattern self-stick floor tile over light grey vinyl floor & mastic in the kitchen

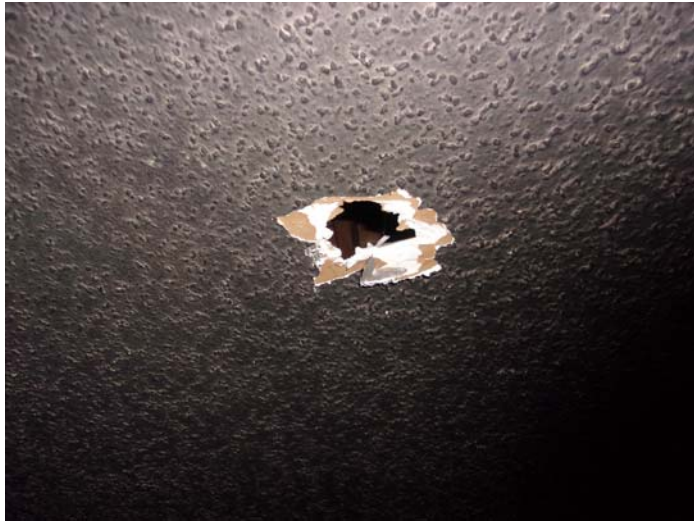
Photo 7 – popcorn ceiling texture throughout

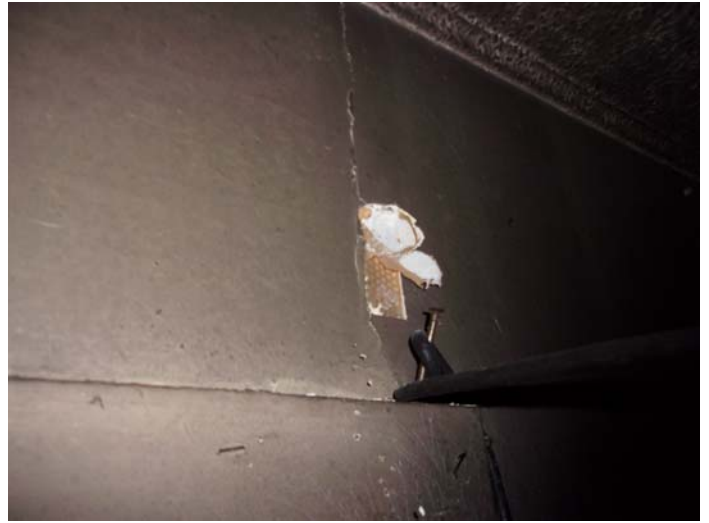
Photo 8 –Drywall with joint compound & tape throughout
