Asbestos & Lead Based Paint Assessment

City of Spartanburg
800 South Church Street
Spartanburg, South Carolina 29303

Project Number: 0118-14

November 21, 2018

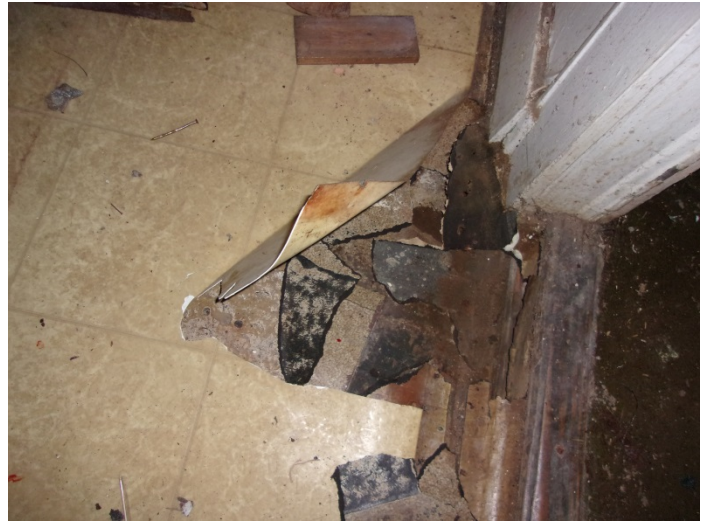
Photo 2 – 5 layers of vinyl flooring in the kitchen

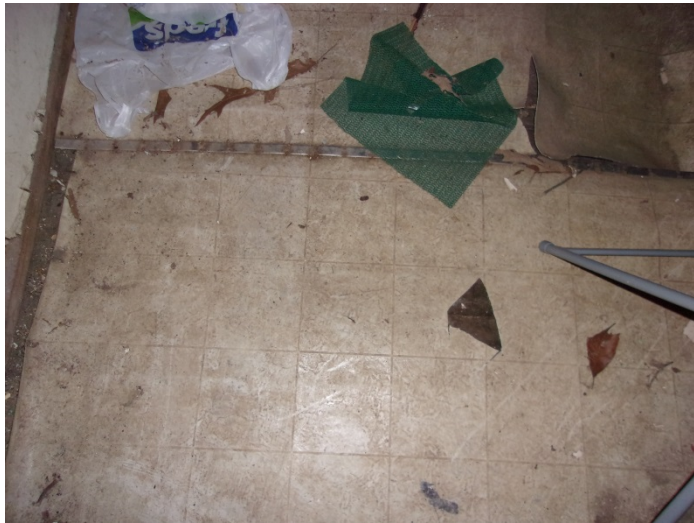
Photo 3 – Tan square pattern vinyl floor with no mastic in the front left room off of the kitchen entry door

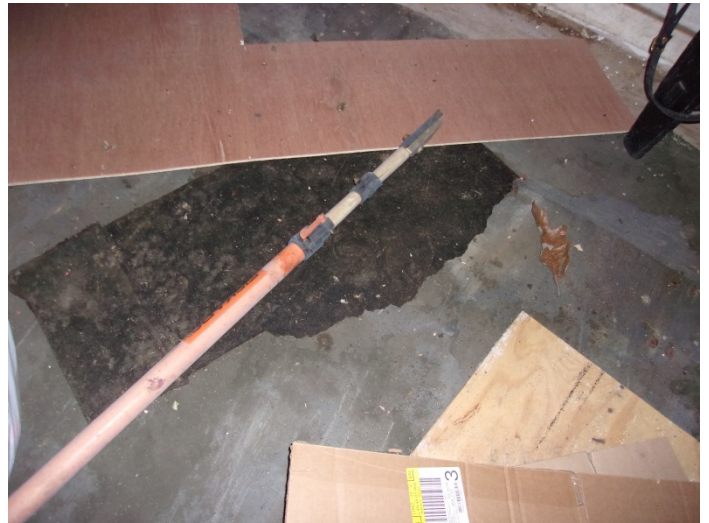
Photo 4 – Black flooring material with no mastic in the front left room off of the kitchen entry door

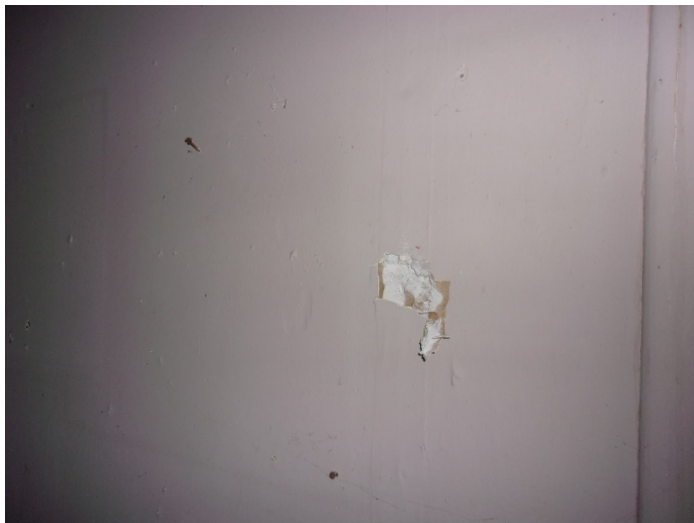
- Approximately 1,150 SF of drywall system sporadically throughout the residence.
- Approximately 1,700 SF of exterior cement board siding.
- Approximately 12 LF of tar on 2 chimneys. 1 chimney is attached to the front of the house and the other chimney is on the ground at the back of the house.

Photo 5 – Drywall with joint compound & tape throughout

1. Abate the asbestos containing materials in the structure prior to renovation or demolition.
2. Follow applicable asbestos regulations during renovation or demolition of the structure. You should be aware that stringent requirements are imposed upon anyone renovating or demolishing a structure in which ACM will be disturbed. This work must be performed in accordance with OSHA asbestos regulations, 29 CFR 1910 & 1926, and NESHAP asbestos regulations 40 CFR 61, subpart M. South Carolina regulations require the accreditation of personnel who work in the asbestos field and notification and permitting fees for asbestos

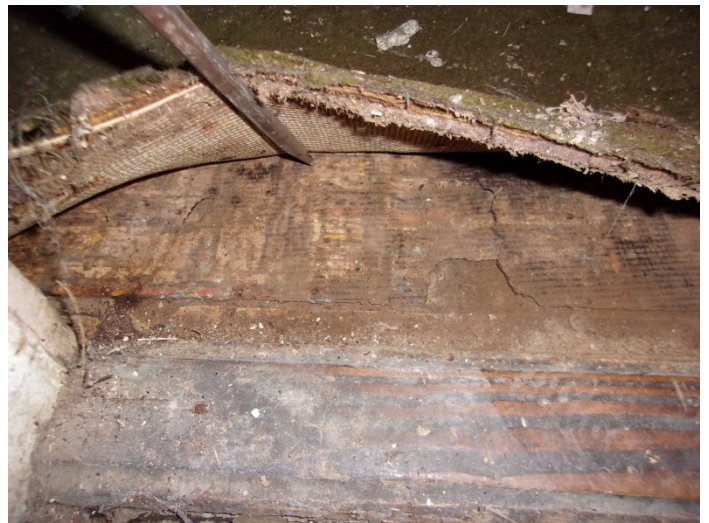
Photo 6 – 2 layers of vinyl floor under carpet in the dining room

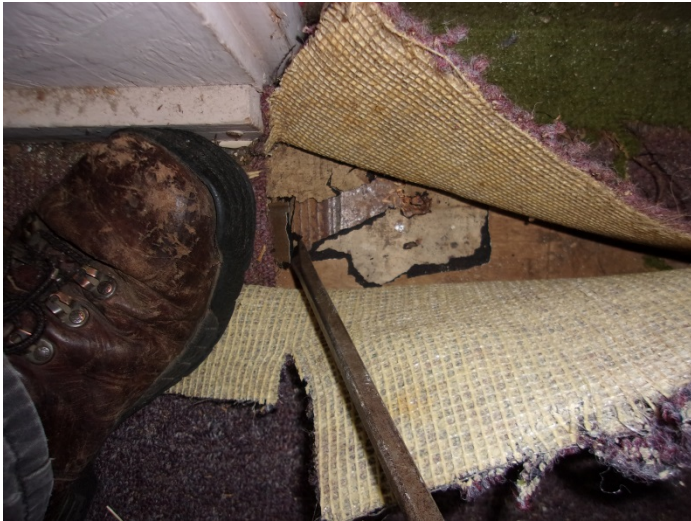
Photo 7 – 2 layers of vinyl floor under carpet in the living room

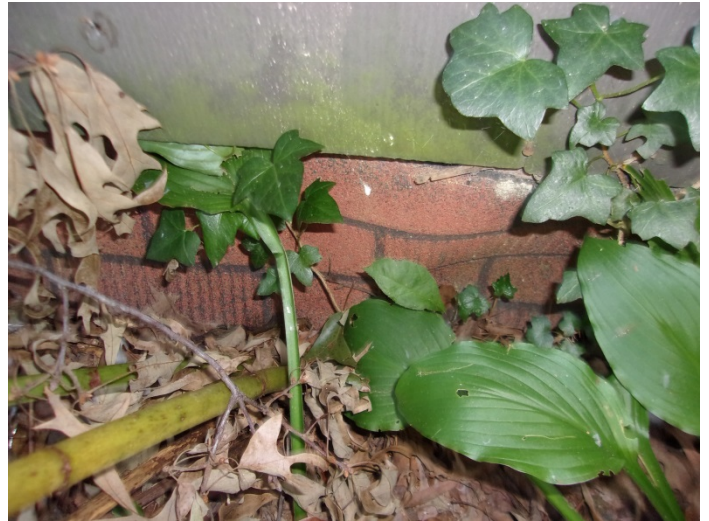
Photo 8 – Red brick pattern roll shingle exterior siding

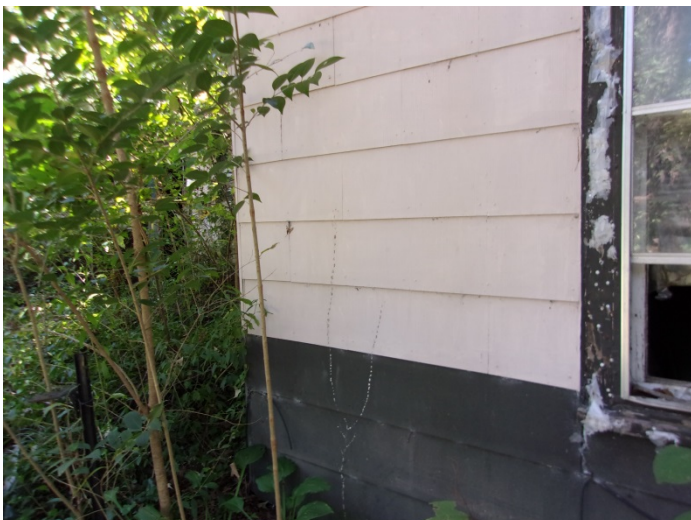
Photo 9 – Cement board exterior siding over felt paper

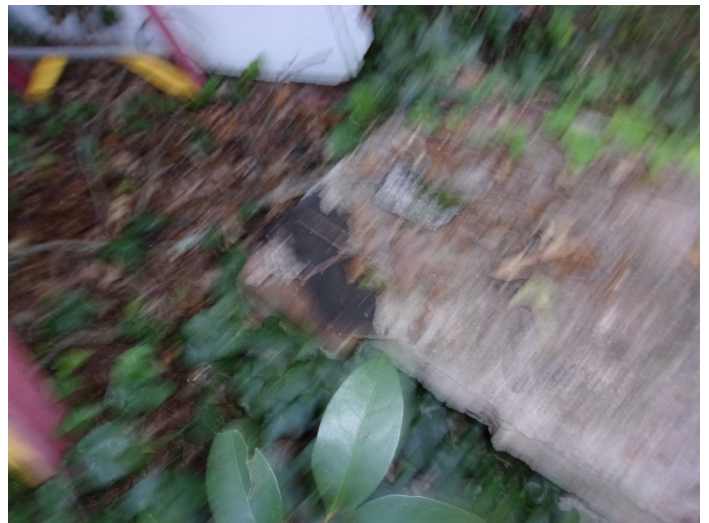
Photo 10 – Tar on chimney on the ground at the back of the house

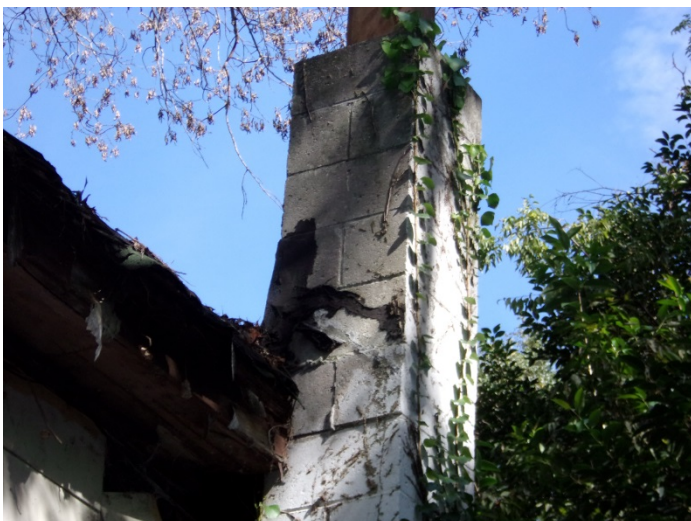
Photo 11 – Tar on chimney at the front of the house

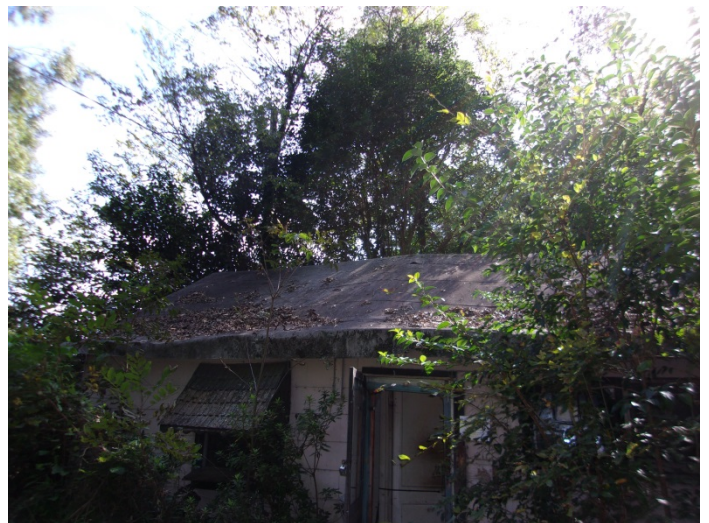
Photo 12 – Roof roll shingles with no felt on the addition of the house

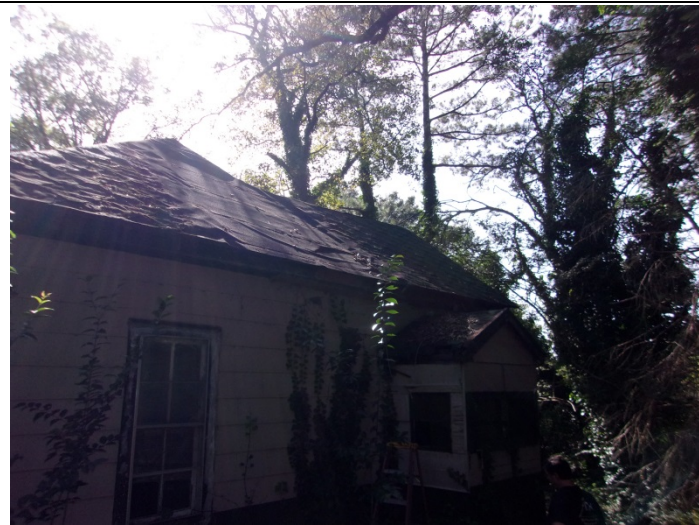
Photo 13 – Red, green & black roof shingles on the main roof of the house

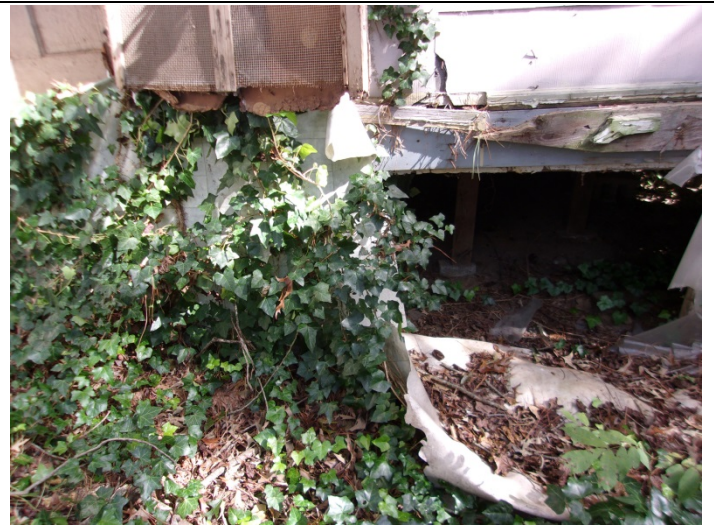
Photo 14 – Tan brick pattern roll vinyl floor with no mastic used as exterior siding
