Reference: Coral Reef Park Structural Investigations for the Existing Community Center

Coral Reef Park Structural Investigations
for the Existing Community Center

Structural Investigations Report

Reference: Structural Engineering Services for the Preliminary Structural Investigation of the Community Center at Coral Reef Park at the Village of Palmetto Bay.

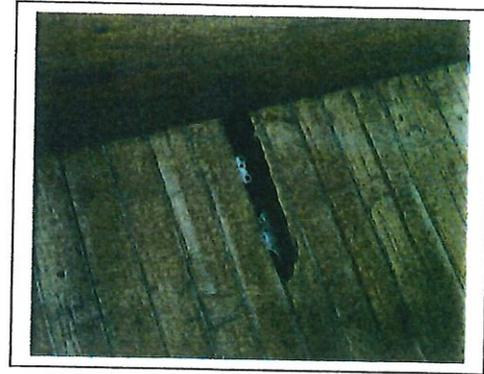
As per visual observation, several areas of the roof deck have experiencing a measure of rotting from what appears to be water intrusion. The perimeter wood beam is also experiencing some level of deterioration, manifesting itself as horizontal splitting and warping due to prolonged exposure.

Deteriorated Wood Deck

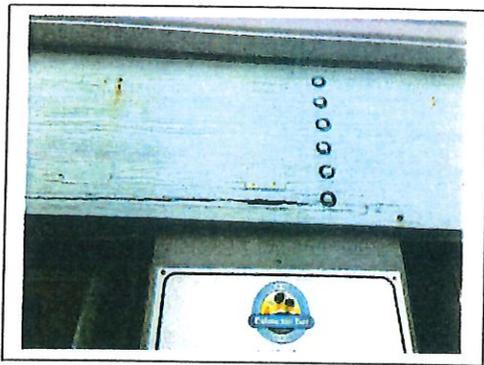
Horizontal Splitting at Connection

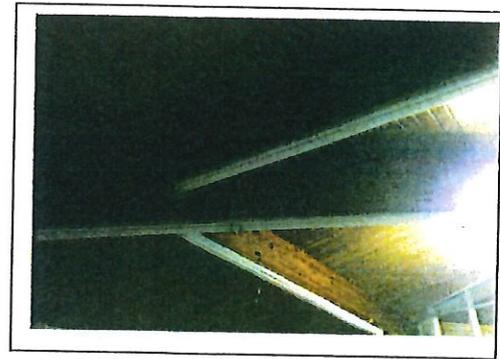
Upon first impression, the diagonal wood girders attached to the main wood girder with a bolted connection, appear to be insufficient. The connections insufficiency does pose a structural concern and should be addressed in the case of the probability that hurricane wind loads are experienced.

Hurricane wind loads are dynamic cyclic loads which may result in the prying action of connections, especially in flexible members. Furthermore, the replacement of the deteriorated areas of deck will require the full length replacement of the members, which may prove to be more costly and difficult due to the custom nature of the roof deck members.

Girder to Girder Connection

If the existing facility were to be continued to be used, numerous repairs will have to be performed in order to restore/strengthen the roof framing structure to safely accommodate the design loads. In the opinion, of our structural engineer steps should be taken if the repairs were to be implemented to add temporary supports throughout the facility in order for connections to be properly addressed.
