### **Asbestos Survey for**

### **Greenwood School District 50**

## **4805 Main Street**Single-Family Dwelling

D&F Job No. 013948.00

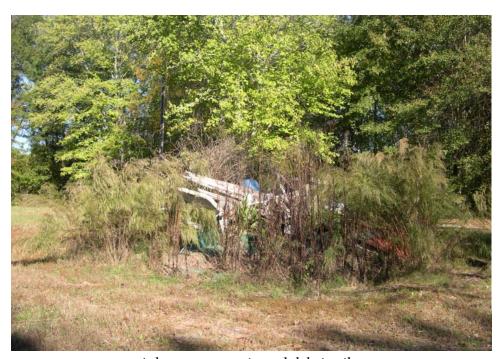
There is a 30 ft. x 30 ft. x 6 ft. (200 cy) debris pile located behind the home that has transite (asbestos) siding and other building materials mixed in. This debris pile will need to be disposed of as asbestos containing materials.

Asbestos contaminated debris pile

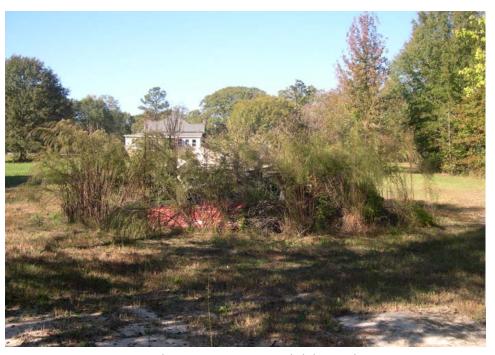
Asbestos contaminated debris pile

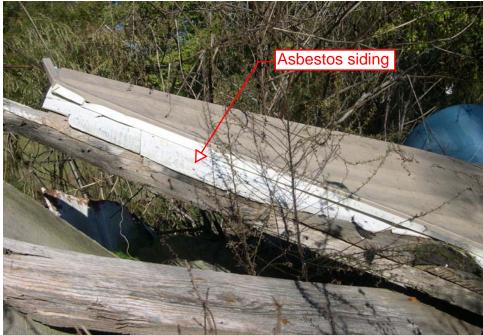
Asbestos contaminated debris pile

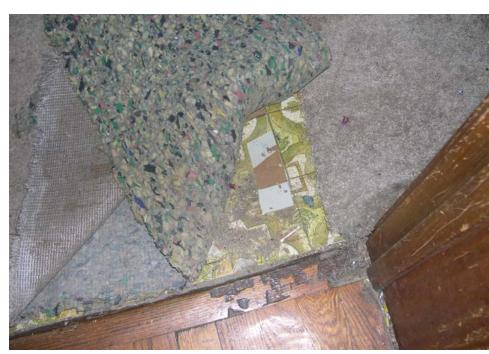
Asbestos floor covering under carpet

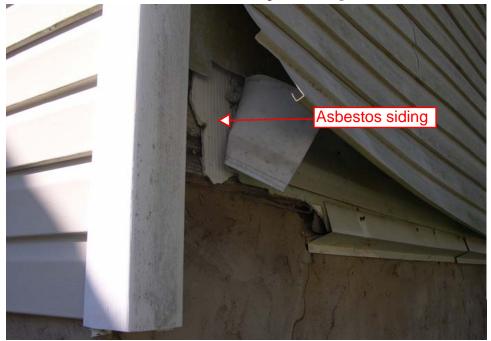
Asbestos exterior siding (transite) under vinyl siding
