ASBESTOS INSPECTION REPORT

70 Foxfire Court

Asbestos Inspections, LLC Project # 2023-01-344

Inspection Completed On – September 14, 2023
Report Prepared On – October 4, 2023

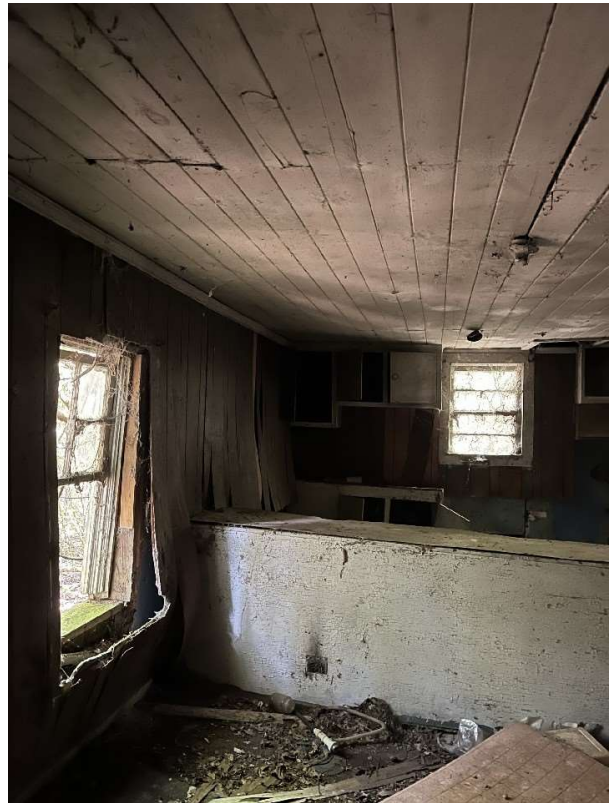
Interior Drywall on Floor

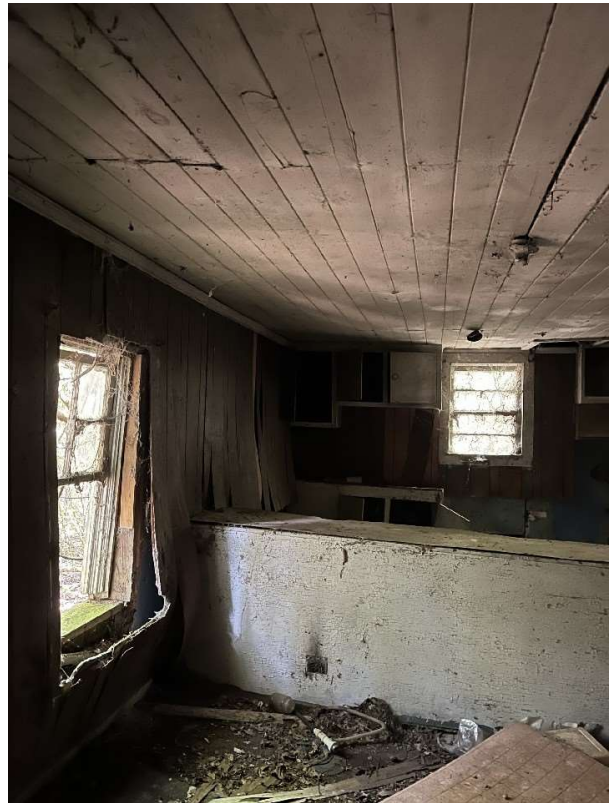
Interior Showing Drywall Debris

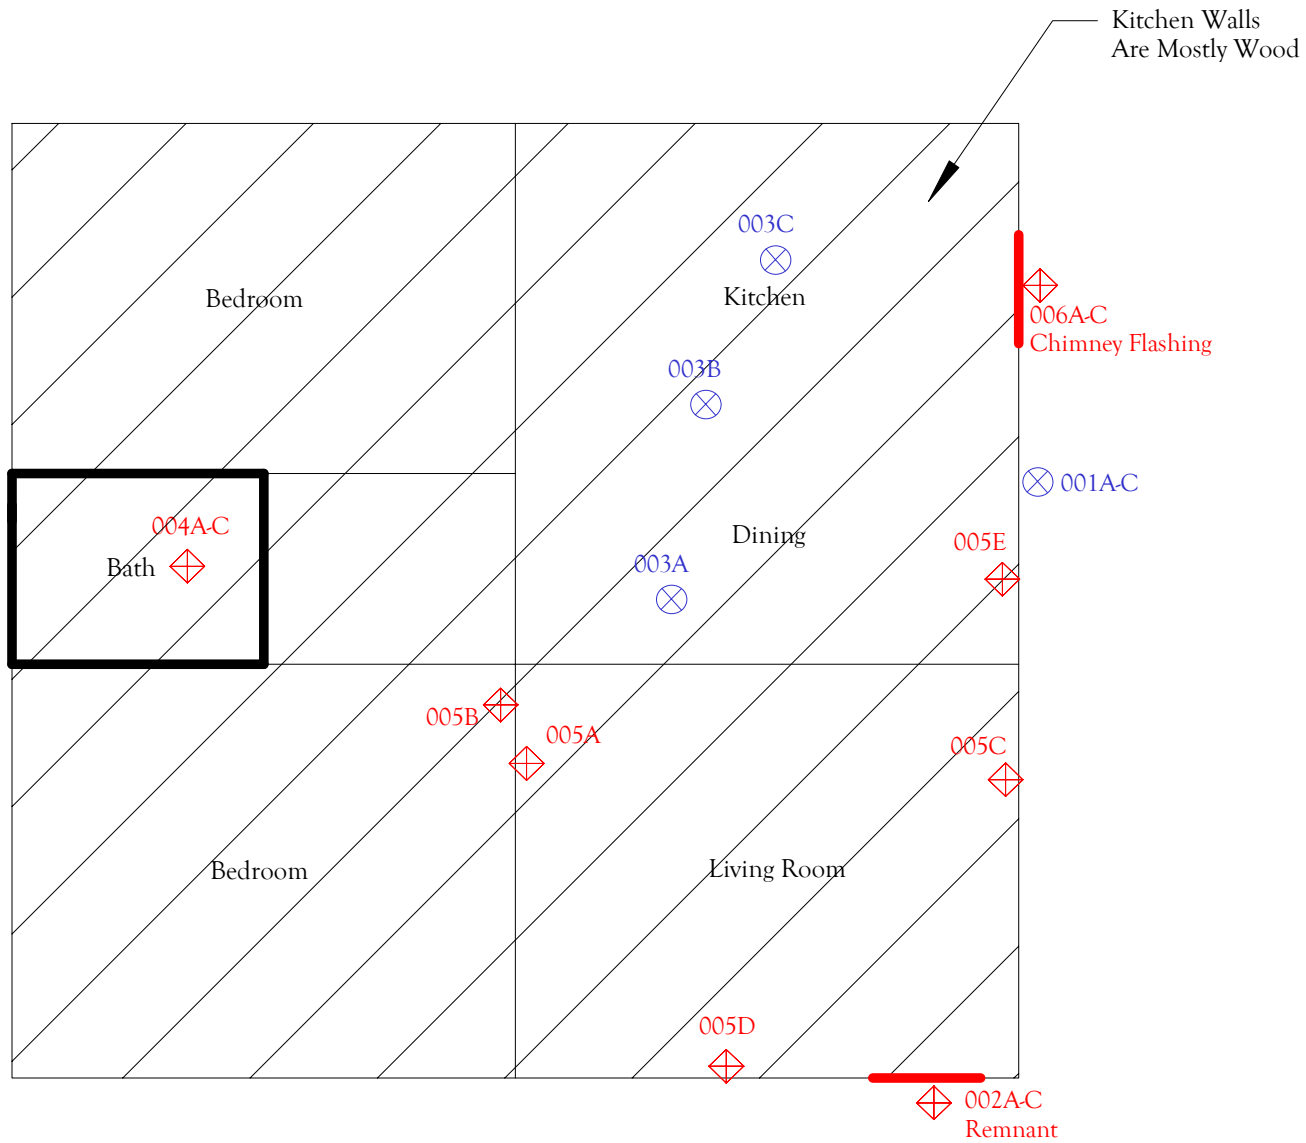
Note: Asbestos containing chimney flashing - Approx. 5 sq. ft.
 Asbestos containing remnant cementitious siding on front of house Approx. 12 sq. ft.

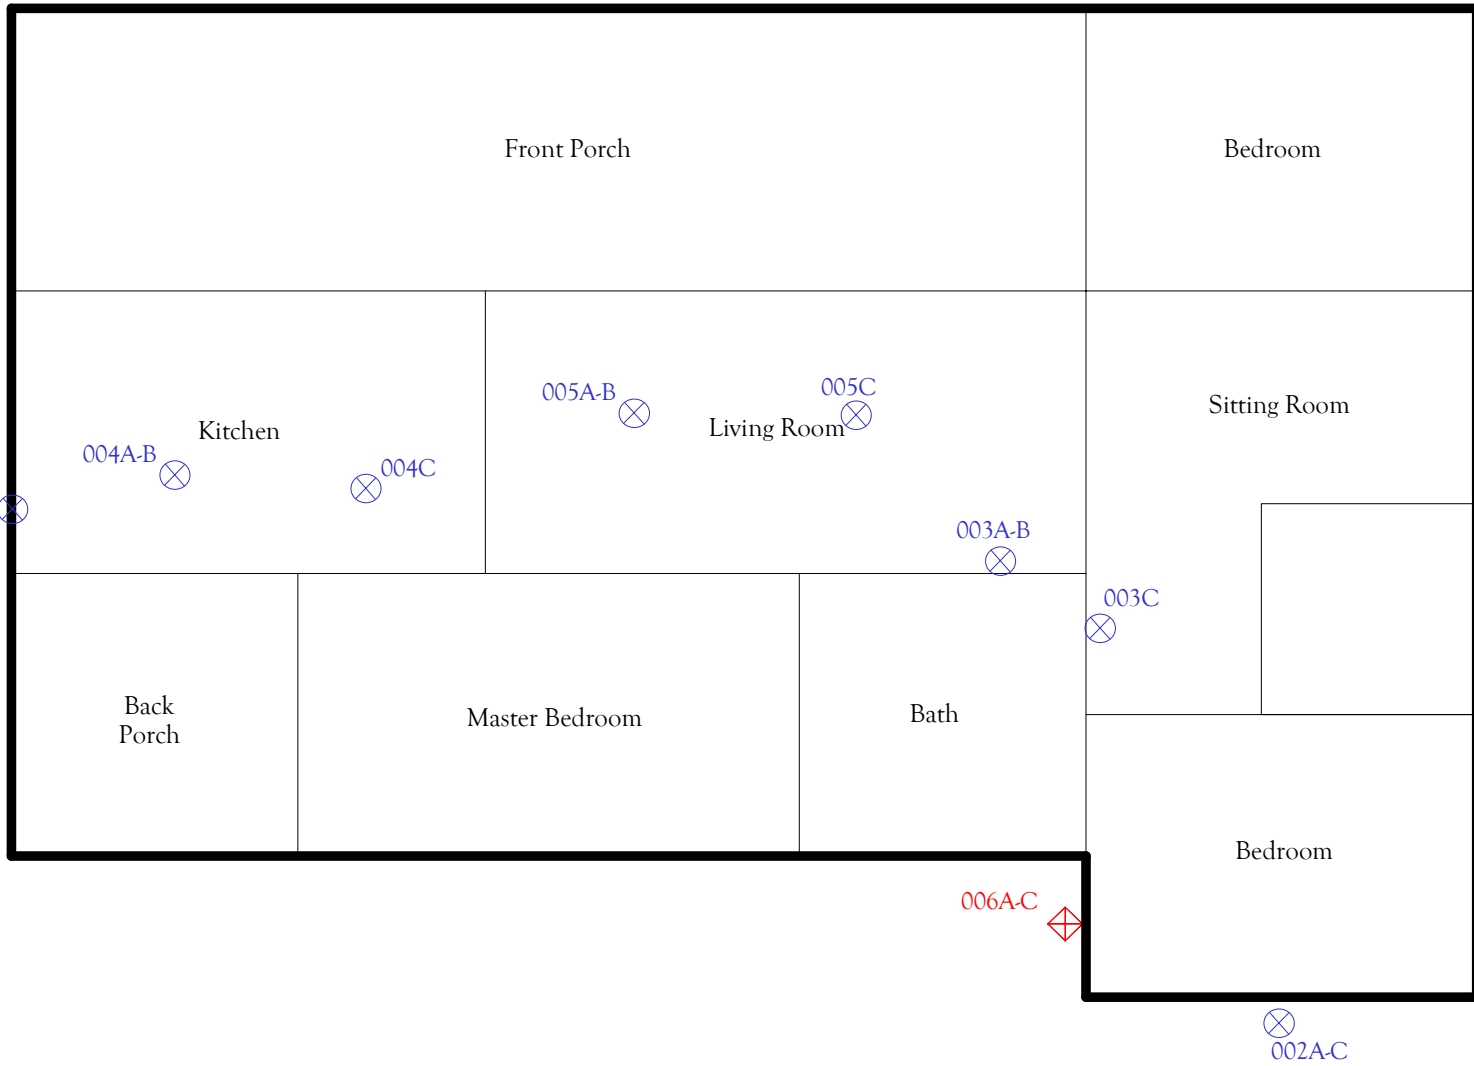
- ⊗ Sample Location
- ⊠ Asbestos Containing Sample Location
- Asbestos containing silver roof coating - Approx. 1,417 sq. ft.
