**GRANT COUNTY/SILVER CITY AIRPORT COMMERCIAL SERVICE TERMINAL
ASSESSMENT**

AIP PROJECT NO. 3-35-0039-019-2018

AUGUST 2018

BOHANNAN HUSTON, INC.

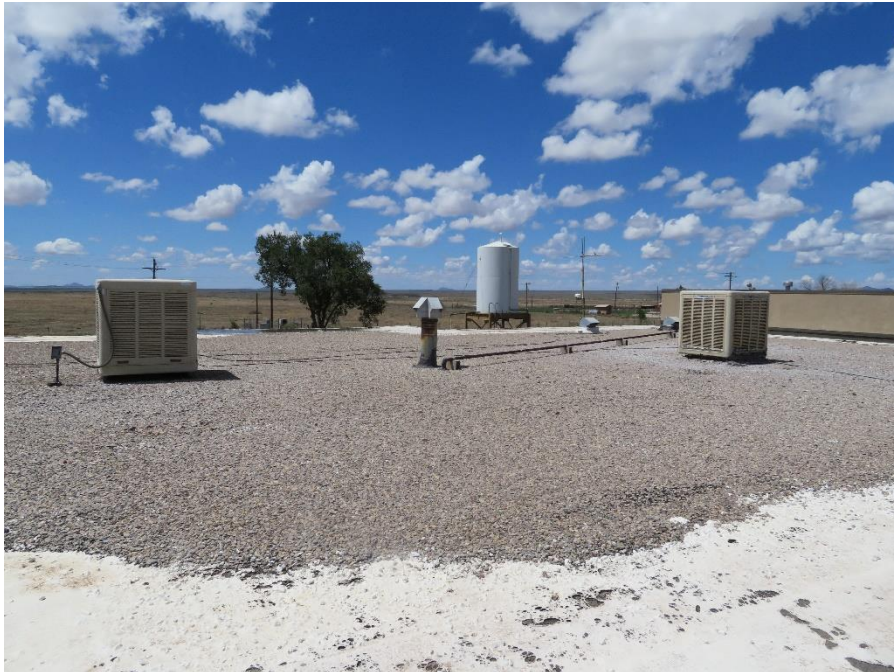
Figure 2: EXISTING COMMERCIAL TERMINAL EVAPORATIVE COOLERS

The current terminal building is cooled by two evaporative coolers, one located near the center of the public use/waiting area and the other near the center of the airline use area See **Figure 2** below. Public Use/Waiting Area cooler will need to be replaced as it is aged, rusting, and ultimately affects the air quality administered to the zone. While the airline use area, cooler is much less worn and still viable, it would be beneficial to replace and upgrade both coolers at the same time as this will maintain a uniform life span of the HVAC system.

Currently, the expanded waiting area has no existing heating, ventilation, or air conditioning. A split system is recommended to replace both heating and cooling systems. Four-way direct-expansion heat pump cassette air handlers with ground mounted condensers can replace the evaporative cooling diffusers. A wall mounted air handling unit can also be added to the expanded waiting area off this same heating and cooling system. The split system will eliminate the need for individual equipment for both heating and cooling and will not require installation of ducts thus reducing costs. These air handling units will provide the proper amount of outdoor air required for this occupancy. Further air flow analysis of the terminal could increase the number of units required. Exhaust vents and heaters are non-functional in the restrooms and will need to be replaced.

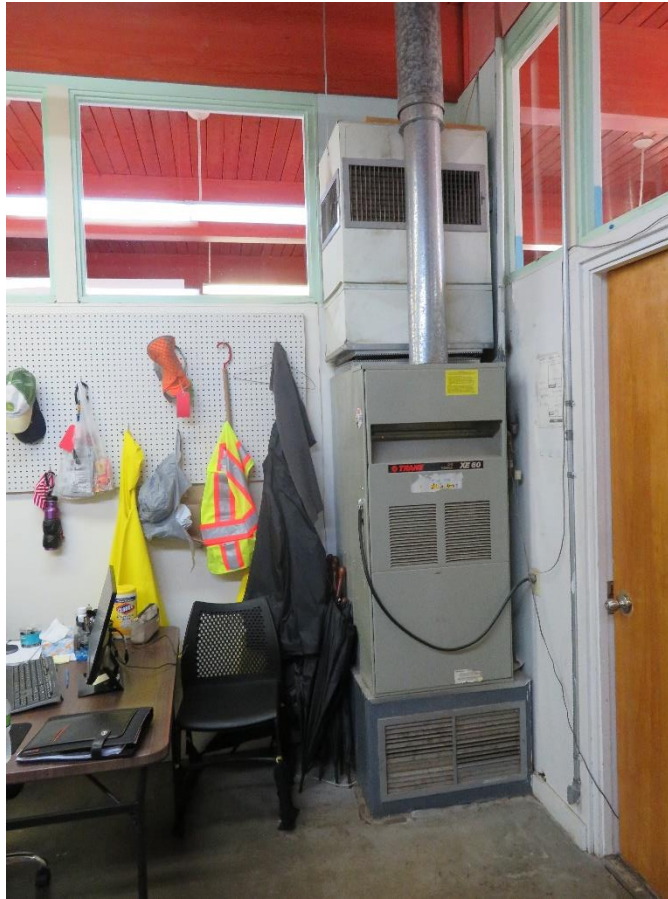
Figure 3: EXISTING COMMERCIAL TERMINAL

Heating in the terminal is provided by a single indoor furnace located in the airline use bay area. Though the furnace is elevated, it does not meet code requirements as there is no visible name plate, although this is a standard manufactured product. There is no separation of flammable stored items from the furnace housing. See **Figure 33** below.

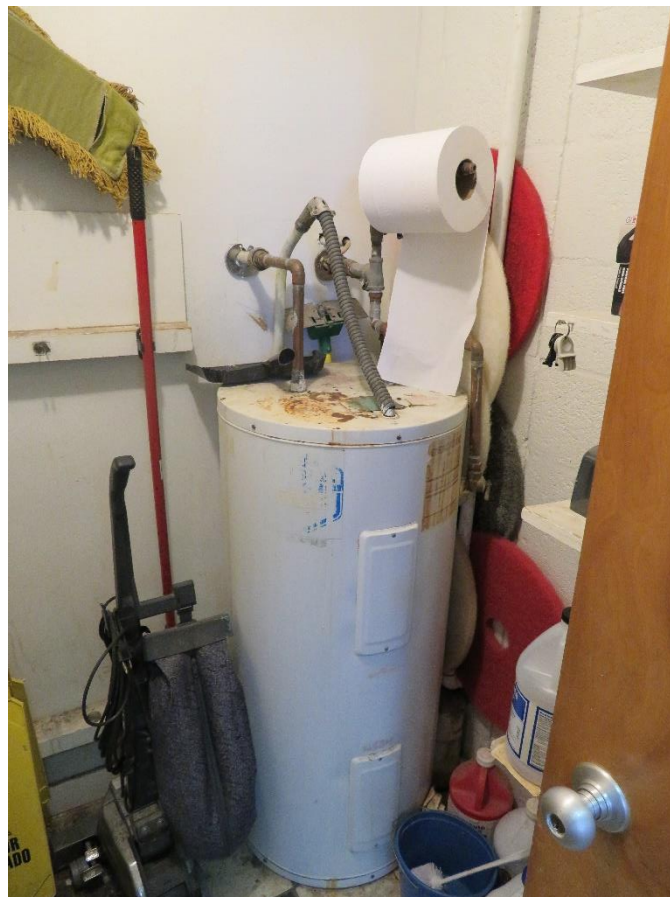
Figure 4: EXISTING COMMERCIAL TERMINAL WATER HEATER

Fixtures are fed via a well with a regulated pressure of 45 psi, by means of a pressure tank at the well head. A 40-gallon capacity water heater located in the janitor's supply closet delivers hot water in the system. The existing water heater has begun to rust, the name plate is becoming illegible, and is not adhering to proper code clearances. The source of water is not disinfected by any means.

Water supply piping material appears to be copper tubing, but the overall condition was not analyzed during the site visit due to lack of access. Judging from the appearance of exposed piping (See Figure 44), it is possible the supply piping will need to be fully replaced.

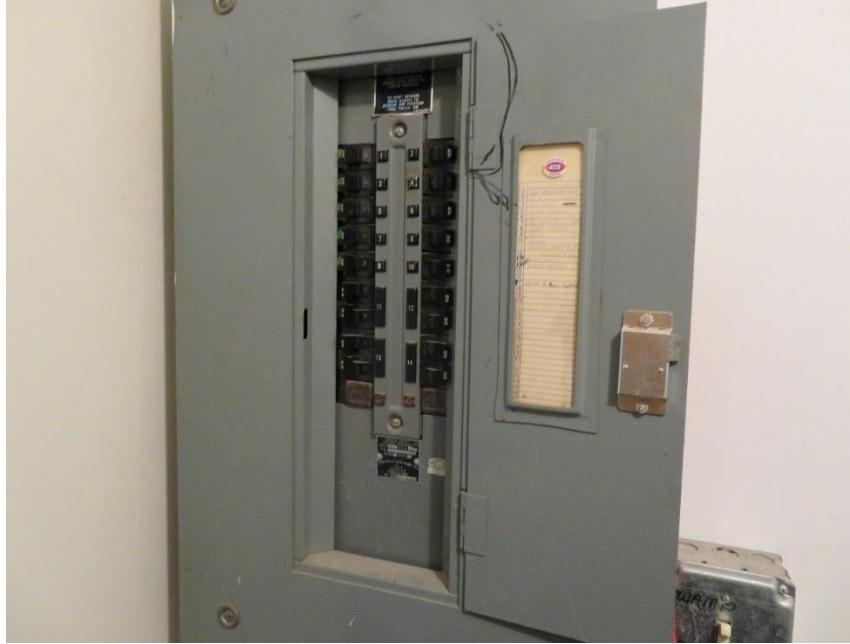
Figure 5: UNNAMED PANEL

The new main disconnect panel at the electrical service (Panel "DP") serves the airfield electrical vault and three sub-panels within the commercial service terminal. Sub-panel "C" is in the ARFF storage room (space 9) and is a modern electrical panel. There is a sub-panel with no ID label located in the Janitor Closet (space 7) located near the water heater and sink, and is an older electrical panel made by Federal Pacific. It does not have a manufacture date label but from its appearance it can be assumed that is was installed during a 1971 renovation.

1. It is recommended that the sub-panels in original building (spaces 2 and 7) be replaced with modern units that are properly rated for available short circuit current from the utility.
2. The panel in the janitor's closet is quite close to the water sources and should be moved or replaced with a wet location rated panel.

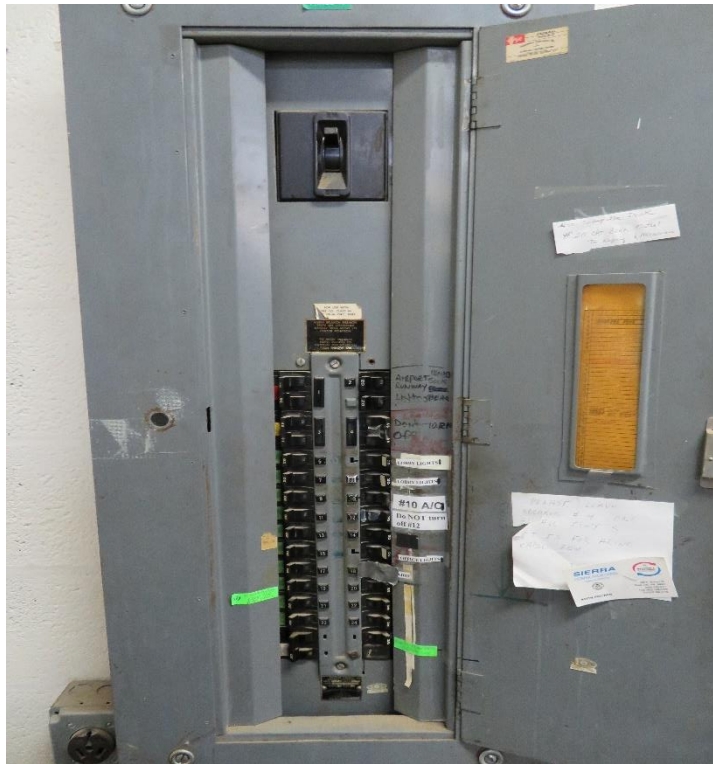
Figure 7: PANEL A

Sub-panel "A" is in the airline use area (space 2) and is also an older Federal Pacific Panel, it also appears to be from a 1971 renovation.

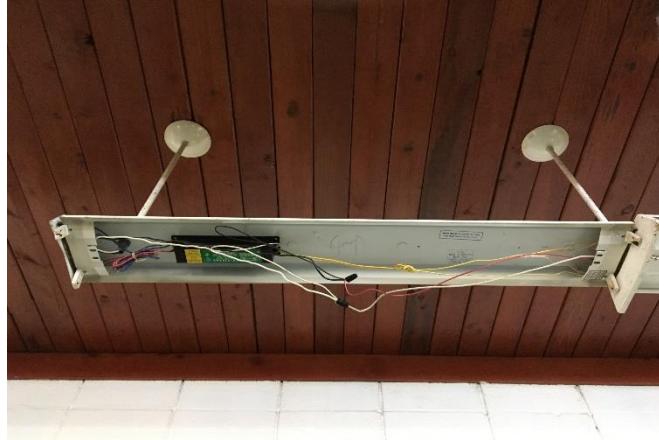
Figure 8: NON-FUNCTIONAL LIGHTING

The interior lighting is ceiling mounted fluorescent fixtures in the ARFF section of the building in the ARFF addition (spaces 8, 9, and 10). The rest of the building is also lighted with fluorescent fixtures, many of which are non-functional especially in the airline use area (space 2). None of the fixtures provide life safety emergency egress lighting.

3. Replace all receptacles and associated wiring and conduits in the original building (spaces 1 through 7 and 11).
4. Replace all interior lighting fixtures and associated switches, wiring and conduits in original building (spaces 1 through 7 and 11).
5. Install building egress perimeter lighting and parking area lighting.
6. Replace all power branch circuits including wiring and conduits in original building (spaces 1 through 7 and 11).

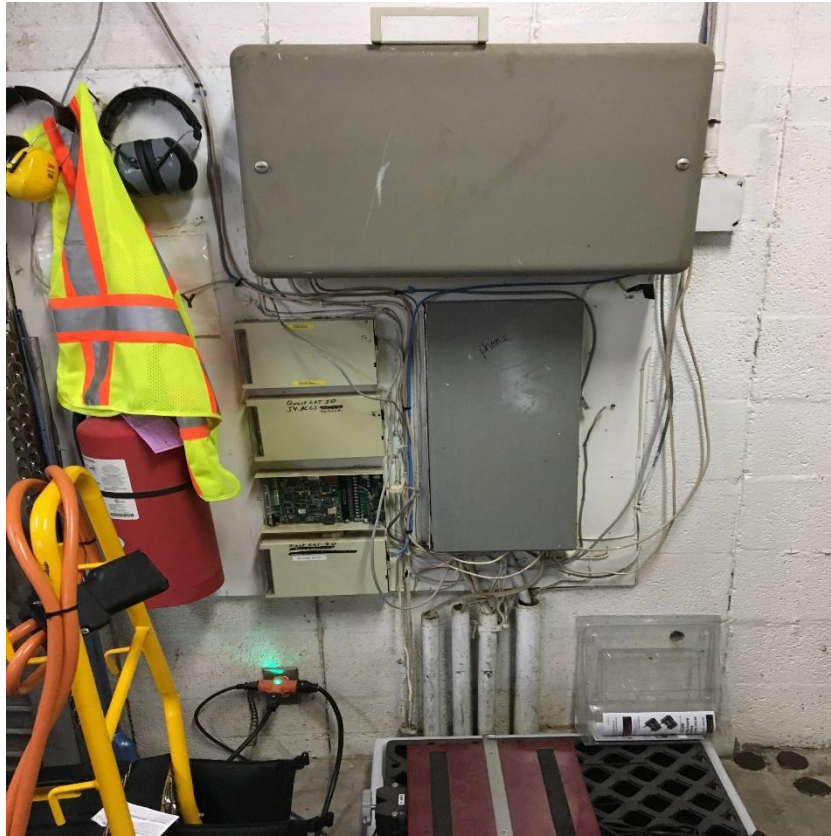
Figure 9: COMMUNICATIONS WIRING

The communication systems are functional, and staff reported no complaints, but the installation appears to have been an install to fit design. (see Figure 98 below).

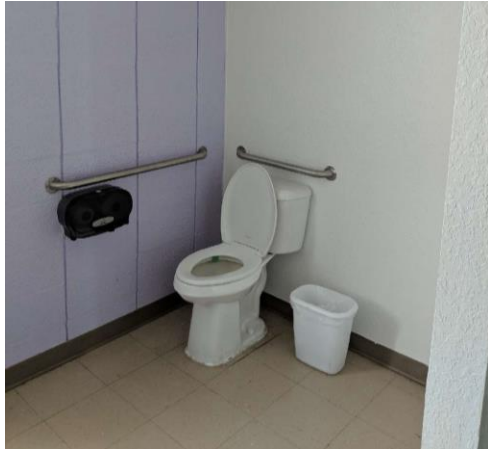
The restrooms do not meet ADA standards, and the layout in the restrooms will need to be changed. The fixtures within these restrooms also do not meet ADA dimensional and material standards.

Figure 15: P6 WOMENS RESTROOM – note only one toilet

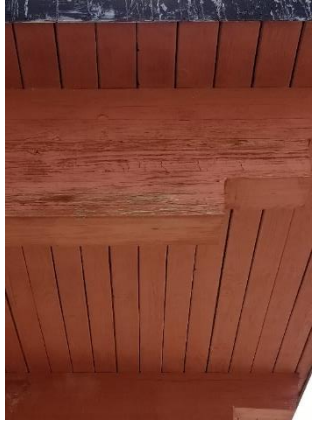
Figure 21: EXTERIOR
GLULAM BEAM –
WEATHERED DETAIL

3. The weathered exterior portion of the glulam beams on the exterior of the building are of structural concern and will just need to be refinished to remove damaged portions and resealed. Also recommended is regular maintenance and reapplication of wood sealant on exterior conditions.

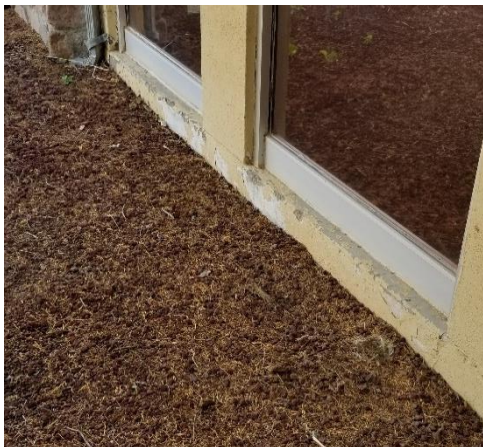
Figure 24: EXTERIOR NW STEM
WALL AT VESTIBULE

1. Based on visual observations during the structural site visit, the building is in fair condition, structurally. The biggest concern is the area outside of the terminal vestibule where water is being reported to migrate through the CMU stem wall into the building. This can cause the steel reinforcement to become rusted and begin to swell and damage the stem wall and footings.

2. A recommendation is a moisture barrier be placed between the CMU stem wall and the soil, as well as between the slab and the soil to reduce the risk of moisture intrusion through the masonry. This would include removal of the interior slab to allow for the installation of a vapor barrier and replacing the slab and reinforcement.
