Preliminary Engineering Assessment (PEA)

Pensacola Beach Public Safety

June 3, 2021

**Thompson Engineering &
Thompson Consulting Services**

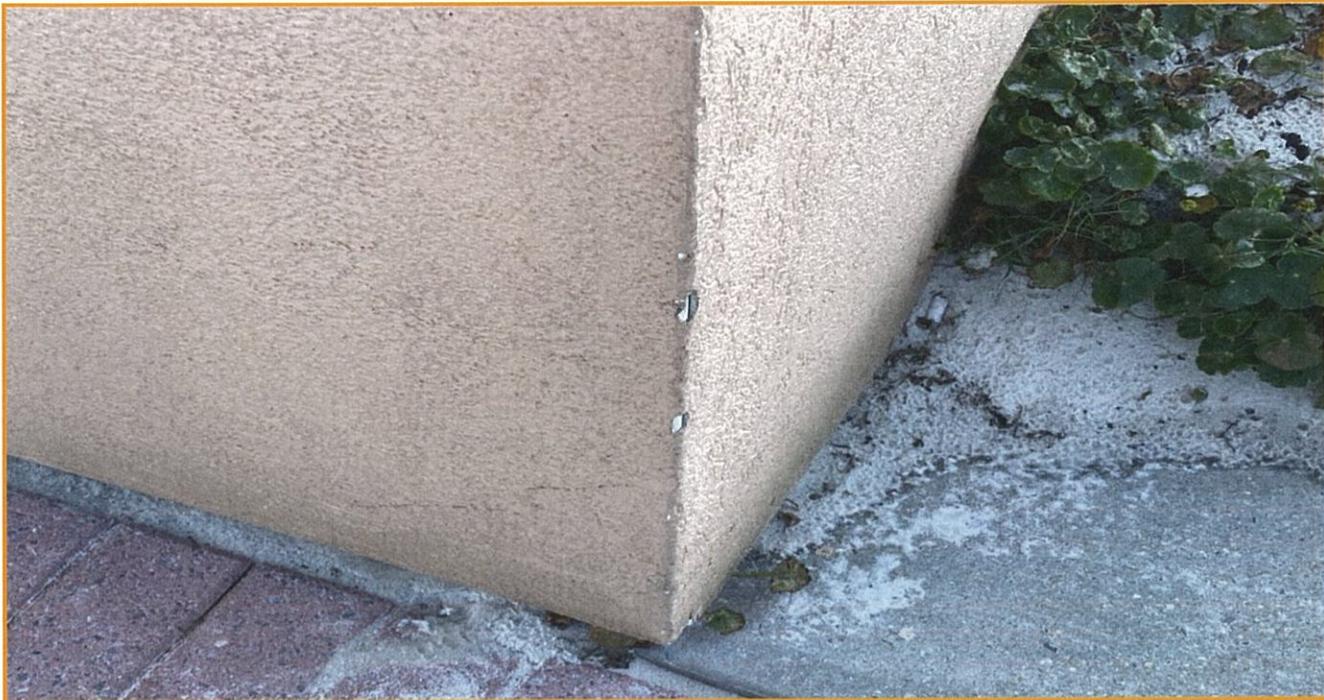
Location	Observed Damage	Condition Assessment Recommendations	Quantity	Reference Image
Stucco Façade	Impact damage to southeast corner	Remove and Replace	6 SF of selective stucco siding demolition 3 LF of stucco bead trim 0.67 SY of 3 coat stucco with bonding agent 6 SF of exterior stucco siding paint	Figure 2.2.1.1
Stucco Façade	Damage to elastomeric coating	Repaint	93.6 SF of paint and waterproofing	Figure 2.2.1.2 Figure 2.2.1.3
Exterior Door	Moisture damage to door, door closer, and electronic keypad	Remove and Replace	One (1) of exterior door lockset demolition One (1) of door closer demolition One (1) rack and pinion door closer One (1) keypad access lockset 21 SF of exterior door surface prep and paint	Figure 2.2.1.4 Figure 2.2.1.5
Ground Level Foyer	Moisture damage to wall finish assemblies	Remove, Replace, and Repaint	175 SF of double coat plaster on wall demolition 175 SF of gypsum wallboard demolition 19.5 SY of ½" thick gypsum lath 19.5 SY of 2 coat gypsum plaster 175 SF of priming and painting	Figure 2.2.1.6 Figure 2.2.1.7 Figure 2.2.1.8

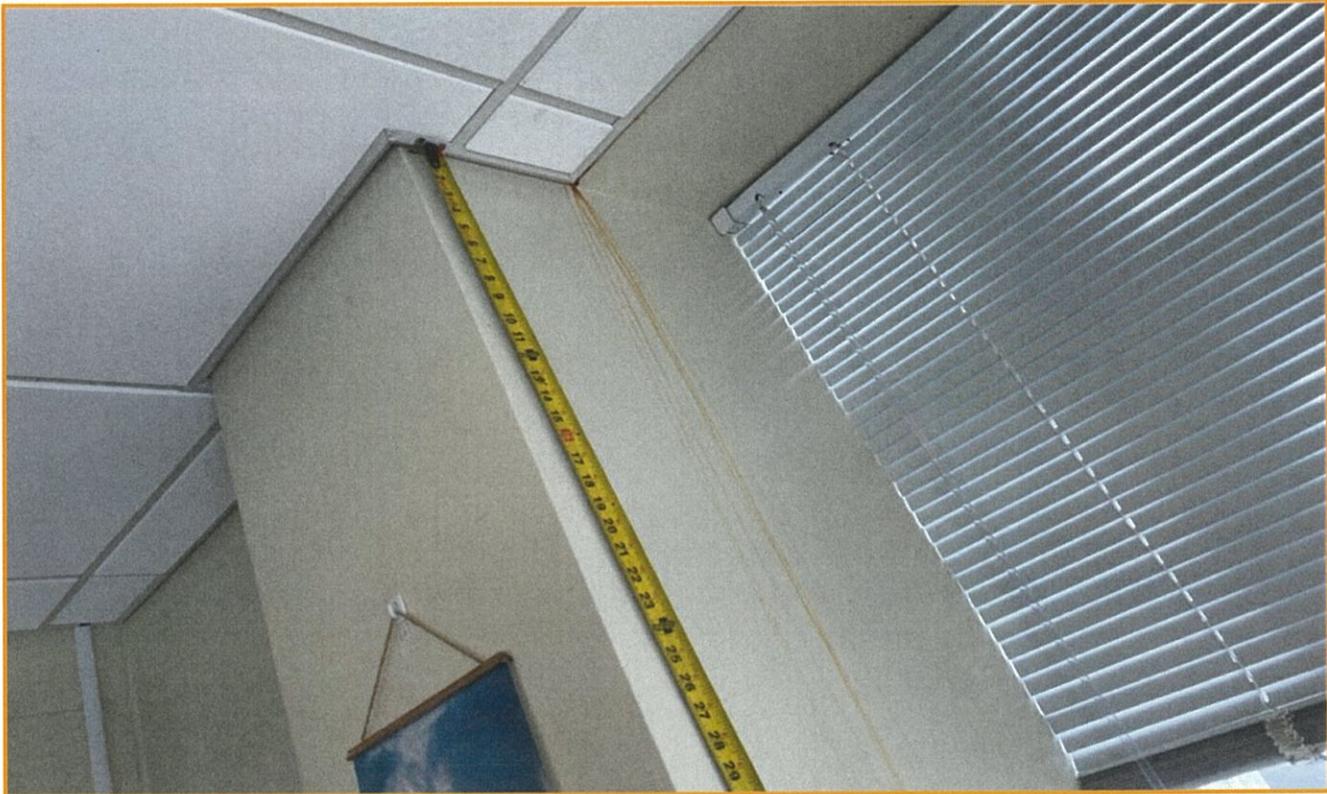
Ground Level Foyer	Moisture damage to window sill tops	Remove and Replace	8 SF of selective marble demolition 8 LF of marble window sill	--
Dave's Office	Moisture damage to wall finish assemblies	Remove, Replace, and Repaint	4.4 SF of double coat plaster on wall demolition 4.4 SF of gypsum wallboard demolition 0.44 SY of ½" thick gypsum lath 0.44 SY of 2 coat gypsum plaster 4.4 SF of priming and painting	Figure 2.2.1.9
Dave's Office	Moisture damage to window sill tops	Remove and Replace	8 SF of selective marble demolition 8 LF of marble window sill	--
Command Center	Moisture damage to wall finish assemblies	Remove, Replace, and Repaint	55.4 SF of double coat plaster on wall demolition 40.5 SF of gypsum wallboard demolition 4.50 SY of ½" thick gypsum lath 6.16 SY of 2 coat gypsum plaster 55.4 SF of priming and painting	Figure 2.2.1.10 Figure 2.2.1.11 Figure 2.2.1.12
Command Center	Moisture damage to window sill tops	Remove and Replace	5.5 SF of selective marble demolition 11 LF of 6" wide marble window sill	Figure 2.2.1.13

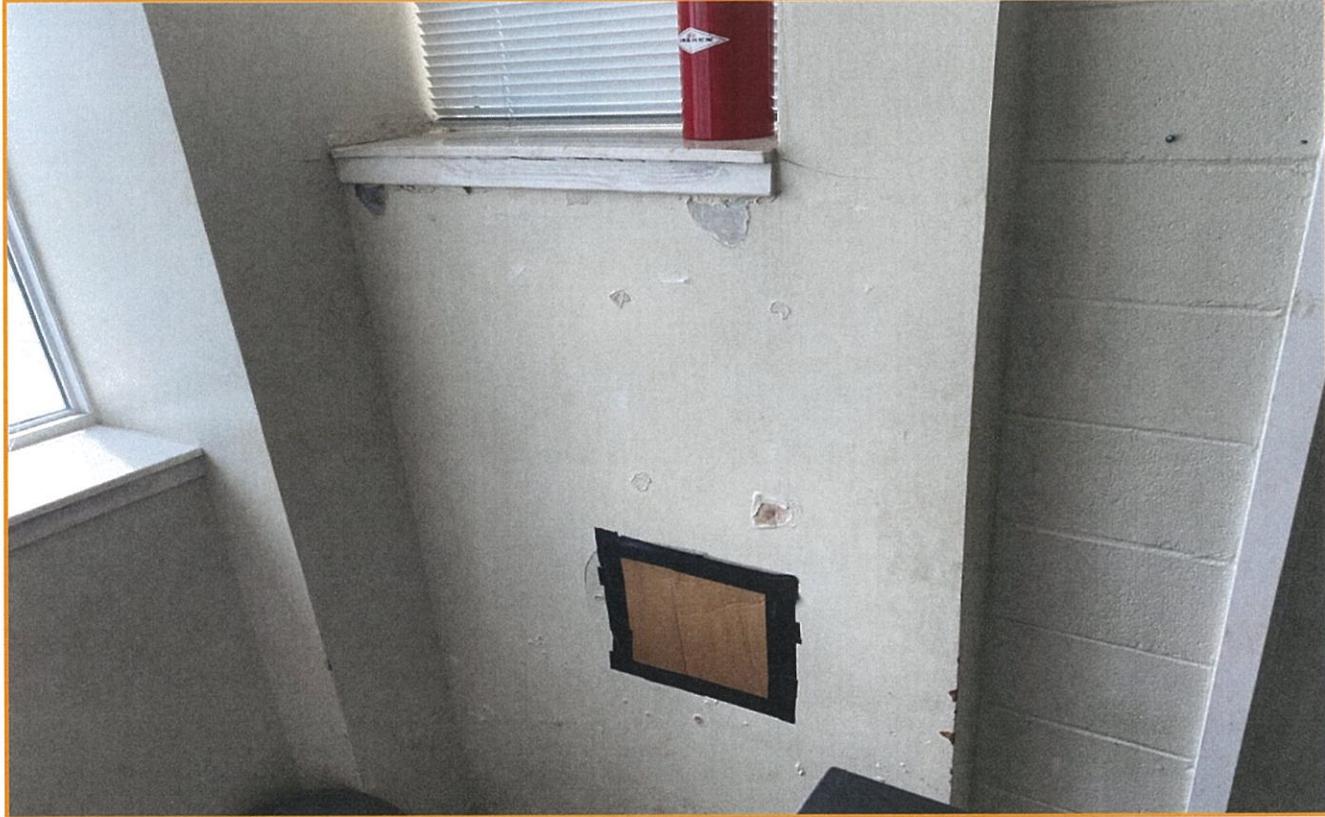
Weight Room	Moisture damage to wall finish assemblies	Remove, Replace, and Repaint	30 SF of double coat plaster on wall demolition 30 SF of gypsum wallboard demolition 3.33 SY of ½" thick gypsum lath 3.33 SY of 2 coat gypsum plaster 30 SF of priming and painting	Figure 2.2.1.14 Figure 2.2.1.15 Figure 2.2.1.16
