FIELD REPORT

PROJECT: Summerville Parking Garage Spalling Assessment and Repair

OWNER: Town of Summerville, SC **CEMS PROJECT NO:** 21-009

MEETING: Field Observation **OBSERVATION DATES:** 20 & 22 SEPT 2021

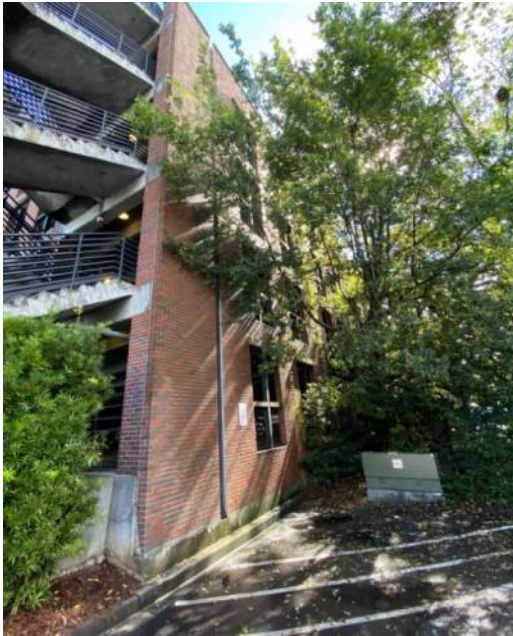
PHOTO 1: VEGETATION AGAINST THE SOUTH EXTERIOR WALL

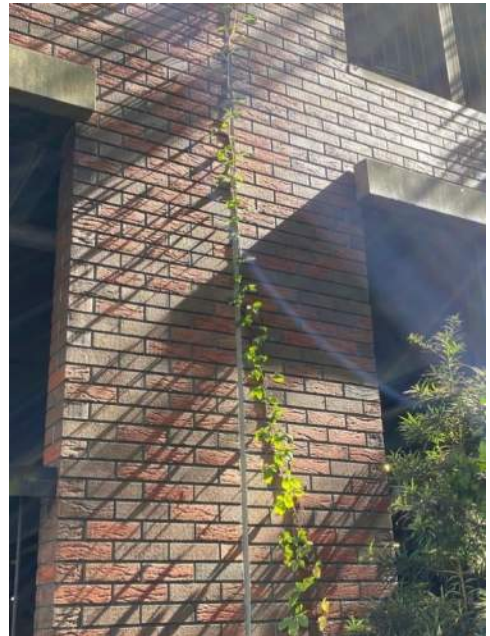
PHOTO 2: VINES ATTACHED TO SOUTH EXTERIOR WALL

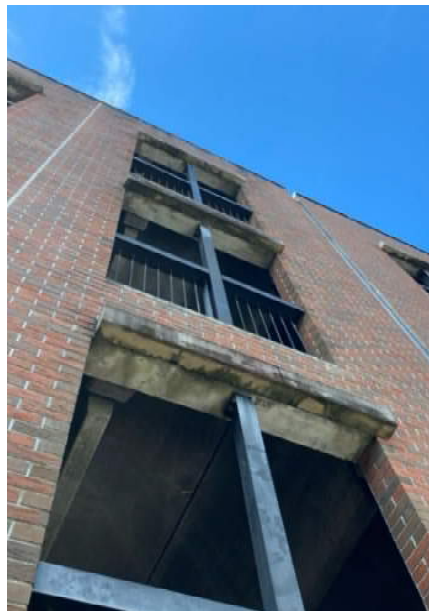
1. A significant amount of rainwater is running off the highest deck levels down through the voids in the walls between adjacent staggered deck levels. Water is also migrating vertically through the joints between horizontal and vertical members.
2. In general, the caulking of the precast wall panel-to-panel joints is in good condition, however, there are isolated locations where caulking is deteriorated, especially adjacent to areas of concrete panel spalling.
3. The exterior of the structure is in generally good condition.
 - a) The south exterior of the structure has vegetation from trees and other plants growing against the exterior walls of the structure. There are several vines attached to wall.
 - b) Exterior cast stone pieces have signs of moisture saturation and resultant organic growth. on their surfaces.

PHOTO 3: MOISTURE AND ORGANIC GROWTH ON CAST STONE PIECES

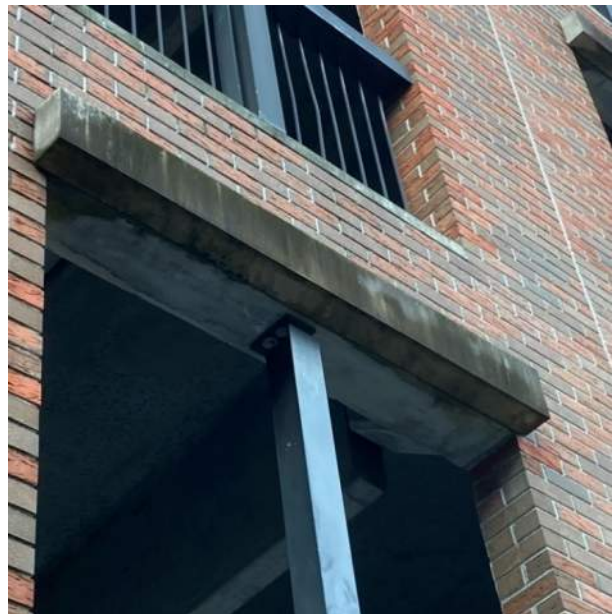
PHOTO 4: MOISTURE AND ORGANIC GROWTH ON CAST STONE PIECES

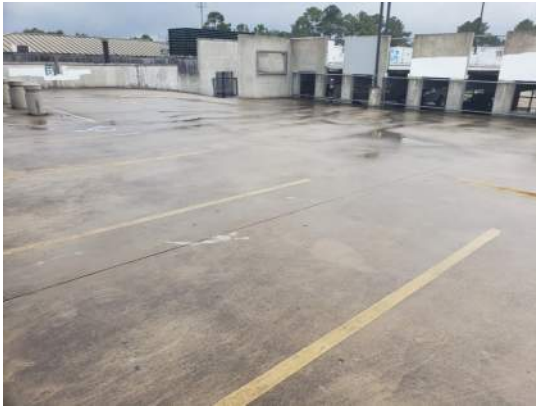
PHOTO 5: OVERVIEW OF UPPER LEVEL DECK

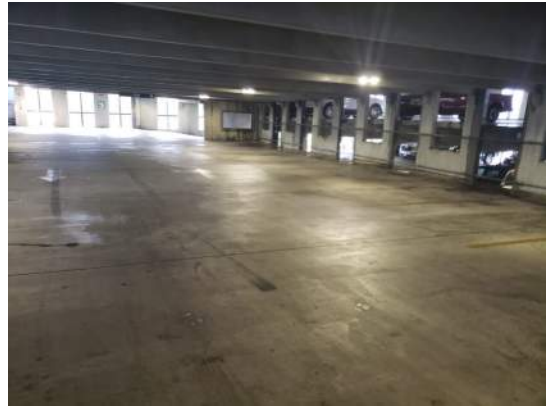
PHOTO 6: OVERVIEW OF INTERMEDIATE LEVEL DECK

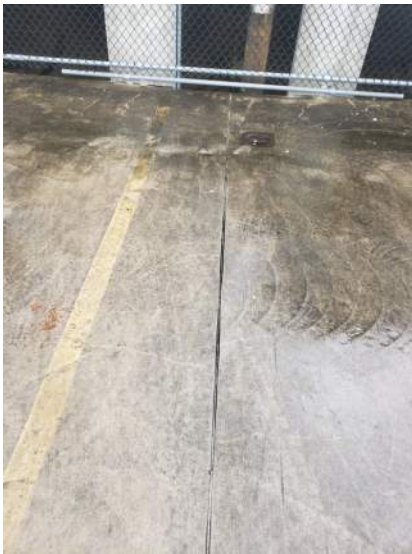
PHOTO 7: TOPPING SLAB JOINT AT UPPER LEVEL DECK

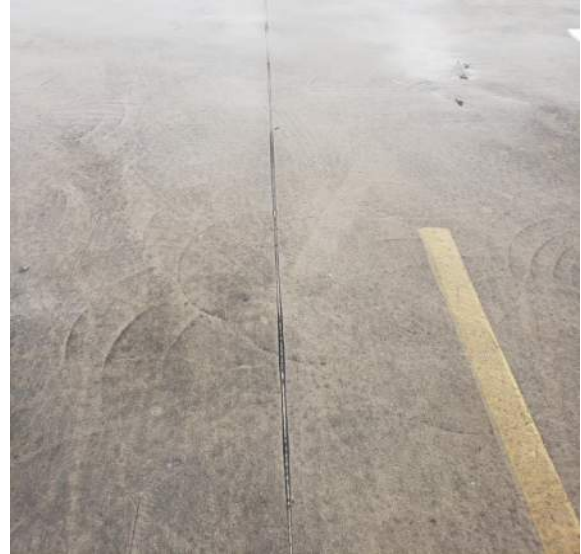
PHOTO 8: TOPPING SLAB JOINT AT UPPER LEVEL DECK

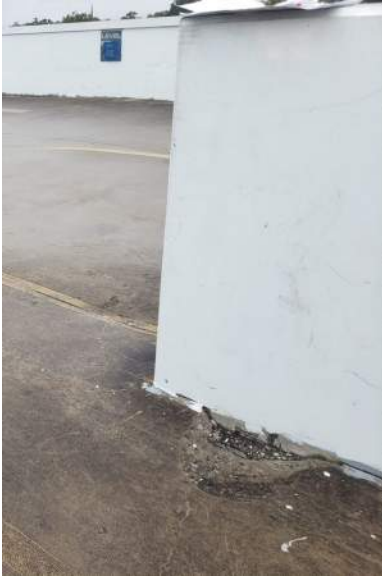
4. The concrete topping of the main parking structure is in generally good condition with minimal cracking or damage.
 - a) The joints in the concrete topping above the double-tee joints are in generally good condition.
 - b) Sealants are in generally good condition except in isolated locations where rainwater is migrating through the highest levels exposed to rain.
 - c) Minor damage was observed at the southwest corner of the west ramp at the upper level.

PHOTO 9: CONCRETE TOPPING DAMAGE AT UPPER LEVEL

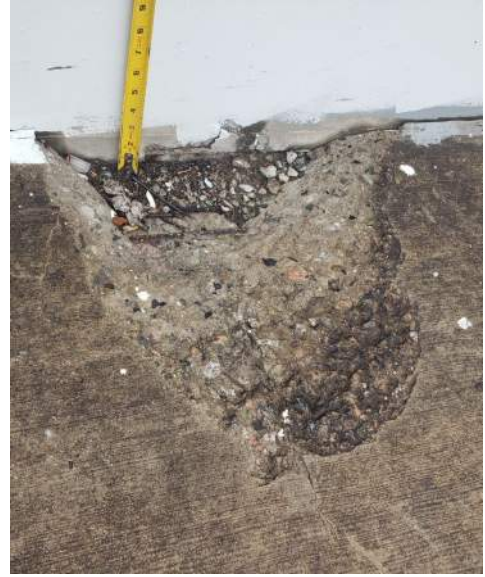
PHOTO 10: CLOSE UP OF CONCRETE TOPPING DAMAGE AT UPPER LEVEL

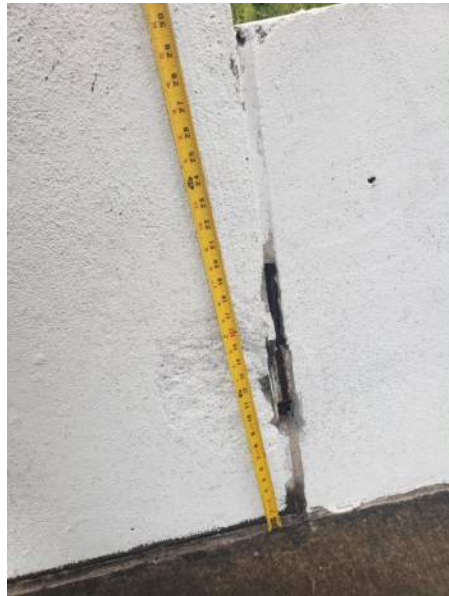
5. Grout packing over concealed wall panel-to-panel connections is consistently failing.
 - a) Connections along the vertical panel to panel edge connections are degraded.
 - i) At the highest levels which are exposed to the elements, the grout is very soft, loose, and spalling. The conditions improve but are still failing in the intermediate levels protected from rain. At the lower levels, the grout is performing better. The grout has a darker grey color at the lower levels, possibly indicating a different type of grout mix.

PHOTO 11: SPALLED UPPER LEVEL PANEL CONNECTION

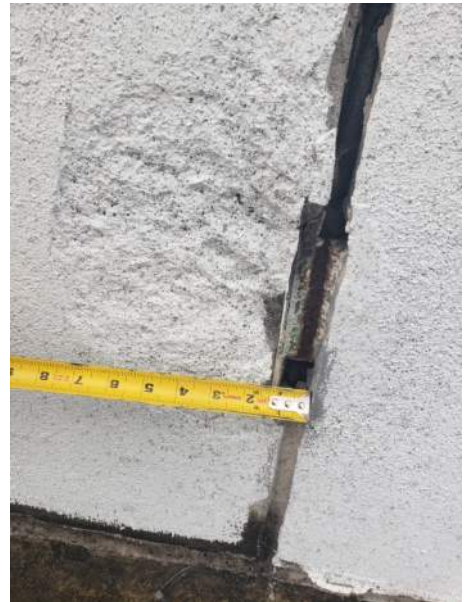
PHOTO 12: SPALLED UPPER LEVEL PANEL CONNECTION

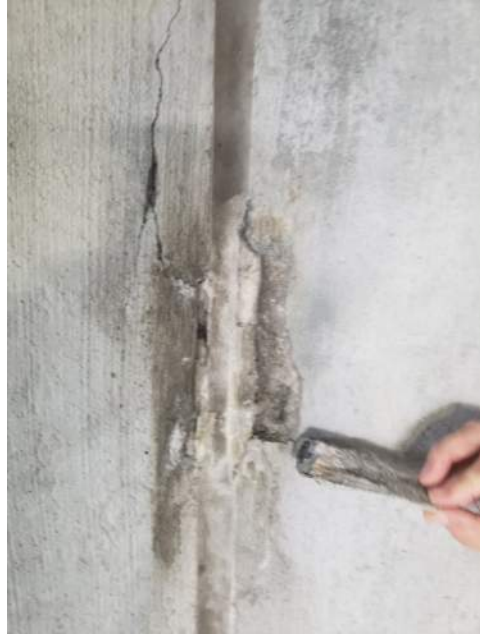
PHOTO 13: SPALLED INTERMEDIATE LEVEL PANEL CONNECTION

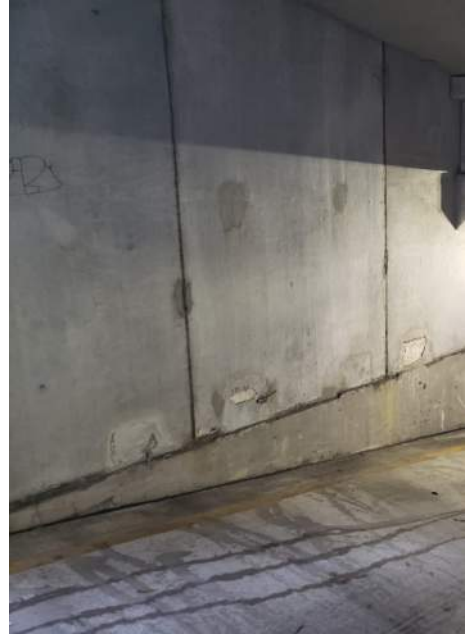
PHOTO 14: LOWER LEVEL PANEL CONNECTIONS (NOTE DARKER GROUT)

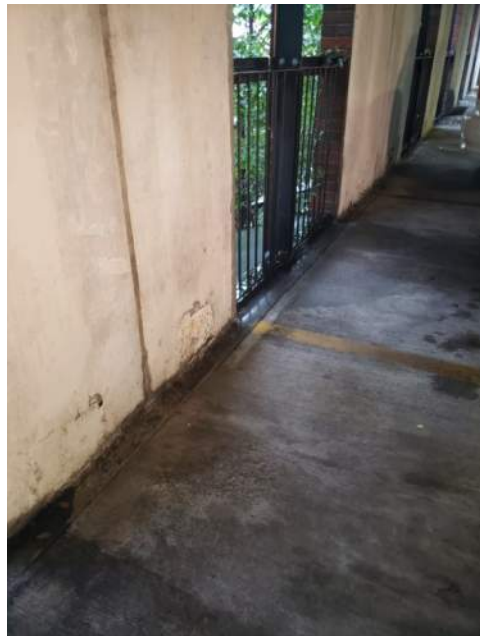
- ii) Grout packing over concealed wall panel-to-panel connections along the base of 8" thick wall panels bearing on 12" thick panels is consistently failing. The grout appears to be expanded, loose, and spalling. The outer portion of the cover was dislodged with minor probing.

PHOTO 15: EXPANSIVE SPALLING GROUT AT WALL PANEL BASE CONNECTION

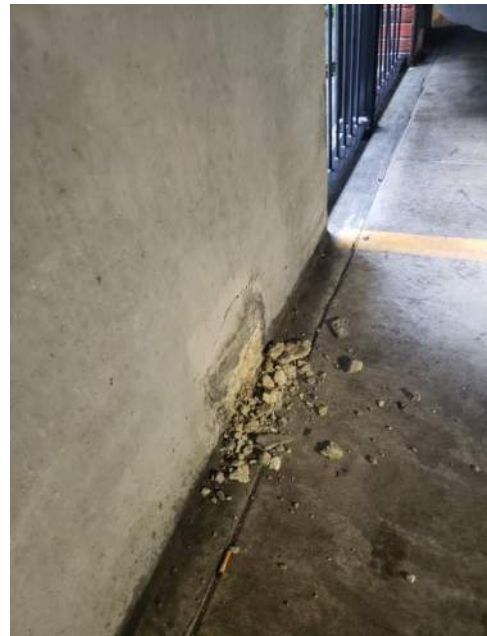
PHOTO 16: DISLODGED GROUT AT WALL PANEL BASE CONNECTION

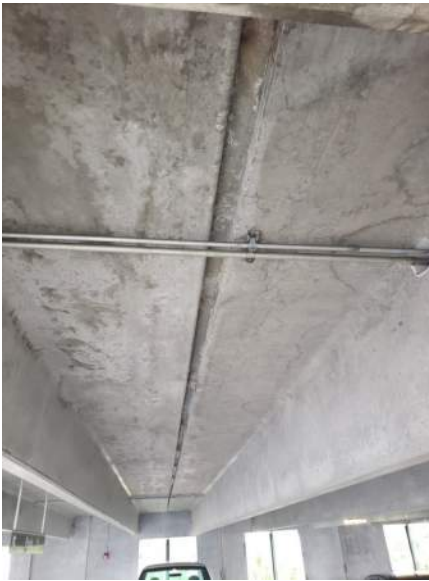
6. At each level near the southeast end of the structure, the second and third double tee members from the east end appear to have been installed slightly out of alignment. The longitudinal joint between adjacent double tee edges tapers from approximately 4" at the north end to the typical joint width of approximately $\frac{3}{4}$ " at the south end. This appears to be an intentional decision as it is repeated at each level. The concrete topping slab bridges over the joint and has a typical, constant width joint at all locations. This condition does not appear to be negatively affecting the performance of the structure nor of the joints.

PHOTO 17: TAPERED JOINT BETWEEN PRECAST DOUBLE-TEE MEMBERS

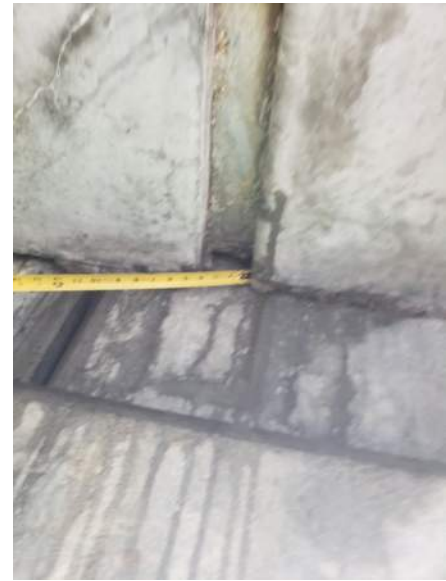
PHOTO 18: NORTH END OF TAPERED JOINT BETWEEN PRECAST DOUBLE-TEE MEMBERS

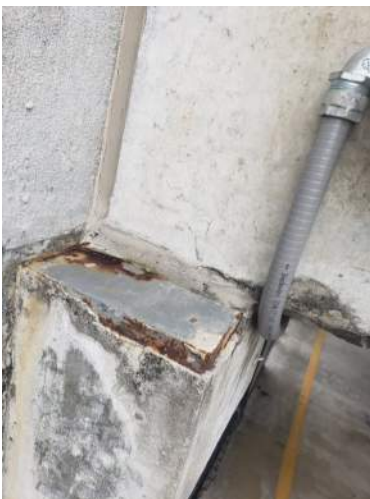
7. At the east end of the upper level, the east end bearing of the precast L-beam over the drive ramp has a moderately corroded bearing plate.

PHOTO 19: CORRODED BEAM BEARING PLATE

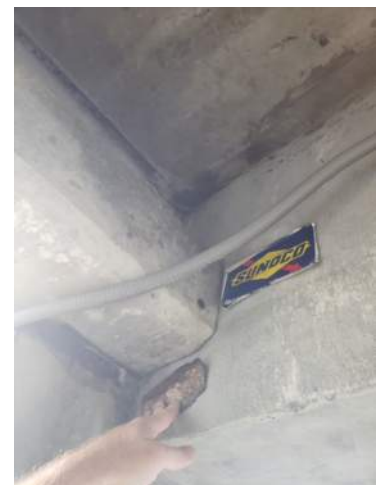
PHOTO 20: LOOSE PIECE FROM CORRODED BEAM BEARING PLATE

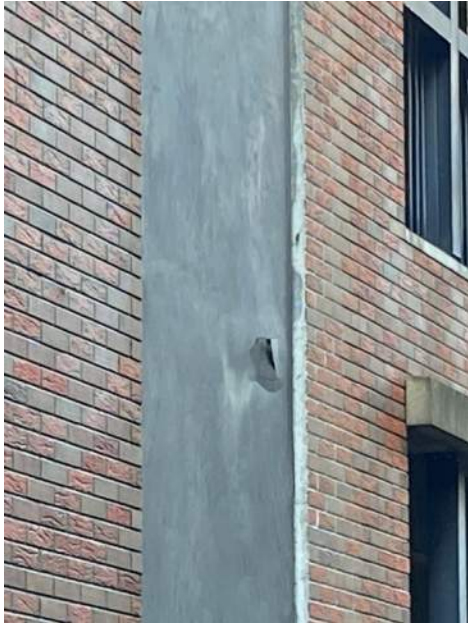
8. Isolated concrete spalling was observed on the east exterior wall panel.

PHOTO 20: ISOLATED SPALLING ON EAST WALL

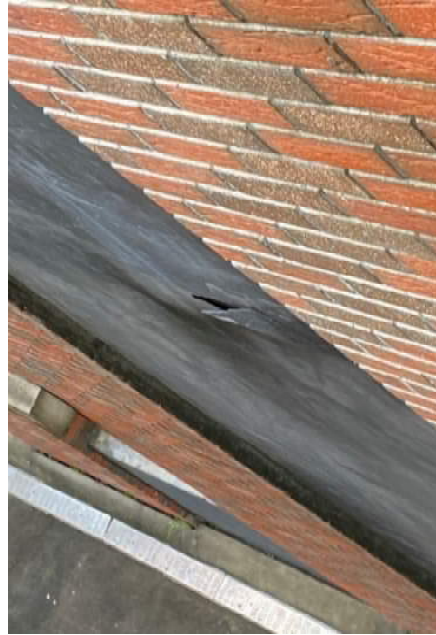
PHOTO 21: ISOLATED SPALLING ON EAST WALL (FROM ABOVE)

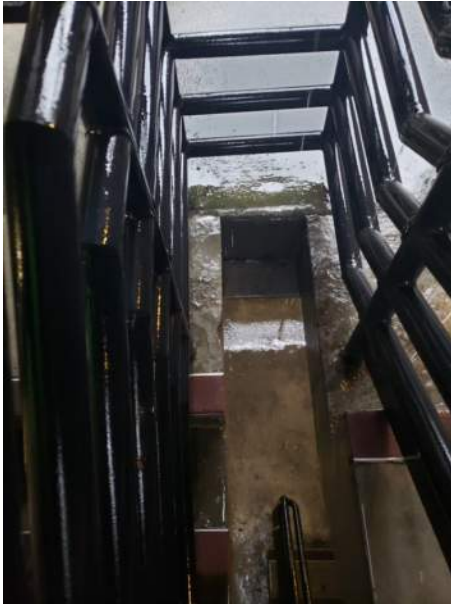
1. A significant amount of rainwater runoff was observed at all levels of the stairs. Most significant runoff was down the gap between the parallel flights of stairs and through the landing penetrations for the standpipe. Water is ponding on the landing slabs in some areas.

PHOTO 22: RAINWATER RUNOFF BETWEEN STAIR FLIGHTS

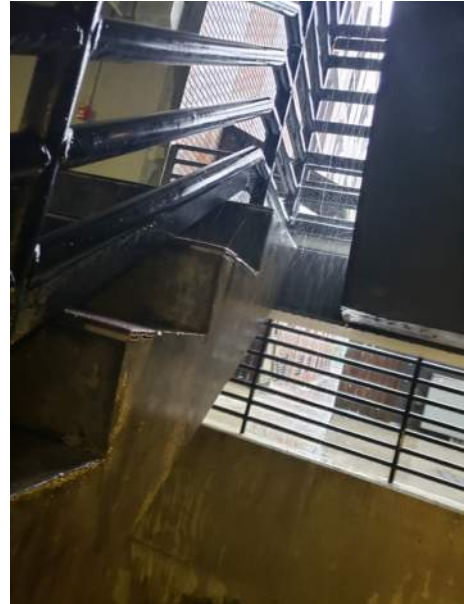
PHOTO 23: RAINWATER RUNOFF BETWEEN STAIR FLIGHTS

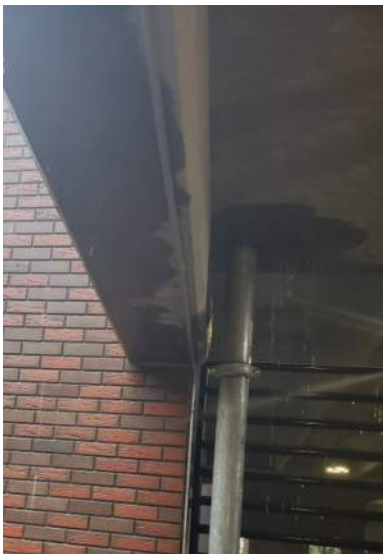
PHOTO 24: RAINWATER RUNOFF THROUGH STANDPIPE OPENING

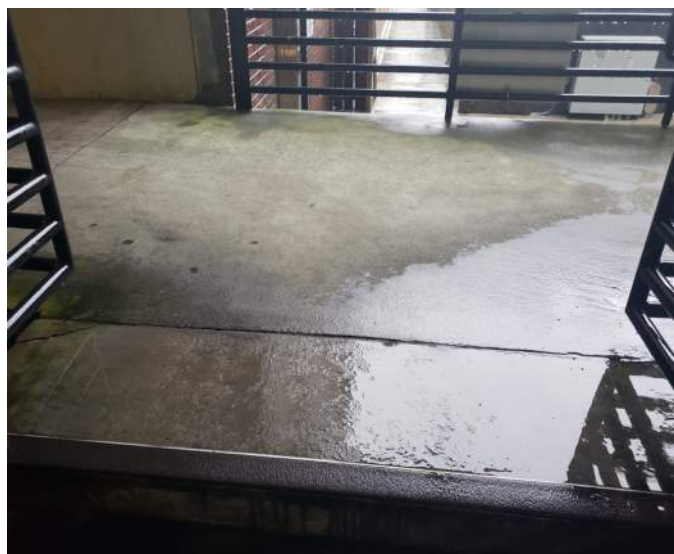
PHOTO 25: RAINWATER PONDING ON STAIR LANDING

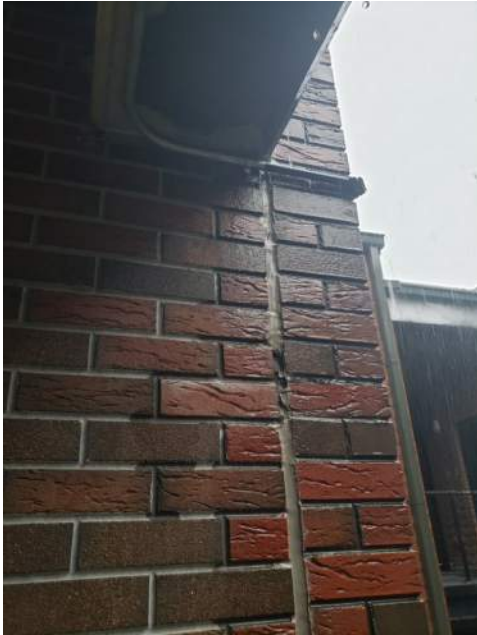
2. Deteriorated and missing caulking was observed at the exterior stair wall panel joints.

PHOTO 26: DETERIORATED CAULK IN WALL PANEL JOINTS

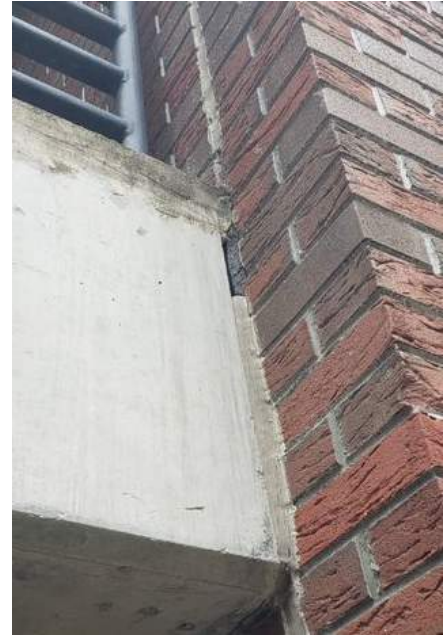
PHOTO 27: MISSING CAULK AT THE WALL PANEL AND BEAM JOINT

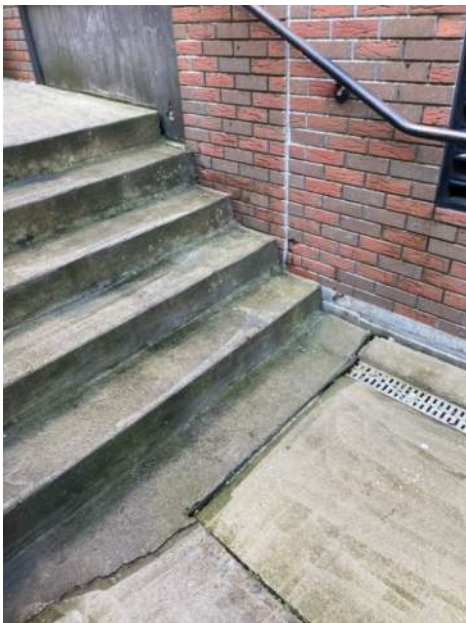
3. Minor damage to exterior brick veneer was observed at the exterior lower levels of the north exterior wall, adjacent to Stair A.

PHOTO 28: DAMAGED BRICK VENEER

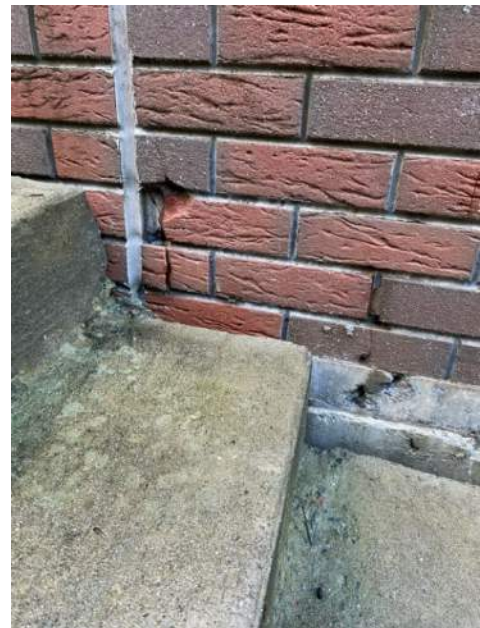
PHOTO 29: CLOSEUP OF DAMAGED BRICK VENEER

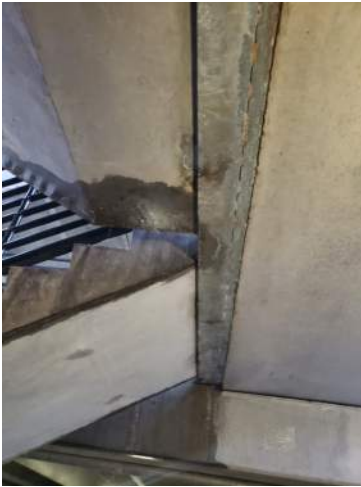
4. Minor corrosion was observed on the underside of connections between the stair flight pieces and the supporting landing slabs.

PHOTO 30: CORROSION AT STAIR FLIGHT CONNECTIONS TO LANDING BEAM

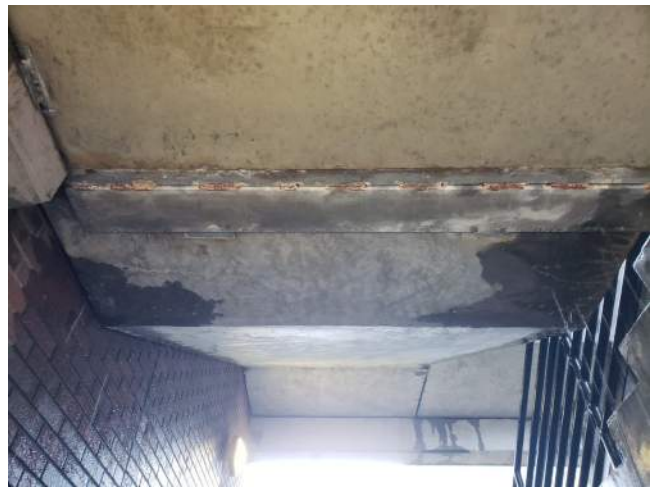
PHOTO 31: CORROSION AT STAIR FLIGHT CONNECTIONS TO LANDING BEAM

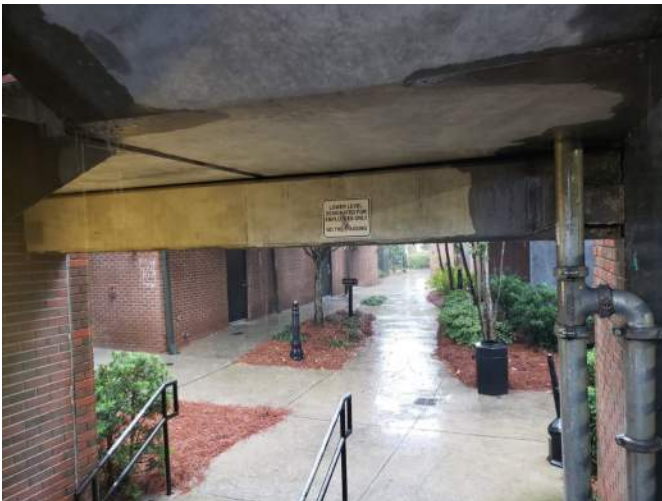
PHOTO 32: STAIR LANDING BEAM ABOVE ENTRANCE AT EAST END OF STAIRS

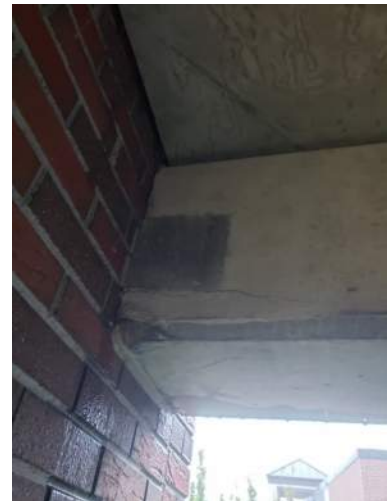
5. Concrete beam cracking and spalling were observed at the end connections of each intermediate landing beam at the east end of the stairs.
 - a) Minor cracking was observed at the north end connections of the landing beam over ground level stair entrance.

PHOTO 33: MINOR CRACKING AT NORTH END CONNECTION OF LANDING BEAM

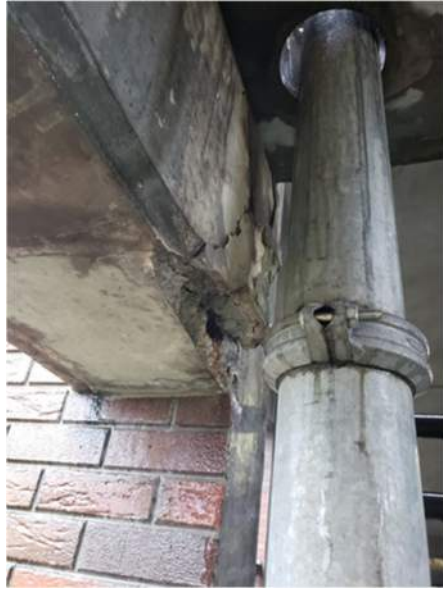
- b) Significant cracking and spalling were observed at every level at the south end connections of these landing beams.
 - i) Bottom reinforcing bars with noticeable corrosion were exposed in at least one location.
 - ii) The rainwater runoff through the landing slab standpipe penetrations onto this end of these landing beams may be contributing to the more severe damage at the south end connections.

PHOTO 34: CRACKING AND SPALLING AT SOUTH END OF LANDING BEAM

1. The concrete spalling conditions observed at Stair A will need to be addressed however, CEMS personnel did not observe structural conditions which pose an obvious and immediately imminent life-safety issue.
2. All items including the existing conditions at Stair A will be evaluated further and addressed as needed in the subsequent Assessment Report.

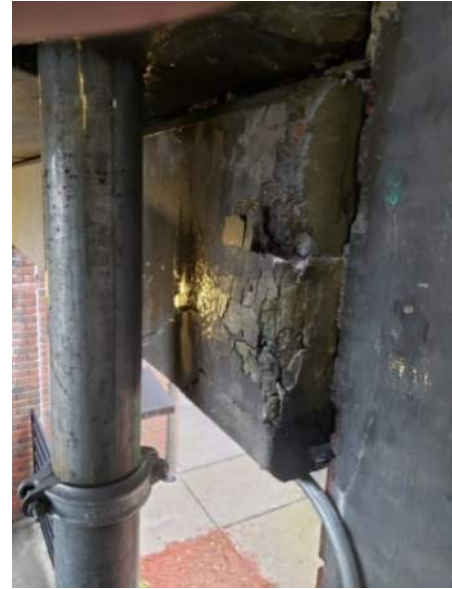
PHOTO 35: CRACKING AND SPALLING AT SOUTH END OF LANDING BEAM

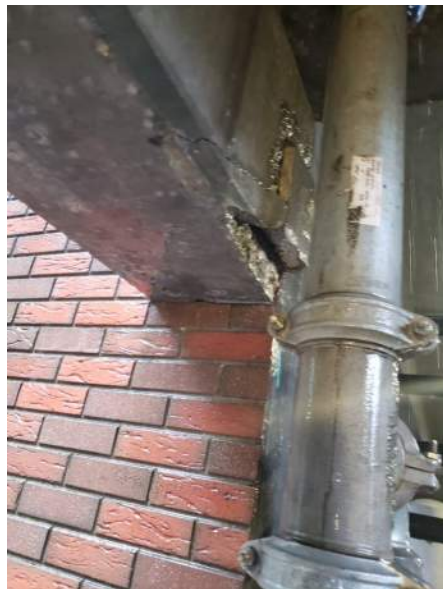
PHOTO 36: CRACKING AND SPALLING AT SOUTH END OF LANDING BEAM

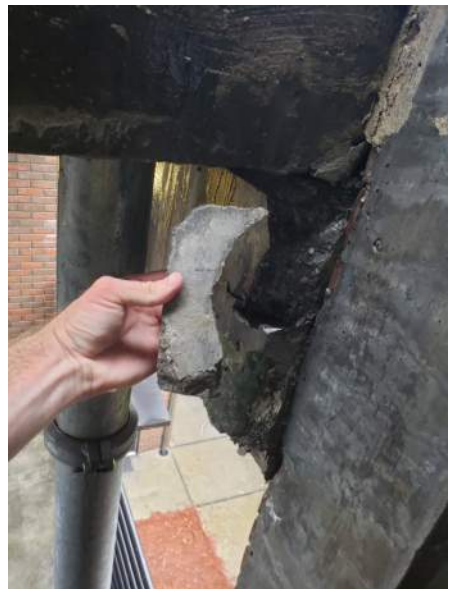
PHOTO 37: LOOSE PIECE OF CONCRETE AT SOUTH END OF LANDING BEAM

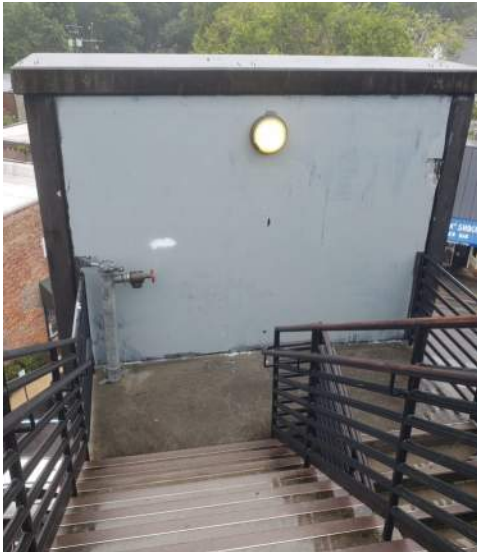
1. Rainwater runoff was observed at all levels of the stairs, but was not as significant as observed at Stair A.
2. Concrete cover over several panel-to-panel connections near the top of the west wall is spalled. The underlying steel connections have some degree of corrosion.

PHOTO 38: SPALLED CONCRETE COVER OVER PANEL JOINT

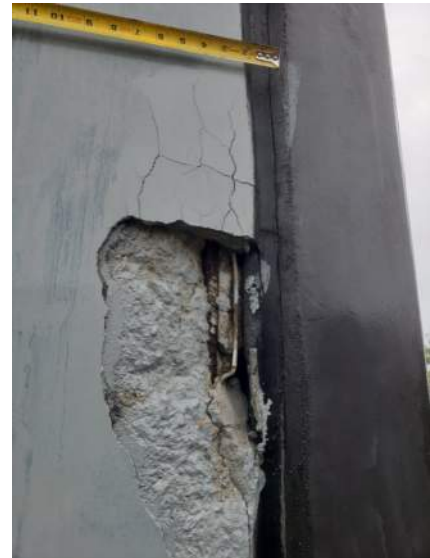
PHOTO 39: CLOSE UP OF SPALLED CONCRETE AND CORRODED REINFORCING

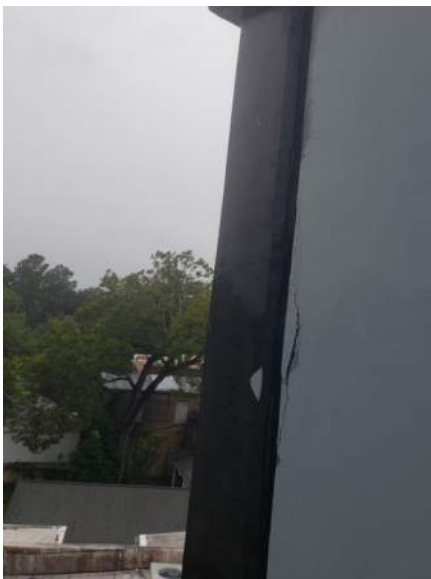
PHOTO 40: SPALLED CONCRETE COVER OVER PANEL JOINT

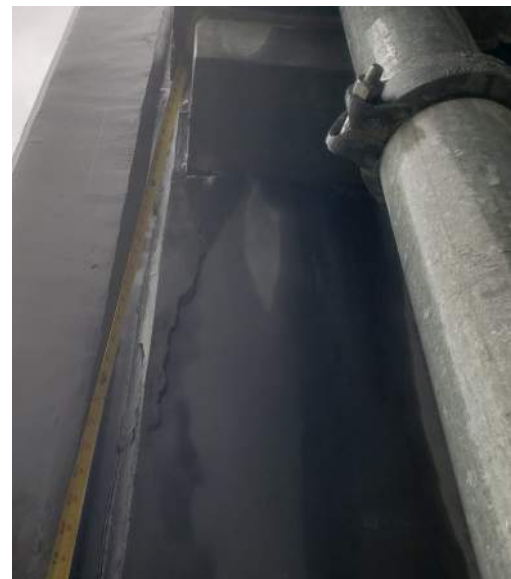
PHOTO 41: SPALLED CONCRETE COVER OVER PANEL JOINT BELOW UPPER LANDING

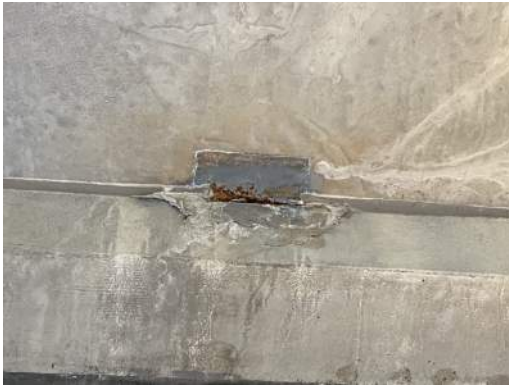
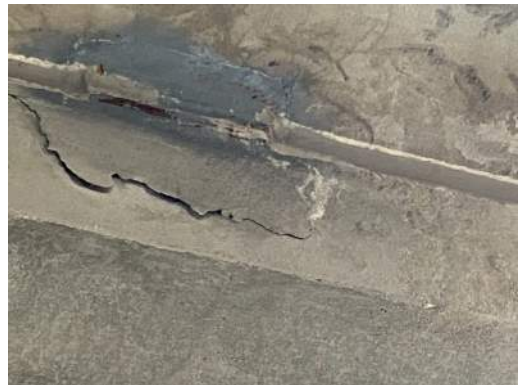
3. At several levels, the stair landing slab connections to the east wall bearing corbels were spalled and corroded.

PHOTO 42: SPALLED AND CORRODED LANDING SLAB CONNECTION TO CORBEL

PHOTO 43: SPALLED AND CORRODED LANDING SLAB CONNECTION TO CORBEL

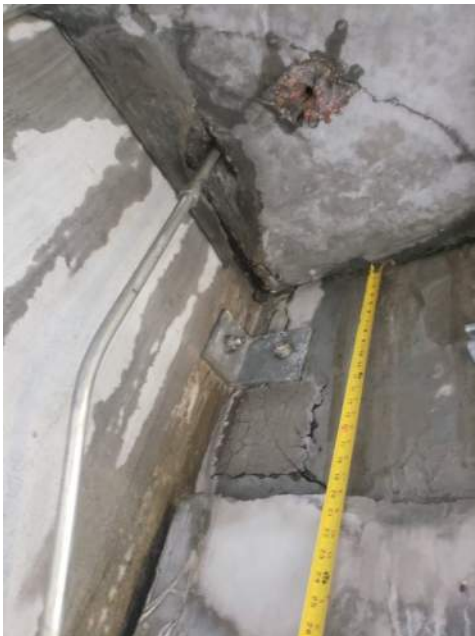
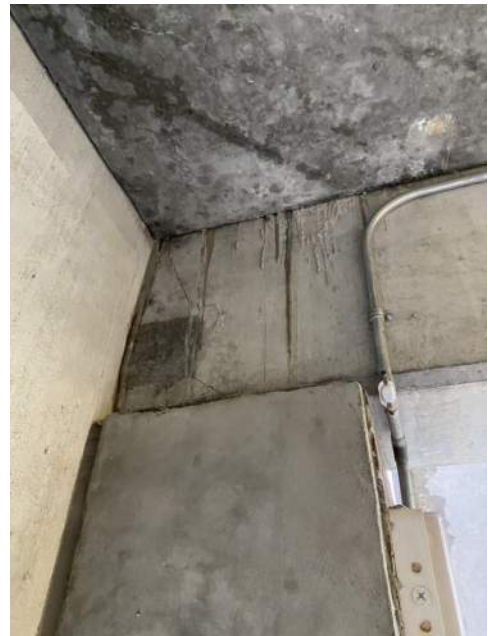
4. Concrete beam cracking and spalling were observed at the end connections of beams supporting the east end of the stair landing at each floor level.
 - a) Cracking was observed at the south end connections of these beams on several levels.

PHOTO 44: CRACKED AND SPALLED CONNECTION AT SOUTH END OF LANDING BEAM

PHOTO 45: CRACKED AND SPALLED CONNECTION AT SOUTH END OF LANDING BEAM

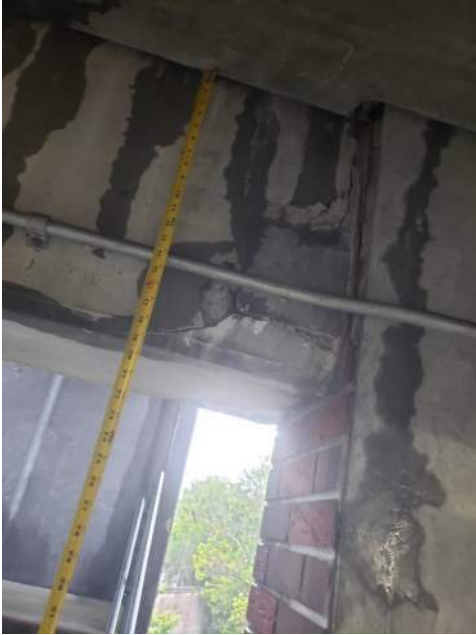
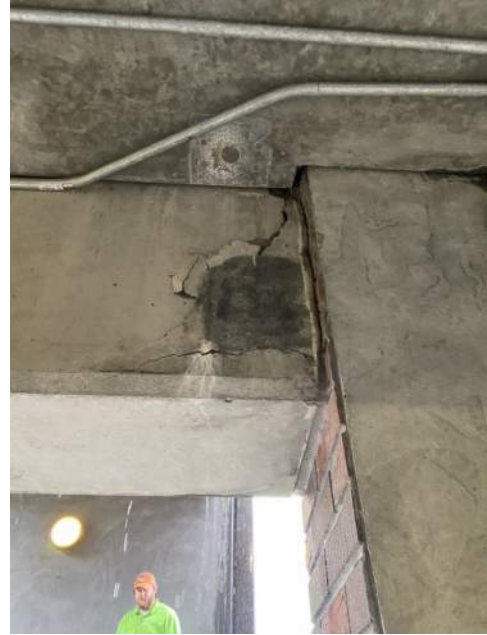
- b) More significant cracking and spalling were observed at the north end connections of these beams.

PHOTO 46: CRACKED AND SPALLED CONNECTION AT NORTH END OF LANDING BEAM

PHOTO 47: CRACKED AND SPALLED CONNECTION AT NORTH END OF LANDING BEAM

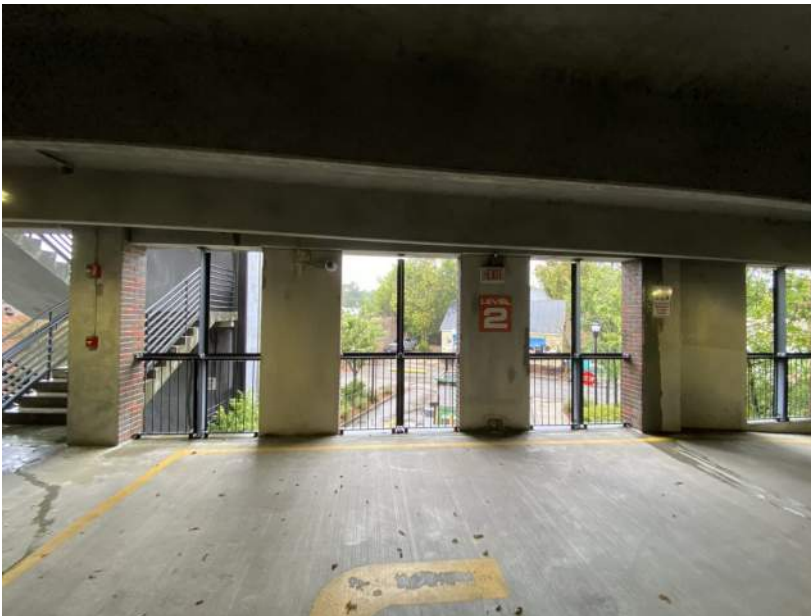
- 5. Beam cracking and spalling were observed in the beams along the same line adjacent to and to the north of the stairs.
 - a) Cracks were observed at each end.
 - b) Spalled and corroded connections were observed at interior supporting columns.

PHOTO 48: BEAM LINE ADJACENT TO STAIRS

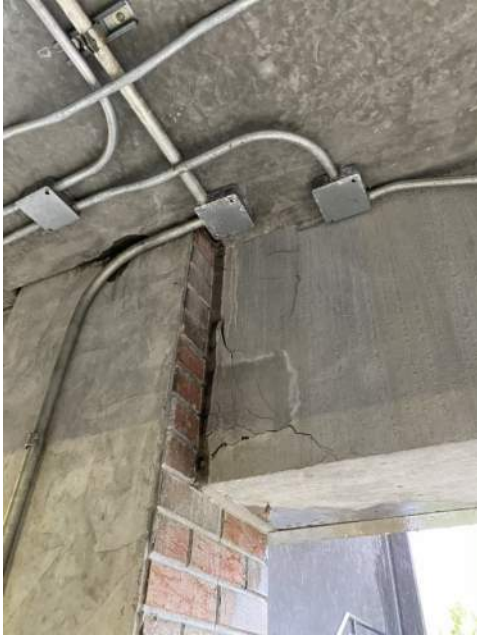
PHOTO 49: CRACKING AT SOUTH END OF BEAM ADJACENT TO STAIRS

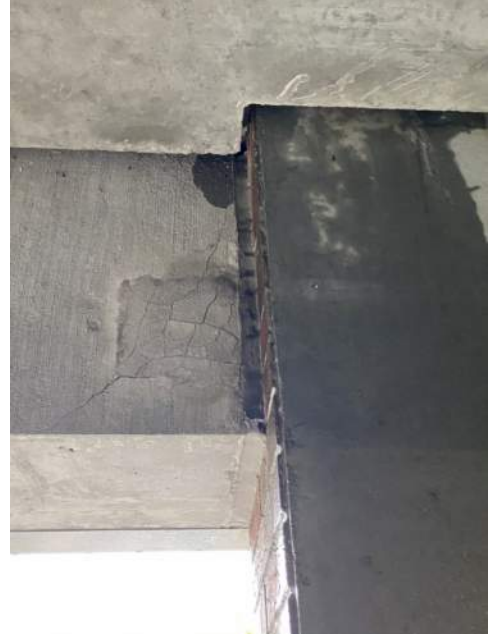
PHOTO 50: CRACKING AT NORTH END OF BEAM ADJACENT TO STAIRS

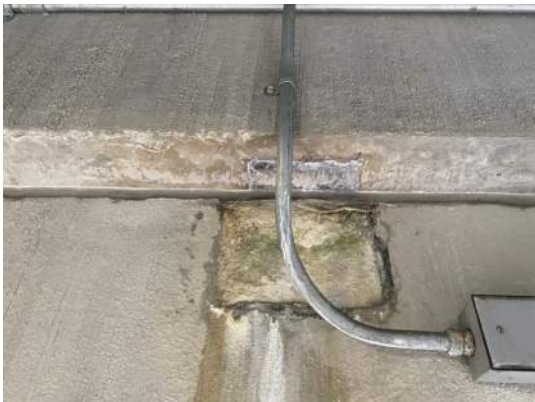
PHOTO 51: SPALLED CONNECTION AT INT. SUPPORT OF BEAM ADJACENT TO STAIRS

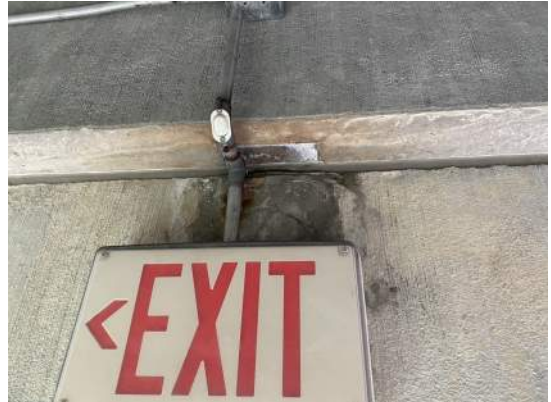
PHOTO 52: SPALLED CONNECTION AT INT. SUPPORT OF BEAM ADJACENT TO STAIRS

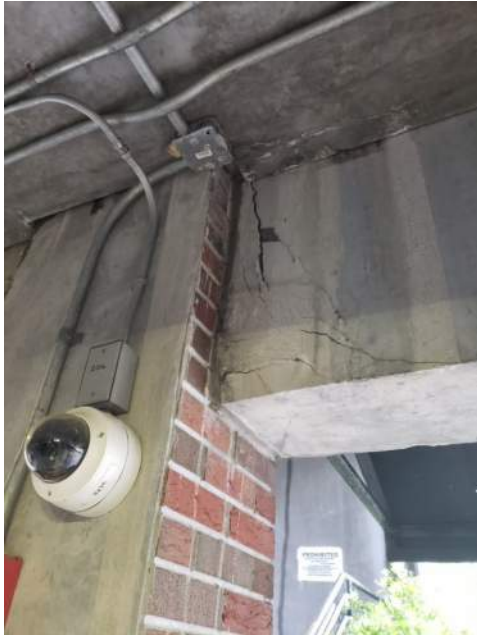
- c) Cracking was observed at the ends of the beam over the main garage entrance.
 - i) On the south end, there is a minor crack through the exterior thin-brick veneer.
 - ii) It appears cracks along the top of the beam were sealed at some point.

PHOTO 53: CRACKING AT SOUTH END OF BEAM OVER MAIN GARAGE ENTRANCE

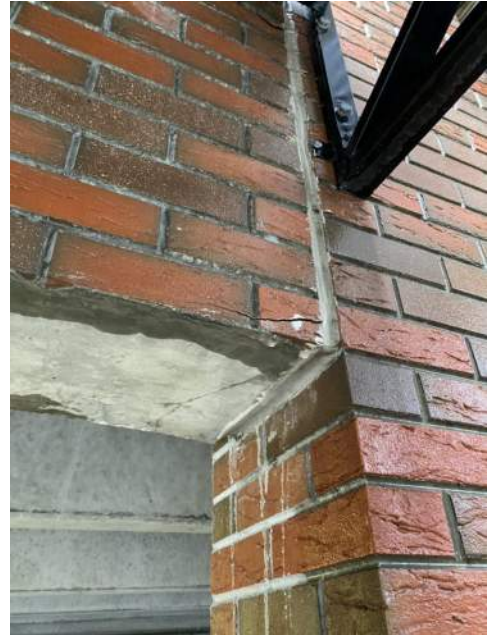
PHOTO 54: CRACK THROUGH EXTERIOR BRICK VENEER

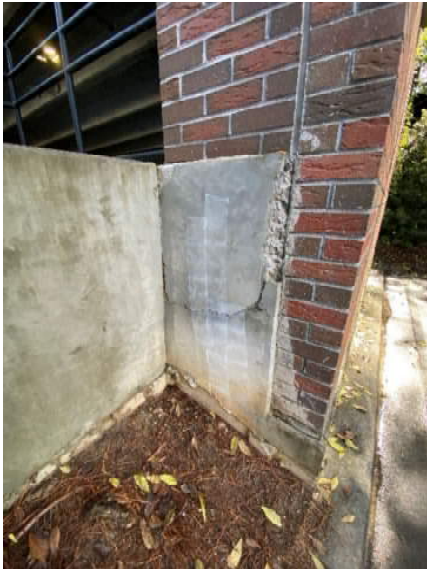
- 6. Isolated foundation cracking and spalling were observed adjacent to the stairs at the southeast corner of the building.

PHOTO 55: CRACK THROUGH EXTERIOR BRICK VENEER
