Asbestos & Lead Based Paint Assessment

City of Spartanburg
665 Saxon Avenue
Spartanburg, South Carolina

Project Number: 0417-66

November 3, 2017

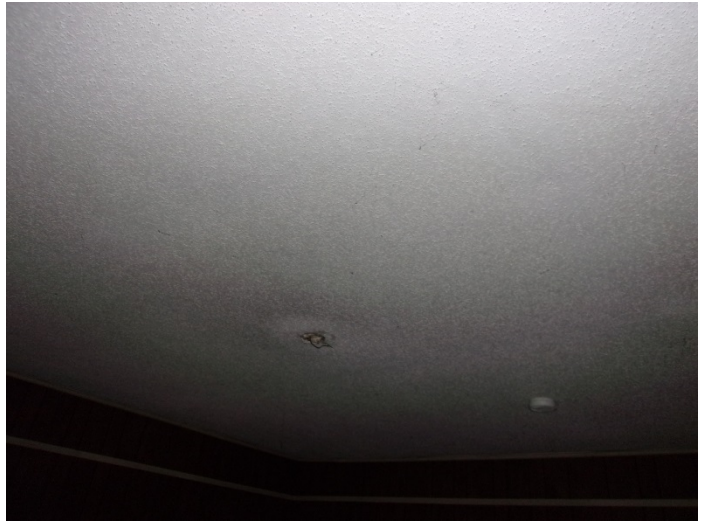
Photo 2 – Popcorn ceiling texture throughout.

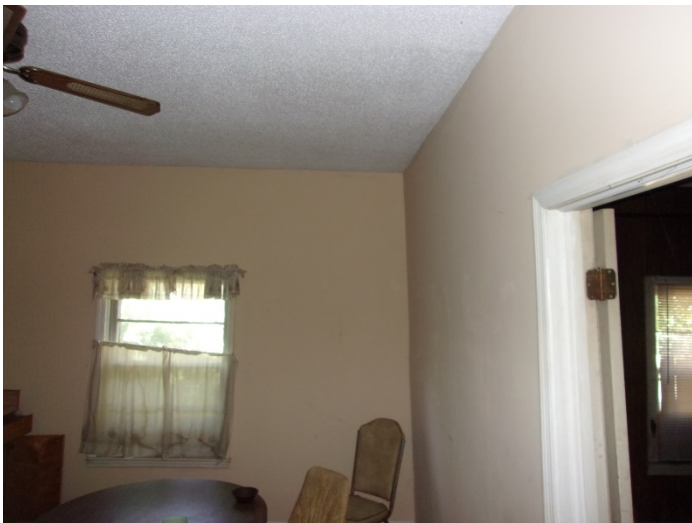
Photo 3 – Drywall with joint compound & tape throughout.

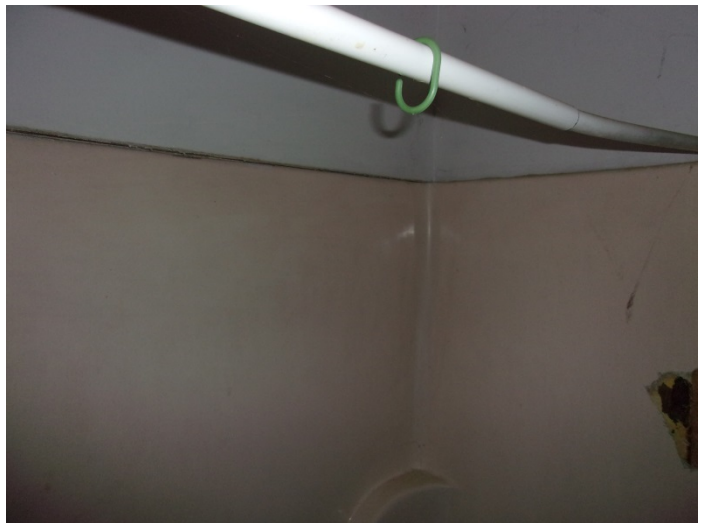
Photo 4 – Shower stall caulk in the bathroom.

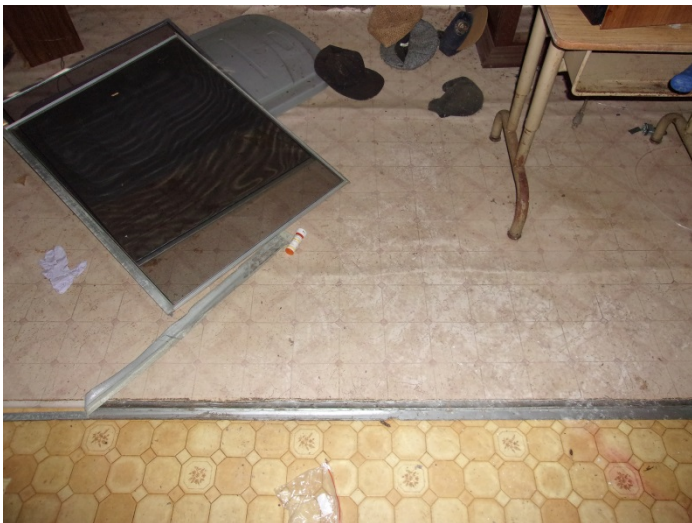
Photo 5 – Grey square pattern vinyl flooring with no mastic in the living room (patch).

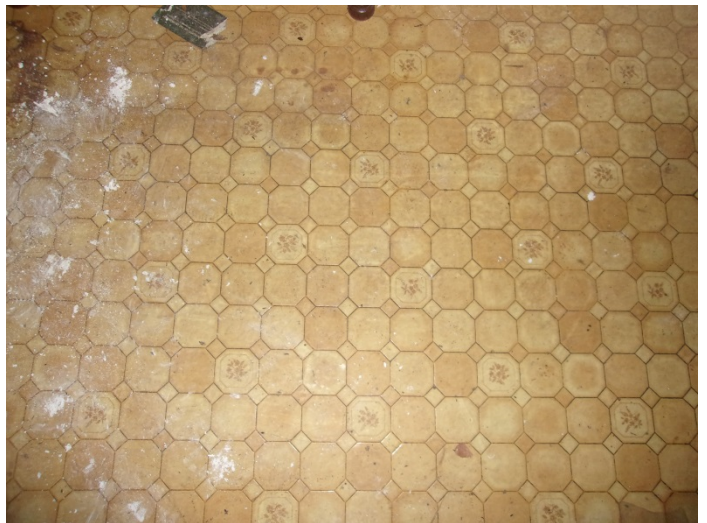
Photo 6 – Yellow octagon pattern vinyl flooring with mastic in the living room (patch).

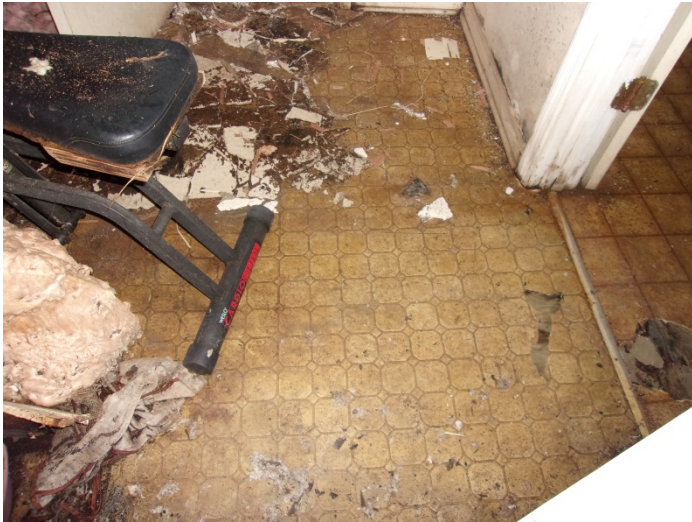
Photo 7 – Brown square pattern vinyl flooring with mastic in the hallway.

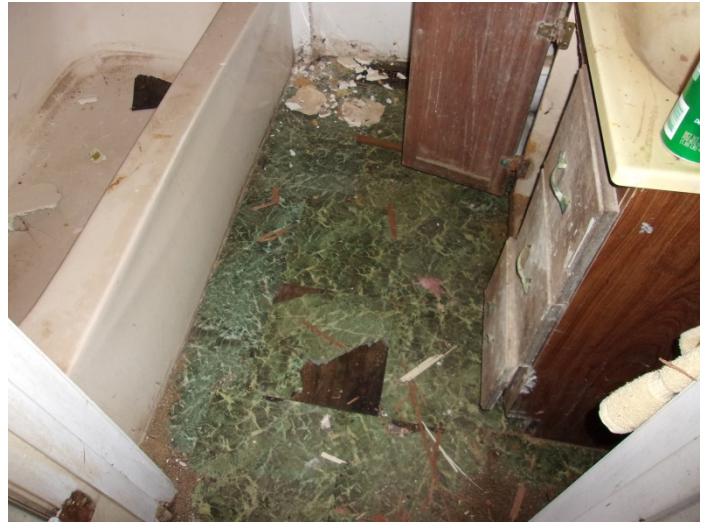
Photo 8 – 12" x 12" grey self-stick vinyl floor tile in the bathroom.

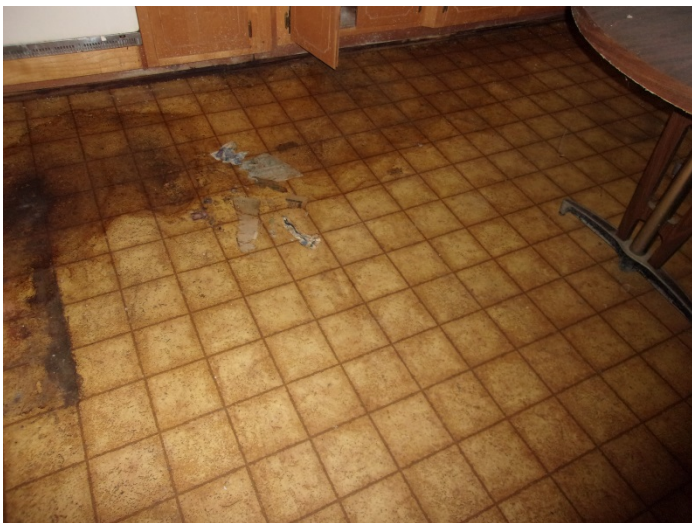
Photo 9 – Yellow large square pattern vinyl flooring with mastic in the kitchen.

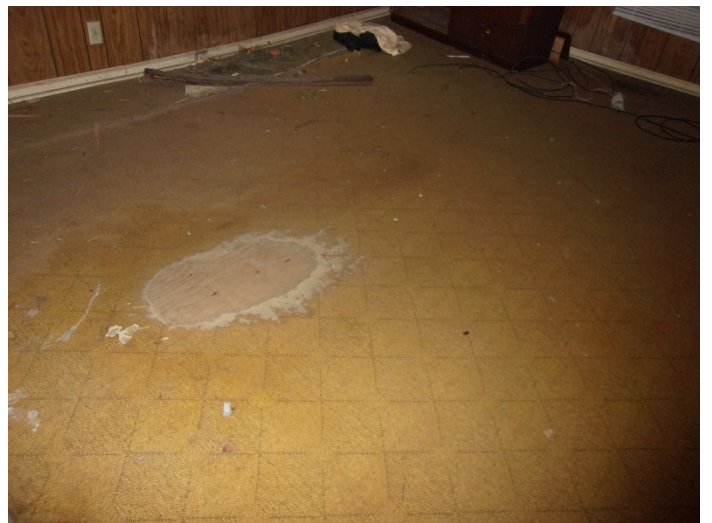
Photo 10 – Thatch pattern vinyl flooring with mastic in the bedroom.

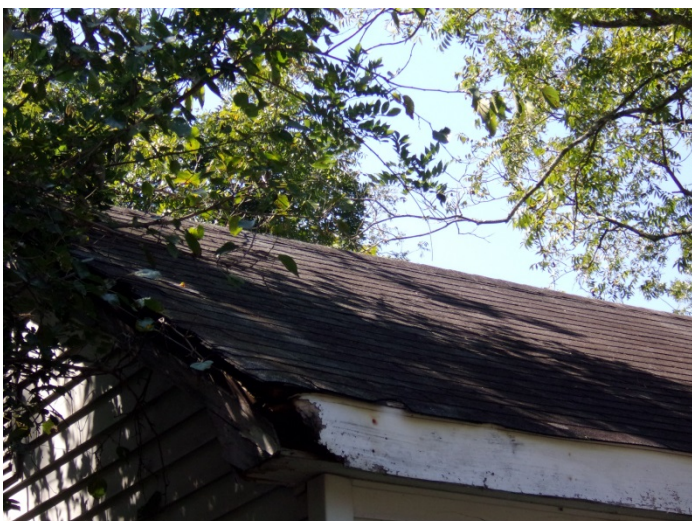
Photo 11 – Roof shingles & felt on the house roof.

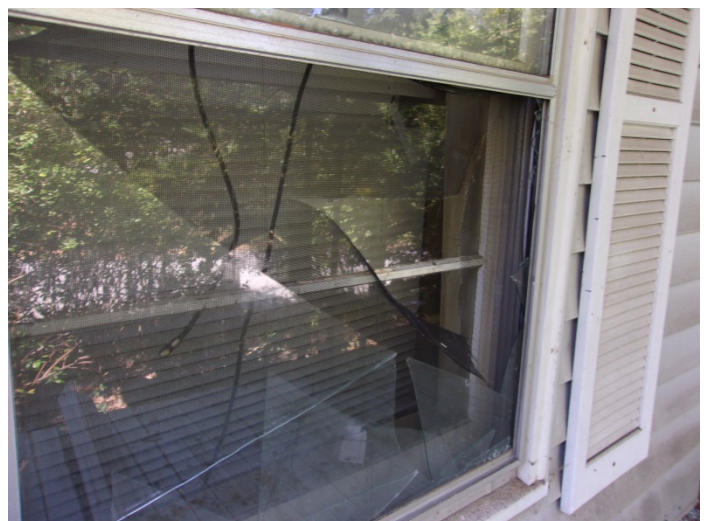
Photo 12 – wooden window glazing.

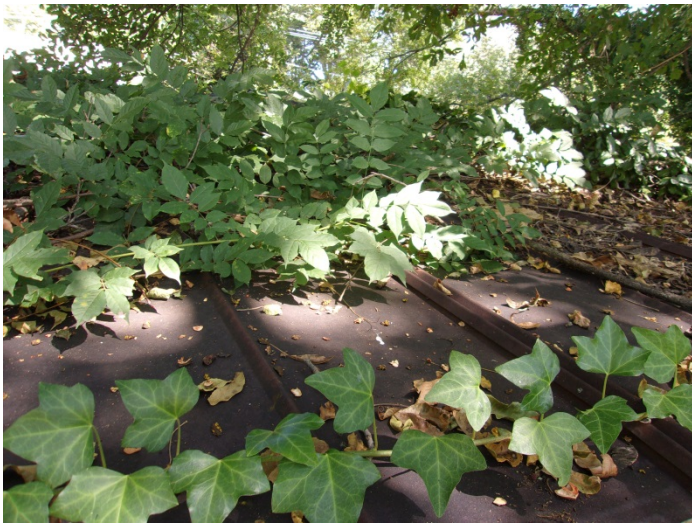
Photo 13 – Metal roof sealant on exterior shed.

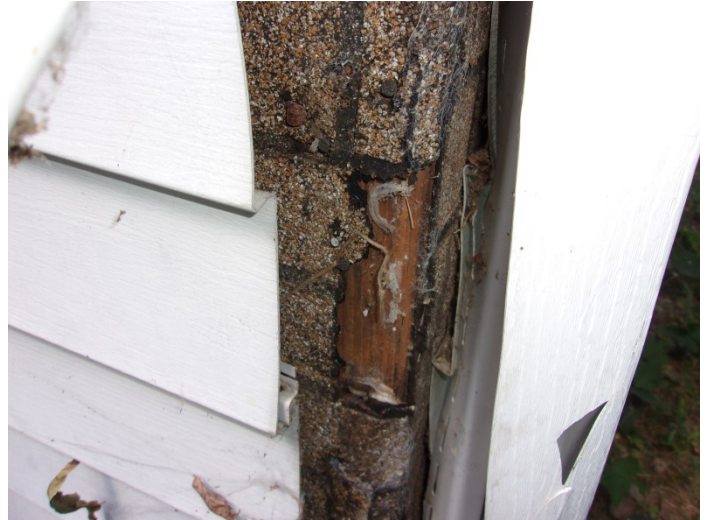
Photo 14 – Asphalt shingle siding under vinyl siding on the house.

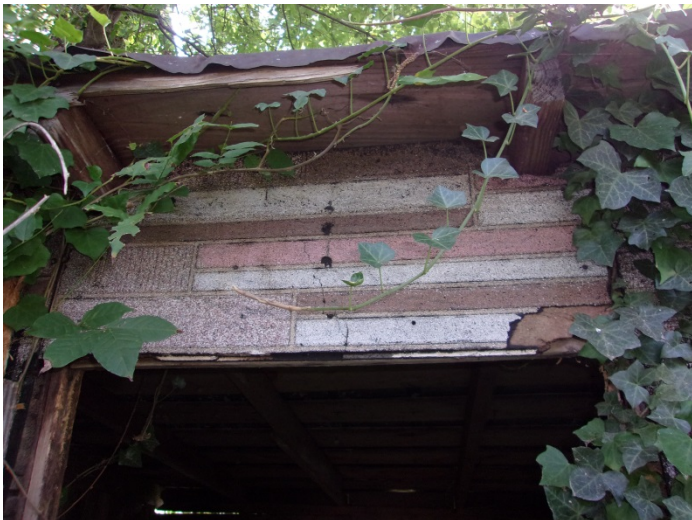
Photo 13 – Asphalt shingle siding on the exterior shed.
