## **Asbestos & Lead Based Paint Assessment**

City of Spartanburg  
400 Kingston Street  
Spartanburg, South Carolina

Project Number: 0417-66

January 3, 2018

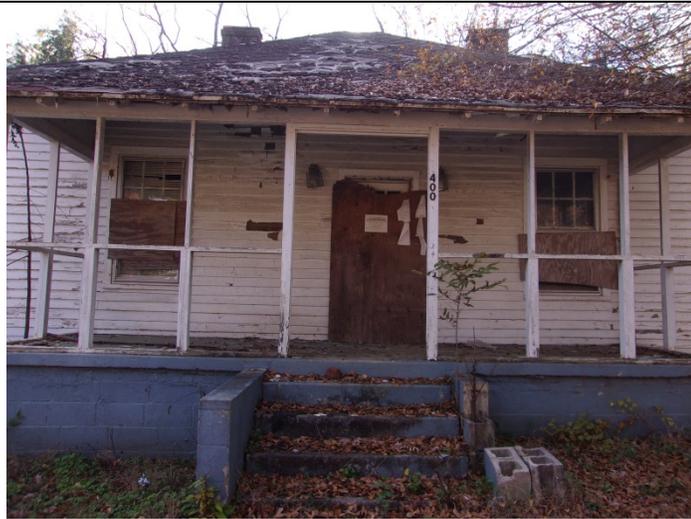
Photo 1 – 400 Kingston Street in Spartanburg, South Carolina.

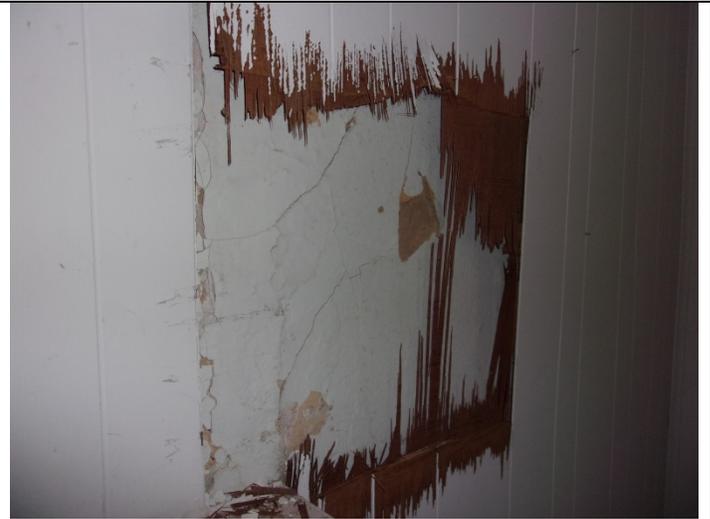
Photo 2 – Plaster with finish.

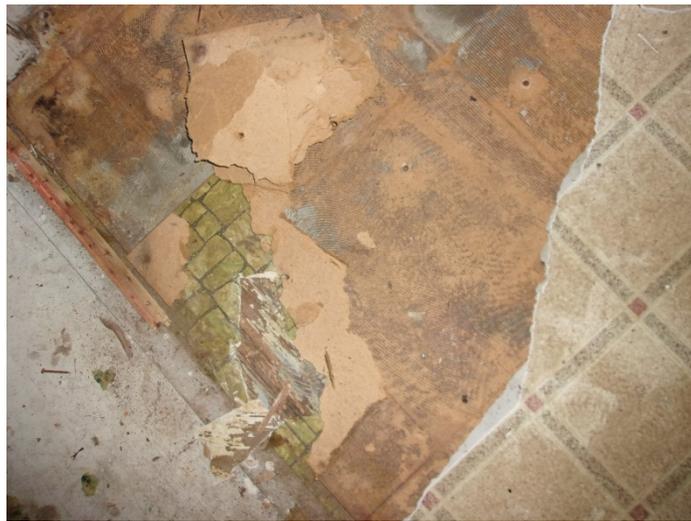
- Approximately 305 SF of the brown stone pattern vinyl floor & mastic (2<sup>nd</sup> layer under wood) in the kitchen.
- Approximately 12 LF of chimney mastic/tar on 2 chimneys – assumed positive.

Photo 3 – Tan square pattern vinyl flooring & mastic (top layer & brown stone pattern vinyl flooring & mastic (2<sup>nd</sup> layer) in the kitchen.

1. Abate the asbestos containing materials in the structure prior to renovation or demolition.
2. Follow applicable asbestos regulations during renovation or demolition of the structure. You should be aware that stringent requirements are imposed upon anyone renovating or demolishing a structure in which ACM will be disturbed. This work must be performed in accordance with OSHA asbestos regulations, 29 CFR 1910 & 1926, and NESHAP asbestos regulations 40 CFR 61, subpart M. South Carolina regulations require the accreditation of personnel who work in the asbestos field and notification and permitting fees for asbestos

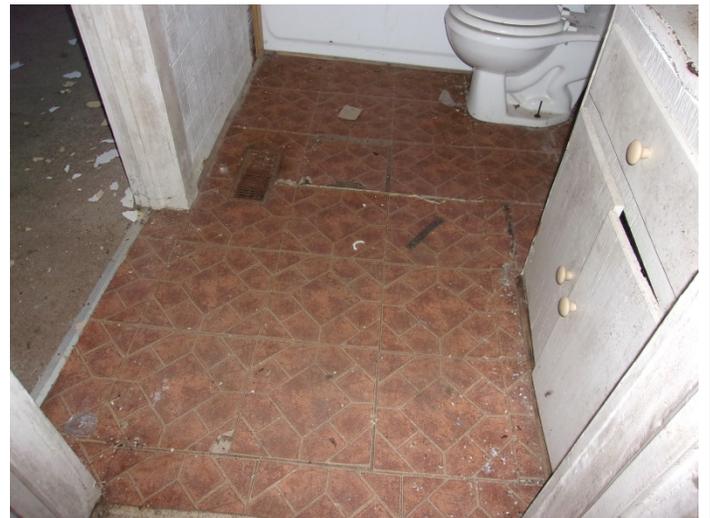
Photo 4 – Red brick patter self-stick vinyl floor tile in the bathroom.

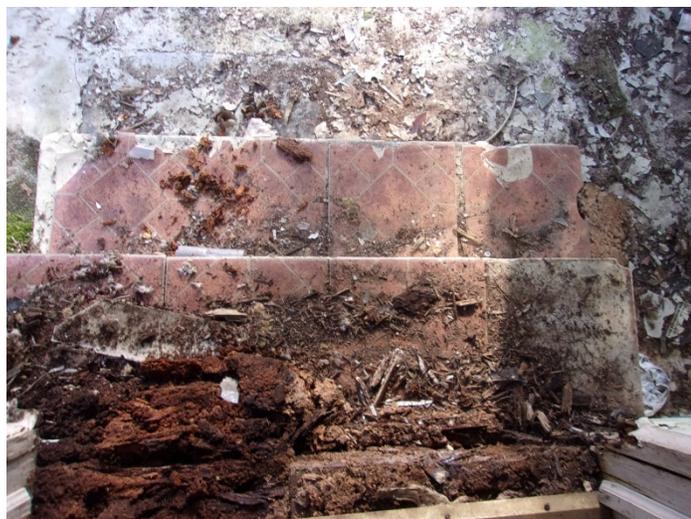
Photo 5 – Red brick patter self-stick vinyl floor tile on the back porch steps.

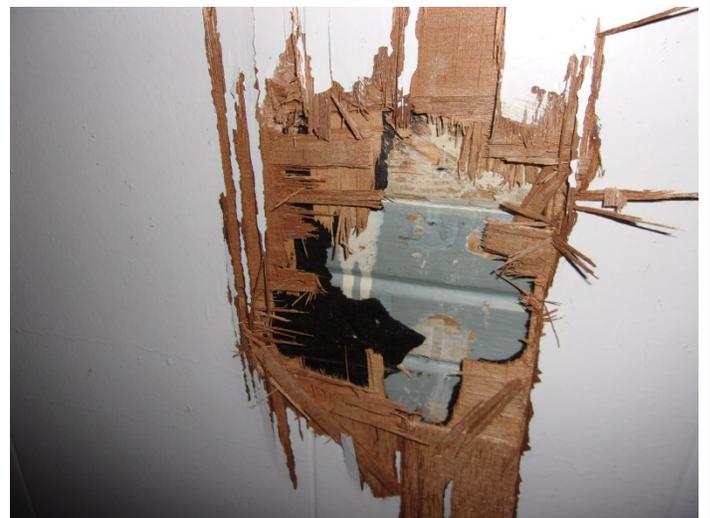
Photo 6 – Felt paper under wooden wall panel in the kitchen.

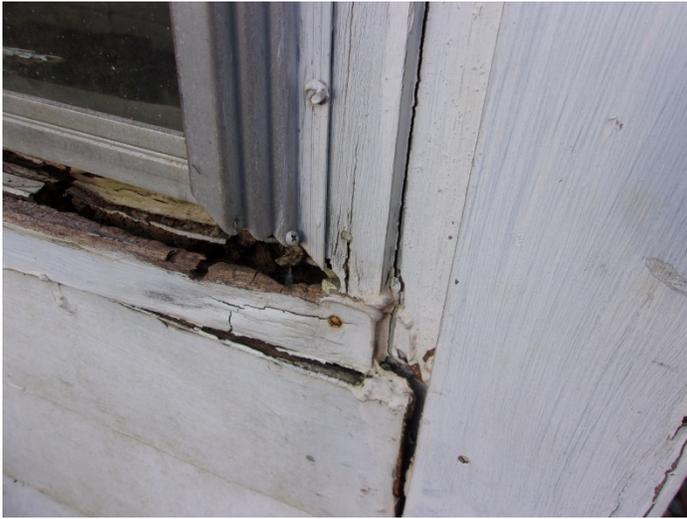
Photo 7 – Caulk on wooden window casings.

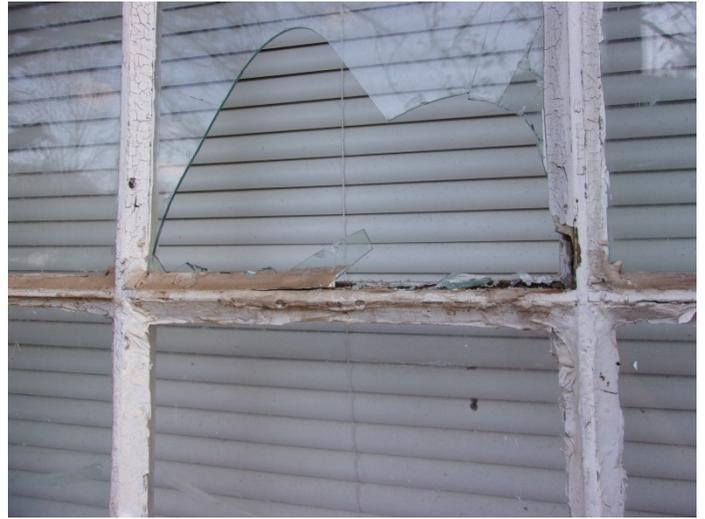
Photo 8 – Glazing & caulk on wooden windows.

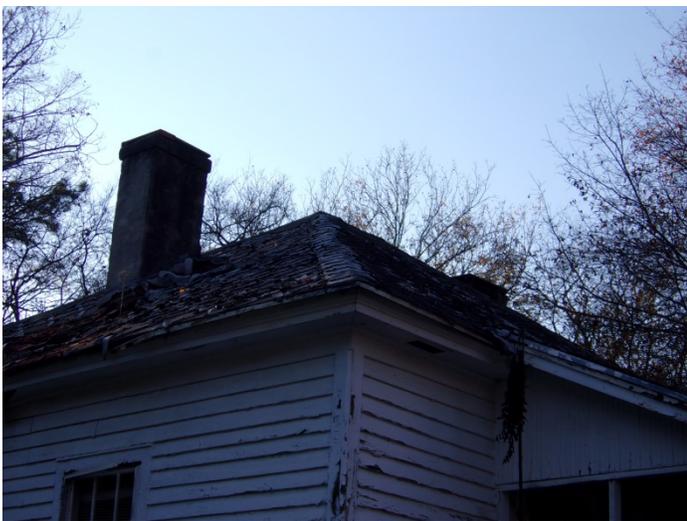
Photo 9 – Front & side roofs with shingles & felt.

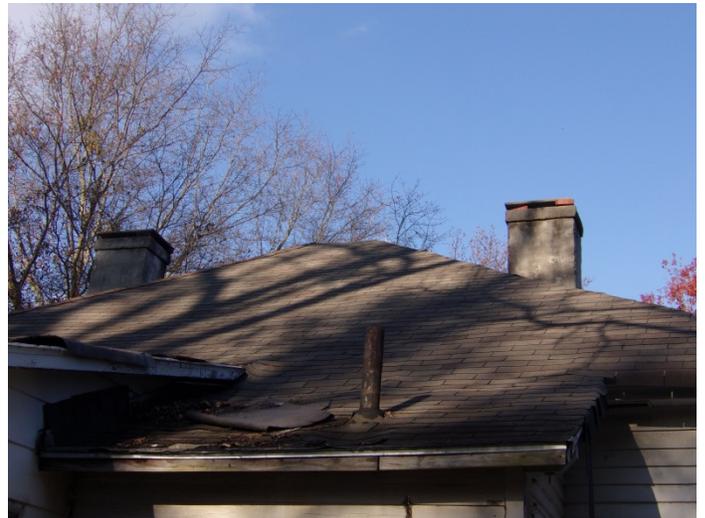
Photo 10 – Back roof with shingles & no felt. 2 Chimneys with mastic – assumed positive.

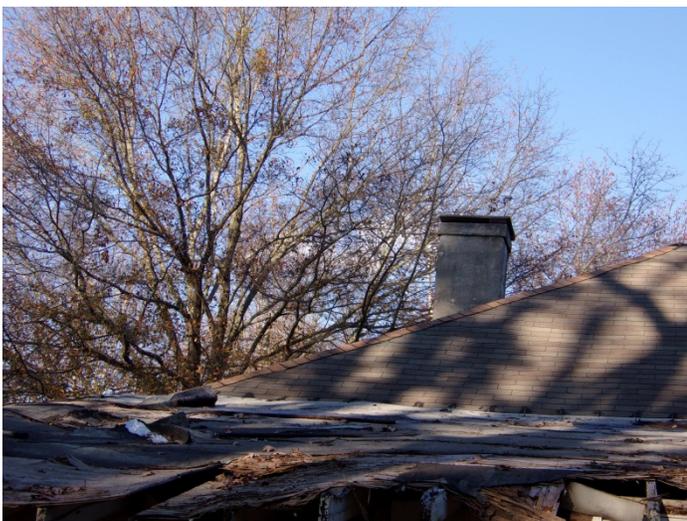
Photo 11 – Roll roofing with tar on back porch.
