COA AVIATION CAMPUS

Project Priorities

Existing Conditions, Program, Equipment

2019 07 10

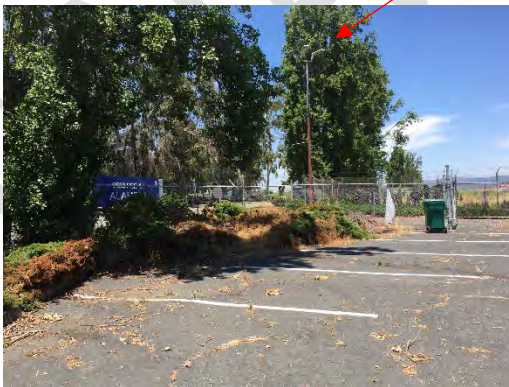
★ This site light does not function. The ground is also uneven near the pole due to tree roots.

Light Pole at campus entry

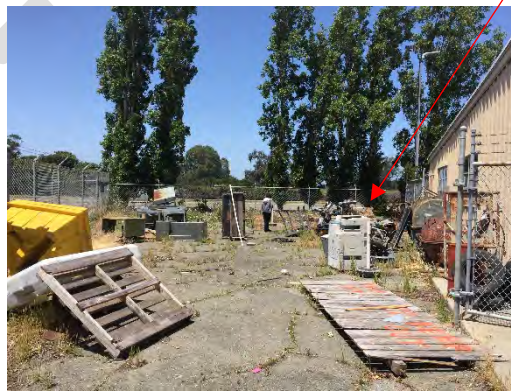
Engine theft access point at main road

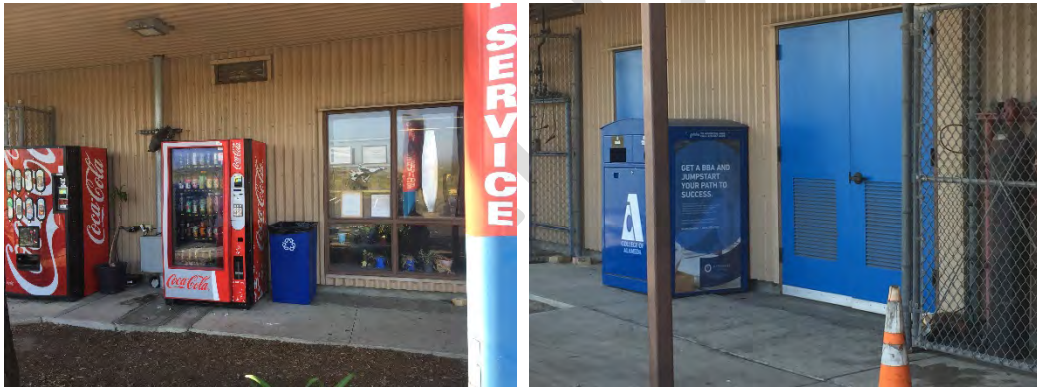
Vending near front door Cylinder supply, utility room access, recycling near front door

The cylinder supply system near the front door is abandoned and can be demolished.

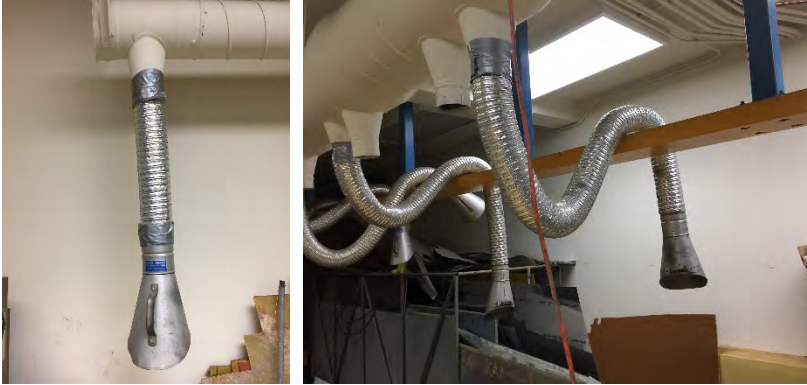
- **Composites Shop:** the AMT curriculum involves a lot of fiberglass work. The existing suction system was fabricated in-house. This space needs at least 15 snorkels, total. Ideally, the filtration system would be a built-in air filtration system, such as the one used by the AMT program at Solano CCD. Filtration system for this area is on the AEDA project equipment list but might need to be reclassified as building HVAC. The Composites Shop is in Hangar B.

House-made suction heads (snorkel) in Composites Lab.

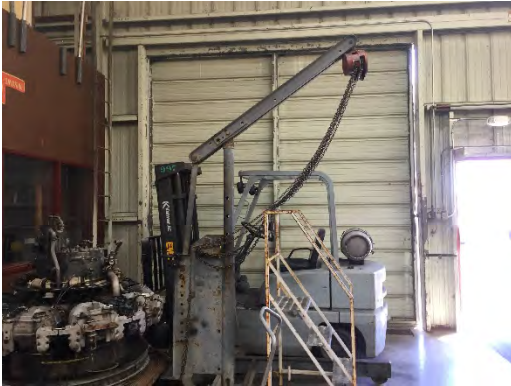
Portable hoist, Hangar A Engine Area

Existing method is to use a combination of portable hoist and forklift. This system should be replaced with an overhead hoist capable of lifting the largest loads.

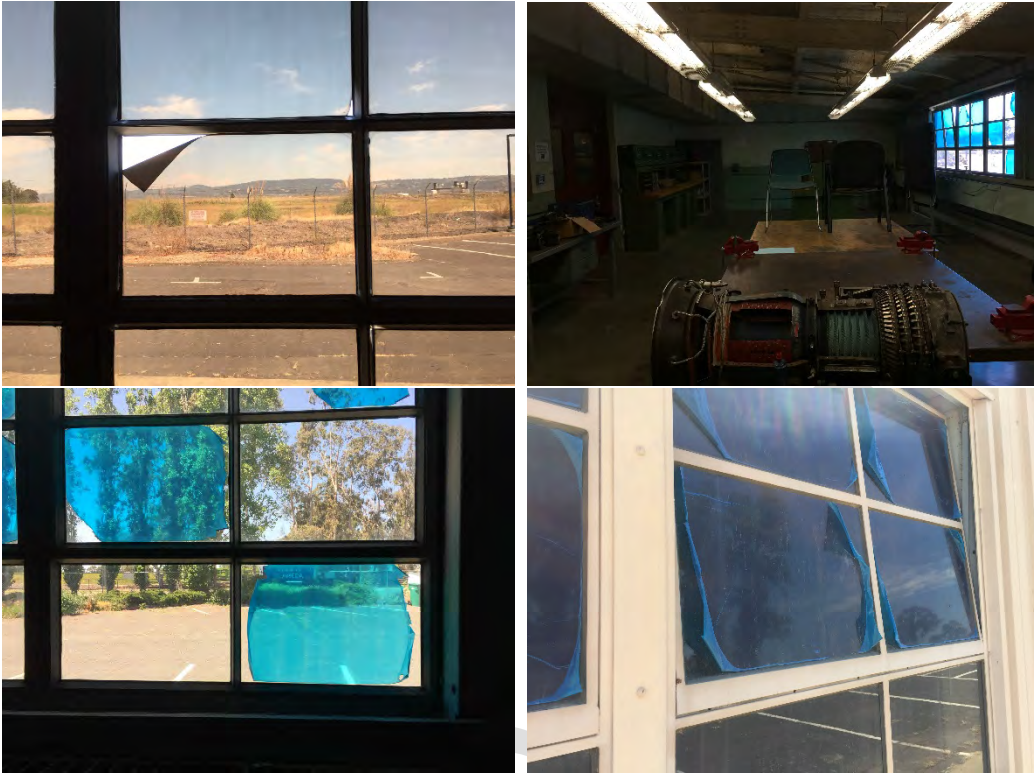
Glare is an issue at classrooms and shops at Hangar A. Classrooms and shops in Hangar B generally lack any windows.

Glare control at Hangar A general classroom, views from interior and exterior

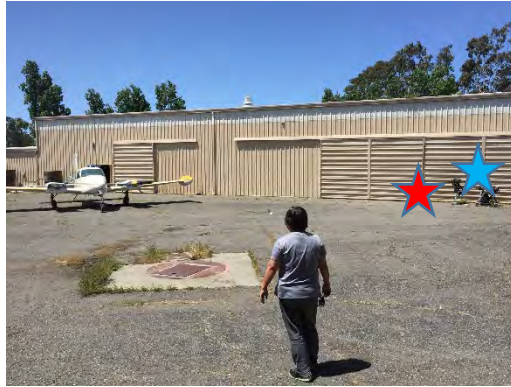
Two sets of hangar doors in Hangar A – one has not been functional in a very long time (“never” per one of the engineers). Carburetor and electrical work stations are relatively stationary. Engines get moved in and out but the hangar door adjacent to the Engine area does not get used much because the closing mechanism is unreliable. Most movable items (engines, sometimes also airplanes) go through the door on the propeller side because the door is in better condition. Hangar A might only need one hangar door but reliable functionality is essential.

Hangar Doors, Hangar A

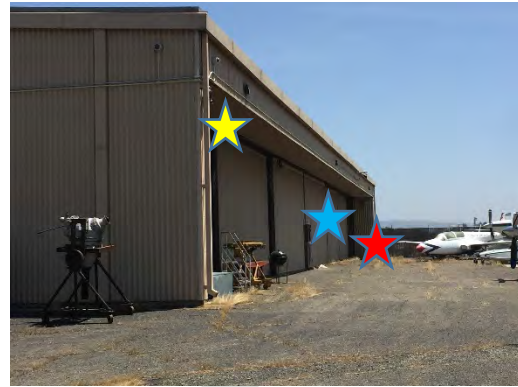
Hangar Doors, Hangar B

Two sets of hangar doors in Hangar B – the one on the mezzanine side has been out of operation for two years because it is broken but otherwise would be used. To restore functionality requires, at a minimum: replace entire track and motor plus new seals and controls. It might be a better investment to replace the hangar doors in their entirety.

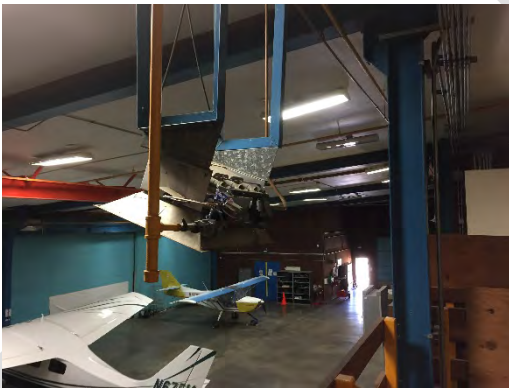
The existing space heaters are fired by natural gas but the vent pipes do not have an induced draft motor, which yields a carbon monoxide hazard. Existing heaters also emit sparks. Per the assistant chief engineer, the high bay space in Hangar B needs new space heater(s).

Overhead heating unit, Hangar B

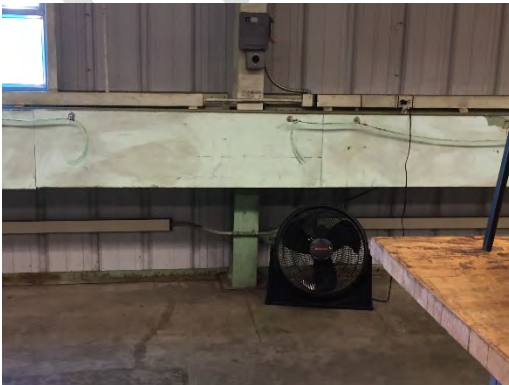
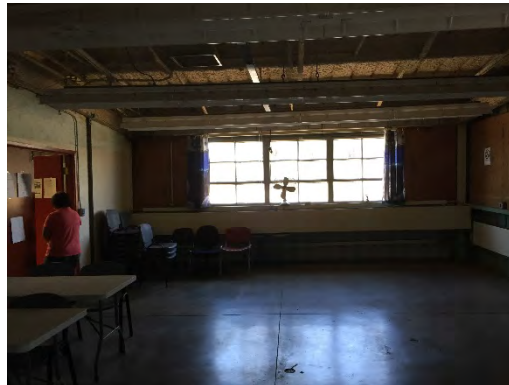
Heater and fan, general classroom, Hangar A Fan and curtains, general classroom, Hangar A

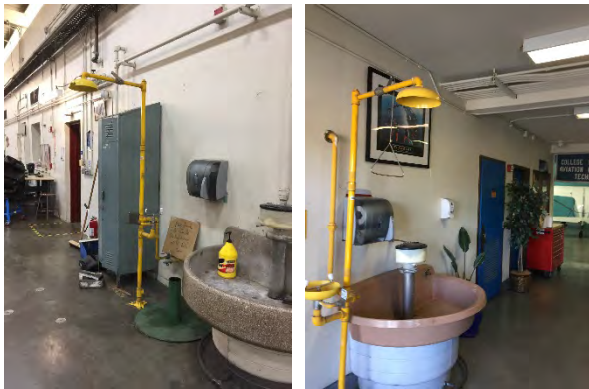
There is an emergency shower/eyewash and hand sink at the Hangar B entry lobby, the Hangar A high bay space, and the Corrosion Room. Emergency showers and eyewashes are required by the FAA and by OSH. Existing emergency showers and eyewashes are not connected to drainage. Emergency (?) shower needed for women's restroom.

Sinks, emergency shower and eyewash stations at Hangar A high bay space and Hangar B entry lobby.
