ROSA PARKS ESCAMBIA
COUNTY AREA TRANSIT (ECAT)
FUEL DEPOT

**FACILITIES
ASSESSMENT
REPORT**

CAA Project No. 21003

Revised: 18 AUGUST 2021

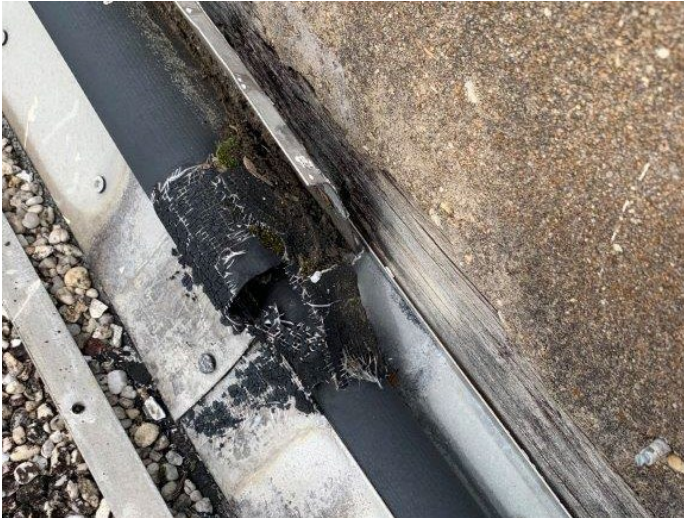
Roof Perimeter -
Termination bar and coping flashing disconnected

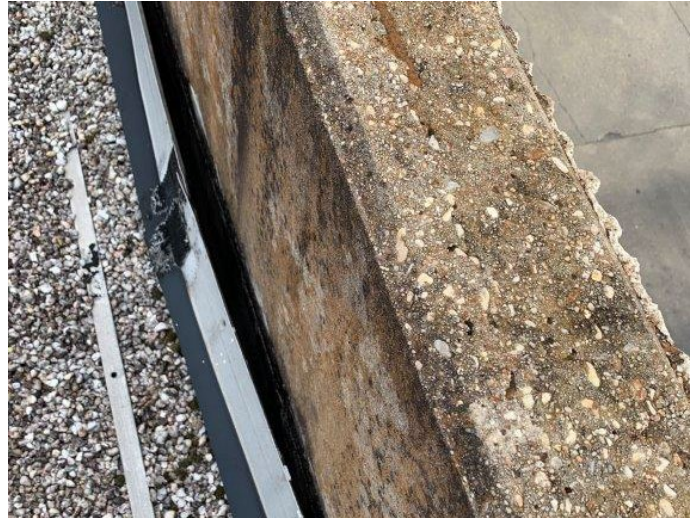
Roof Perimeter -
Termination bar and coping flashing disconnected

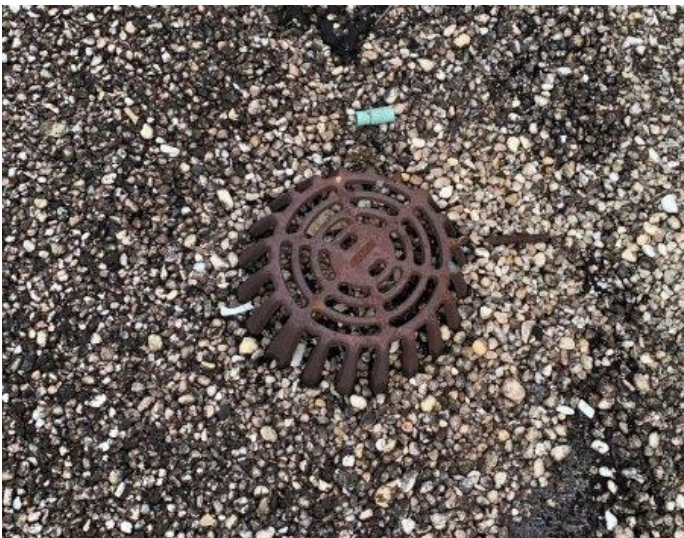
Roof Drain -
Completely blocked

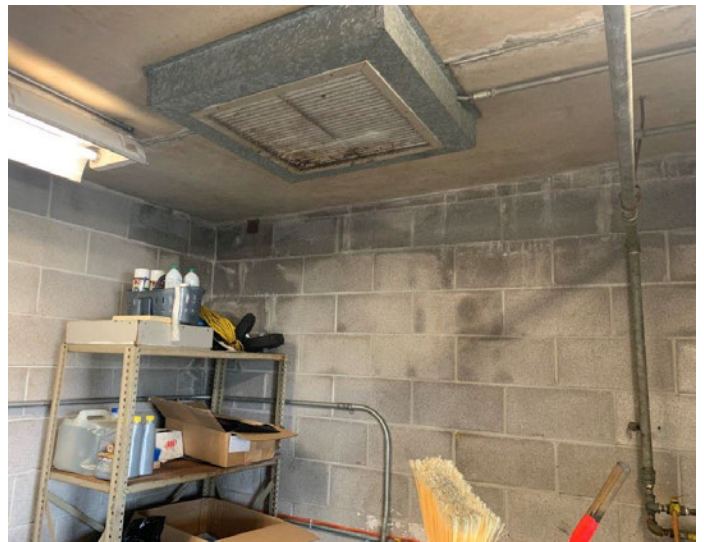
Interior – As the structure is primarily an open structure, no interior observations were noted at the higher roof portion of the structure. The lower roof portion of the structure is divided in to 4 rooms. Two rooms show signs of water damage and efflorescence on the concrete masonry

interior. One room has a large portion of peeling paint and efflorescence behind. The water damage seen appears to be moisture migrating through the exterior wall assembly.

Interior (unpainted) walls -
Efflorescence and water migration/staining

2.5.3 Finally, after moisture migration through the walls has been addressed, the interior face of the walls may be cleaned and, where applicable, repainted.

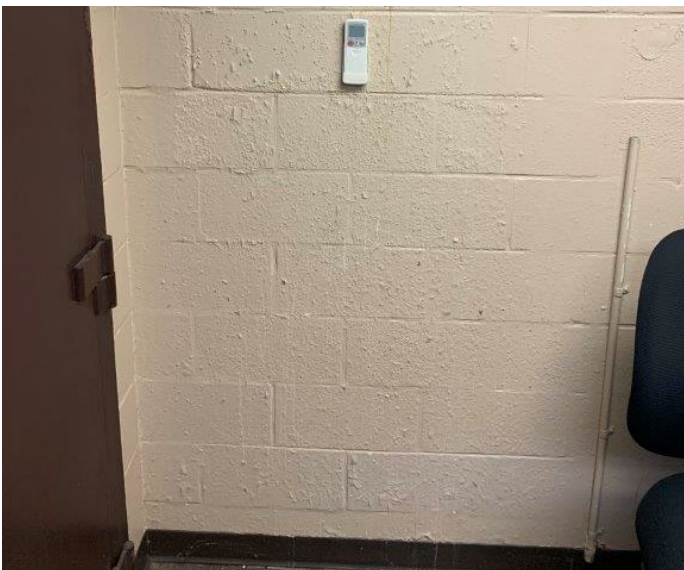
Interior Painted wall -
Efflorescence and peeling paint
