1) Project Title: DESIGN BUILD HILLSBORO COMMUNITY CENTER
Requested Date: 07/30/2020
Approved Date: 07/31/2020
Approved Wage Decision Number: SI-20-1549-B

Window and Door Restoration Level Key Plan
 New Mexico Historic Preservation Division 11/11/2019

Hillsboro Community Center
Preliminary Window Review for Restoration Work –
Level A through Level E

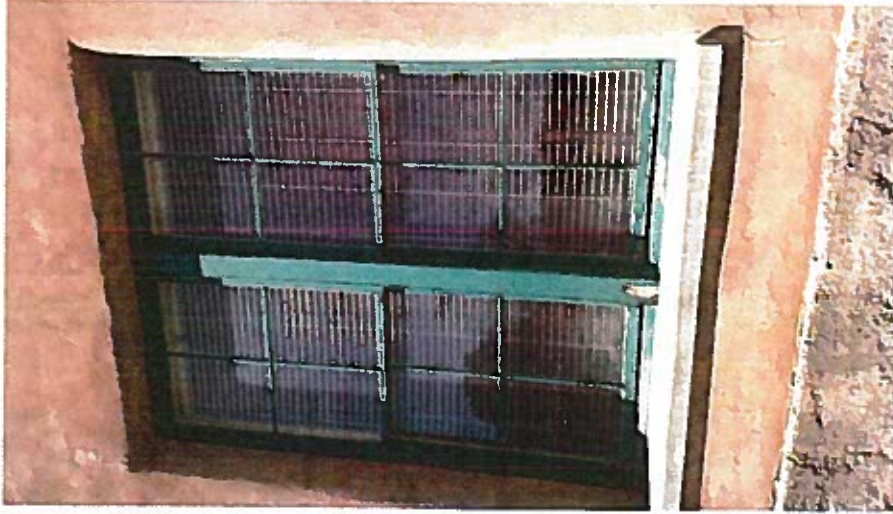
Window 5- Level B work

Note damage at bottom rails, stools and aprons with damage to meeting rails and bottom of center mullion; note gap between window bottom and stool at both windows

Level B – add additional work above Level A for repair of the bottom rail, stool and apron of the sash and the center mullion where sun and water damage has affected both the paint finish and surfaces of the wood.

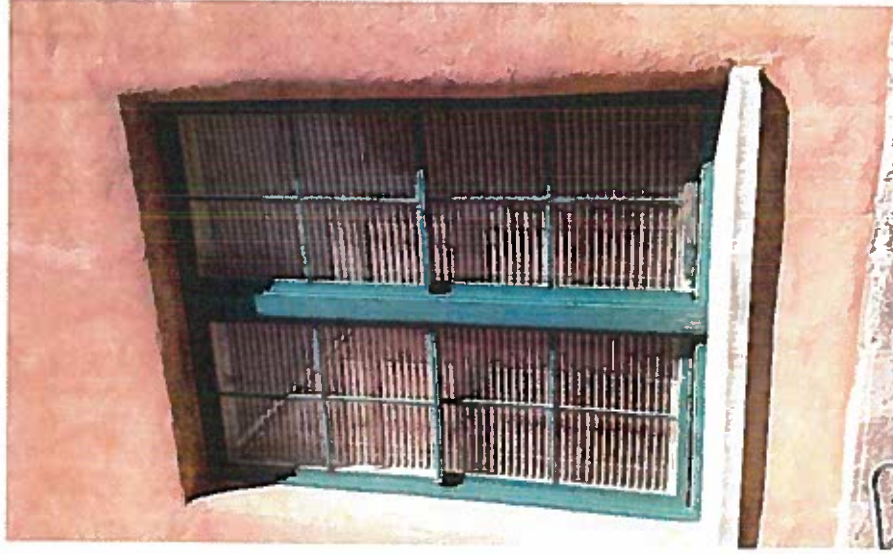
Window 6 - Level B work

Similar repairs as Window 5

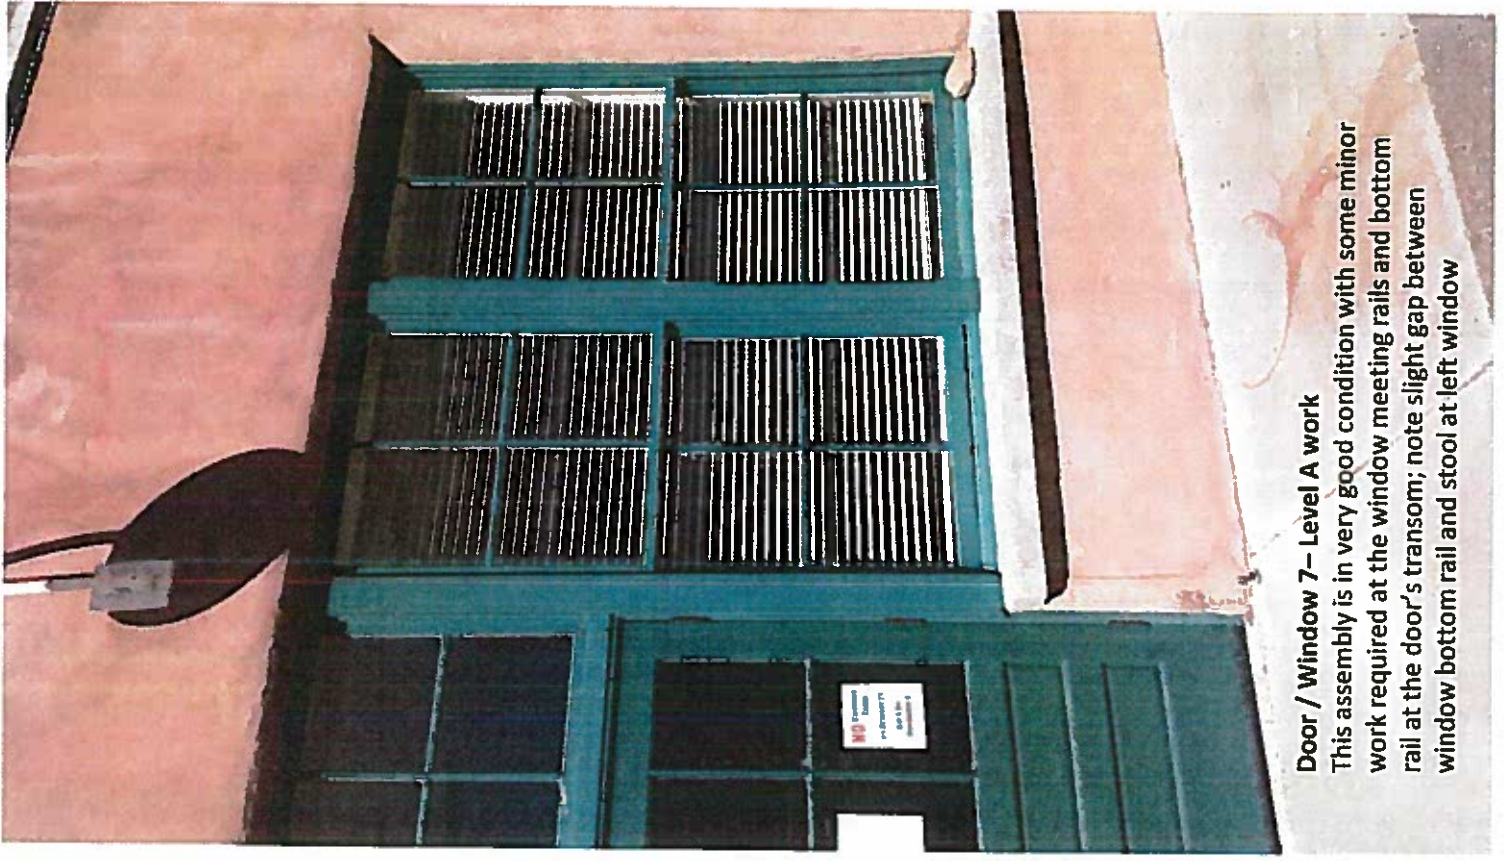
Door / Window 7- Level A work

This assembly is in very good condition with some minor work required at the window meeting rails and bottom rail at the door's transom; note slight gap between window bottom rail and stool at left window

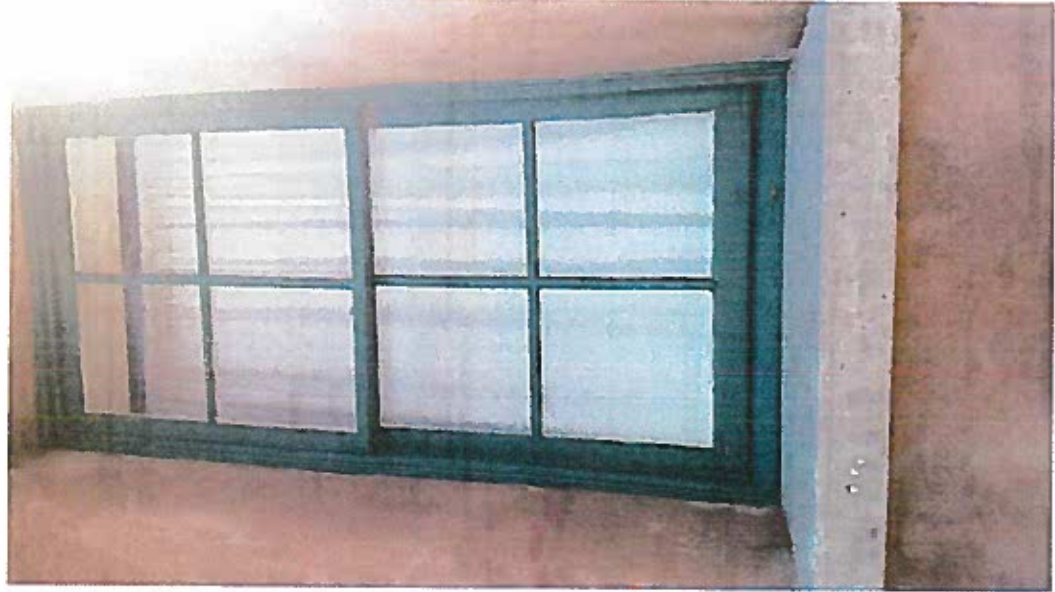
Window 9 – Level A work
This east facing window is in very good condition, different from other windows on this elevation

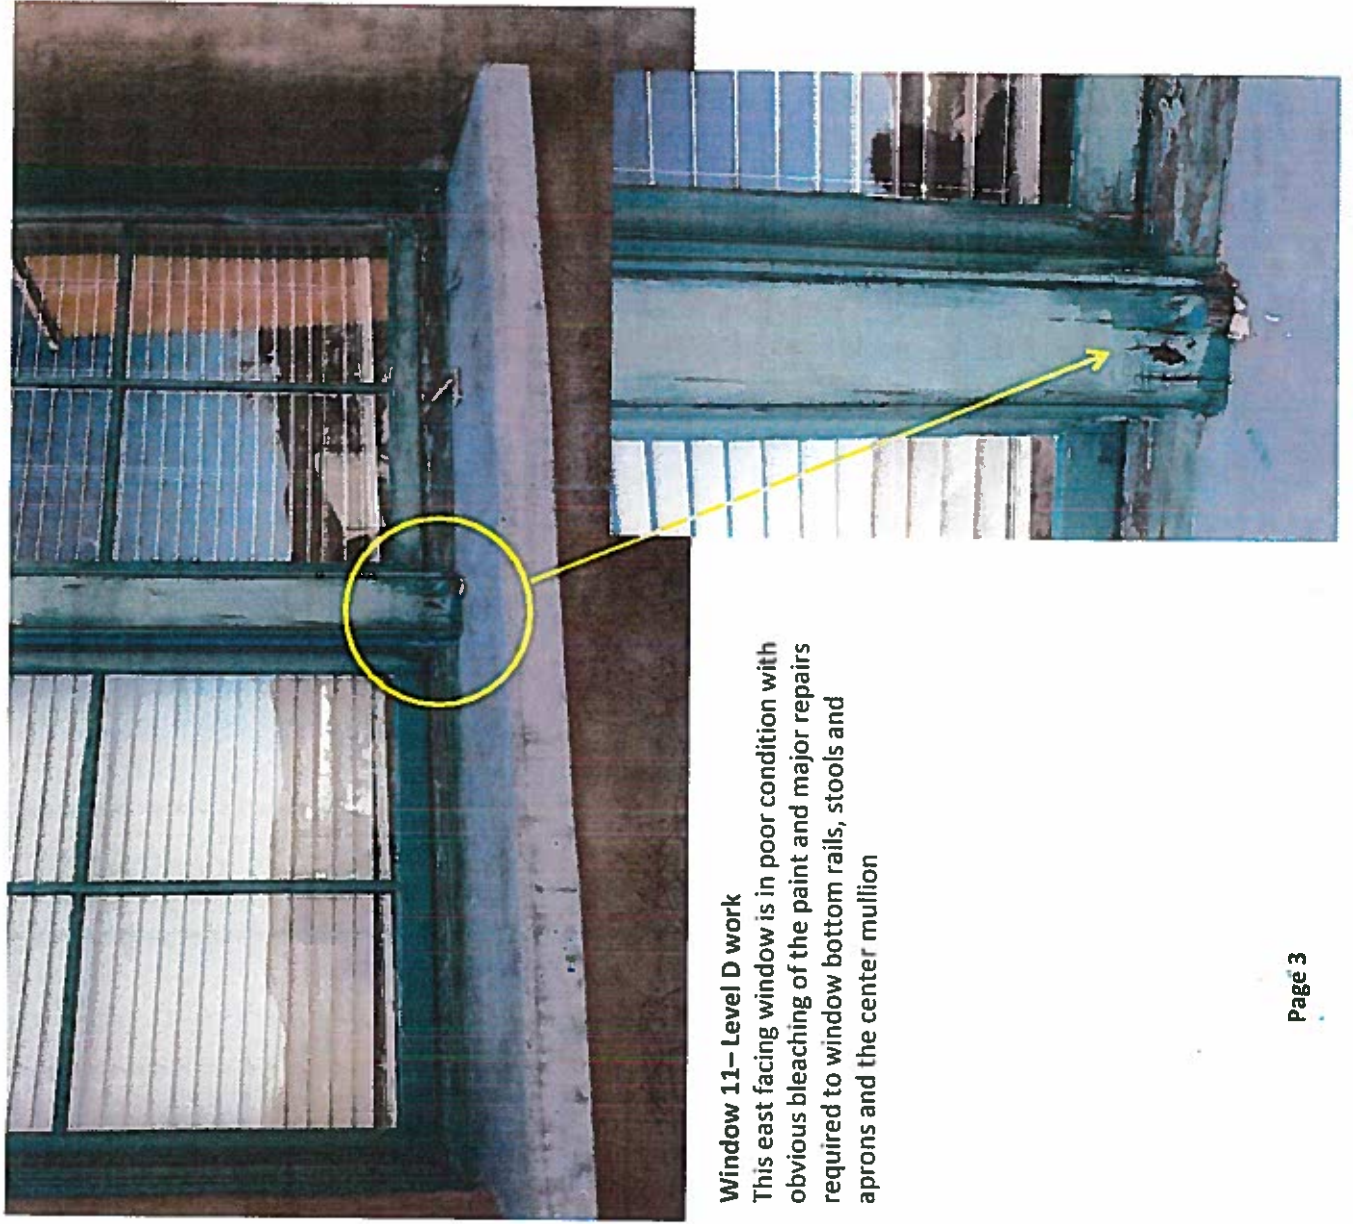
Window 11 – Level D work
This east facing window is in poor condition with obvious bleaching of the paint and major repairs required to window bottom rails, stools and aprons and the center mullion

Level D - this level of work is primarily at the east elevation where windows have taken abuse from weather and are in need of major epoxy repairs to surfaces. In several cases, complete replacement of the meeting rail and some muntins at windows is required.

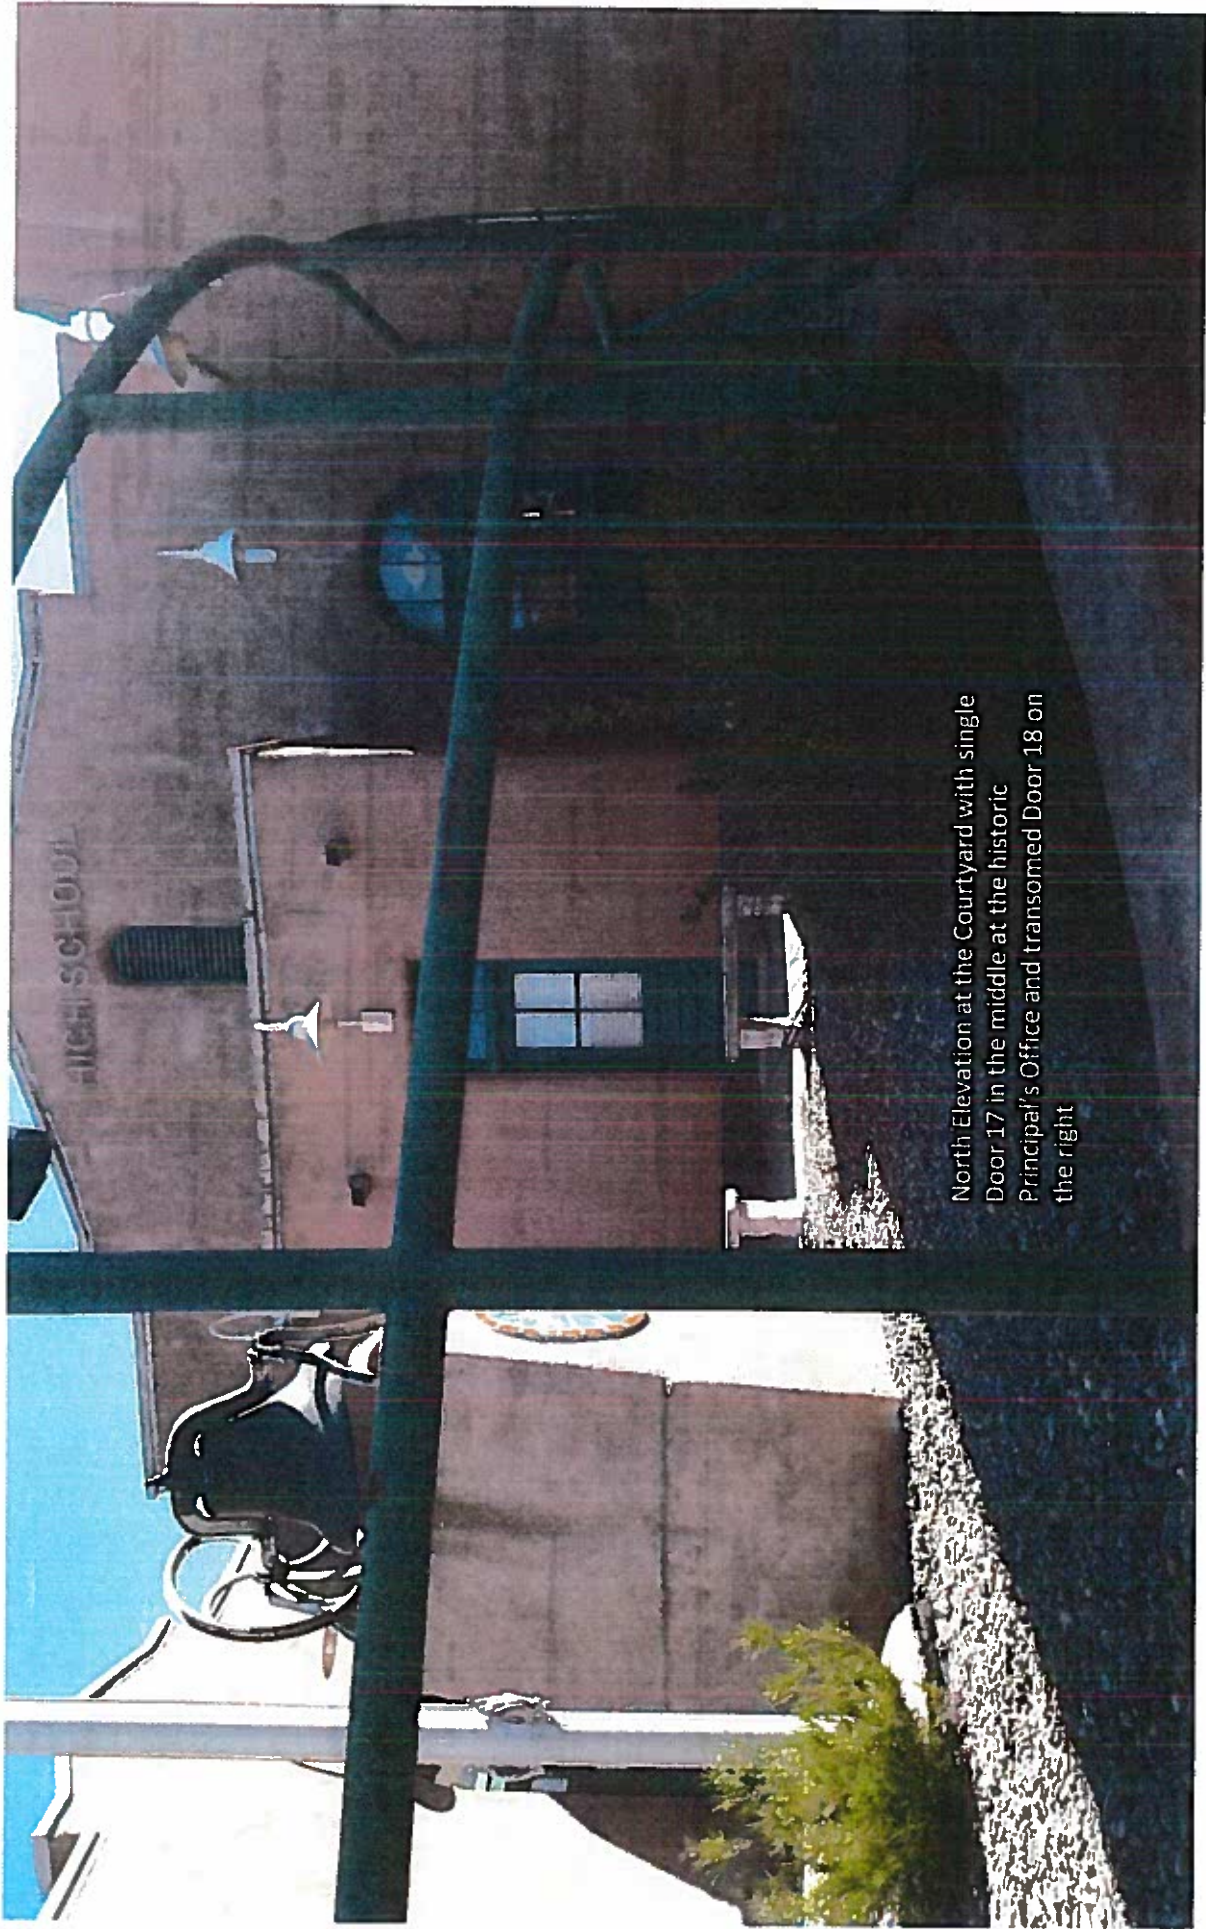
North Elevation at the Courtyard with single Door 17 in the middle at the historic Principal's Office and transomed Door 18 on the right

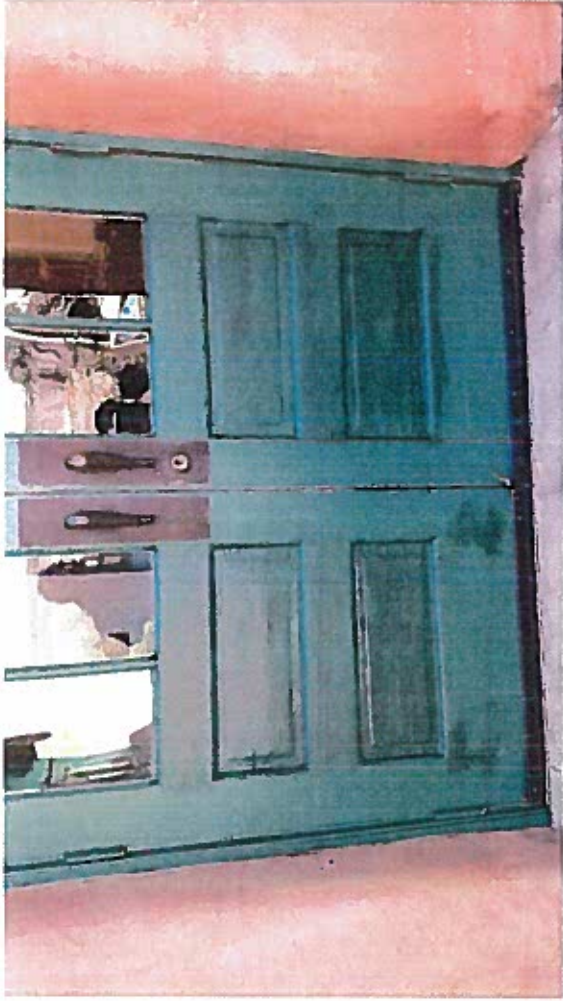
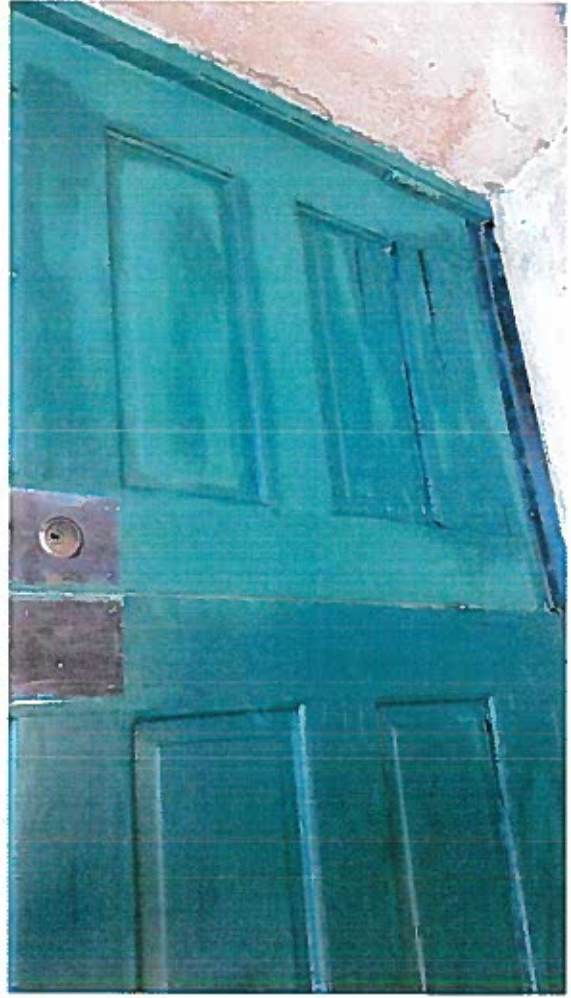
Door 16 above and Door 18 below – Level C work

Both doors need significant work for repair of the panel areas and base of doors where the bottom rail is failing; repairs to roof drainage are required to protect both door systems

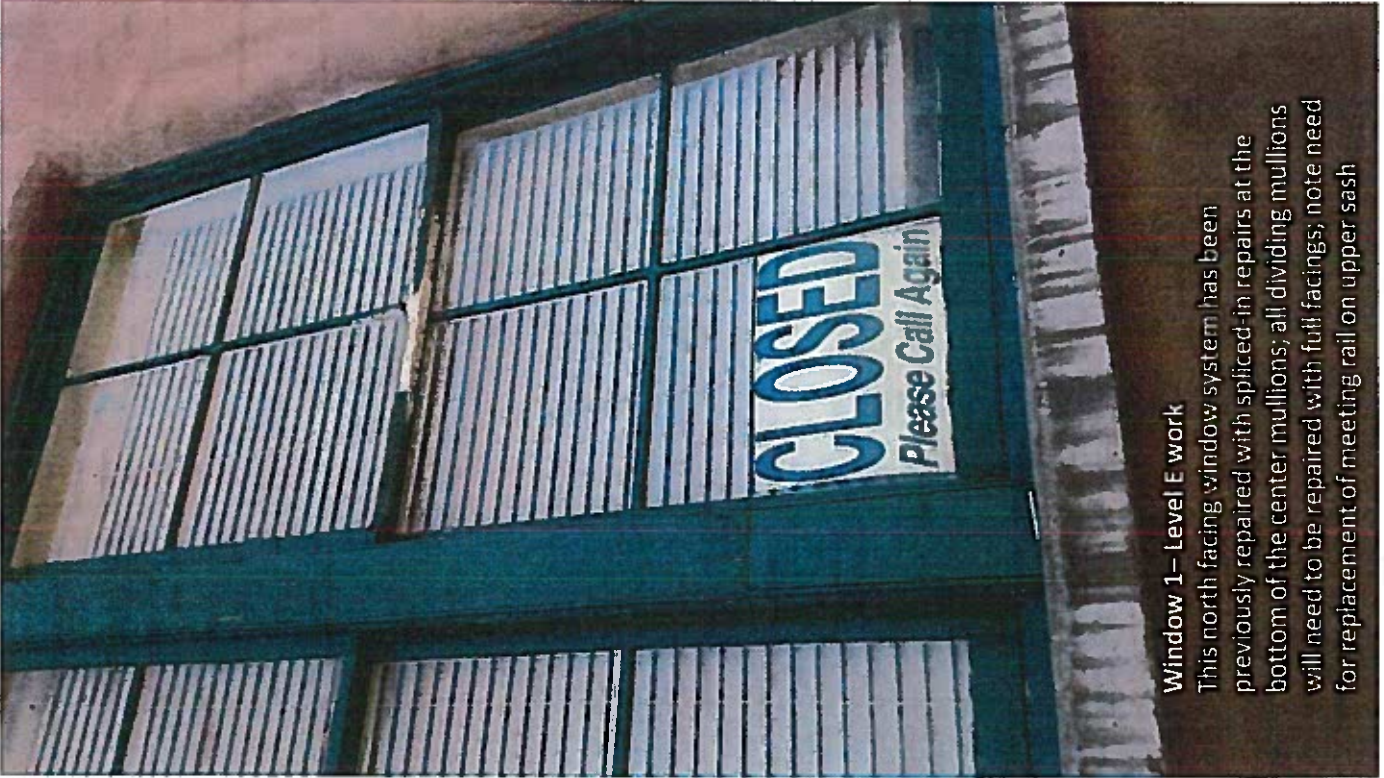
Window 1 – Level E work

This north facing window system has been previously repaired with spliced-in repairs at the bottom of the center mullions; all dividing mullions will need to be repaired with full facings; note need for replacement of meeting rail on upper sash

Level E - this level of work includes all work areas under Levels A-D but also includes the work for total replacement of major dividing mullions at the windows at the south, front elevation.
