RE: Limited Asbestos and Lead Survey

Barranca Elementary School
HVAC Replacement Project
727 South Barranca Avenue
Covina, California 91723

CES Project No.: 24.CVUSD.01

LIMITED ASBESTOS AND LEAD IN PAINT SURVEY
BARRANCA ELEMENTARY SCHOOL- HVAC REPLACEMENT PROJECT
BUILDING B- MECHANICAL ROOM B113

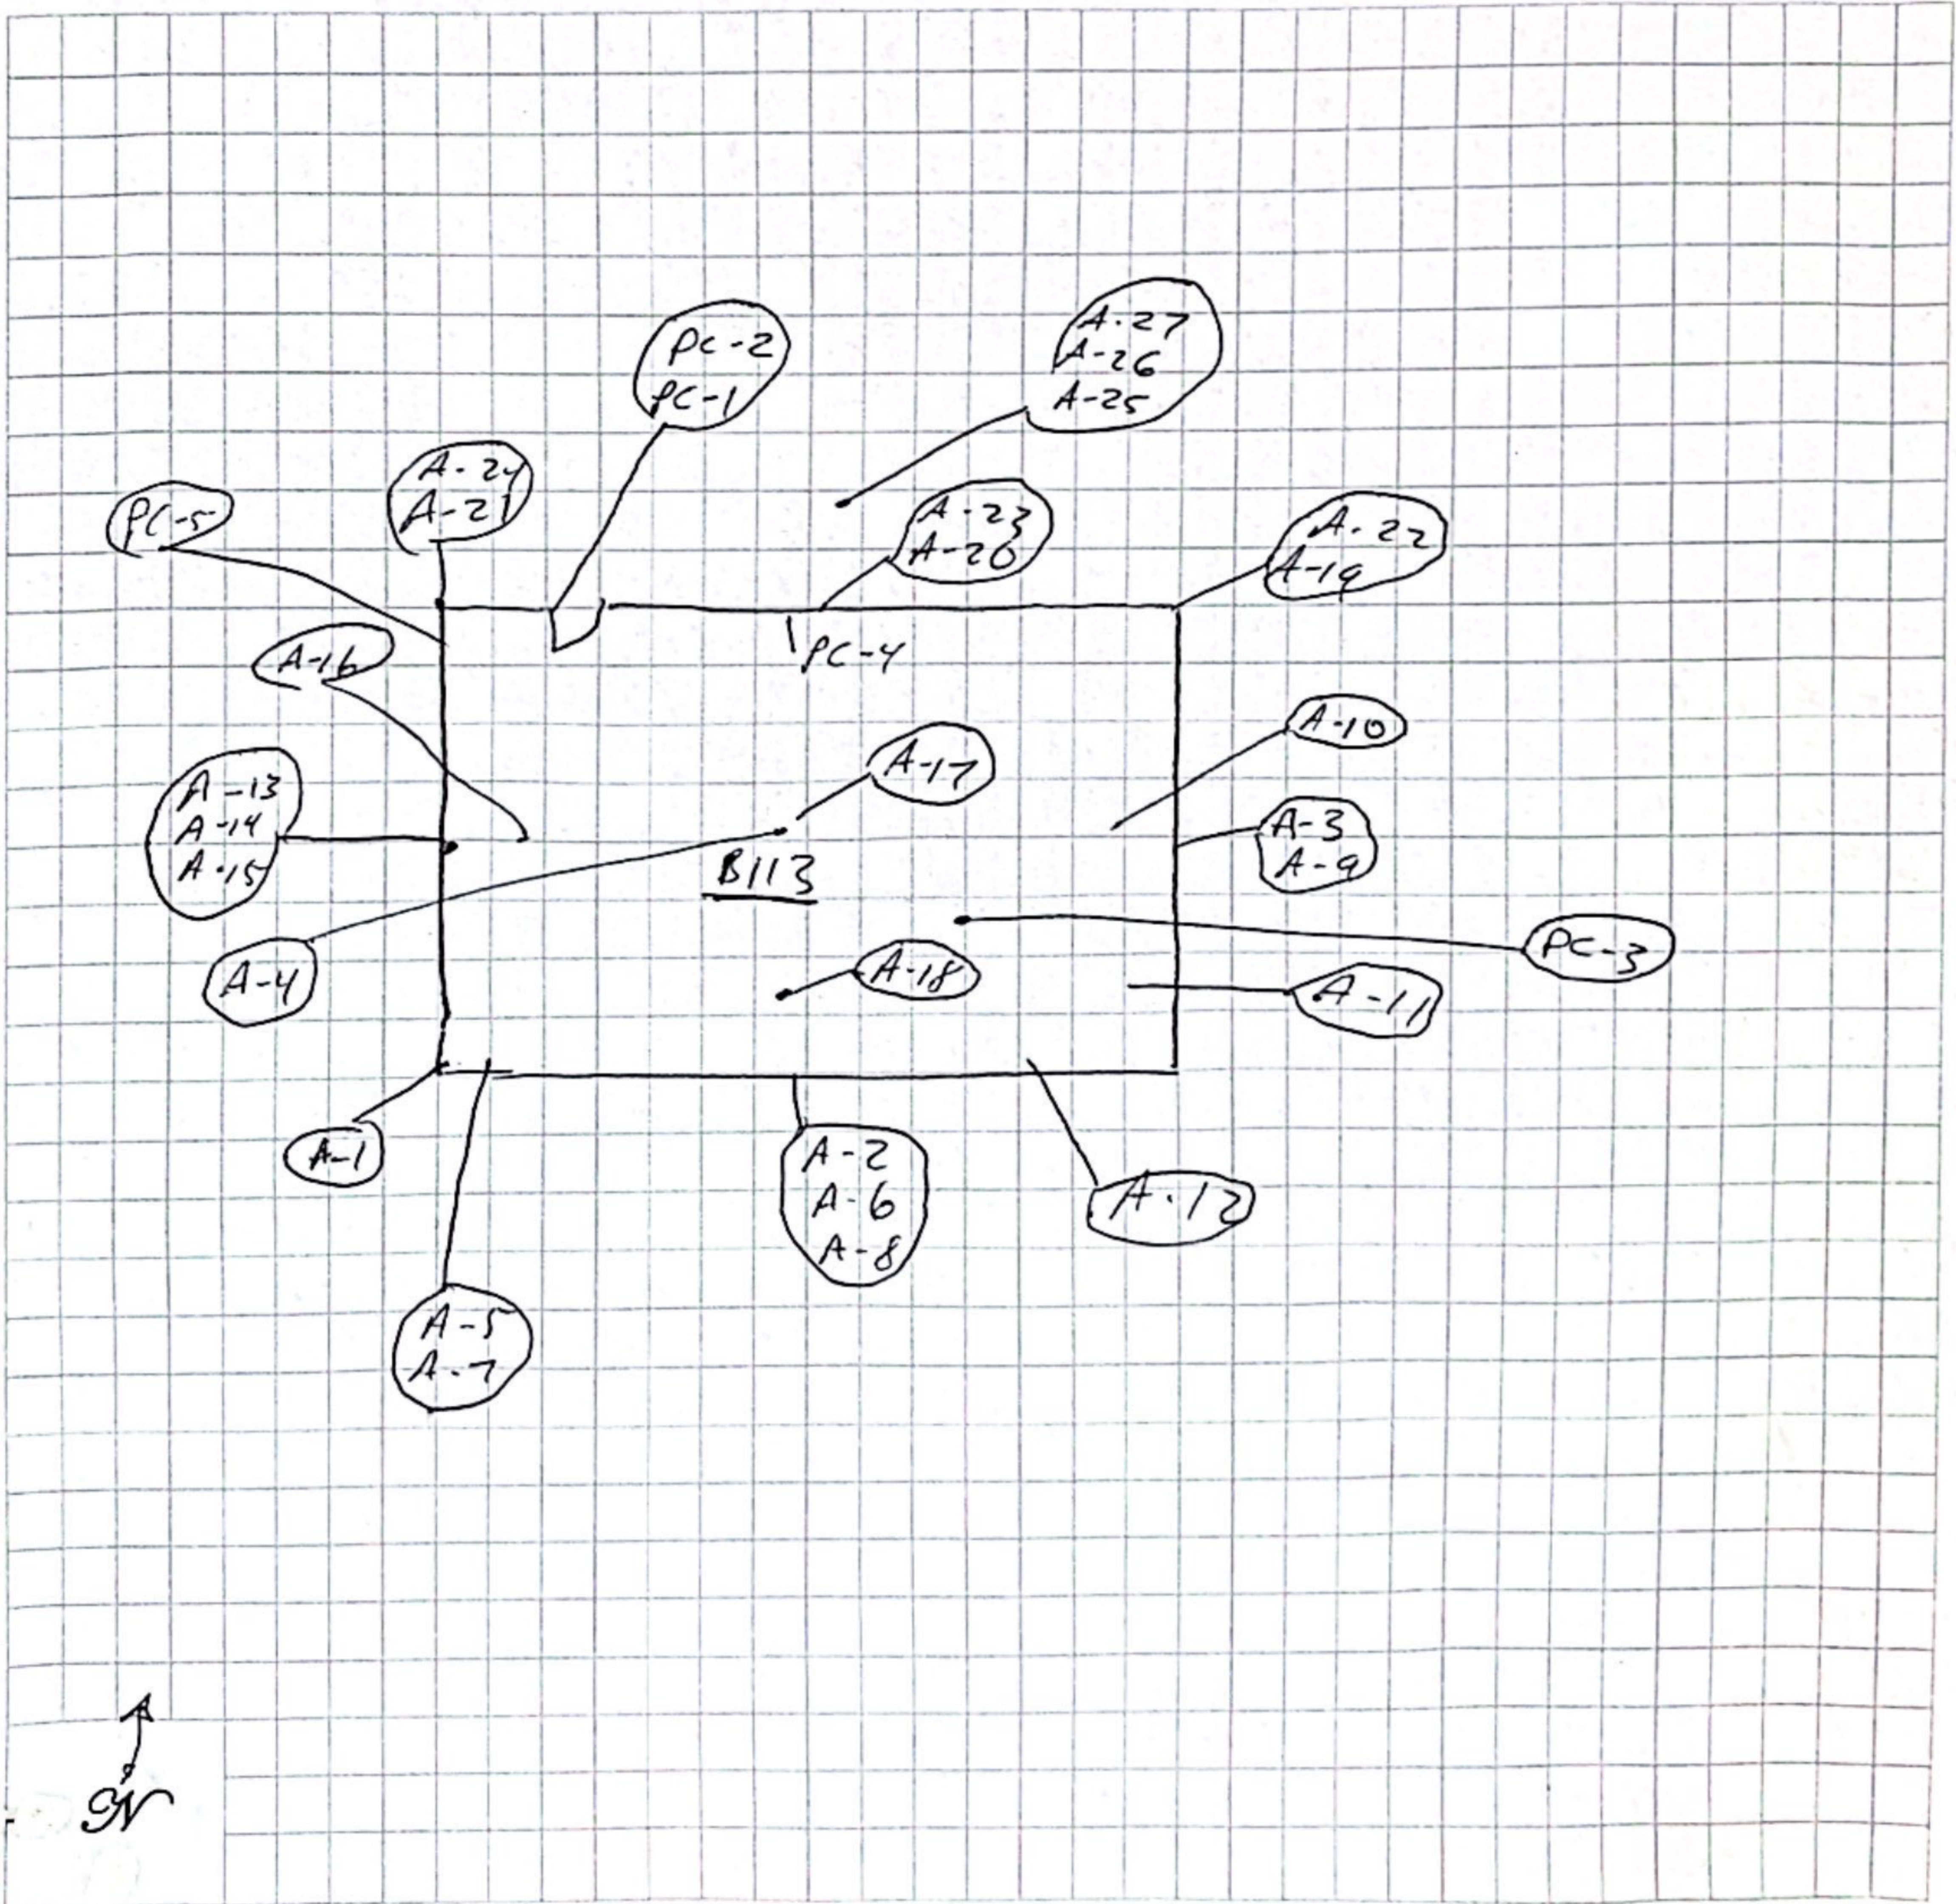
APPENDIX C:
SAMPLE LOCATION MAP

Date:	2-16-2024	CES Representative(s):	Fabian Ruvache
Project No.:		Project Name:	Barranca E.S.
Project Location:	Barranca E.S.	Project Area:	Meck Ln Bldg B - B113
