Structural Assessment Memo

Main Street Pier Existing Concrete Slab and Foundations

Daytona Beach, Florida

August 2019

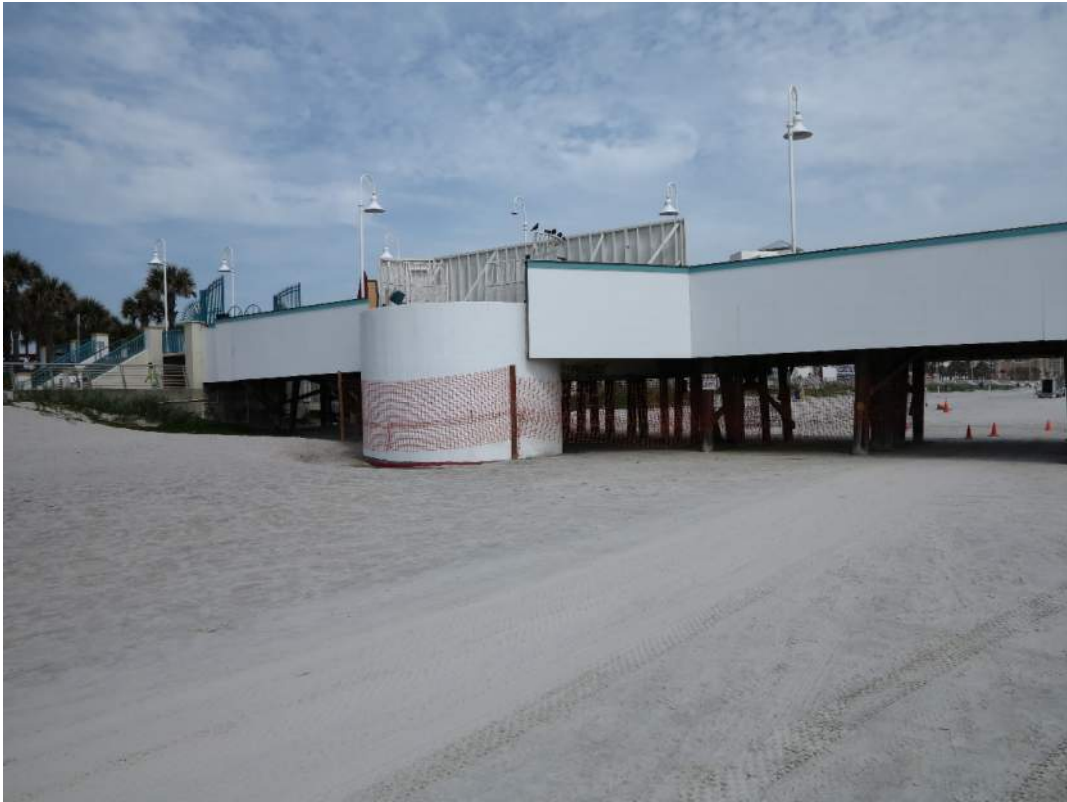
- Former space needle cradle/bowl concrete support and adjacent concrete beams (wings) – No deficiencies of the bowl and cylindrical concrete wall were noted (see Photo 1). The adjacent concrete beams (wings) have major corrosion and the loss reinforcing at the bottom of beams (full length) along with concrete spalling (see Photo 2).

Photo 1
Former Space Needle Cradle/Bowl Concrete Support, Looking Northwest
No Deficiencies Were Noted at the Cylindrical Concrete Support

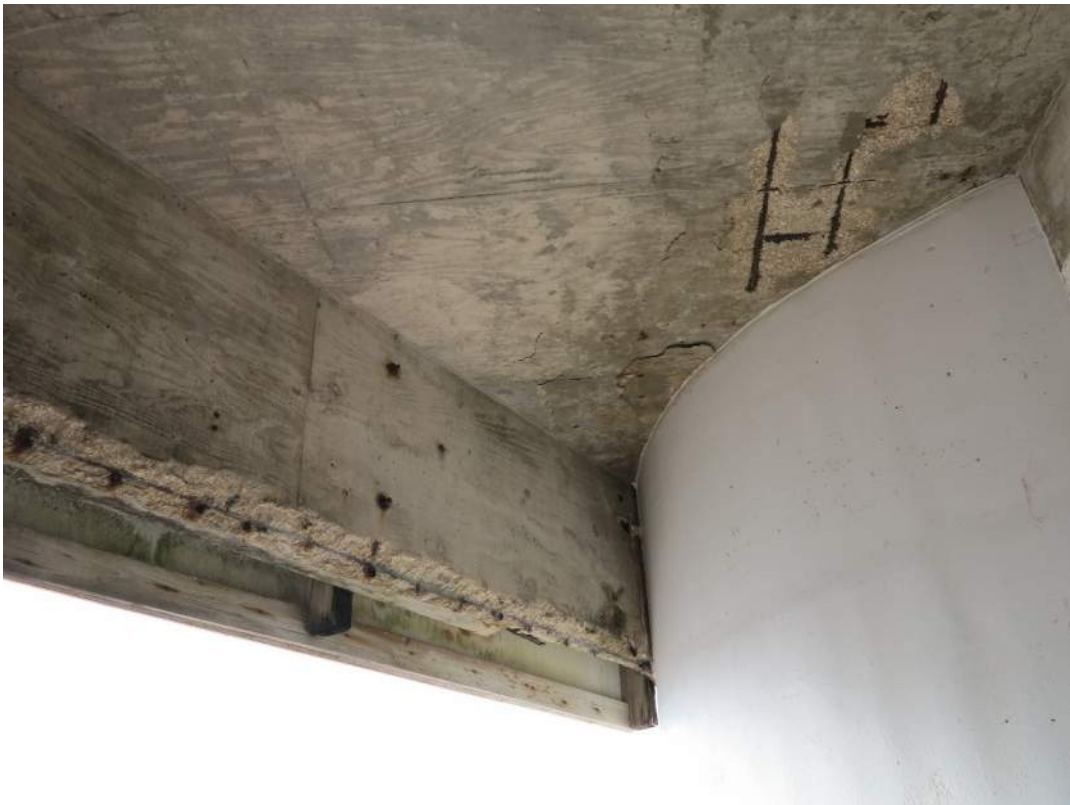
Photo 2
Existing 8"x48" Concrete Beam (Wing), Looking South
Note Missing Steel Reinforcing Bar

- Remove existing concrete beams (wings) adjacent to the former space needle cradle/bowl concrete support. Replace with timber framing.
- Repair former chairlift concrete pier support between Bents 3 and 4 with epoxy crack injection and concrete patch repair.

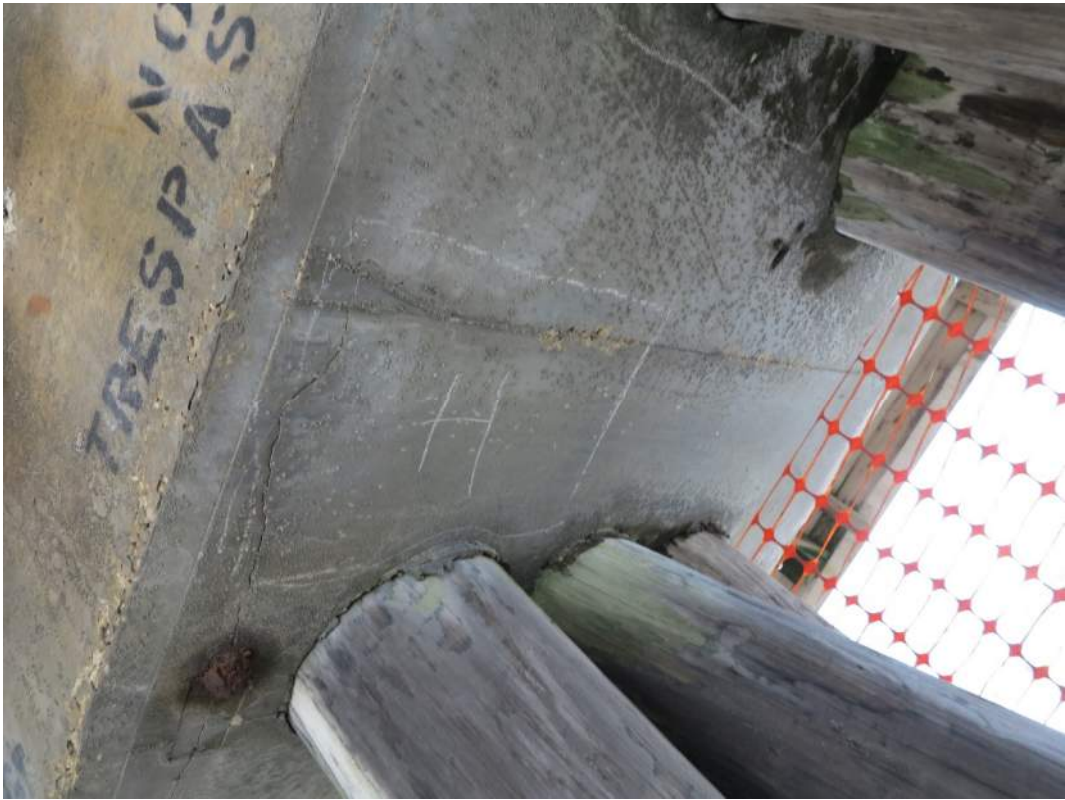
Photo 3

- Former chairlift concrete pier support between Bents 3 and 4 – Some minor cracks are present on the south face as well as delaminations on the bottom (see Photo 3).

Former Chairlift Concrete Pier Support Between Bents 3 and 4, Looking Up and North
Note Delaminated Area Identified with "H" on Bottom

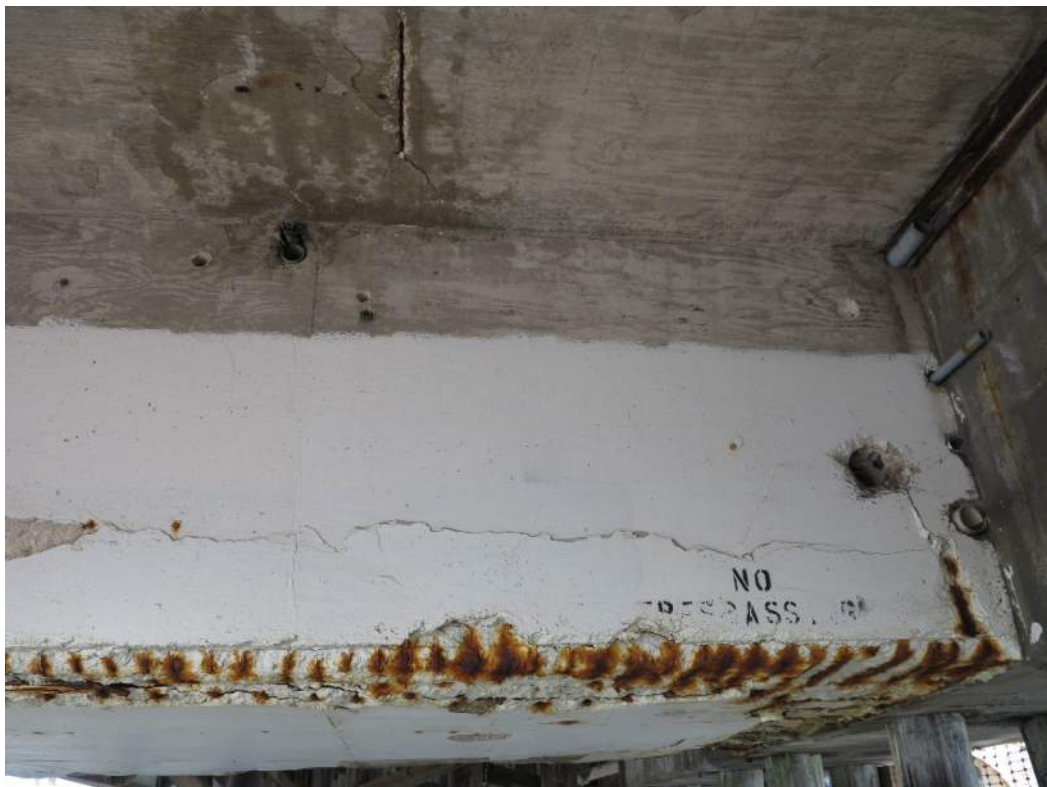
Photo 4

- Concrete U-beam (vault) and slab between Bents 3 and 4 – Several cracks, delaminations, and spalling occur at both the north and south faces as well as the bottom (see Photo 4).

Existing Concrete U-Beam (Vault), Looking West
Note Spalled and Delaminated Areas with Exposed Steel Reinforcing Bars

- Remove existing concrete U-beam (vault) and slab between Bents 3 and 4. Replace with galvanized steel beam connected to former chairlift concrete pier support and former space needle cradle/bowl concrete support. This new beam will support new timber framing and decking.

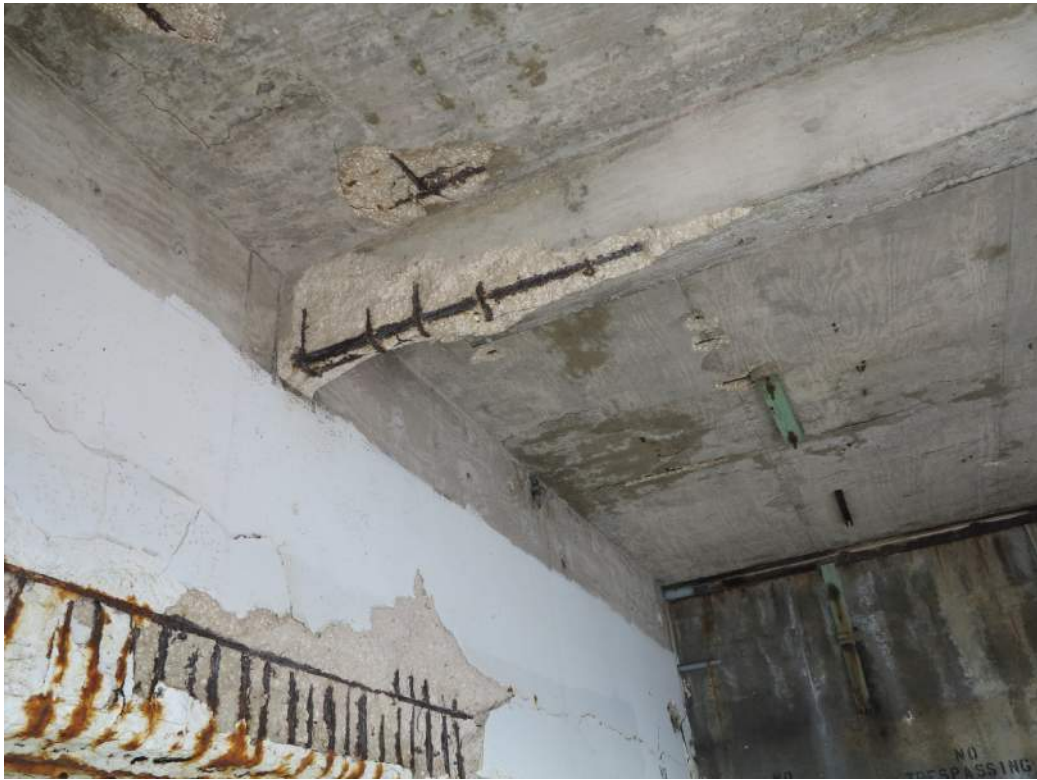
Photo 5

- Concrete beams and slab between Bents 2 through 4 – Several cracks, delaminations, and spalling occur at both the slab and beams (see Photo 5).
- Steel channel beams with transverse steel channels/plates at end for connection of timber bent cap to concrete beam between Bents 2 through 4 – Steel members exhibit major corrosion and section loss. The connection of one of the channels to a concrete beam was also compromised (see Photo 6).

Existing 8"x18" Concrete Beam and Slab, Looking Up and North
Note Spalled Areas with Exposed Steel Reinforcing Bars

- Remove existing concrete beams and slab between Bents 2 through 4. Replace with timber framing and decking.
- Remove existing steel channel beam with transverse steel plate at end for connection of timber bent cap to concrete beam between Bents 2 through 4.

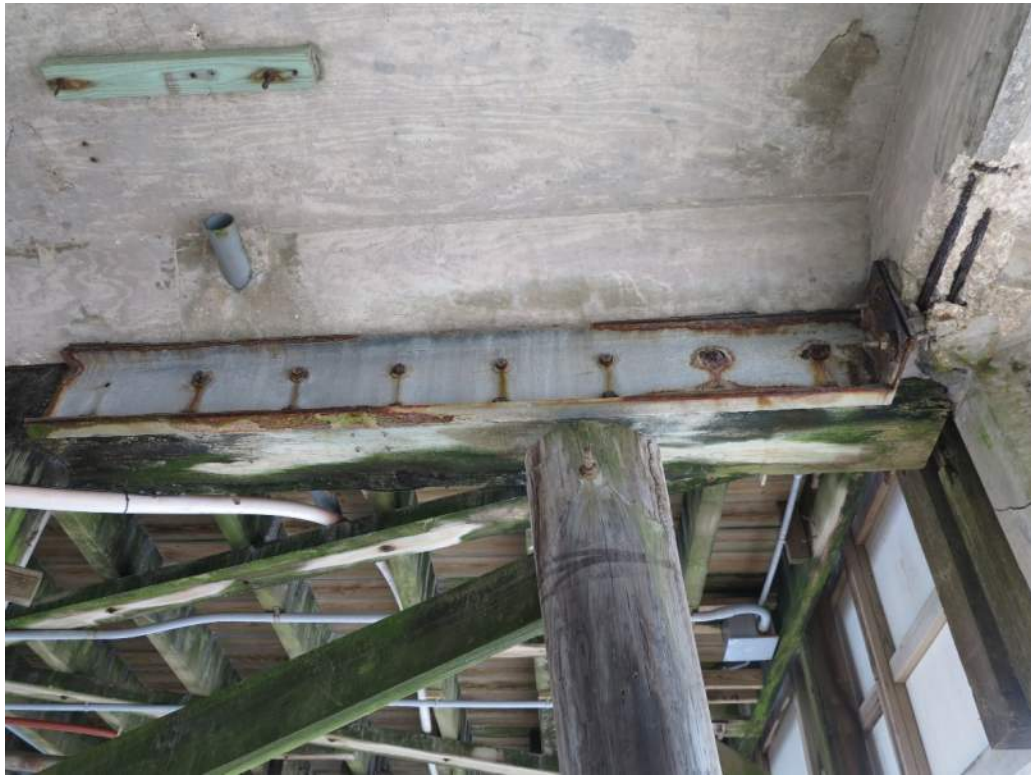
Photo 6

Existing Steel Channel Beam with Transverse Steel Connection Plate at End, Looking Up and East
Note Corrosion as well as Exposed Steel Reinforcing Bars and Anchor at Concrete Beam

- Inject all cracks that are greater than 0.01 inches in width with an epoxy such as Sikadur - 35 Hi-Mod LV or equal.
- Repair the connection between the steel channel beam with transverse steel plate at end and the 8"x18" concrete beam where an existing anchor is exposed. This will require shoring of the existing 8"x18" concrete beam and the adjacent 8"x48" concrete beam, concrete repair of the concrete beam end, and reinstallation of the anchors. The following procedures should be followed:

- Install temporary shoring.
 - Remove existing through bolts in existing steel plate.
 - Remove section of deteriorated existing concrete beam to sound material by chipping with light duty pneumatic or electric concrete chipper. Blast clean existing concrete surfaces that will be in contact with freshly placed repair material and clean to remove loose material and dust immediately prior to application of repair material. Provide 3/4" clearance around all existing reinforcing steel when exposed.

- Coat the prepared concrete surface with an epoxy bonding agent such as MasterEmaco P 124 or equal and apply in accordance with the manufacturer's recommendations. Form and fill prepared area with high-strength, non-metallic, non-shrink grout such as MasterEmaco S 440 Cl or equal, and mix and apply in accordance with the manufacturer's recommendations. Firmly consolidate the grout mix in the area to be repaired. Restore surfaces and edges to the original dimension and shape of the repaired item.

- Reinstall existing through bolts through existing steel plate and repaired concrete beam.
 - Remove temporary shoring.
- Install timber shim where missing between the top of an existing timber pile and the bottom of the existing timber bent cap at south end of Bent 4.

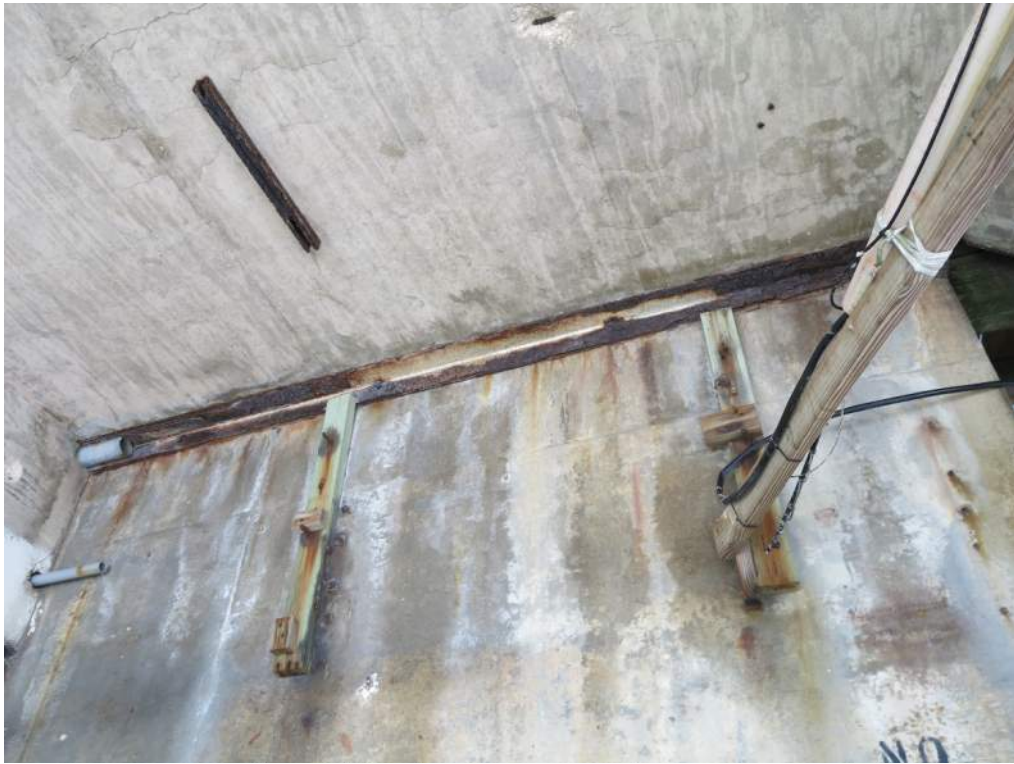
Photo 7
Existing Steel Angle Ledger, Looking Up and North
Note Severe Corrosion of Angle on Right Side

- Steel angle ledger supporting concrete slab at former chairlift concrete pier support between Bents 3 and 4 – Steel members exhibit minor corrosion and section loss at most places with the exception of the interior of the existing U-shaped concrete beam where heavy corrosion was noted (see Photo 7).

- Remove steel angle ledger supporting concrete slab at former chairlift concrete pier support between Bents 3 and 4.
- Repair former chairlift concrete pier support between Bents 14 and 15 with epoxy crack injection and concrete patch repair.

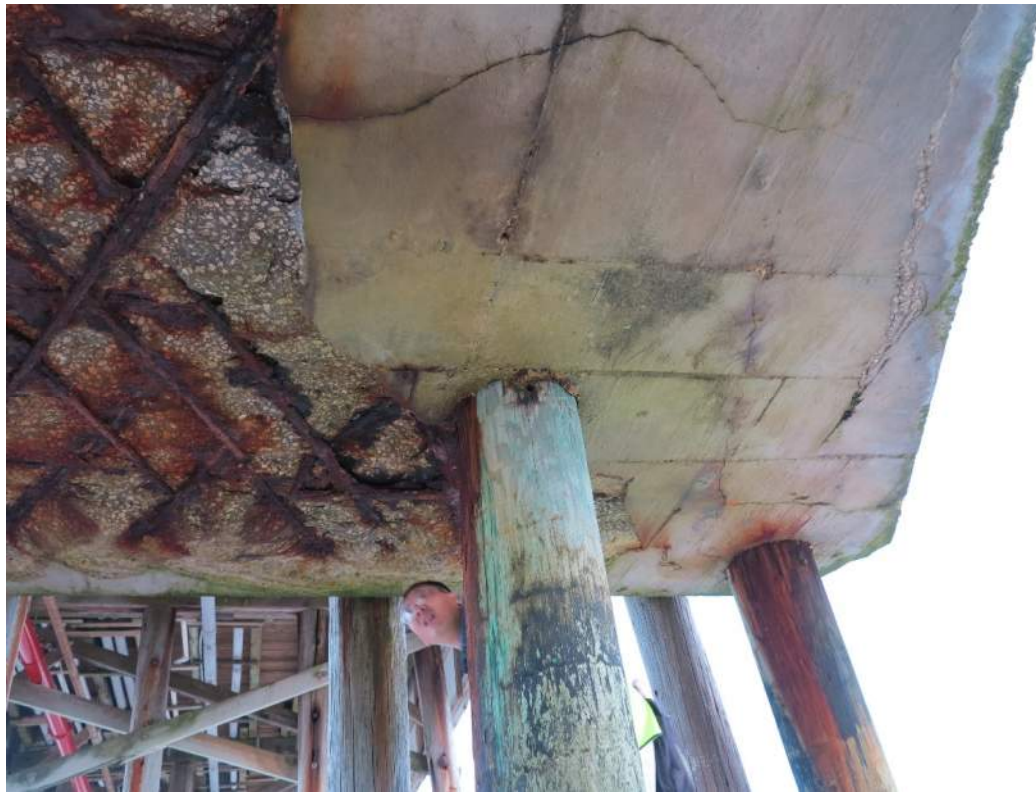
- Former chairlift concrete pier support between Bents 14 and 15 – Several cracks and delaminations were found on the three faces of the pier cap and pier above. Severe deterioration of the bottom of the cap was noted with the exposed bottom layer of reinforcing exposed and a large delamination on the north side of the bottom (see Photos 8 and 9).

Photo 8
Former Chairlift Concrete Pier Support Between Bents 14 and 15, Looking Up and West
Note Spalled and Delaminated Areas with Exposed Steel Reinforcing Bars

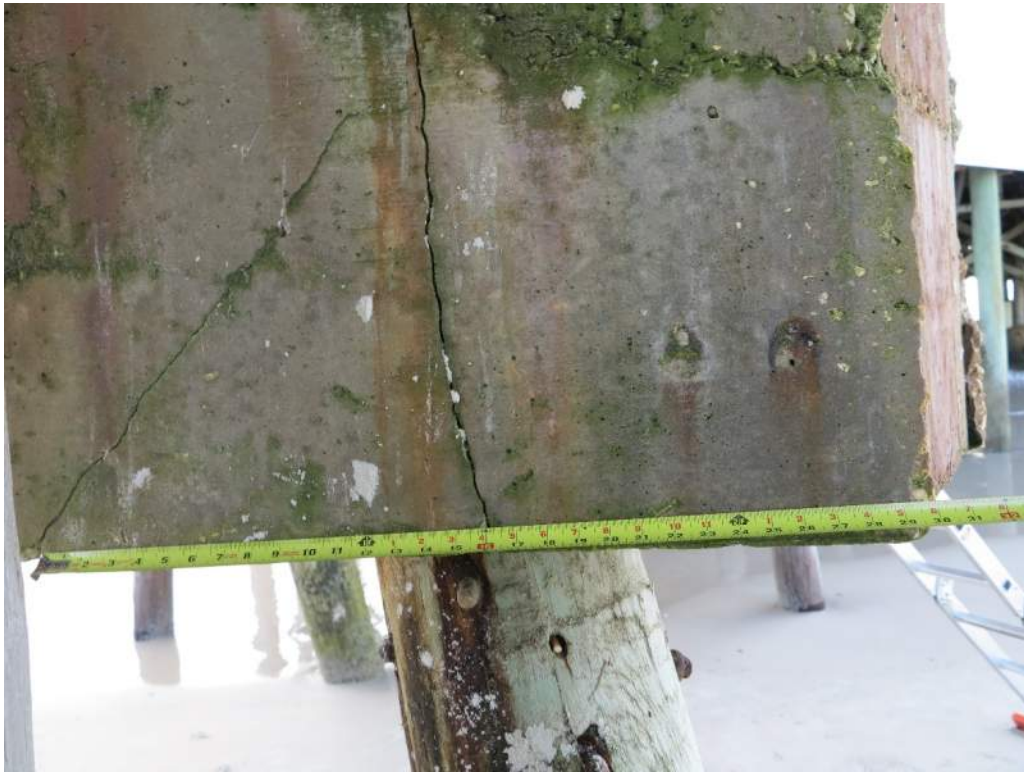
Photo 9

Former Chairlift Concrete Pier Support Between Bents 14 and 15, Looking East
Note Cracking at the South End

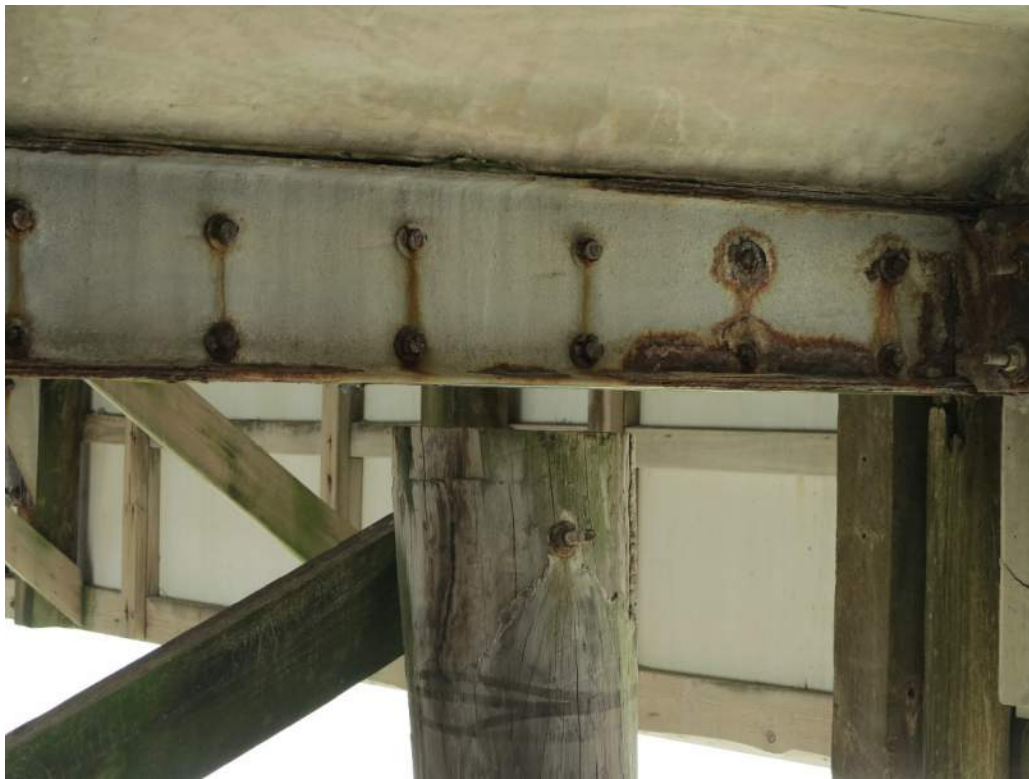
Photo 10

Although we were not observing the condition of the existing timber elements, one additional deficiency that was noted was that a shim was missing between the top of an existing timber pile and the bottom of the existing timber bent cap at south end of Bent 4 (see Photo 10). The structural deficiencies are further identified in the exhibits at the end of this report

Existing Timber Bent 4 South End, Looking Southeast
Note Missing Shim Between Existing Timber Pile and Cap

- Install timber shim where missing between the top of an existing timber pile and the bottom of the existing timber bent cap at south end of Bent 4.
