## LIMITED ASBESTOS CONTAINING MATERIALS SURVEY REPORT

Former Piedmont Community Actions Facility

704 Howard Street

**Issue Date:** February 14, 2018

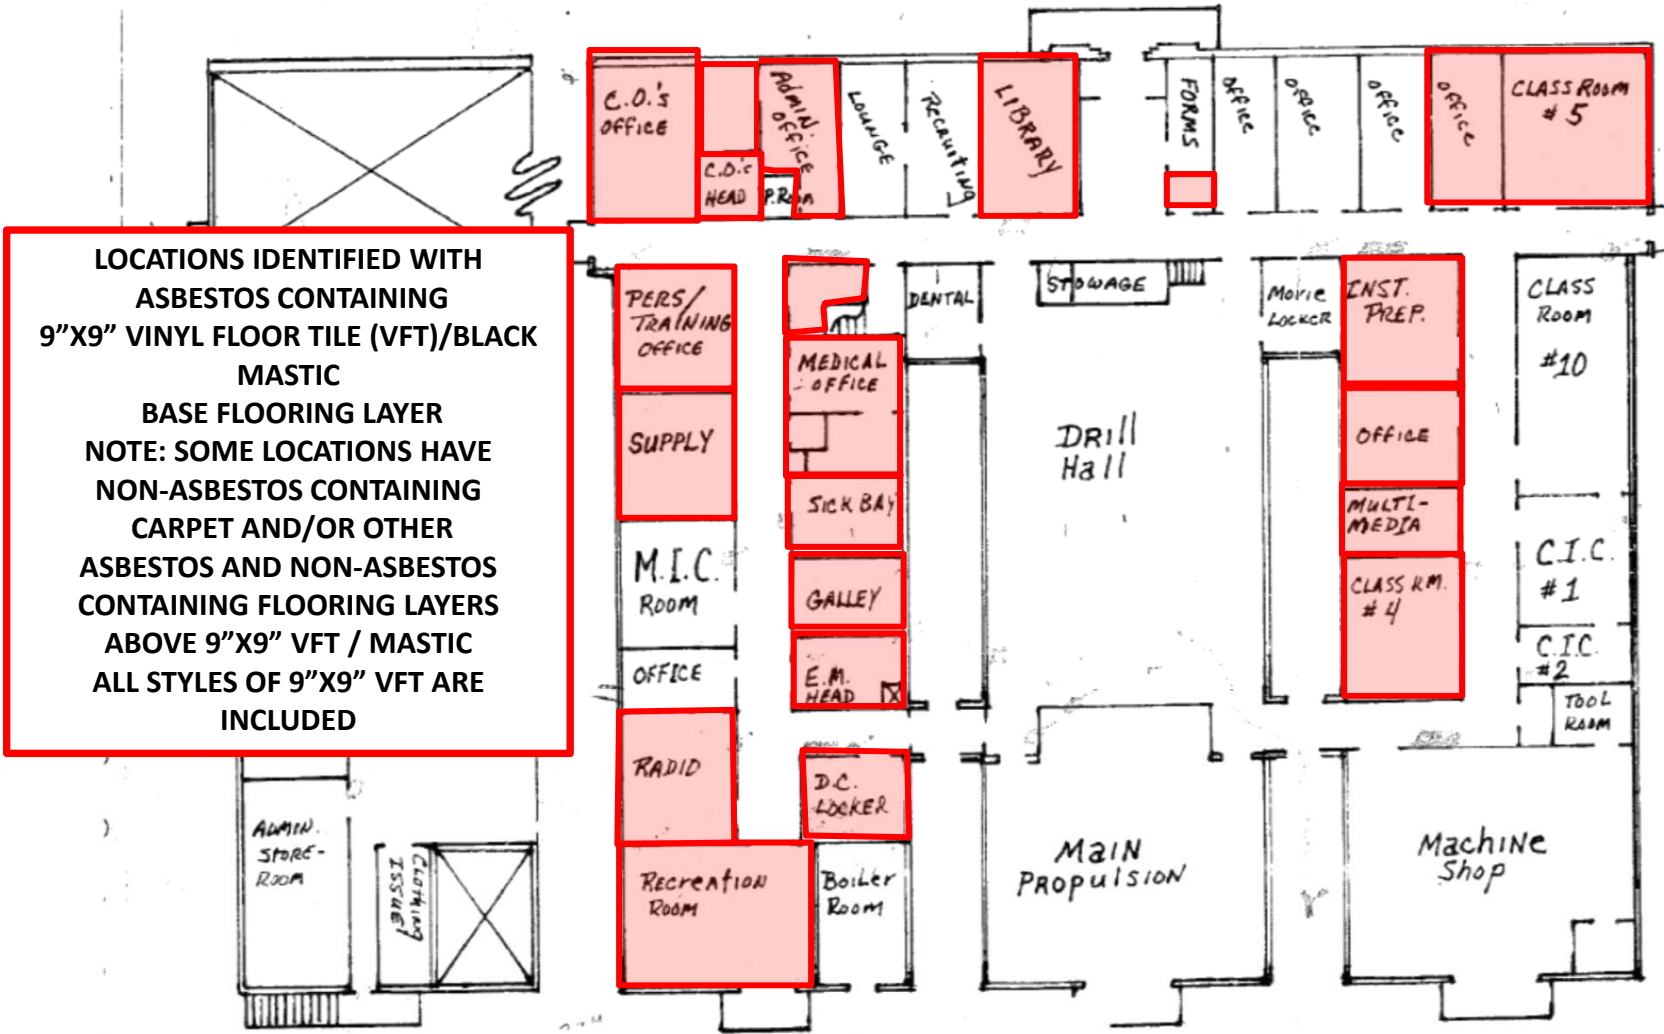
ASBESTOS CONTAINING 9"X9" VFT SAMPLE LOCATION PLAN

*Locations of Asbestos Containing 9"X9" Vinyl Floor Tiles*

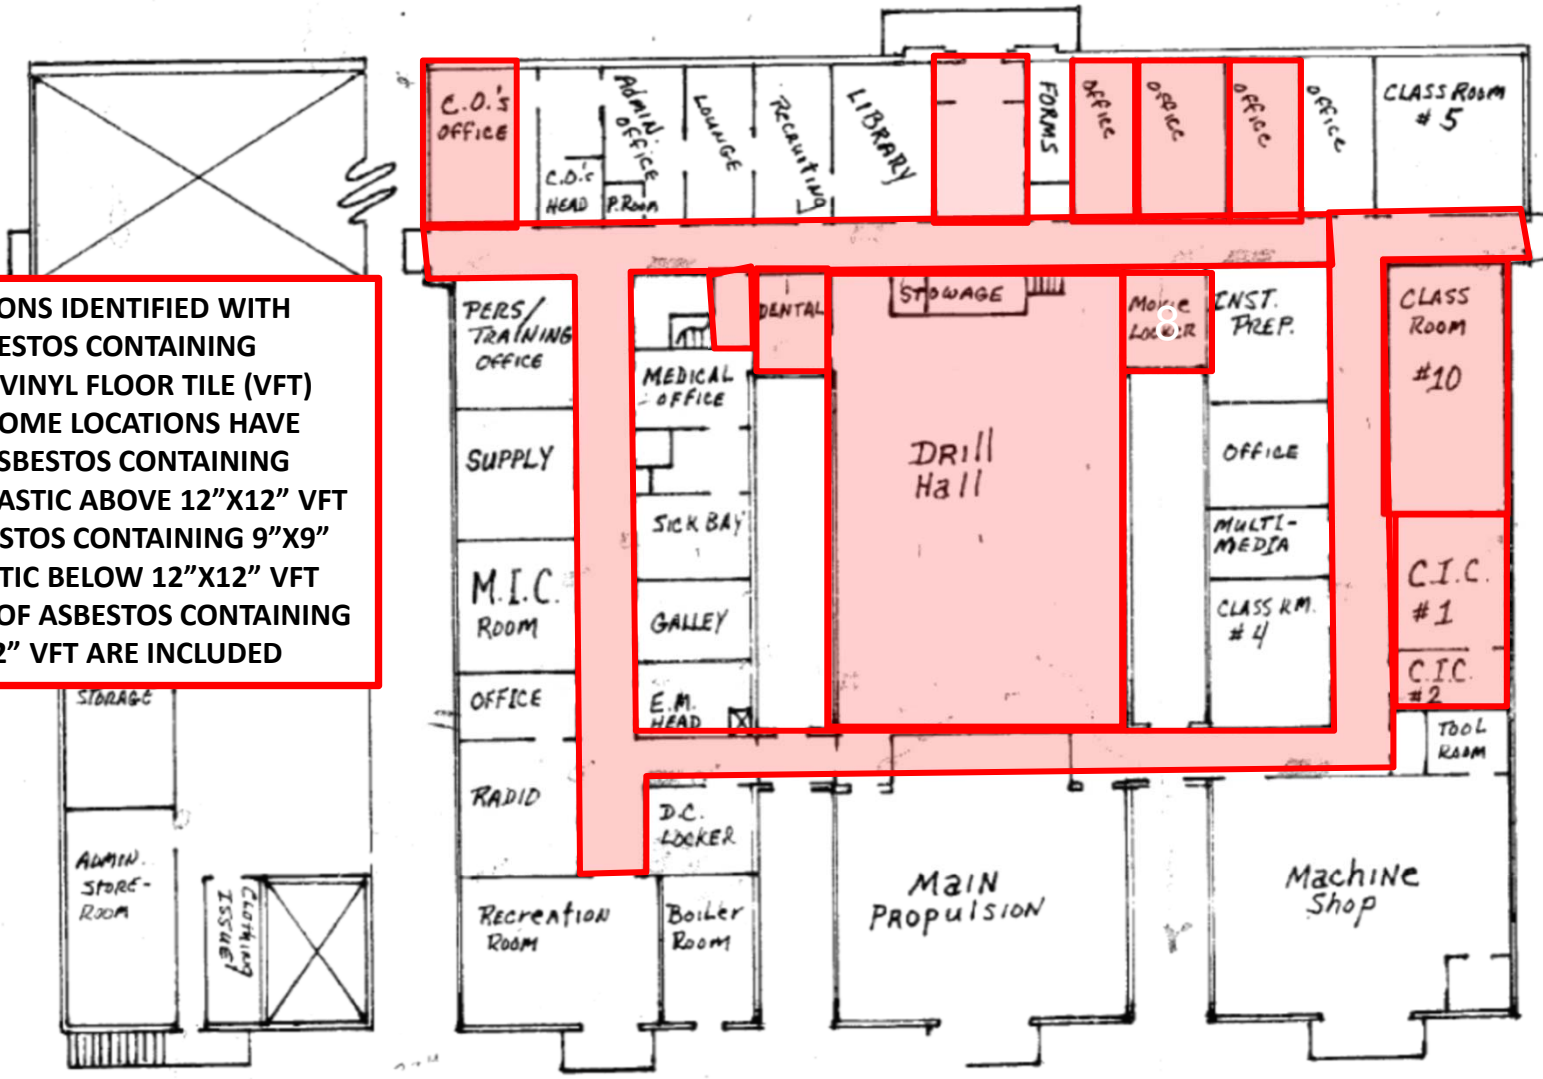
ASBESTOS CONTAINING 12"X12" VFT SAMPLE LOCATION PLAN

**LOCATIONS IDENTIFIED WITH ASBESTOS CONTAINING 12"X12" VINYL FLOOR TILE (VFT)**  
**NOTE: SOME LOCATIONS HAVE NON-ASBESTOS CONTAINING CARPET/MASTIC ABOVE 12"X12" VFT AND ASBESTOS CONTAINING 9"X9" VFT/MASTIC BELOW 12"X12" VFT**  
**ALL STYLES OF ASBESTOS CONTAINING 12"X12" VFT ARE INCLUDED**

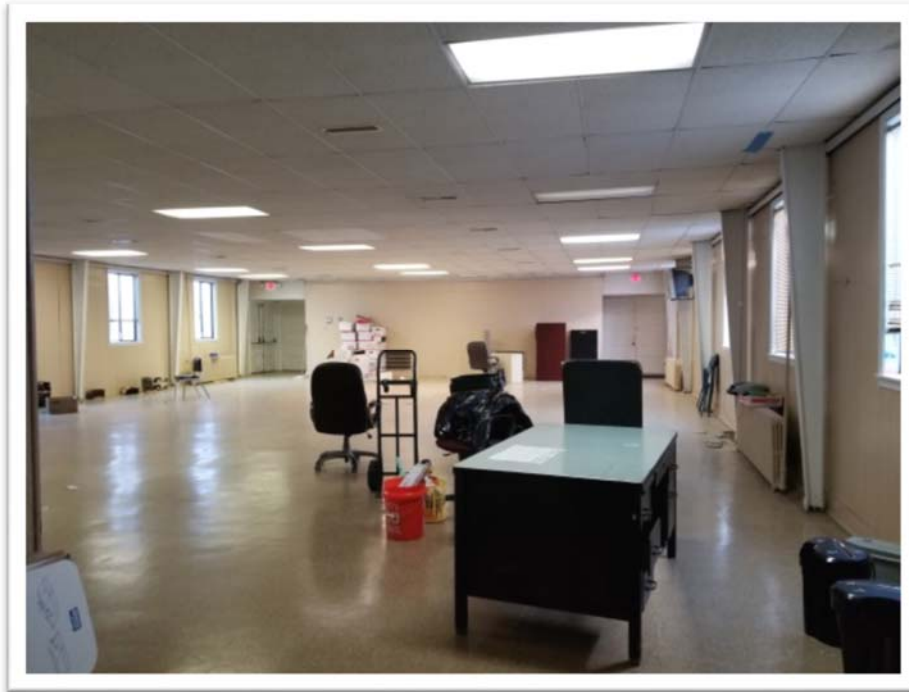
Photograph #003

Drill Hall – 12”X12” Beige with Brown Streaks Vinyl Floor Tile (VFT)/Mastic (3% Chrysotile / 6% Chrysotile). See Appendix B, Figure 9 for Locations.

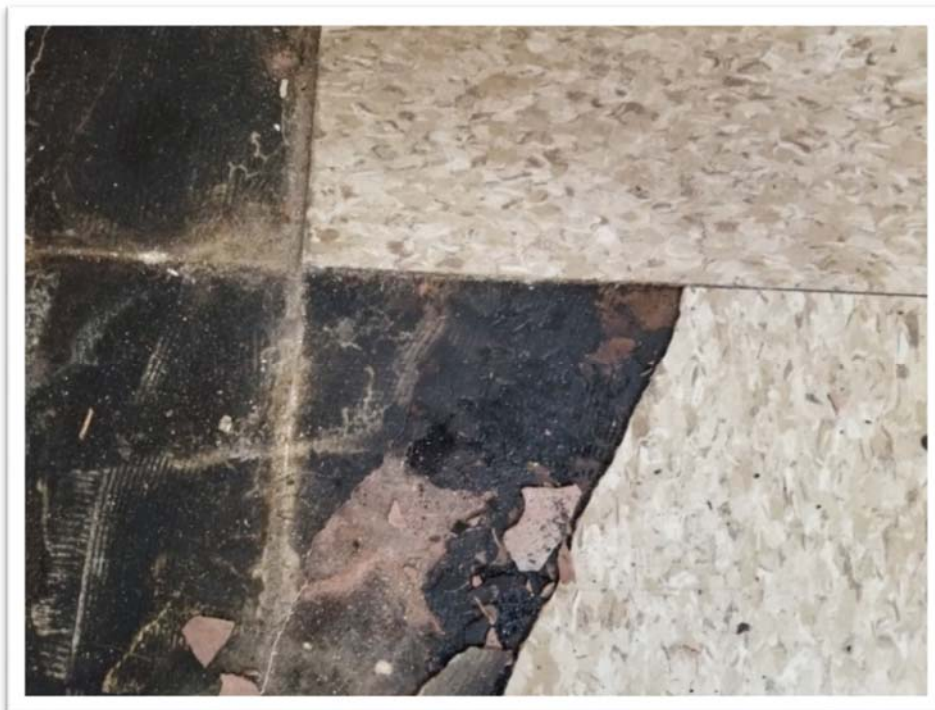
Photograph #04

Drill Hall - Close Up View of 12”X12” Beige with Brown Streaks VFT/Mastic (3% Chrysotile / 6% Chrysotile).

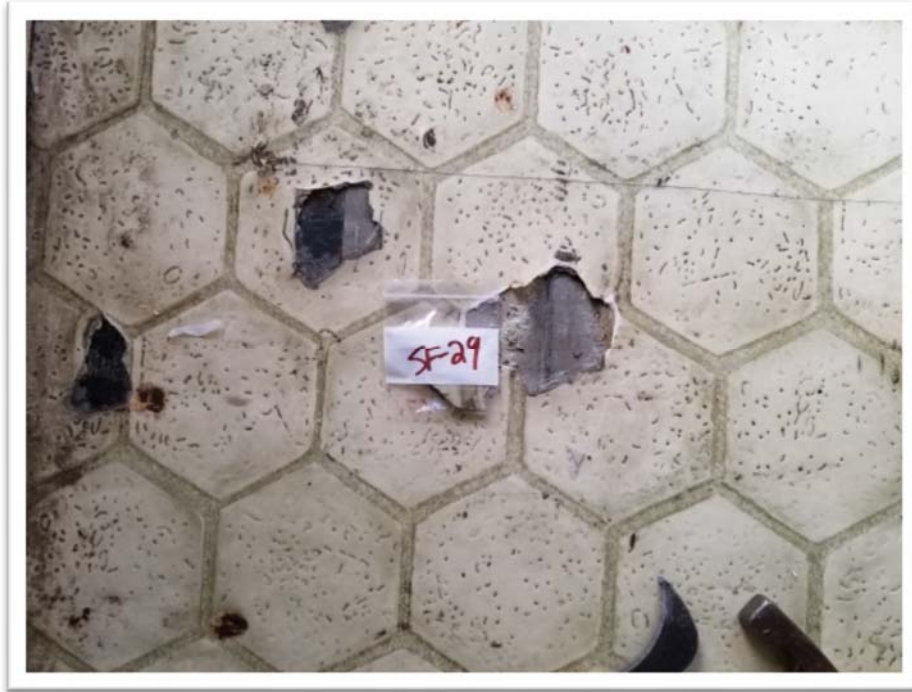
Photograph #05 Sampling Point SF-29 in Galley – Cream w/ Green Trim Hexagon Vinyl Sheet Flooring (15% Chrysotile).

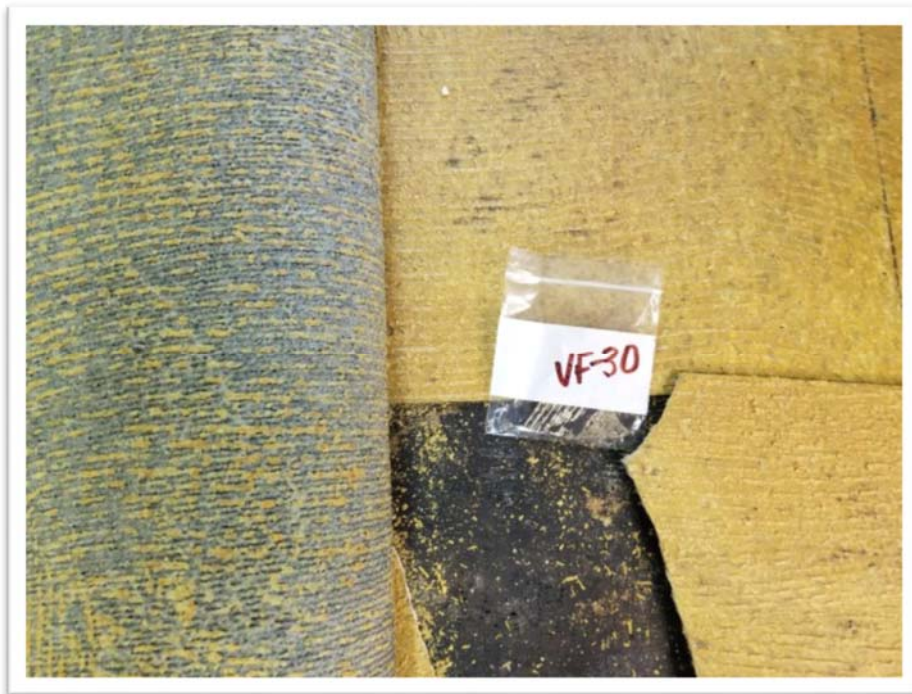
Photograph #06 Sampling Point VF-30, Below Carpet in Hall – 12”X12” VFT/Mastic (4% Chrysotile / 6% Chrysotile).

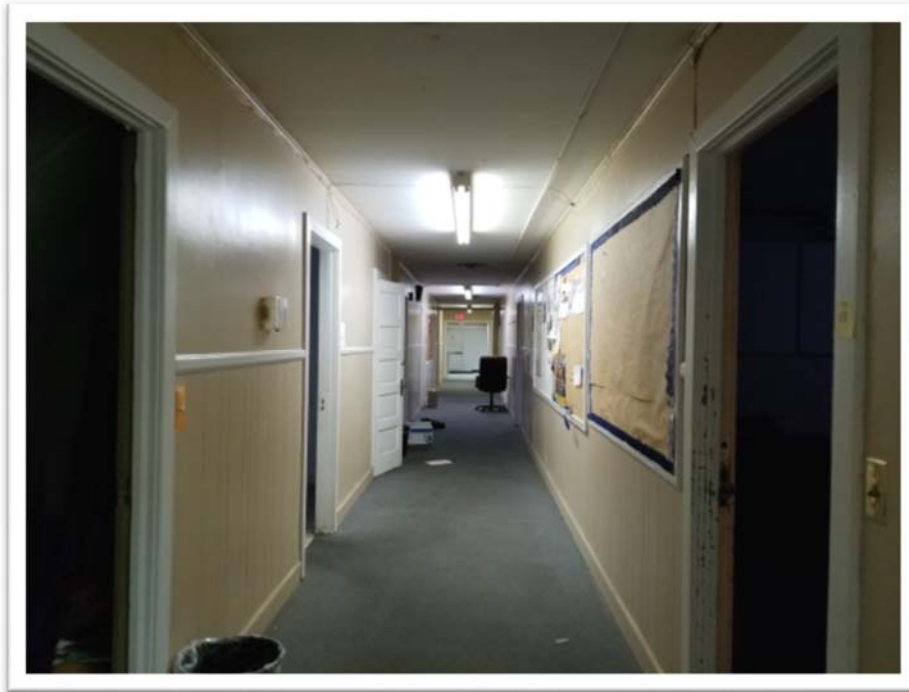
Photograph #07

Hall – Asbestos Containing 12”X12” VFT/Mastic is Located Beneath Carpet Throughout Halls and in Various Offices. See Appendix B, Figure 9 for Locations.

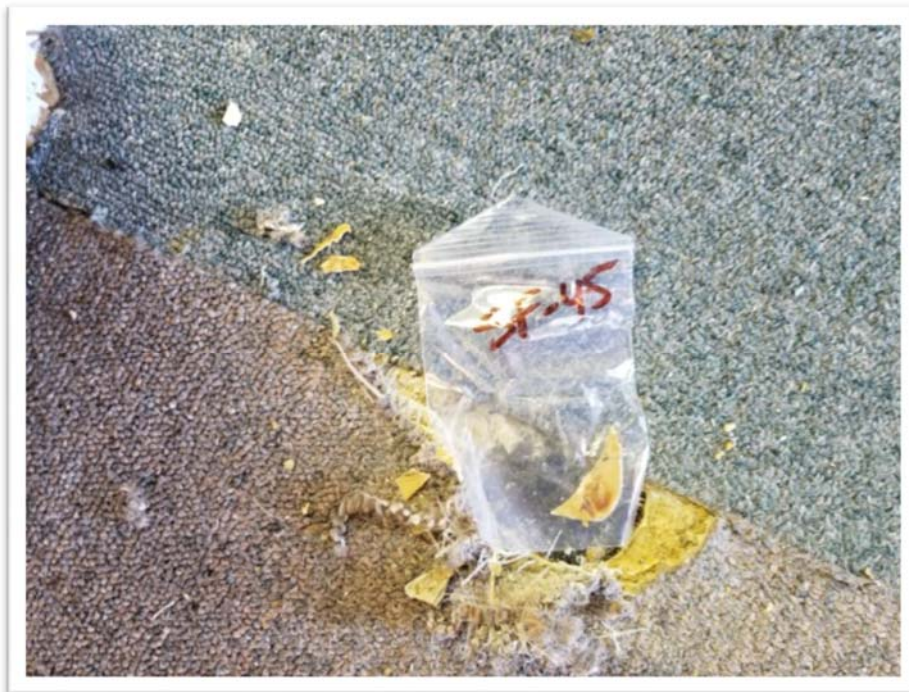
Photograph #08

C.O.’s Office – 12”X12” VFT / Mastic (3% Chrysotile/2% Chrysotile).  
Note: Asbestos Containing 9”X9” VFT/Mastic is Below the 12”X12” VFT.

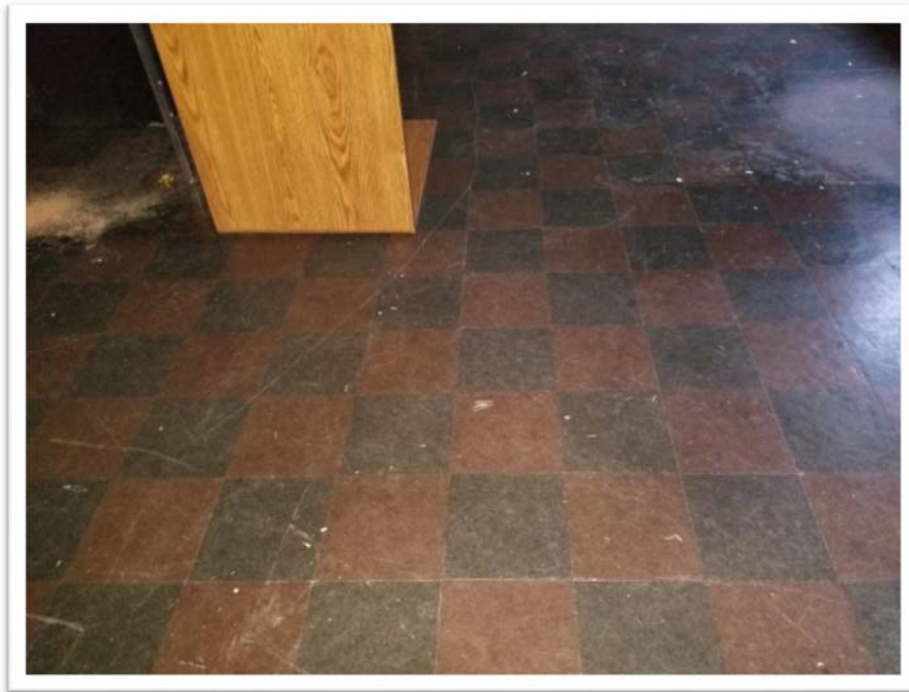
Photograph #10

Classroom #4 – Brown and Black 9”X9” VFT/Mastic (6% Chrysotile / 5% Chrysotile), See Appendix B, Figure 8 for Locations.

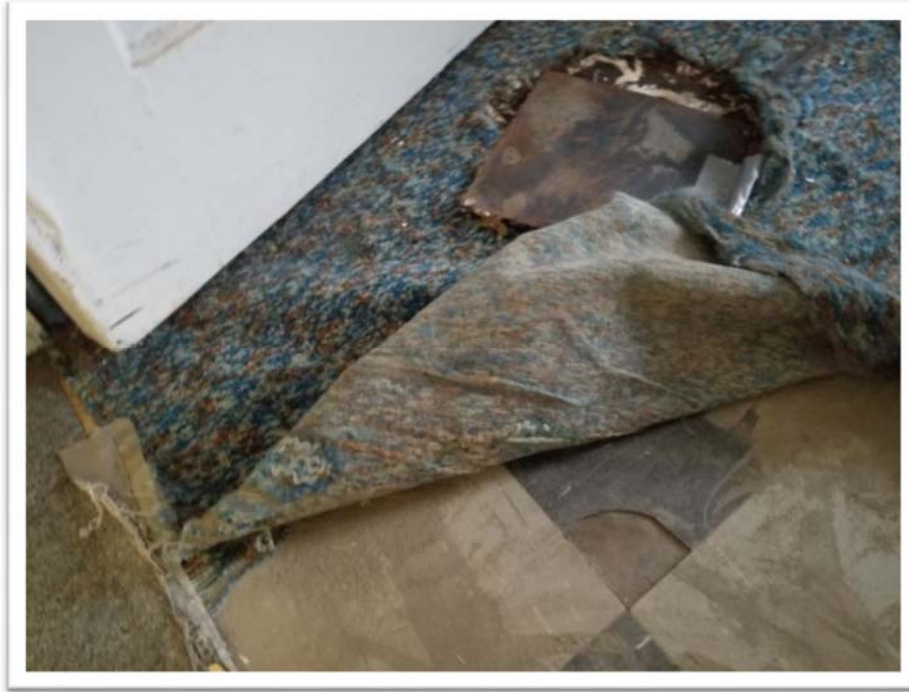
Photograph #11 Medical Office – 9”X9” Black with Cream Streaks and Gray VFT/Mastic (3%, 2% Chrysotile / 6% Chrysotile). See Appendix B, Figure 8 for Locations.

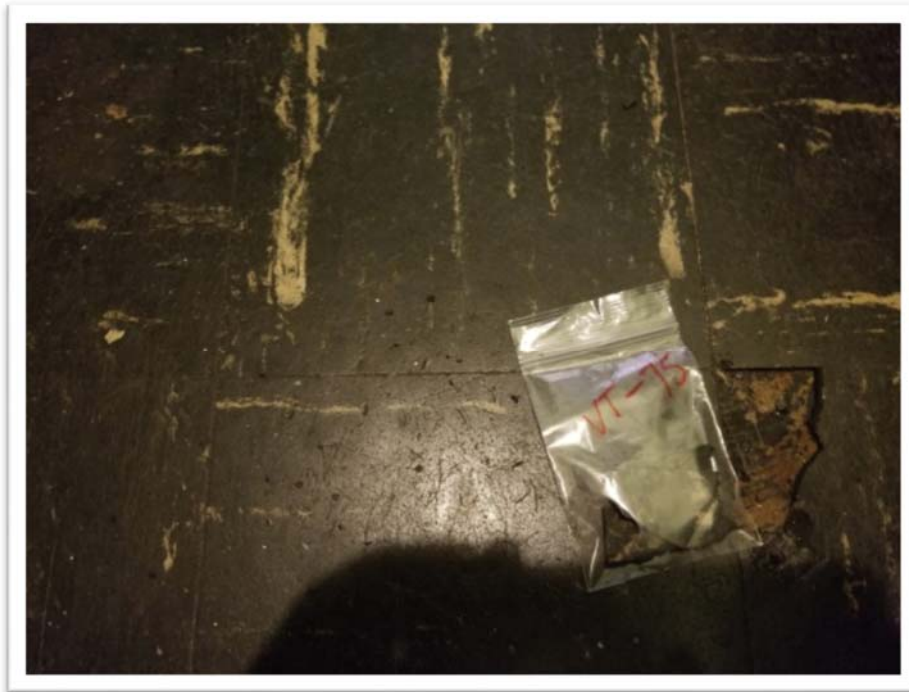
Photograph #12 Storage Closet by Medical Office, Sampling Point VT-75 – Additional View of Asbestos Containing 9”X9” Black with Cream Streaks VFT/Mastic.

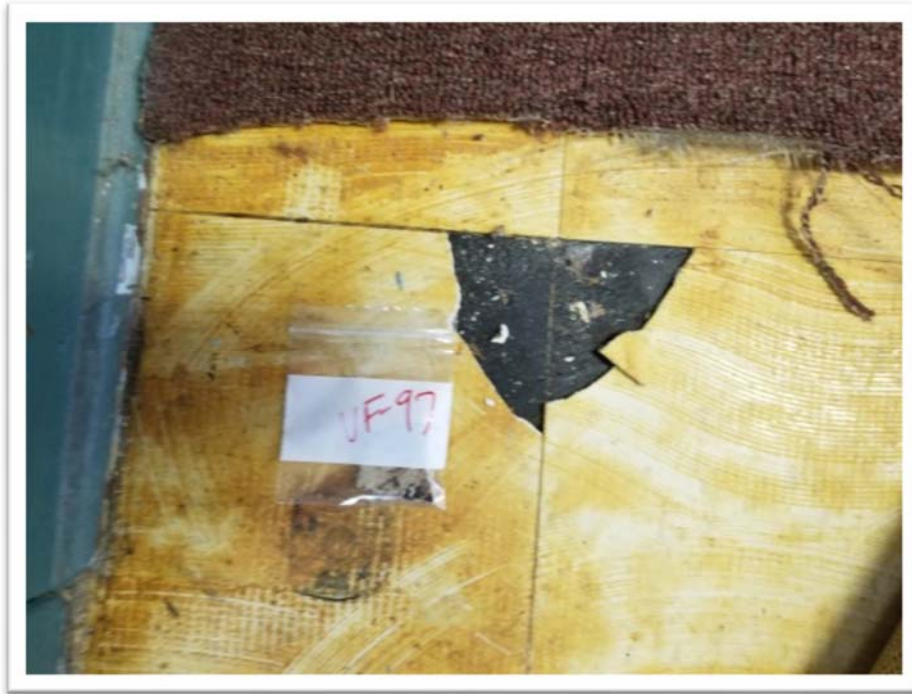
Photograph #13

Office East of Forms, Sampling Point VF-97 – View of Asbestos Containing 12”X12” White w/ Beige Streaks VFT (2% Chrysotile).

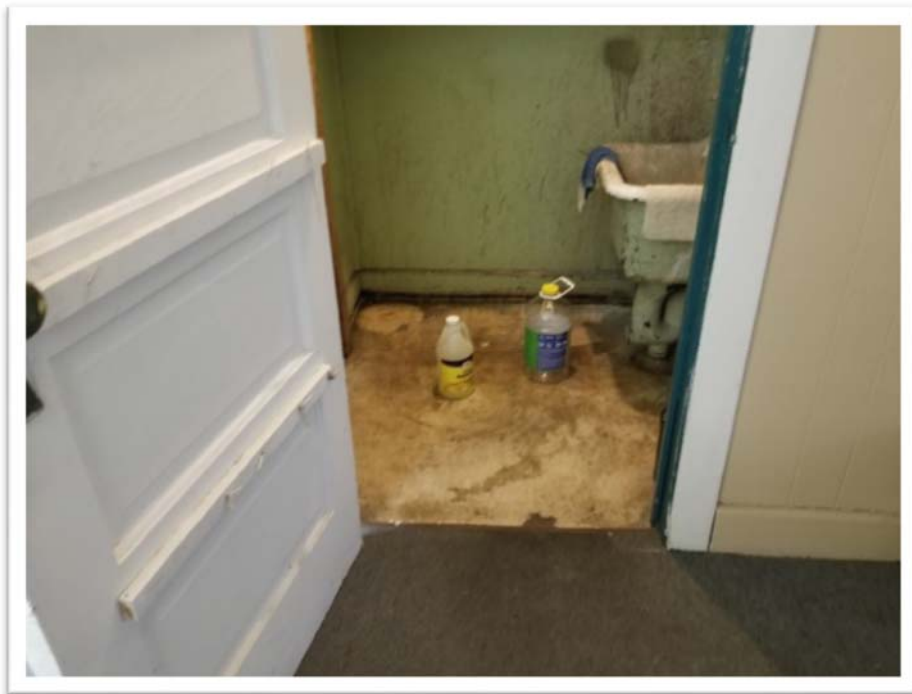
Photograph #14

Mop Closet – View of 9”X9” White VFT/Mastic (4% Chrysotile/ None Detected).

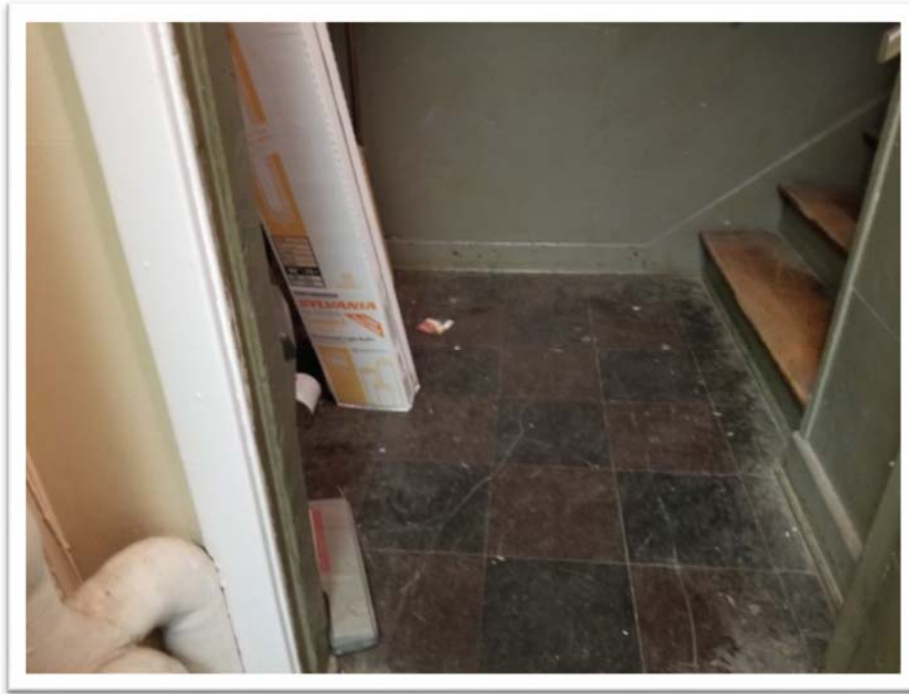
Photograph #15 Entry to 2<sup>nd</sup> Deck Stairs – 12”X 12” Black and Brown VFT/Mastic (5% Chrysotile/5% Chrysotile).

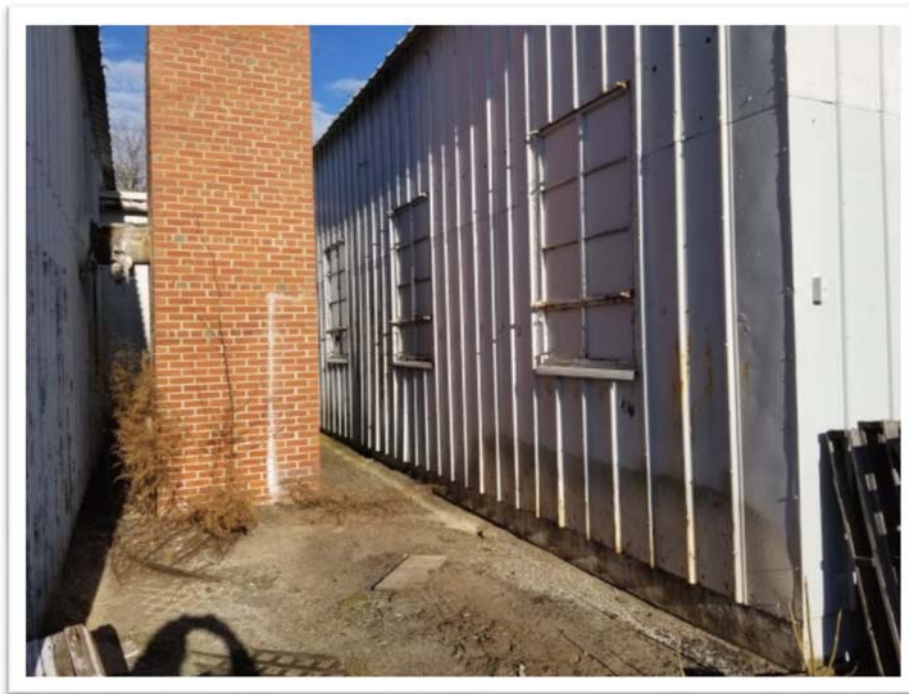
Photograph #16 Exterior View Between Main Propulsion & Boiler Room – Window Glazing is 3% Chrysotile.

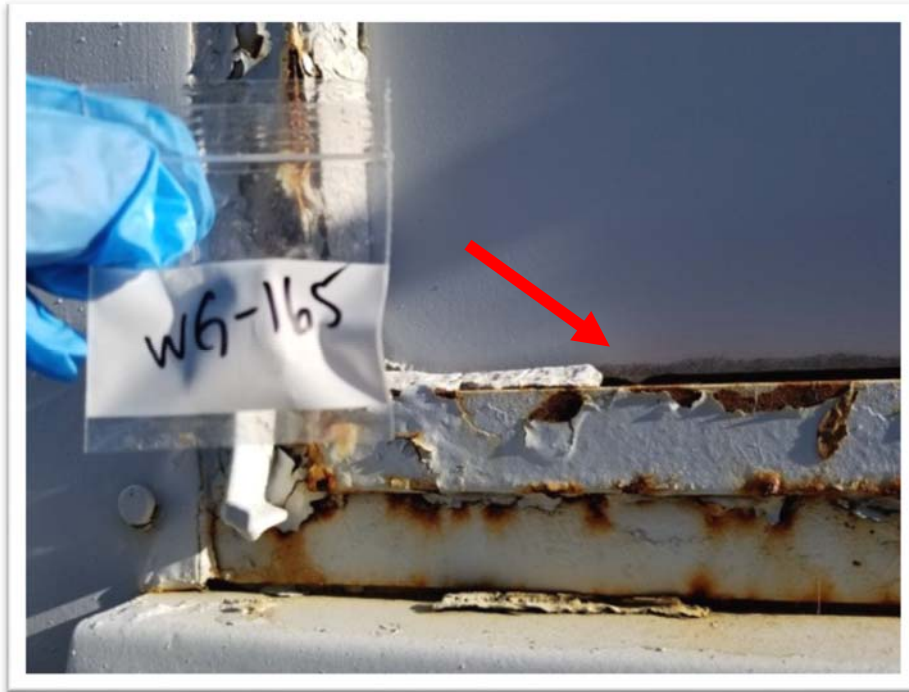
Photograph #17 Exterior Window Between Machine Shop and Main Propulsion – Close Up View of 3% Chrysotile Window Glazing

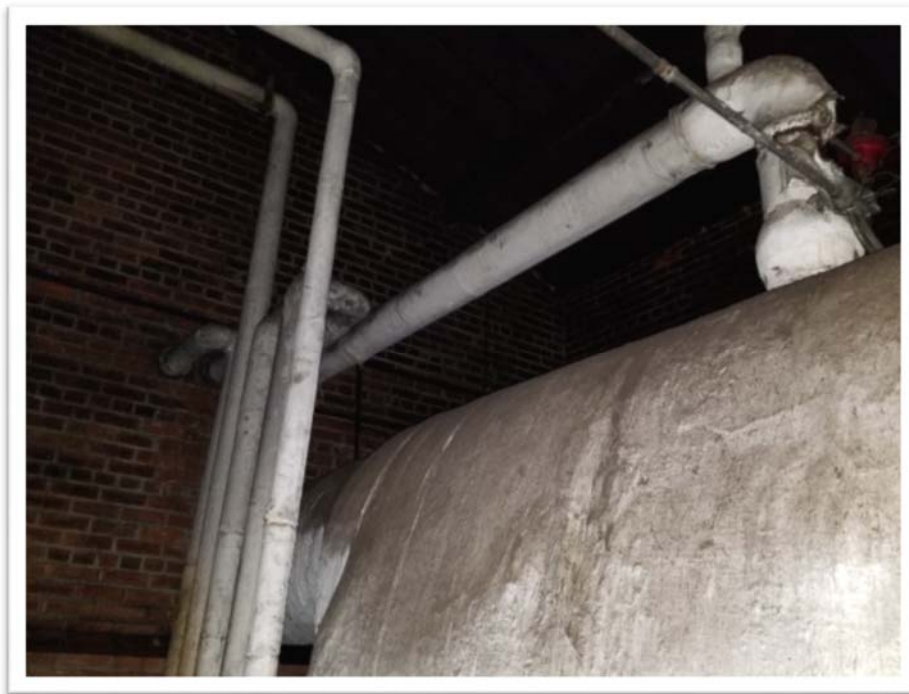
Photograph #18 Boiler Room, Boiler Jacket – 20% Chrysotile

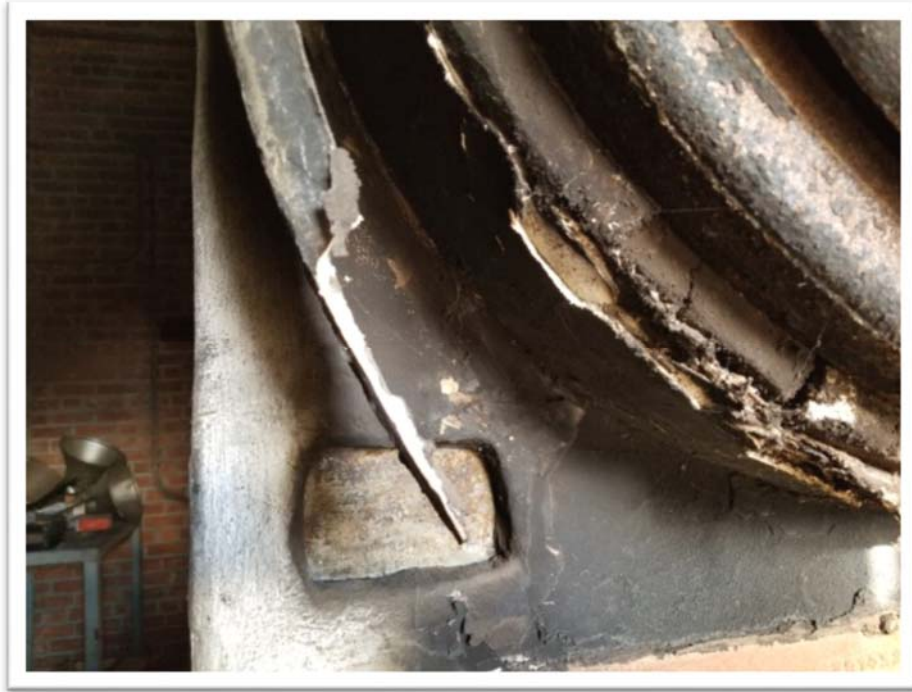
Photograph #19 Boiler Room, Boiler Door – Red and White Insulation, 20% Chrysotile

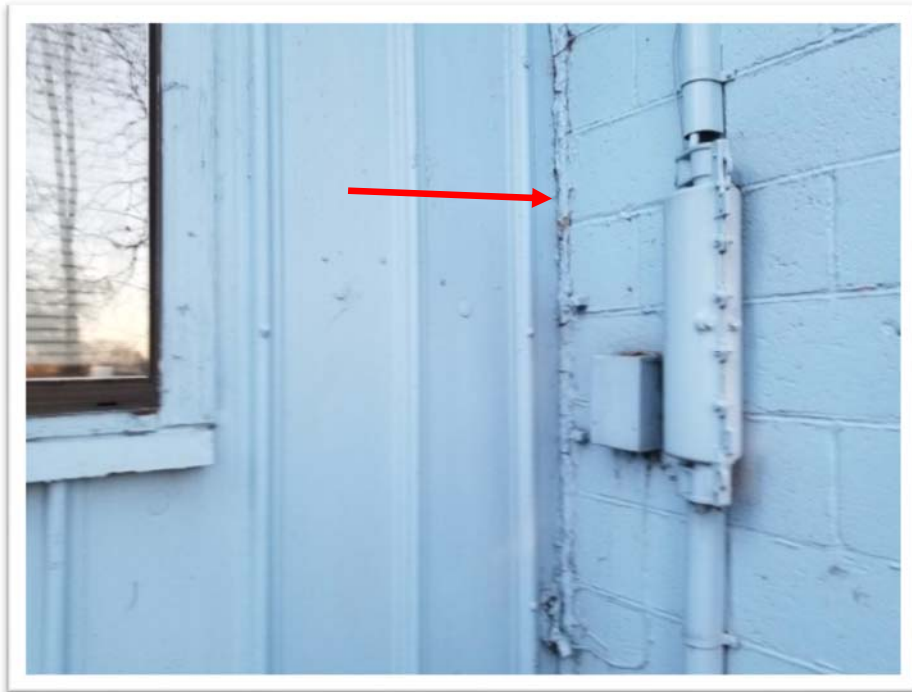
Photograph #20 Building Exterior at Interface of CMU Block Wall and Sheet Metal – Caulk at Building Interface is 5% Chrysotile.

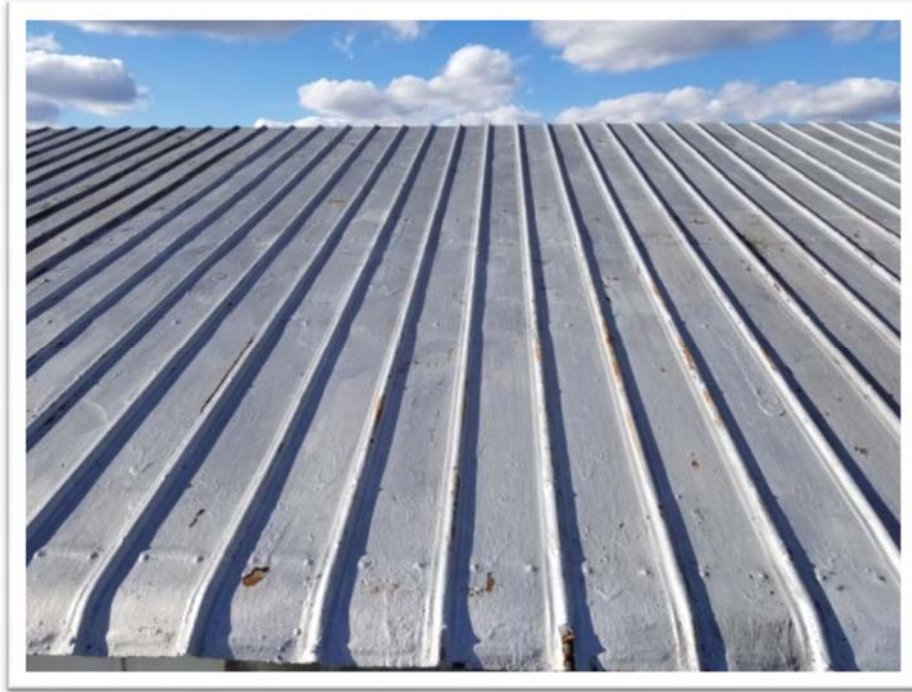
Photograph #21 Metal Roof – Surface Coating is 3% and 4% Chrysotile.

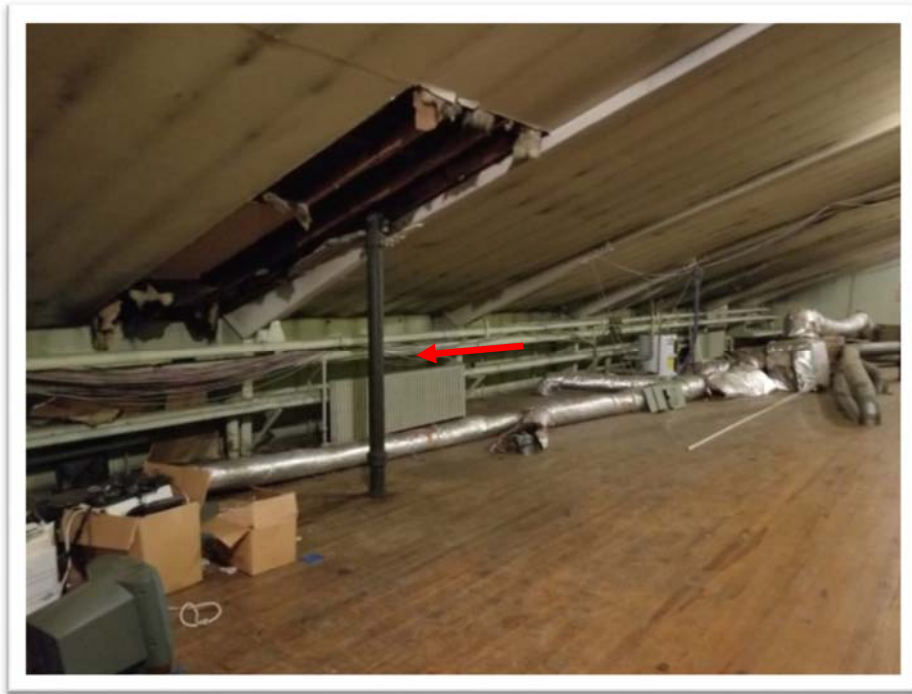
Photograph #22 2<sup>nd</sup> Deck - TSI Pipe Wrap is 25% to 25% Chrysotile and 15% to 18% Amosite. TSI and Pipe Wrap Throughout the Building is Asbestos Containing.

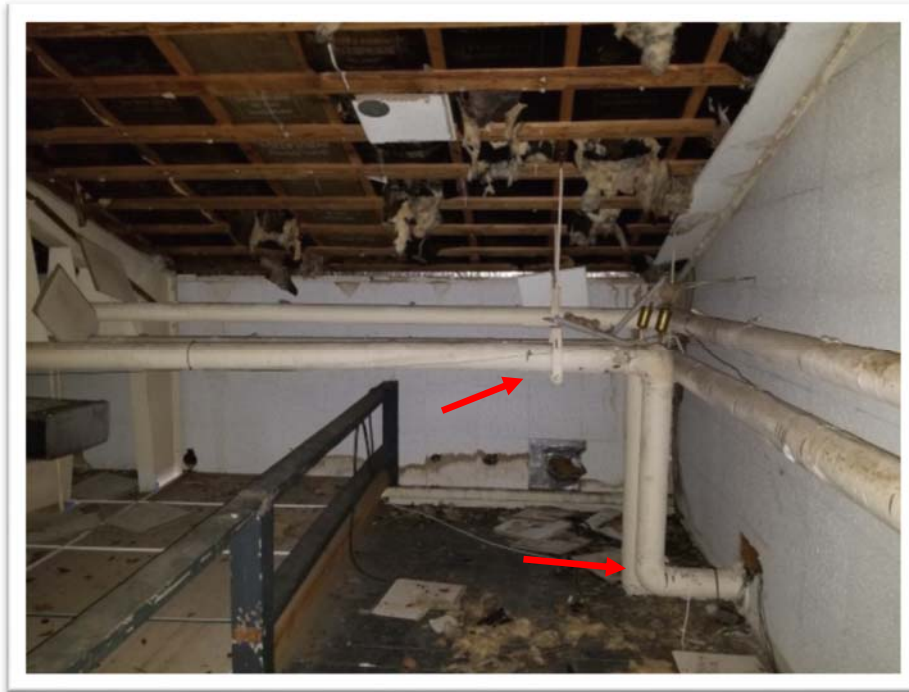
Photograph #23 Attic – View of TSI Pipe Wrap and Elbows. Elbows are 25% Chrysotile. Pipe Wrap is 25% to 30% Chrysotile and 15% to 18% Amosite.

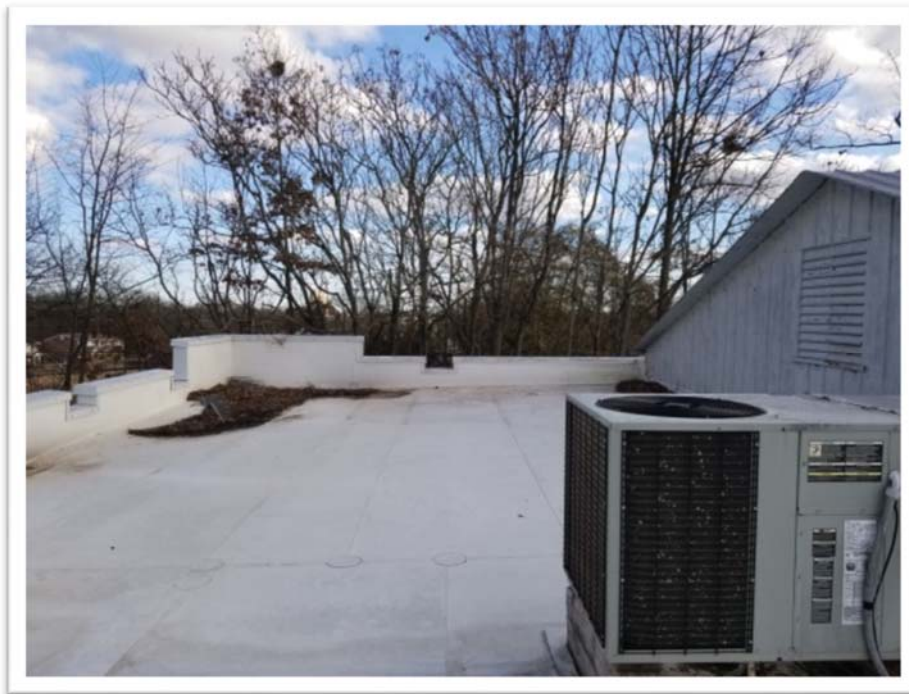
Photograph #24 Composite Roof – No Asbestos Containing Materials were Identified.

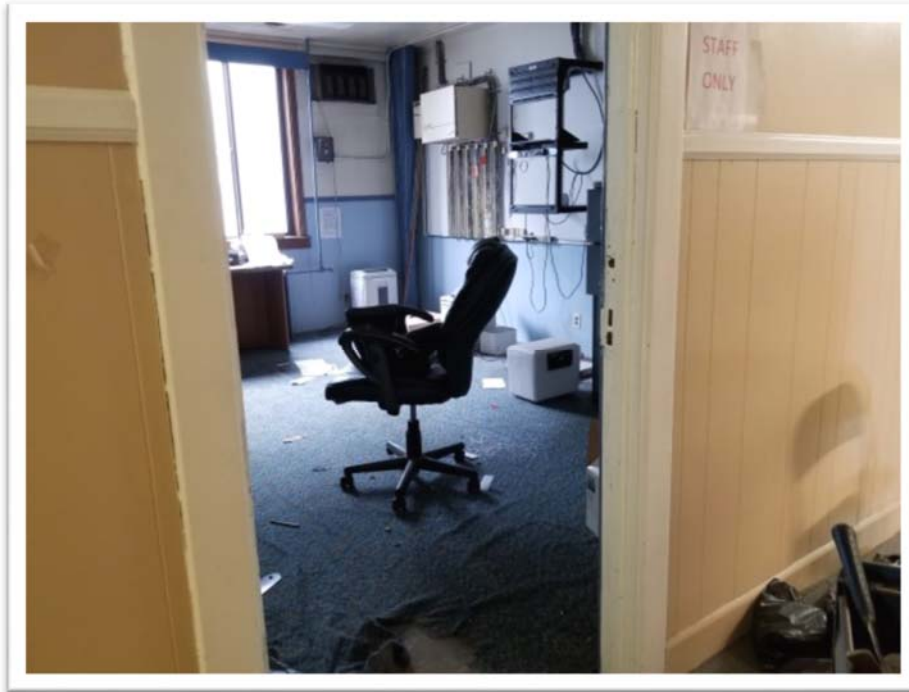
Photograph #25

View of Typical Office – Asbestos Containing Floor Tiles are Located Below Carpet Through Most of the Building. See Appendix B, Figures 8 & 9 for Locations.
