**Engineering Evaluation of Concrete Condition
and Steel Sheet Pile Wing Wall Thickness
St. Johns River Water Control Structure S-96C
Indian River County, Florida**

Ardaman & Associates, Inc.

St. Johns River Water Management District
P.O. Box 1429
Palatka, Florida 32178

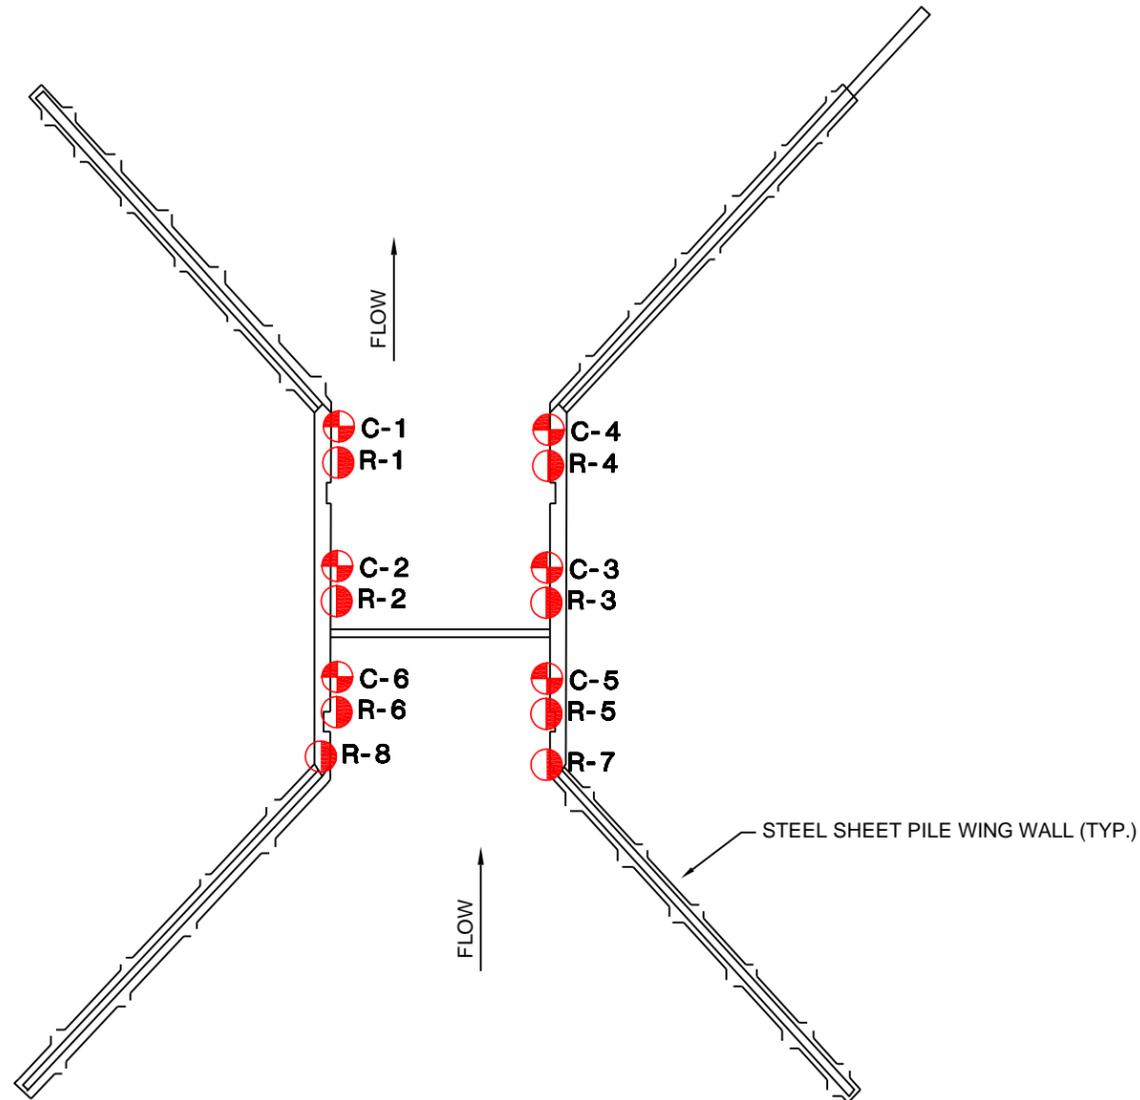
Ardaman & Associates, Inc. Geotechnical, Environmental and Materials Consultants		
ENGINEERING EVALUATION OF SJRWMD STRUCTURE S-96C BREVARD COUNTY, FLORIDA		
DRAWN BY: CD	CHECKED BY:	DATE: 05/14/14
FILE NO. 14-6319	APPROVED BY:	FIGURE: 1

The approximate plan view locations where the readings were obtained are shown on Figure 1.

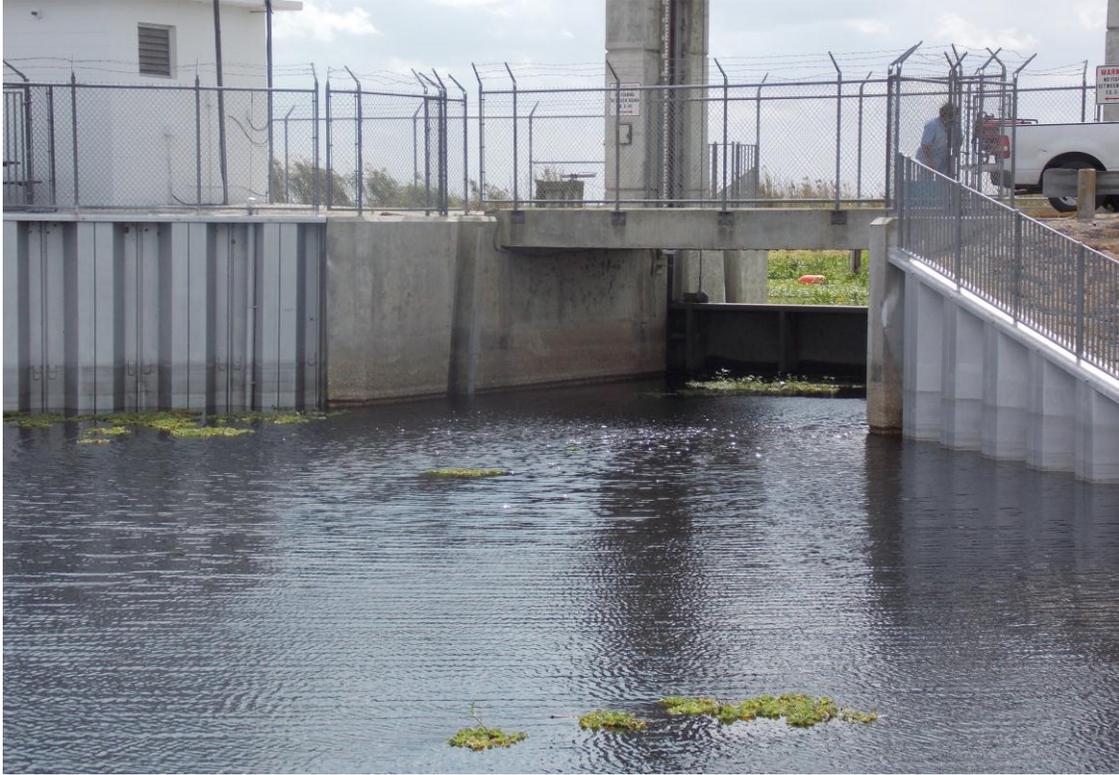
Downstream - View of Structure and Portion of Wing Walls.

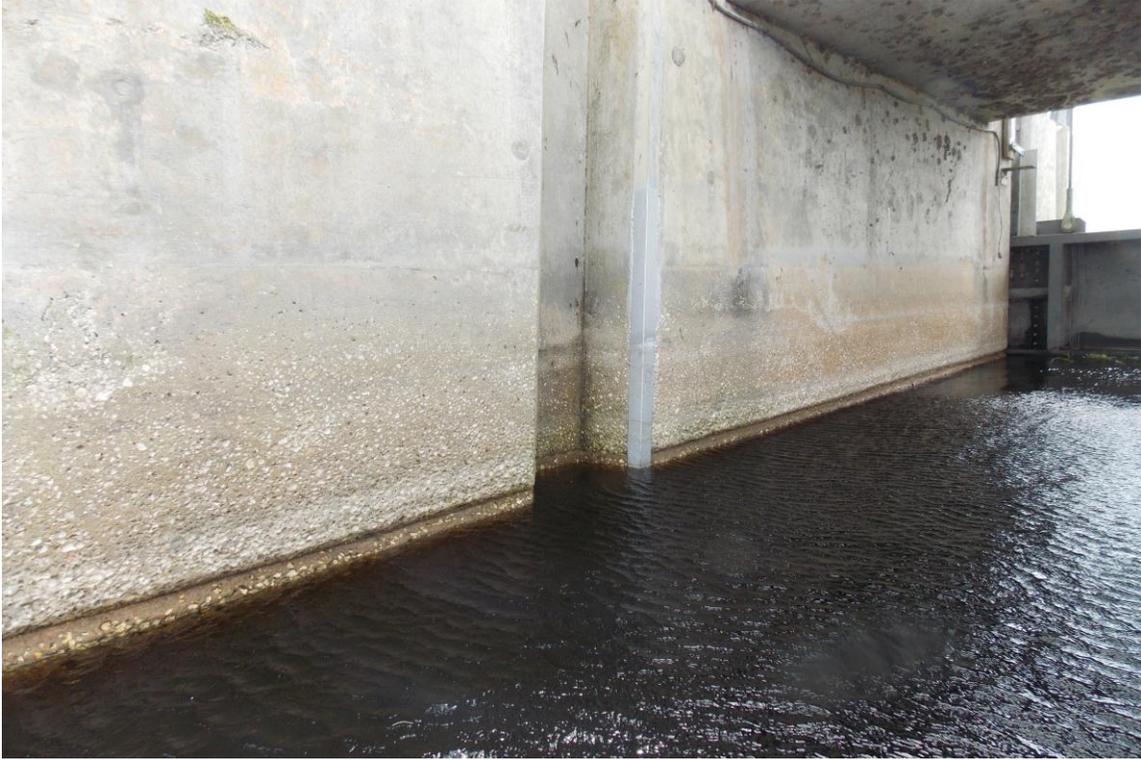
Downstream - North Structure Wall. Note Pitting and "Groove" at Normal Water Level.

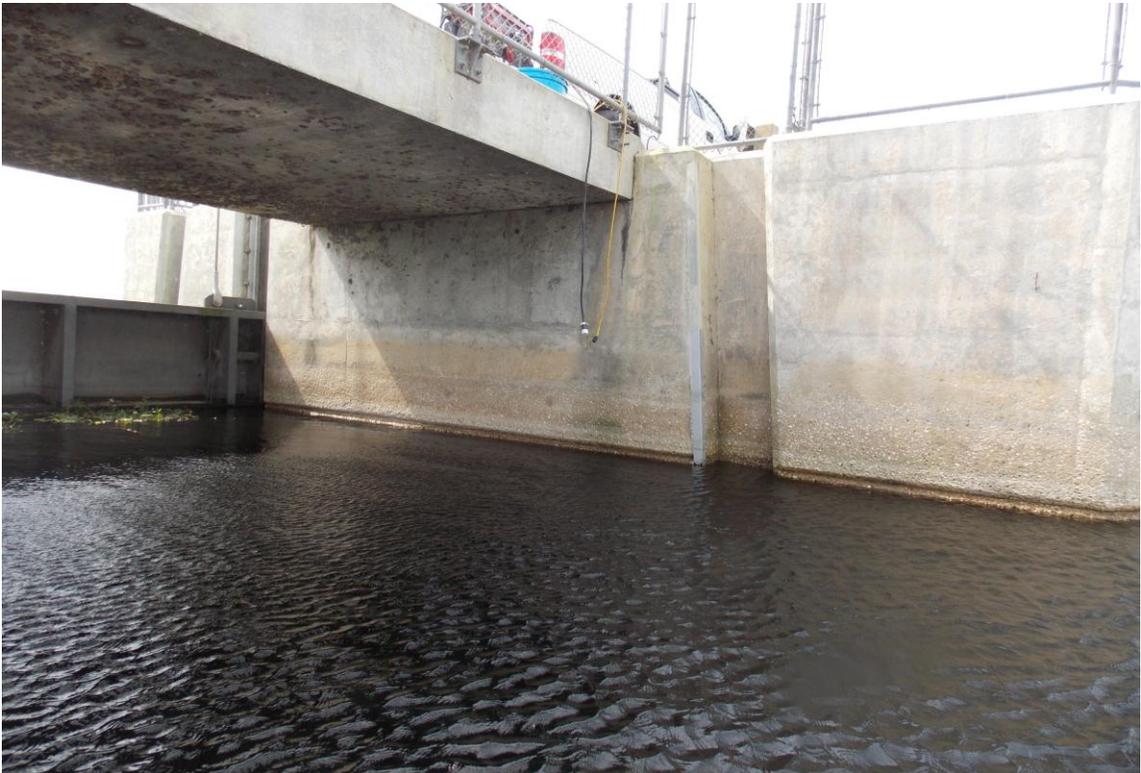
Downstream -South Structure Wall. Note Pitting and "Groove" at Normal Water Level.

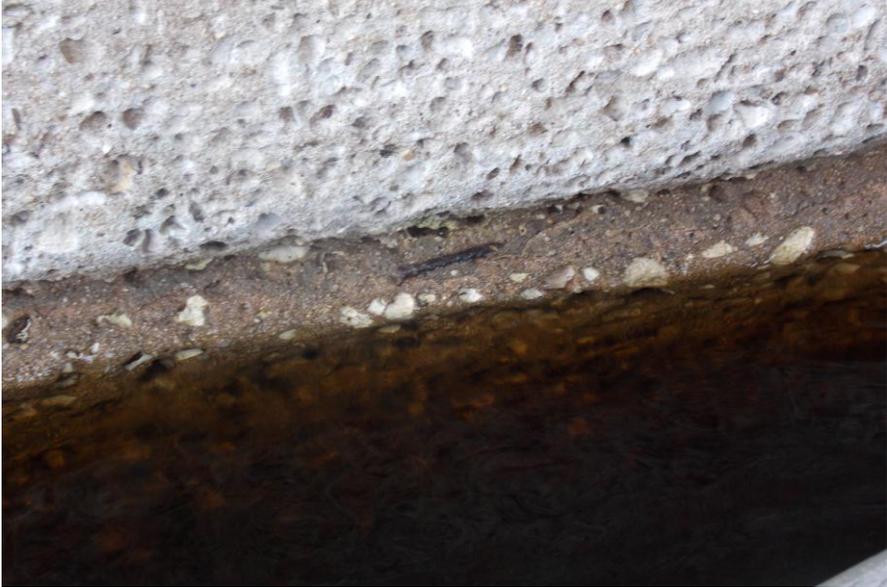
Corrosion of reinforcing steel is one of the most important and prevalent mechanisms of deterioration for concrete structures. The laboratory testing of the cores for pH and carbonation indicate that the alkalinity of the concrete is within the normal range to be expected for a facility of this type and age. However, as mentioned previously there are several isolated areas within the worn "groove" on the downstream side of the structure where the steel reinforcement was visibly exposed. While the exposed reinforcing steel did not appear to be obviously corroded at the time of our observations, the potential for future corrosion is very high.

Downstream - South Structure Wall. Note Exposed Steel Reinforcement in "Groove".

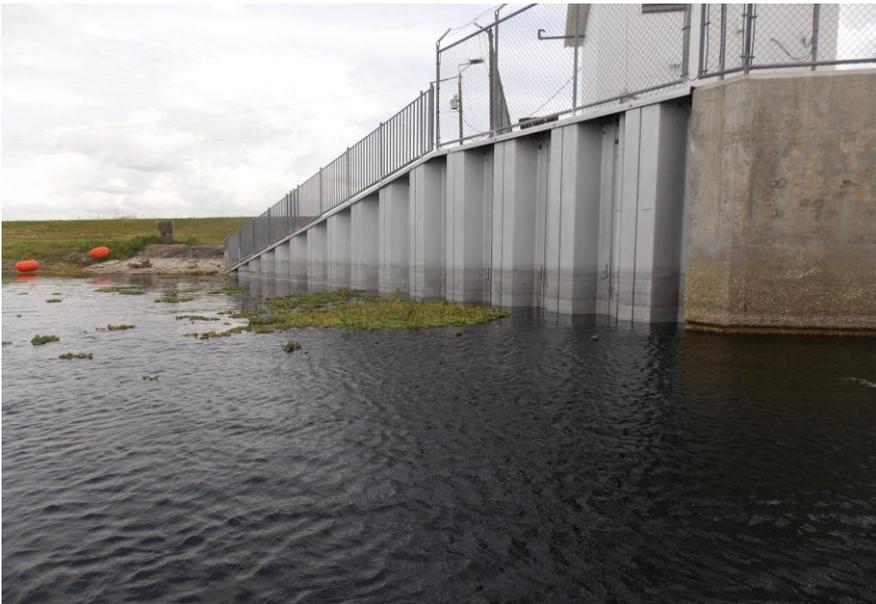
Relative to the steel sheet pile wing walls, the downstream walls appeared to be in very good condition. No evidence of corrosion or seepage between the joints was observed. The portions of the steel sheet pile walls that were below the water surface could not be observed relative to their condition.

Downstream - South Wing Wall.

Based on our observations and thickness readings, it is our opinion that the steel sheet pile wing walls have not experienced excessive erosion or corrosion due to physical or chemical conditions. It appears that the wing walls have been treated with corrosion inhibiting paint/coatings in the past. Routine periodic applications of additional paint/coatings should continue.

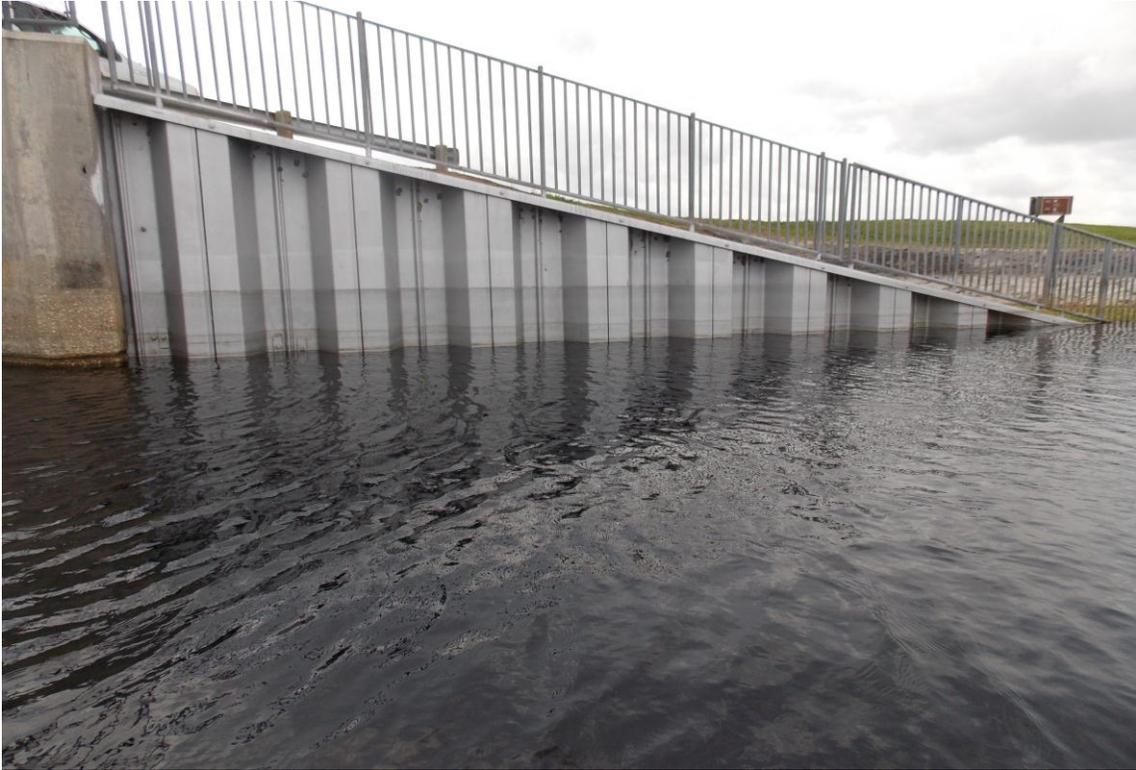
Downstream - North Wing Wall.

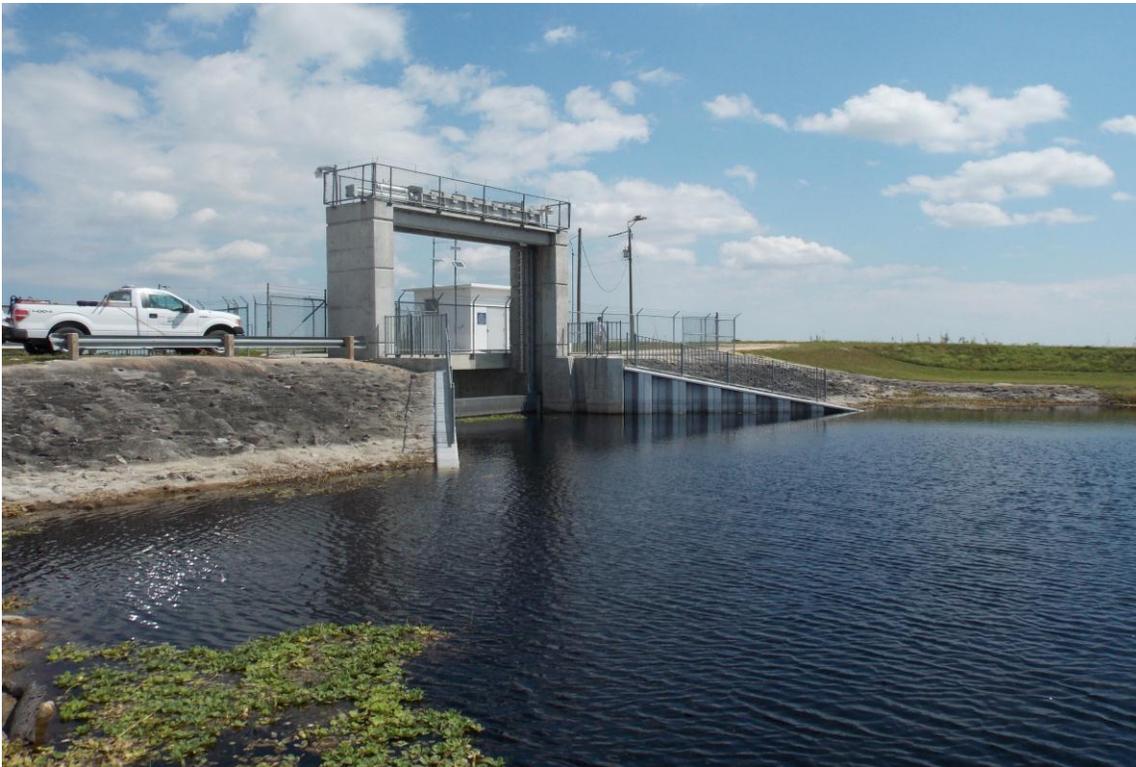
Upstream - Structure and South Wing Wall.

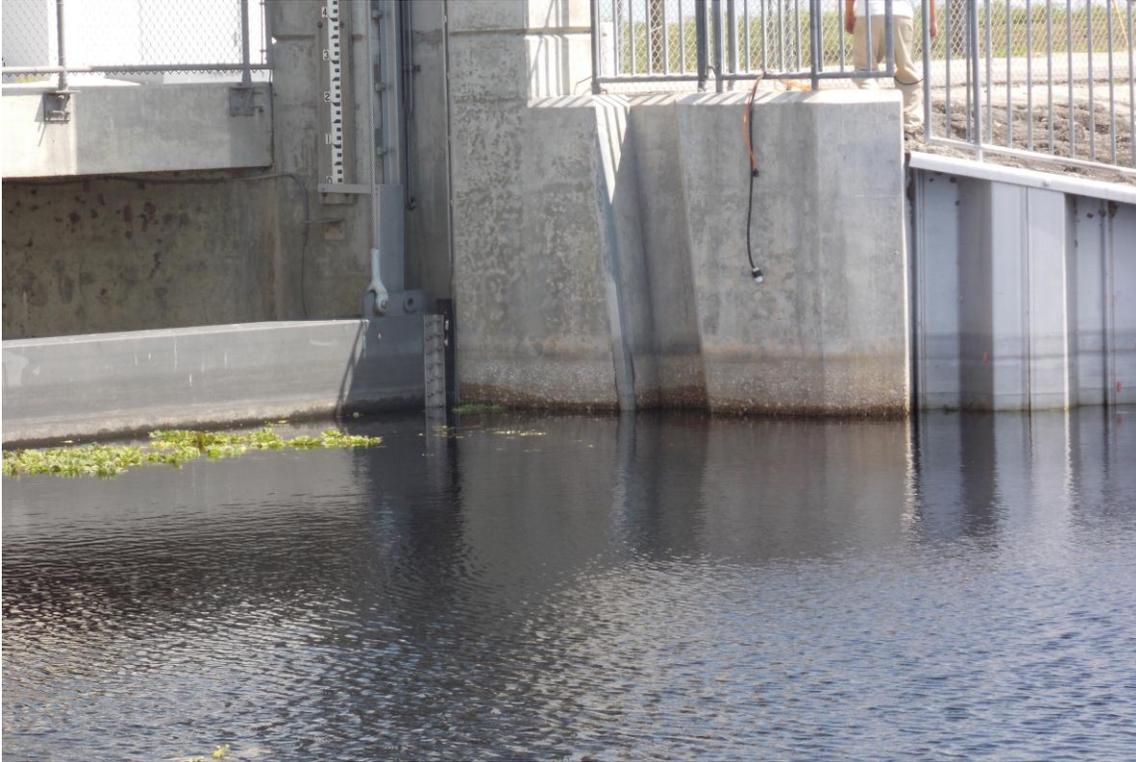
For the upstream side of the structure, our observations indicated that the concrete appeared to be in fair condition. Pitting within the water floatation zone and below the water surface was moderate and observed to be on the order of ¼ to ½ inch with obvious aggregate loss. We were unable to observe the concrete structure below a depth of approximately 6 inches due to water clarity. No spalling, significant cracking, rust staining or other indicators of potential structural defects or corrosion were observed.

Upstream - South Structure Wall.

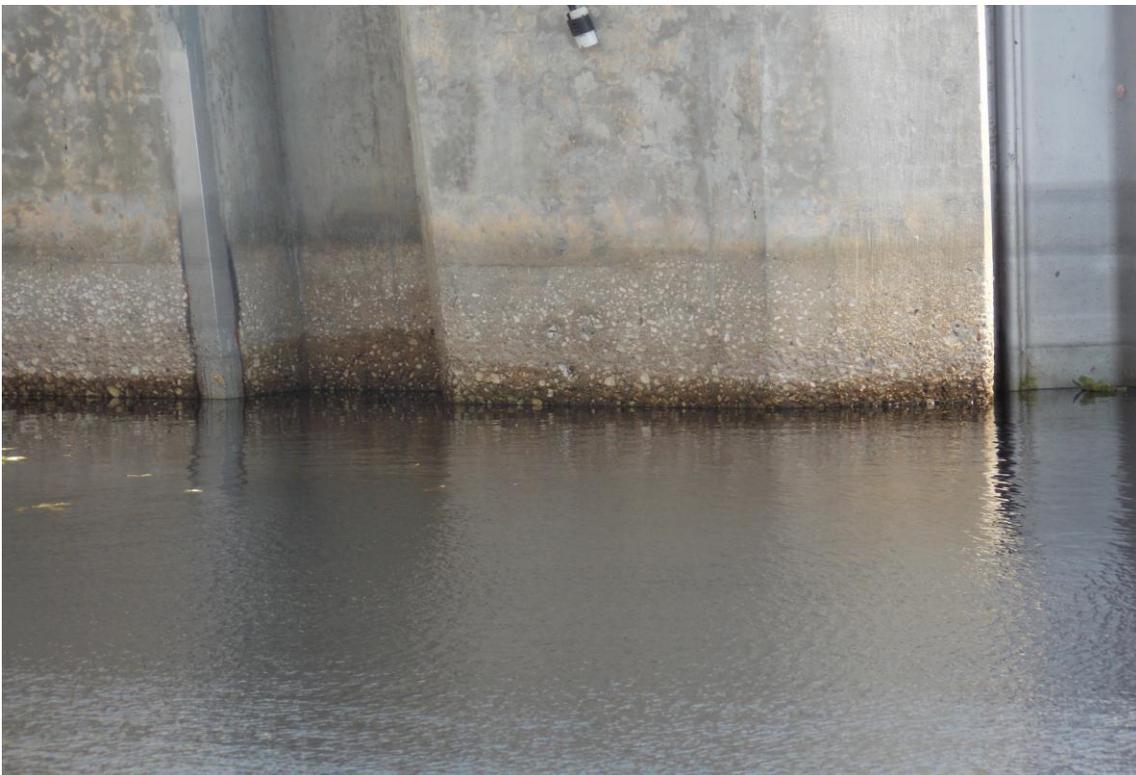
Upstream - North Structure and Wing Wall.

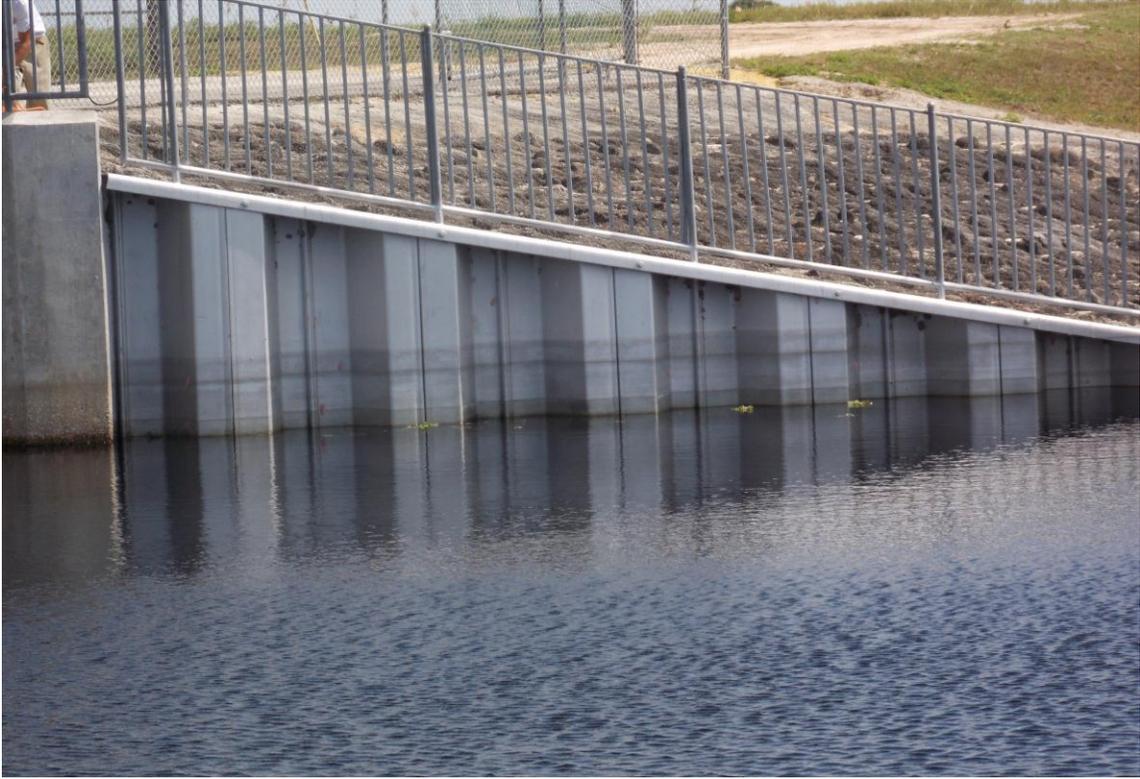
Relative to the steel sheet pile wing walls, the upstream walls appeared to be in very good condition. No evidence of corrosion or seepage between the joints was observed. The portions of the steel sheet pile walls that were below the water surface could not be observed relative to their condition.

Upstream - South Wing Wall.

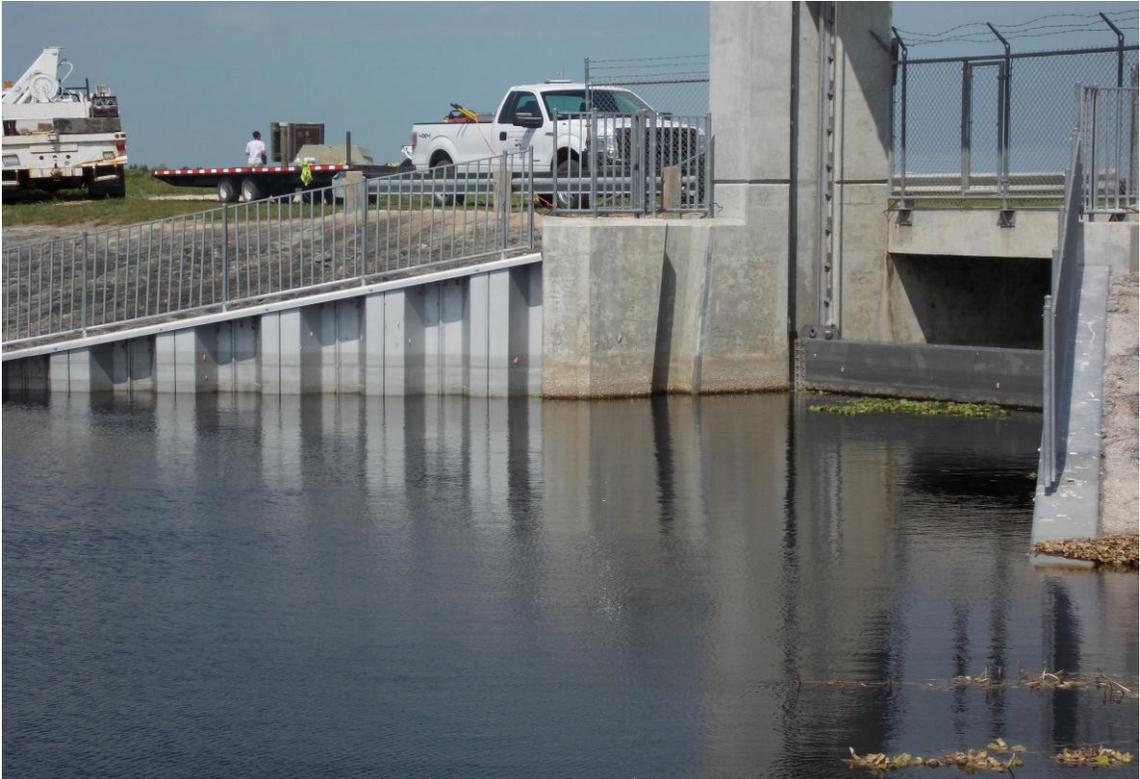
Upstream - South Wing Wall and Structure.

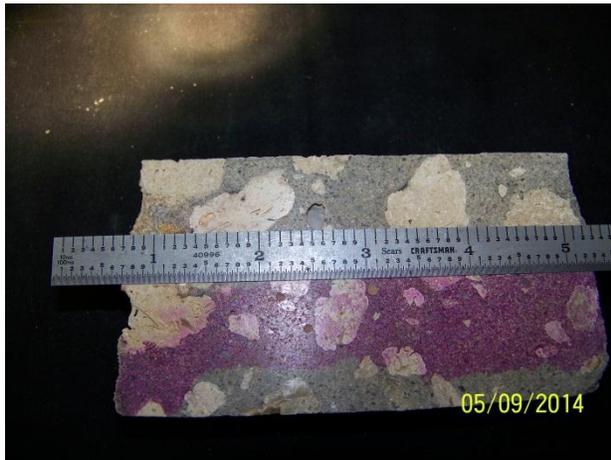
Core 2B

- The surface of the sample is eroded.

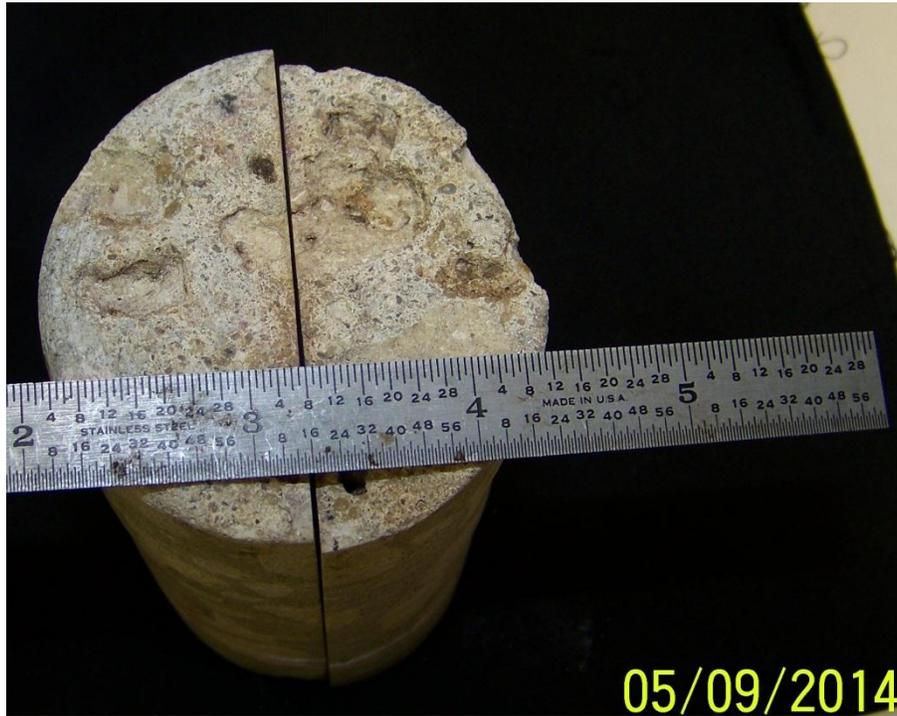
Photo 2 – Sample 2B – end view, note surface erosion.

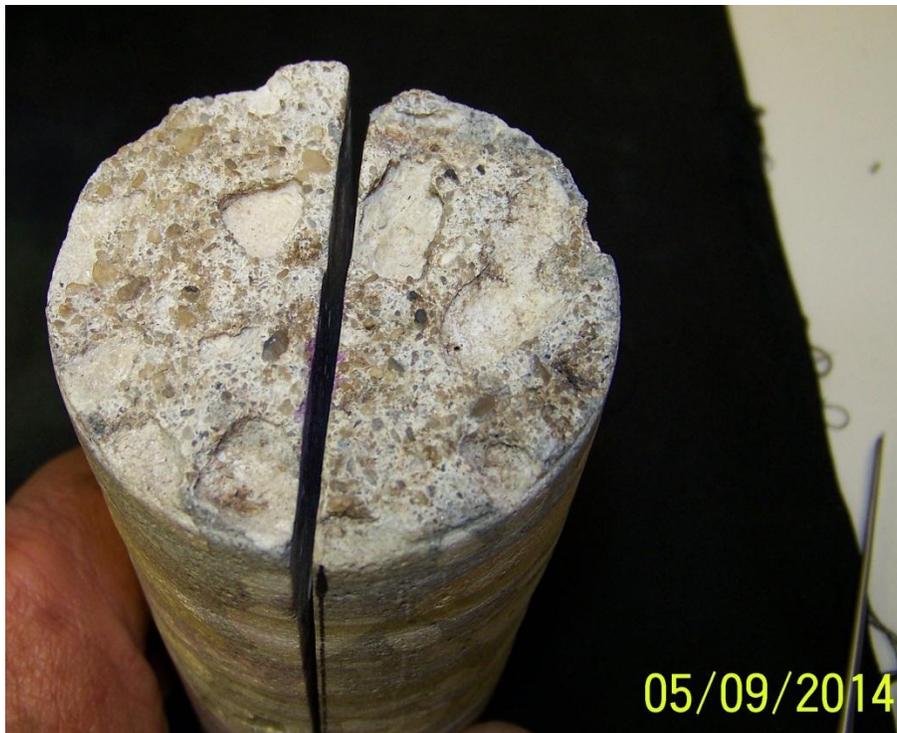
Photo 3 – Sample 3B – end view, note surface erosion.

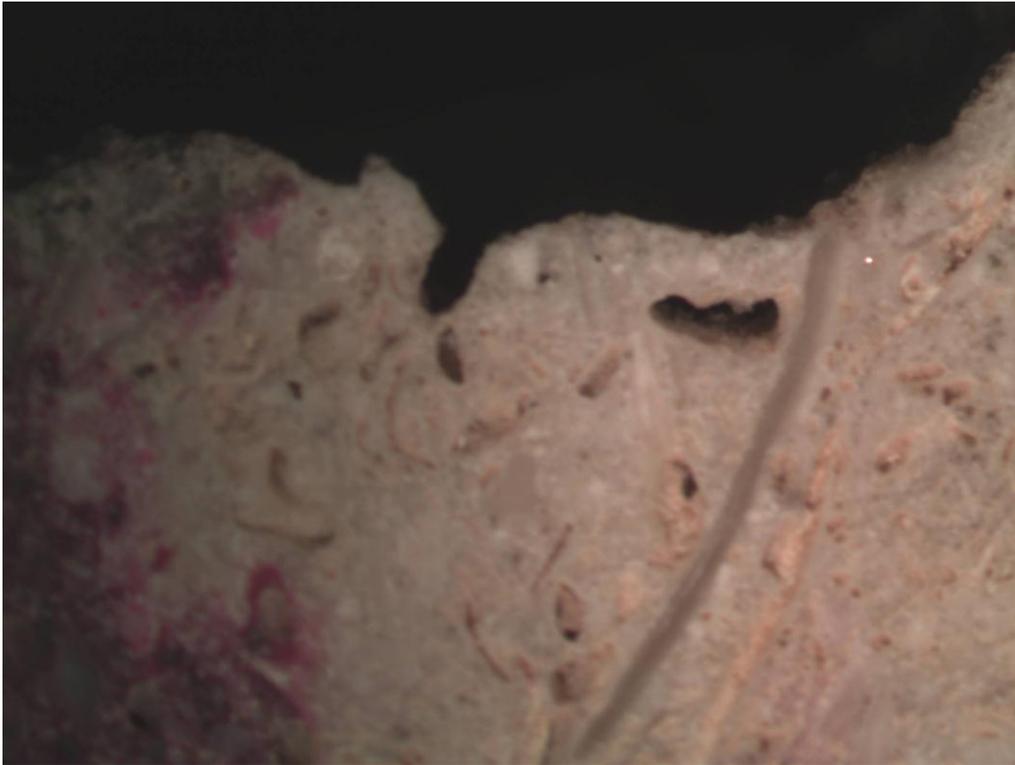
Photo 4 – Sample 2B – magnified view of eroded surface.

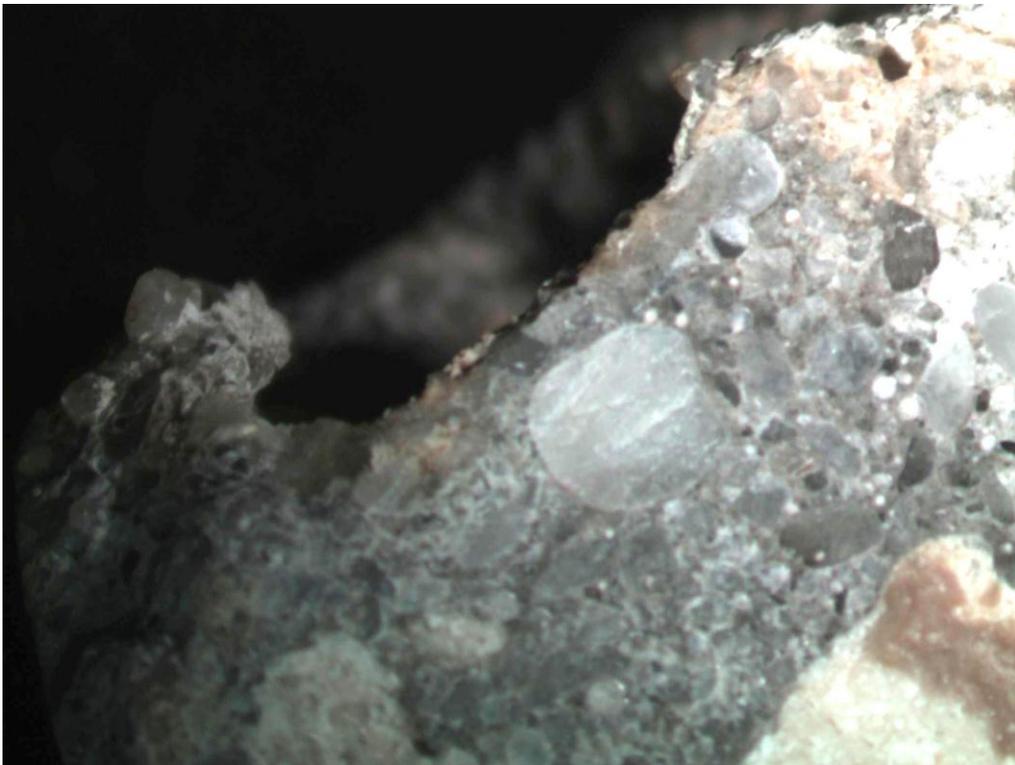
Photo 5 – Sample 3B – magnified view of eroded surface.

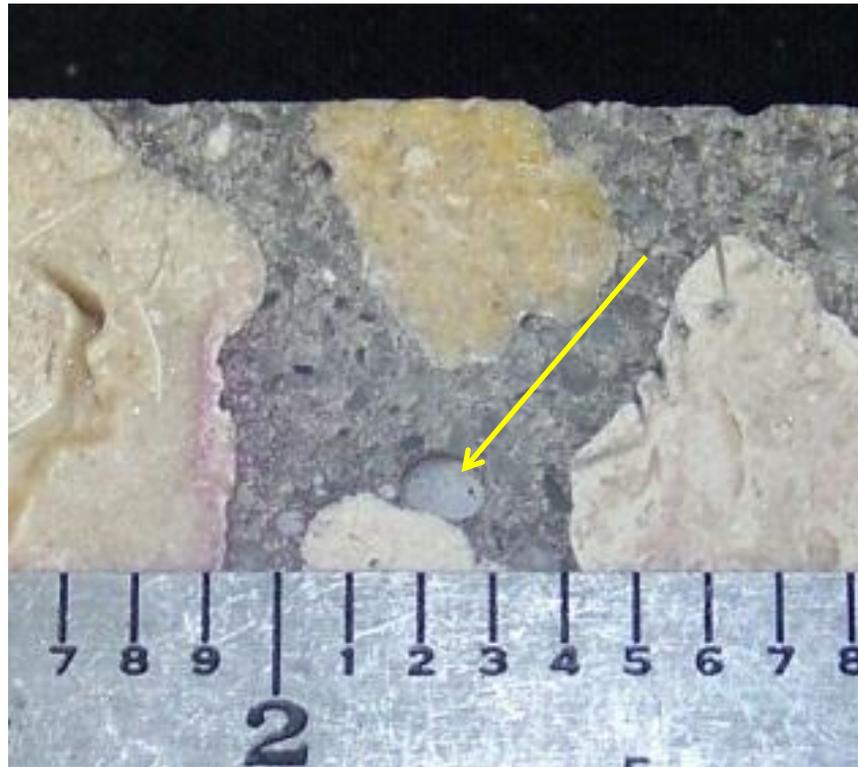
Photo 6 – Sample 3B – magnified view of entrapped air void

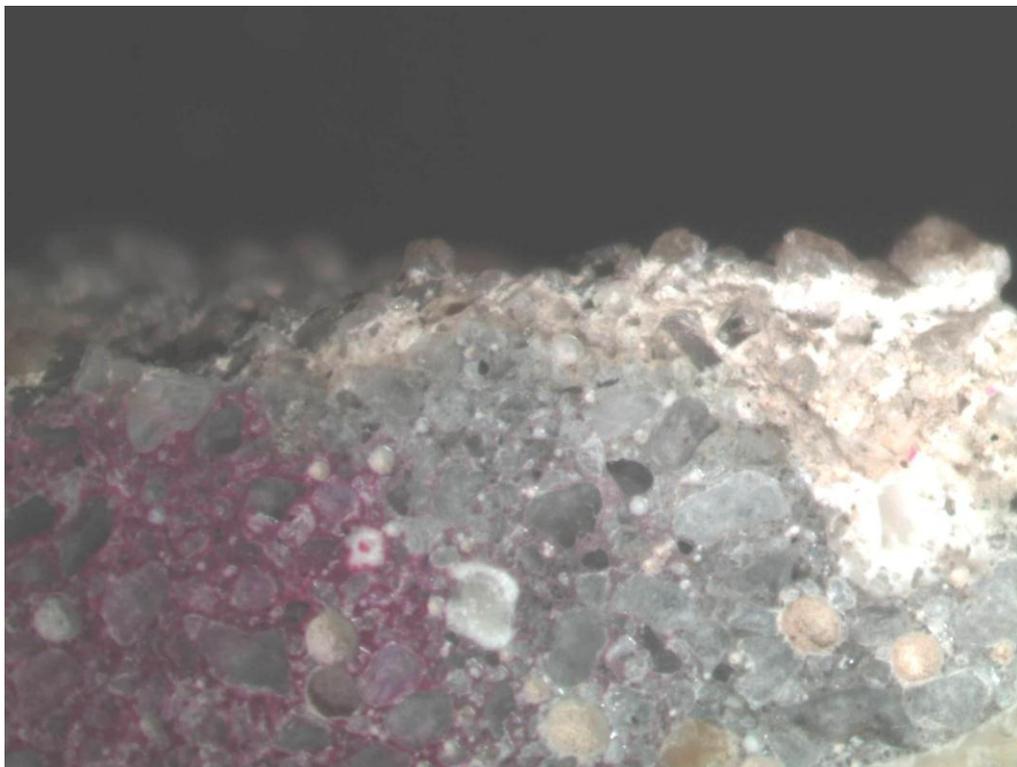
Photo 7 – Sample 3B – magnified view of light colored paste at surface.
