May 21, 2021

Subject: Asbestos Roofing Survey
San Antonio Elementary School – Rooms 3-10 (4 Classroom Buildings)
650 Carne Road, Ojai, CA 93023
FCG Project Code: Ojai USD-62

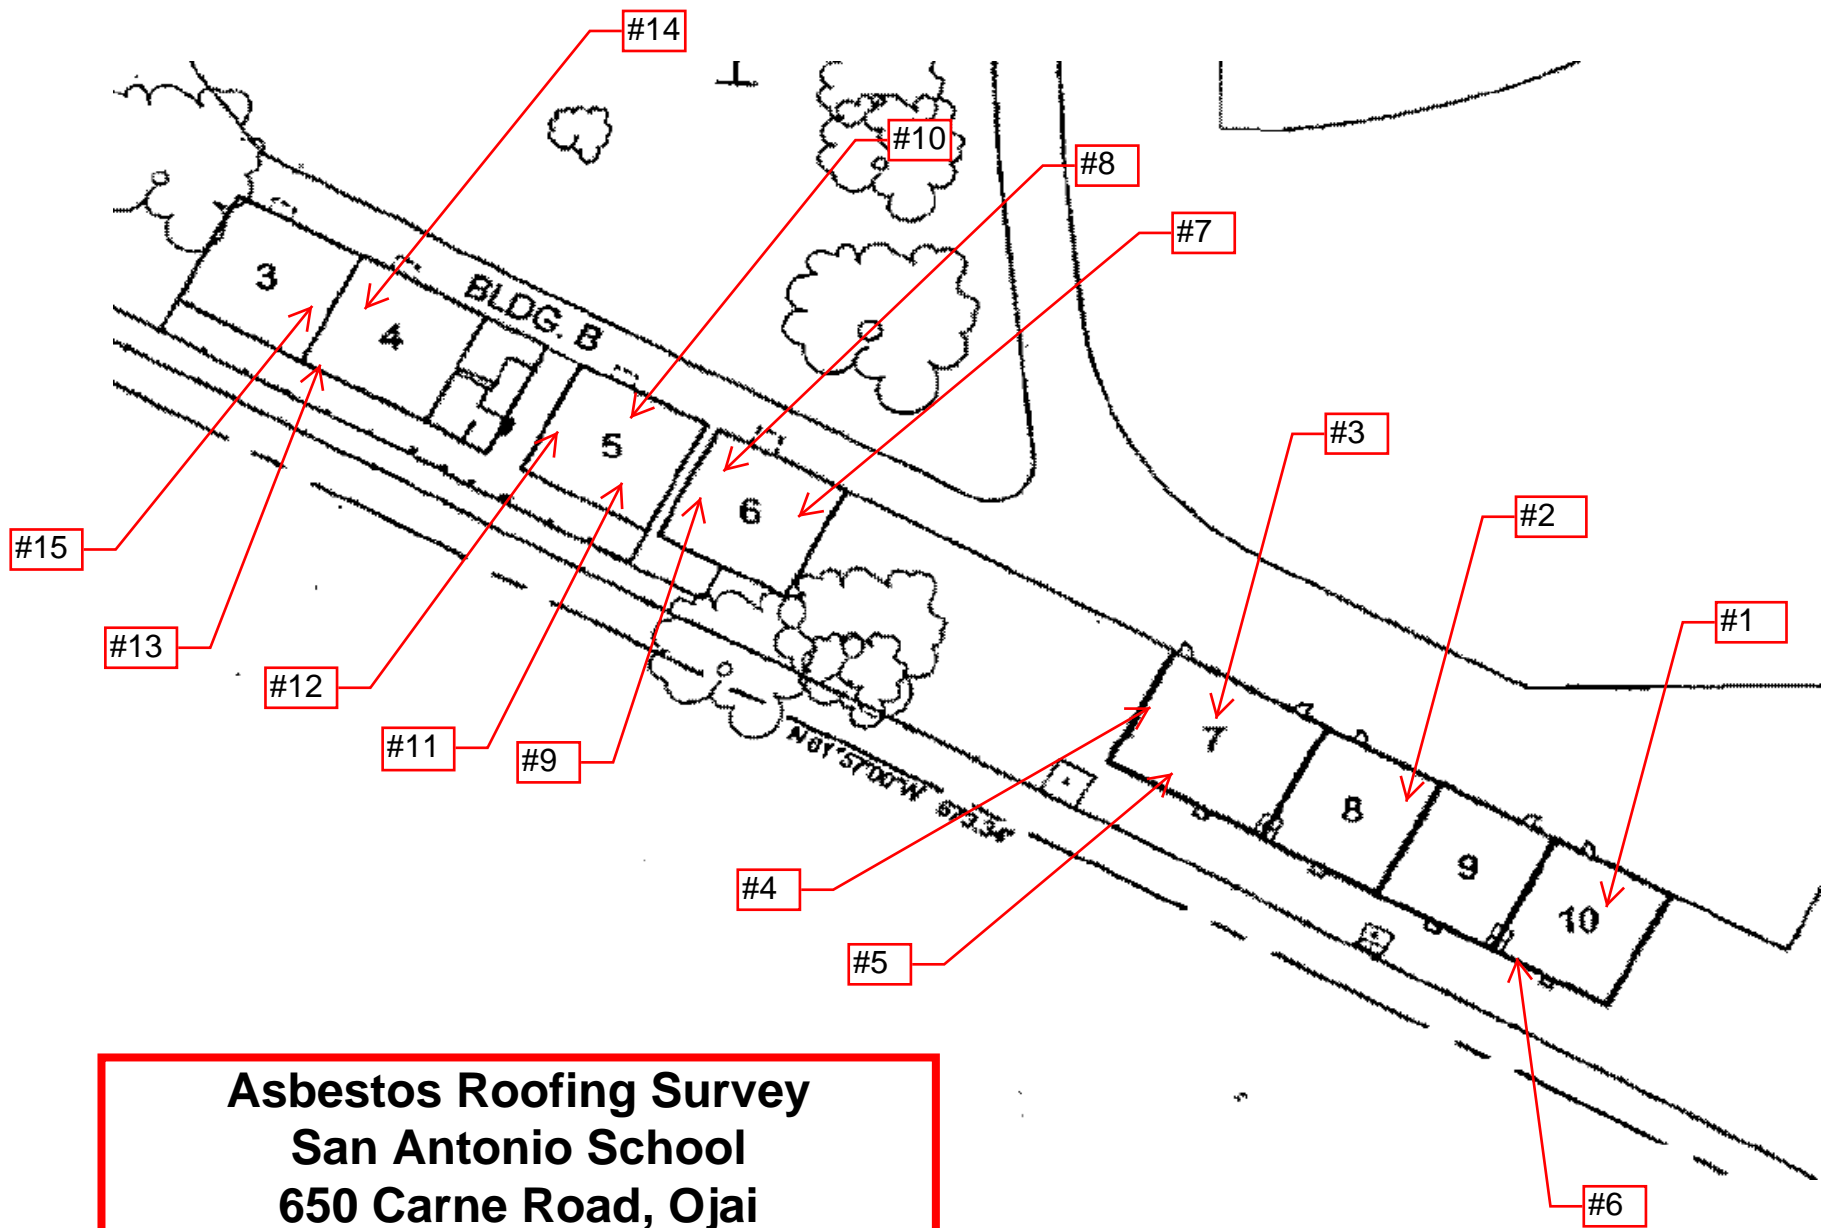
**Asbestos Roofing Survey
San Antonio School
650 Carne Road, Ojai
Sample Locations Noted in Red**

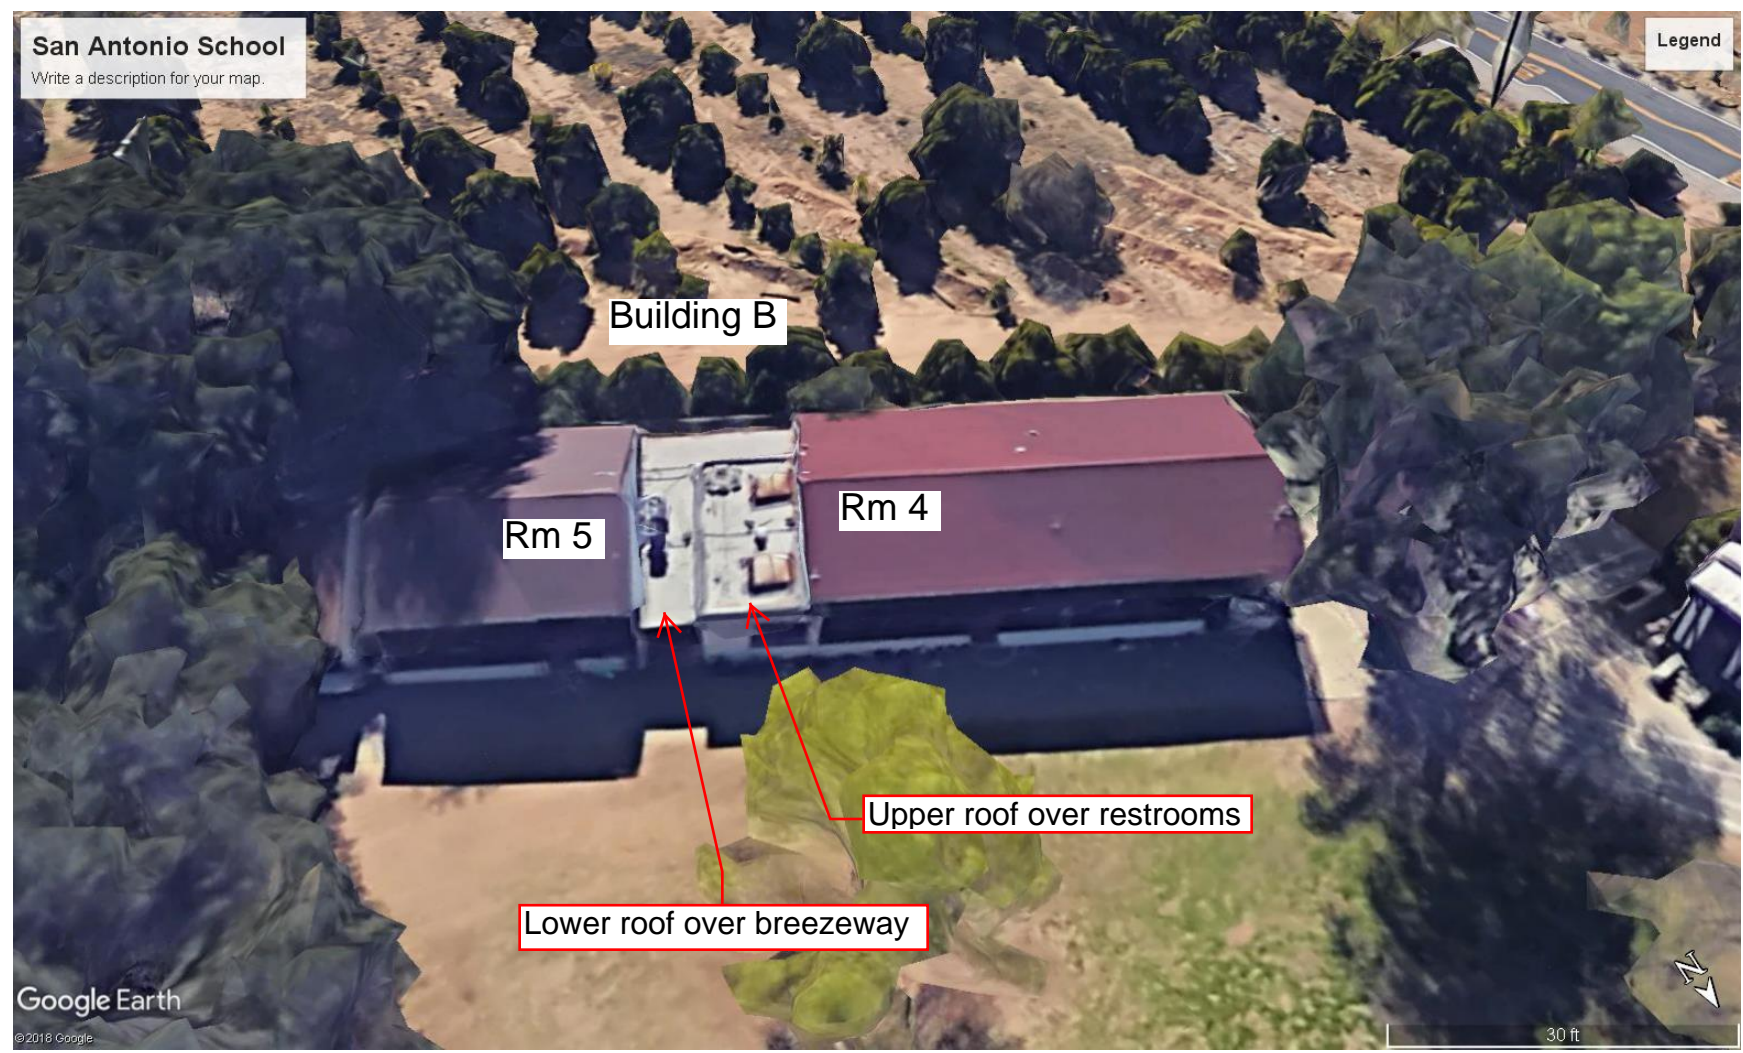
Lower Breezeway Roof

Upper Roof over
restrooms

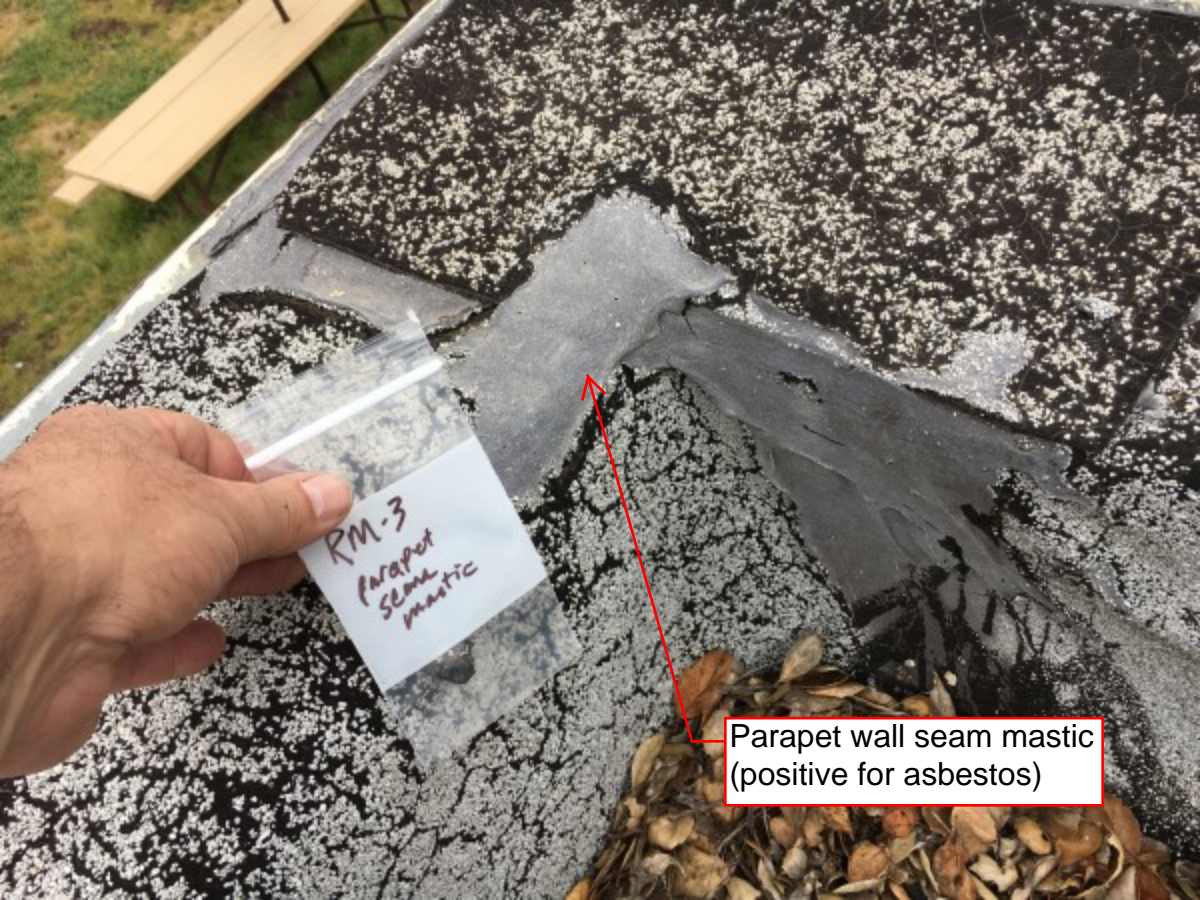
RM-3
Parapet
Seam
Mastic

Parapet wall seam mastic
(positive for asbestos)

mastics found on the roof that have not been tested, all mastics should be managed as asbestos containing and properly removed by trained and licensed asbestos workers.

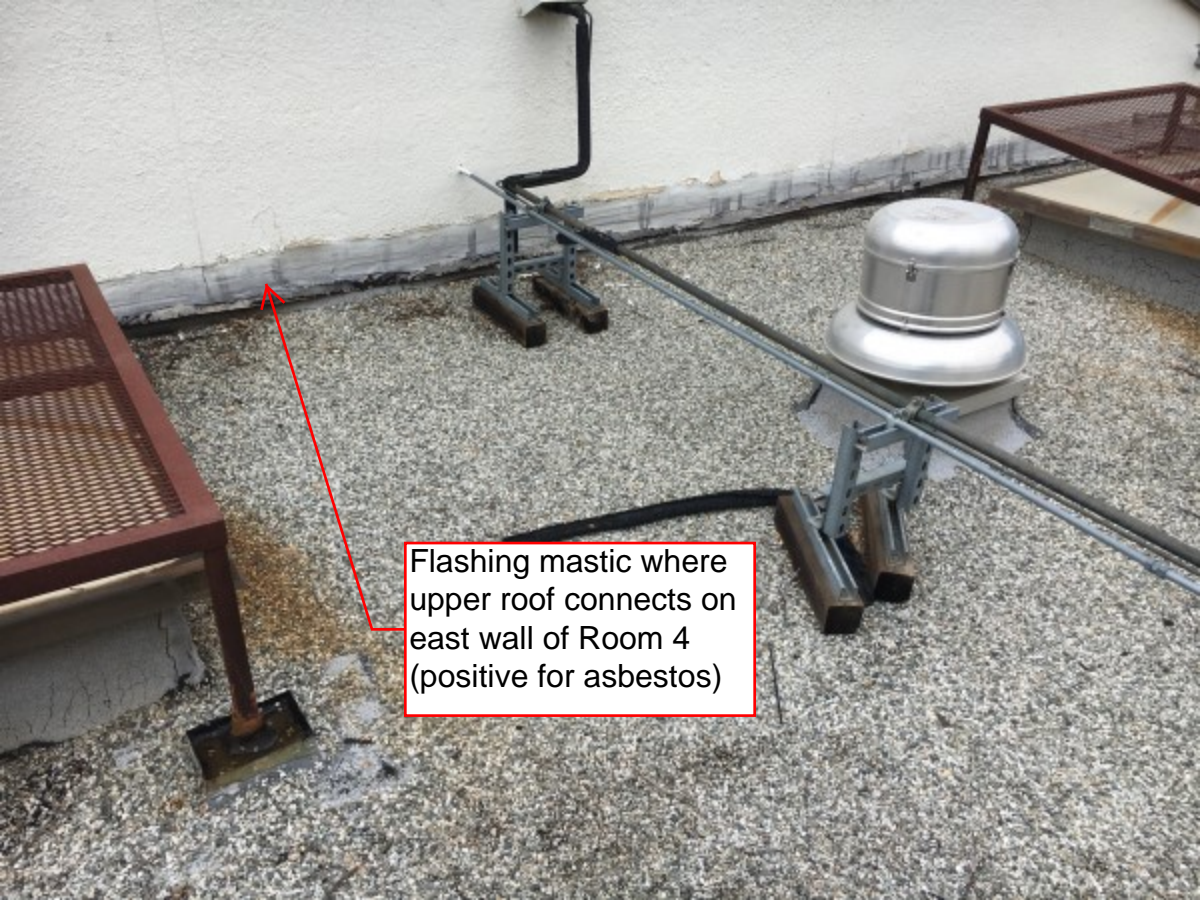
Flashing mastic where
upper roof connects on
east wall of Room 4
(positive for asbestos)

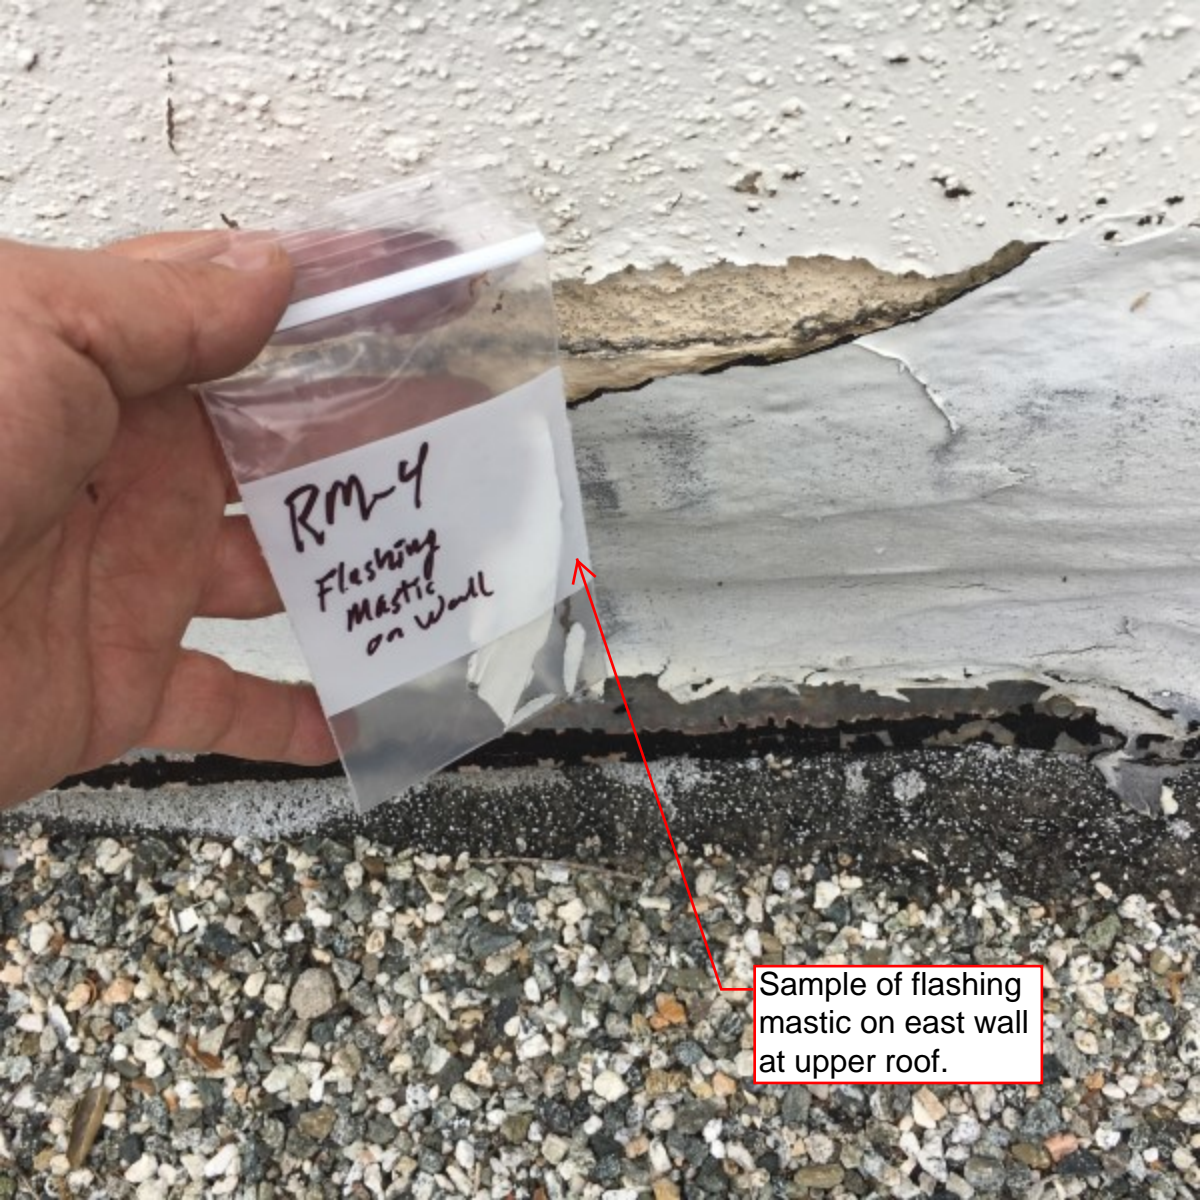
RM-4
Flashing
Mastic
on Wall

Sample of flashing
mastic on east wall
at upper roof.
