REPORT DATE: March 15, 2024
MID-ATLANTIC PROJECT #: R3950.00

NESHAP ASBESTOS SURVEY REPORT

**409, 411, 419 GOLDSBORO STREET SOUTH, 408 AND
410 JONES STREET SOUTH**
Wilson, Wilson County, North Carolina

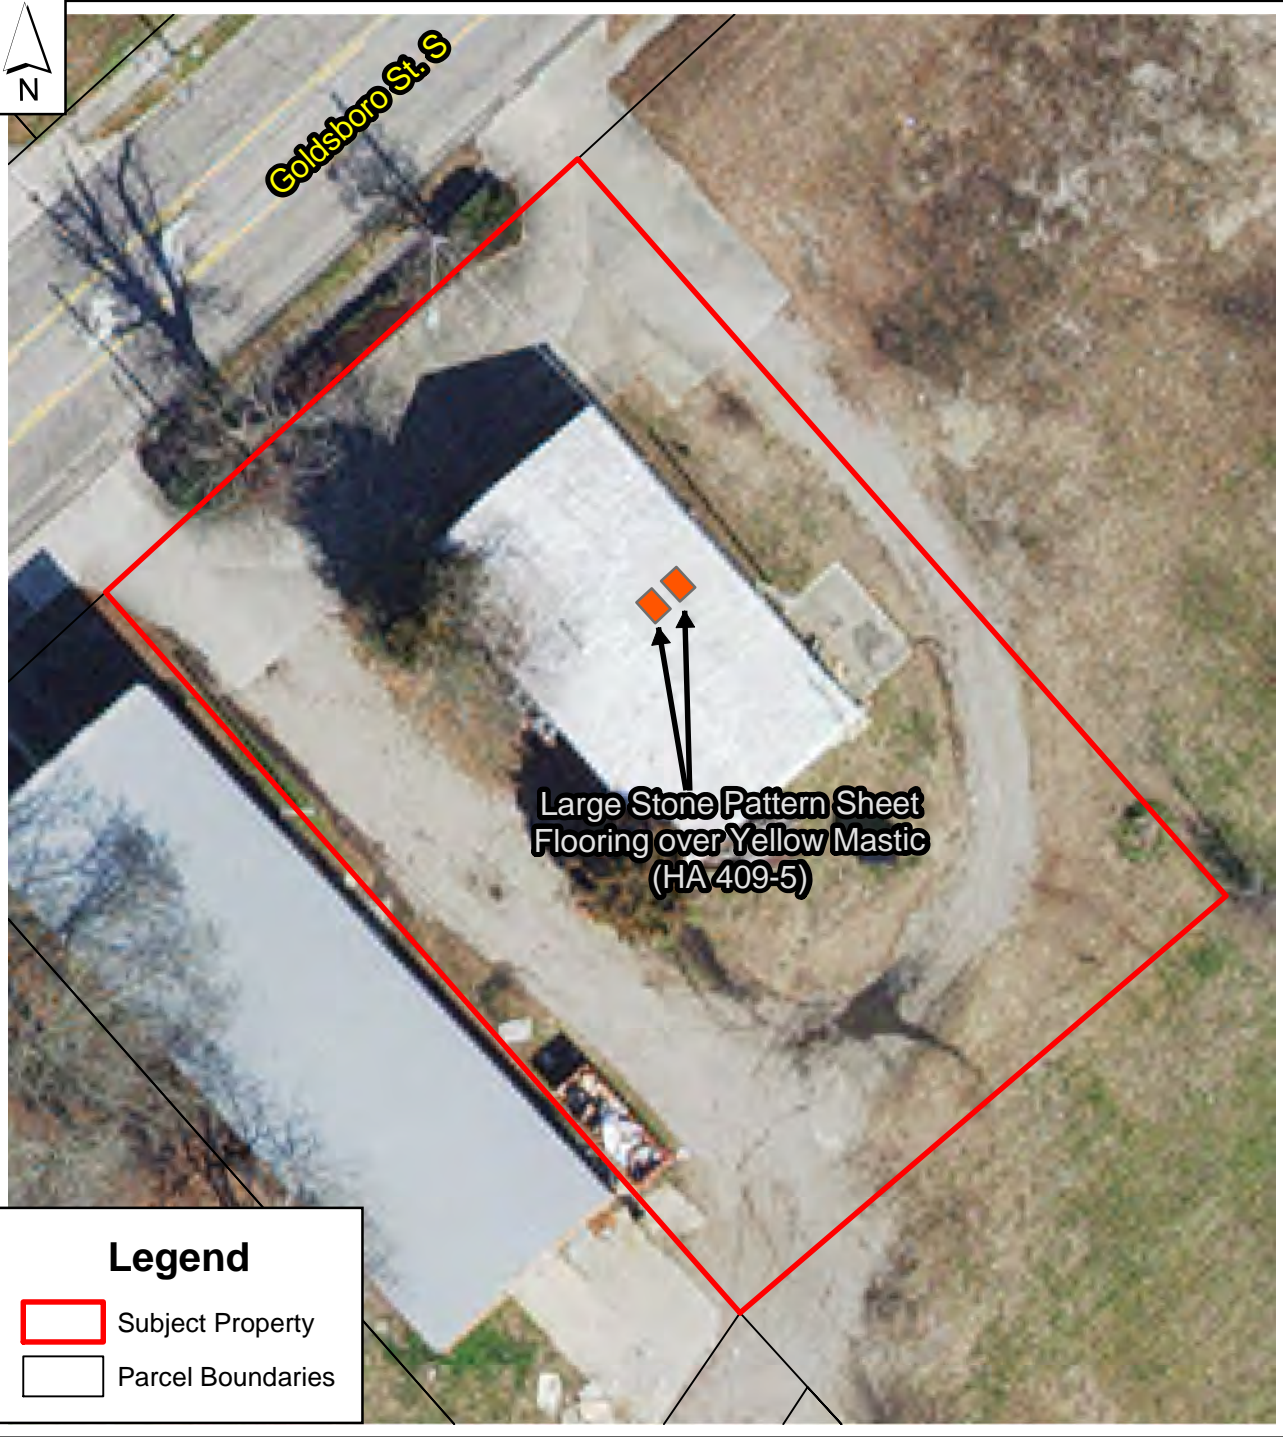
ACM LOCATION MAP
409 GOLDSBORO ST. S.
WILSON, NORTH CAROLINA

**Large Stone Pattern Sheet
Flooring over Yellow Mastic
(HA 409-5)**

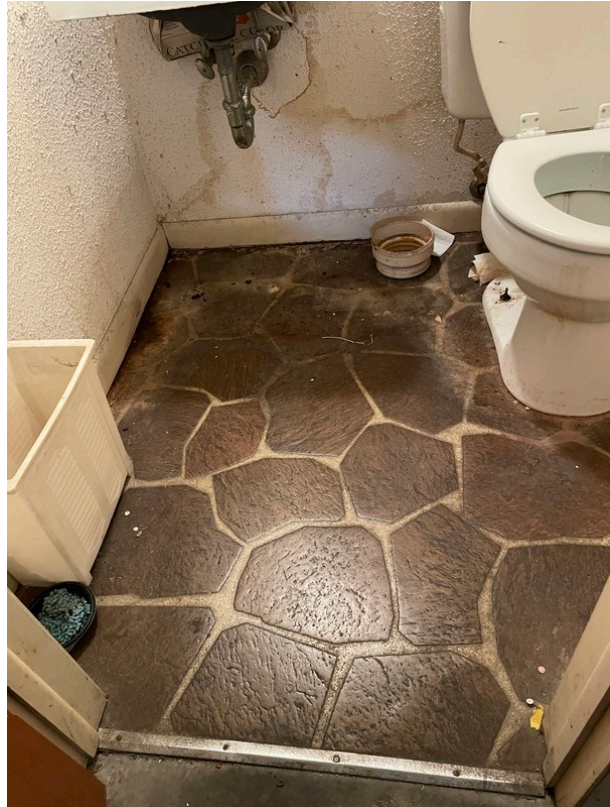
- Large Stone Pattern Sheet Flooring and its associated Yellow Mastic

View of asbestos-containing Large Stone Pattern Sheet Flooring and its associated Yellow Mastic (HA 409-5)

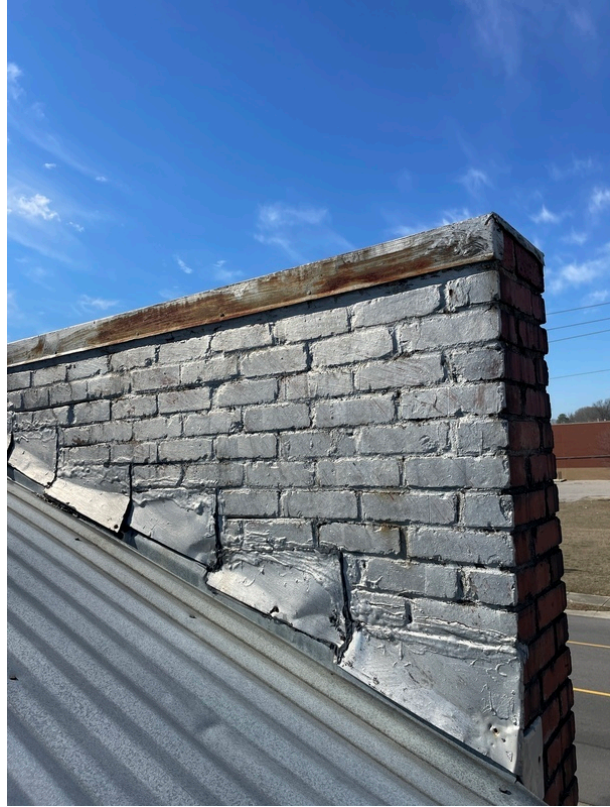
- Silver Coating and its associated Black Tar

View of asbestos-containing Silver Coating and its associated Black Tar (HA 411-3)

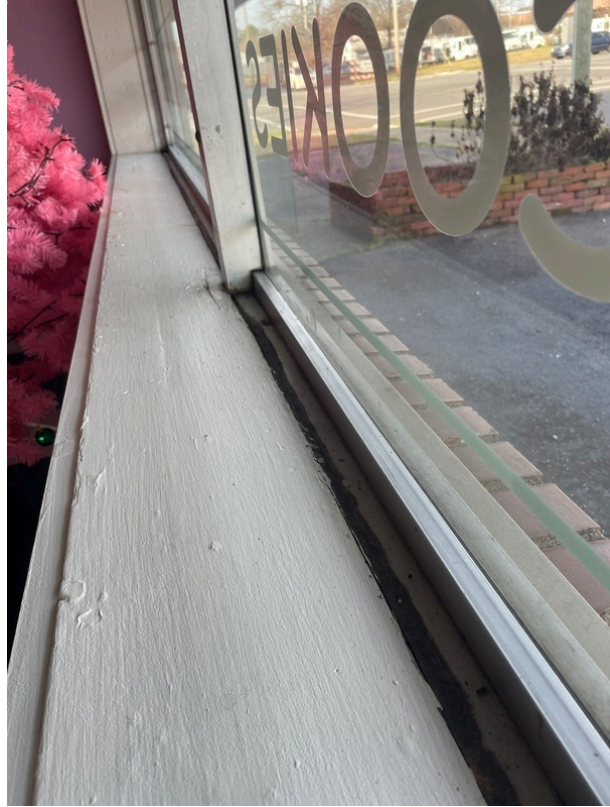
View of asbestos-containing Off-White Interior Window Frame Caulk (HA 419-3)

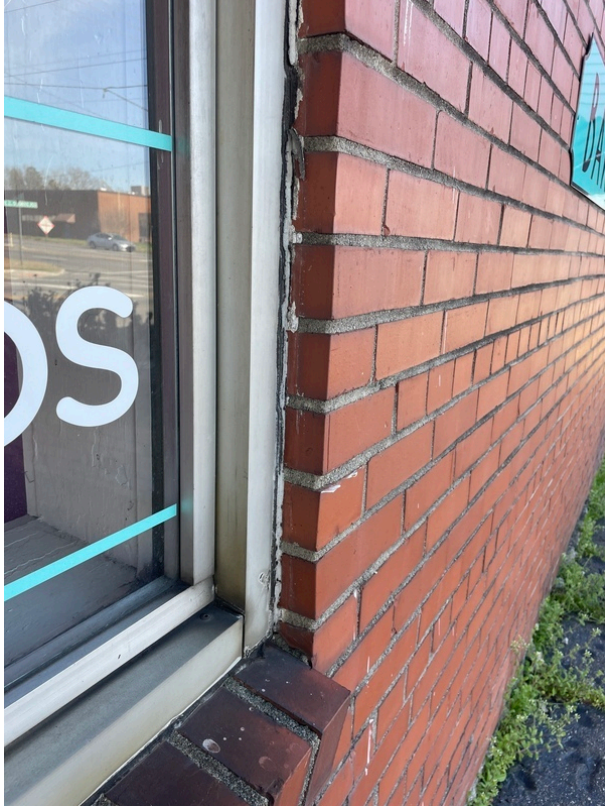
General view of asbestos-containing Gray Exterior Window Frame Caulk beneath White Caulk (HA 419-11)

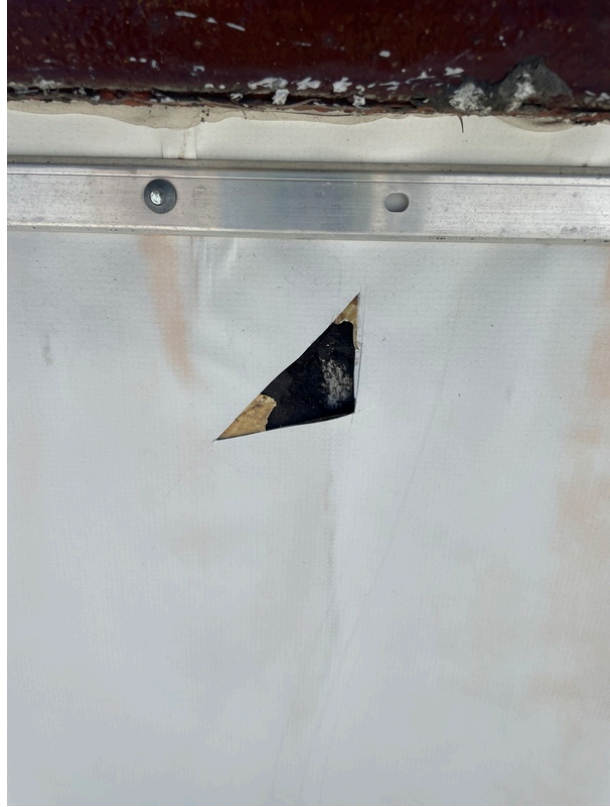
View of asbestos-containing Black Tar located behind rubber membrane on the parapet wall of the roof (HA 419-18)

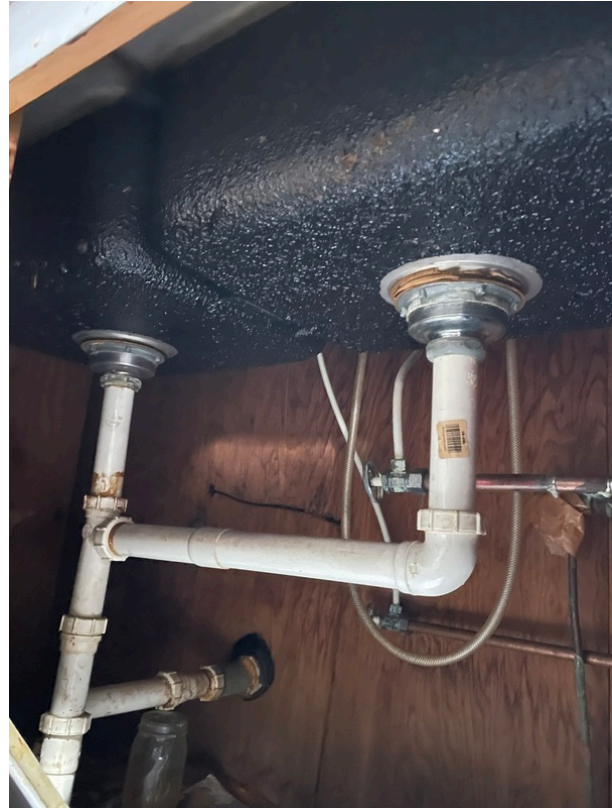
View of asbestos-containing Black Sink Coating (HA 408-7)

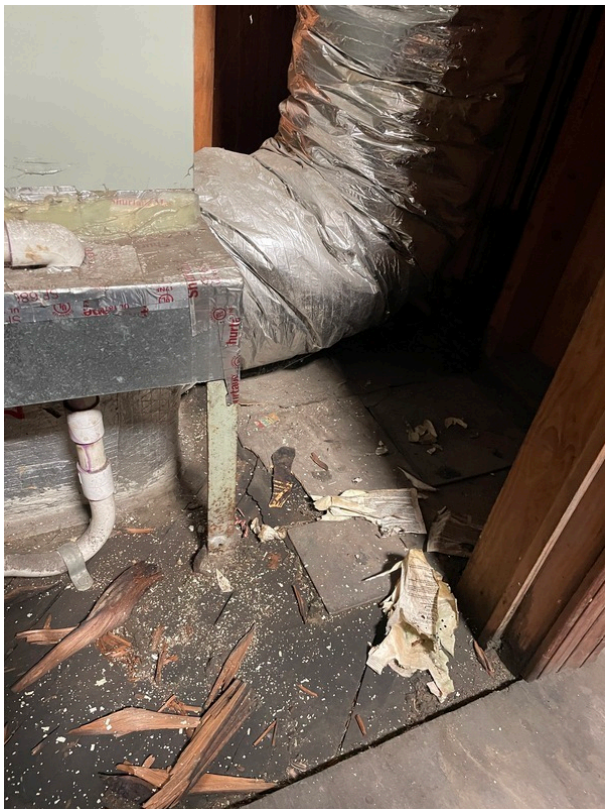
View of asbestos-containing 9" x 9"
Brown/Tan Floor Tile and its associated
Black Mastic (HA 408-8)

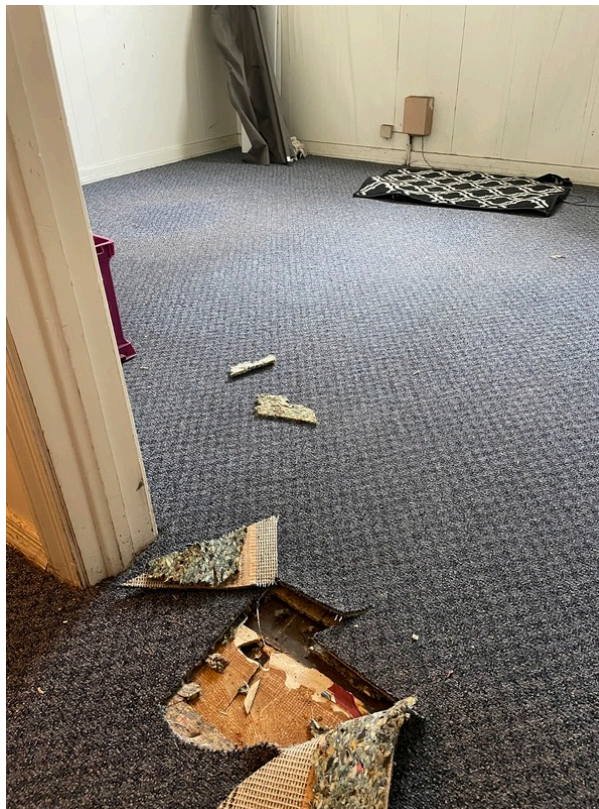
General view of asbestos-containing Tan/
Brown Mastic and its associated Off-White
Backing Material over Tan/Yellow Mastic
over 12" x 12" White/Off-White Floor Tile
over Beige/Tan Floor Tile over Black
Mastic (HA 408-11)

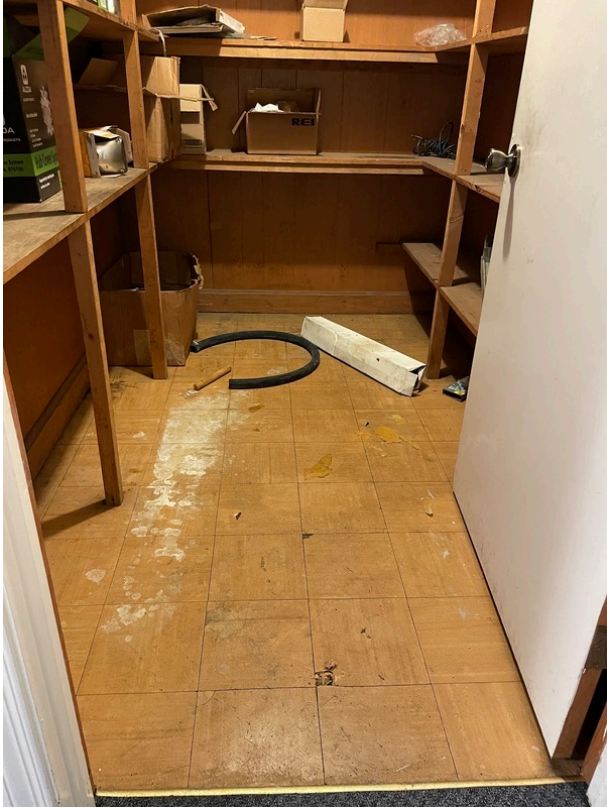
View of asbestos-containing 9" x 9"
Brown/Tan Floor Tile and its
associated Black Mastic
(HA 408-13)

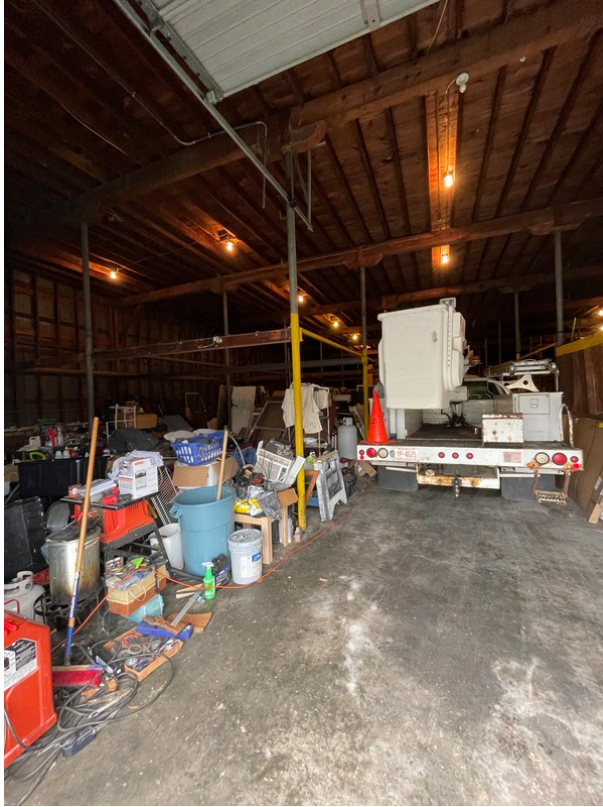
During this assessment, Mid-Atlantic did not identify suspect ACM at the 410 Jones Street South commercial structure. According to the owner of the building, Mr. Darren Skinner, the roof of the building was removed and replaced approximately 10-15 years ago. As previously stated, the structures roof currently consists of flat and sloped rubber membrane/metal over wood decking.

General view of the interior of the 410 Jones Street South commercial structure
