**Engineering Evaluation of Concrete Degradation  
and Steel Sheet Pile Wing Wall Thickness  
C-54 Canal Water Control Structure S-157  
SJRWMD, Brevard County, Florida**

May 28, 2013  
File No. 13-60-6303

Subject: Engineering Evaluation of Concrete Degradation and  
Steel Sheet Pile Wing Wall Thickness  
C-54 Water Control Structure S-157  
SJRWMD, Brevard County, Florida

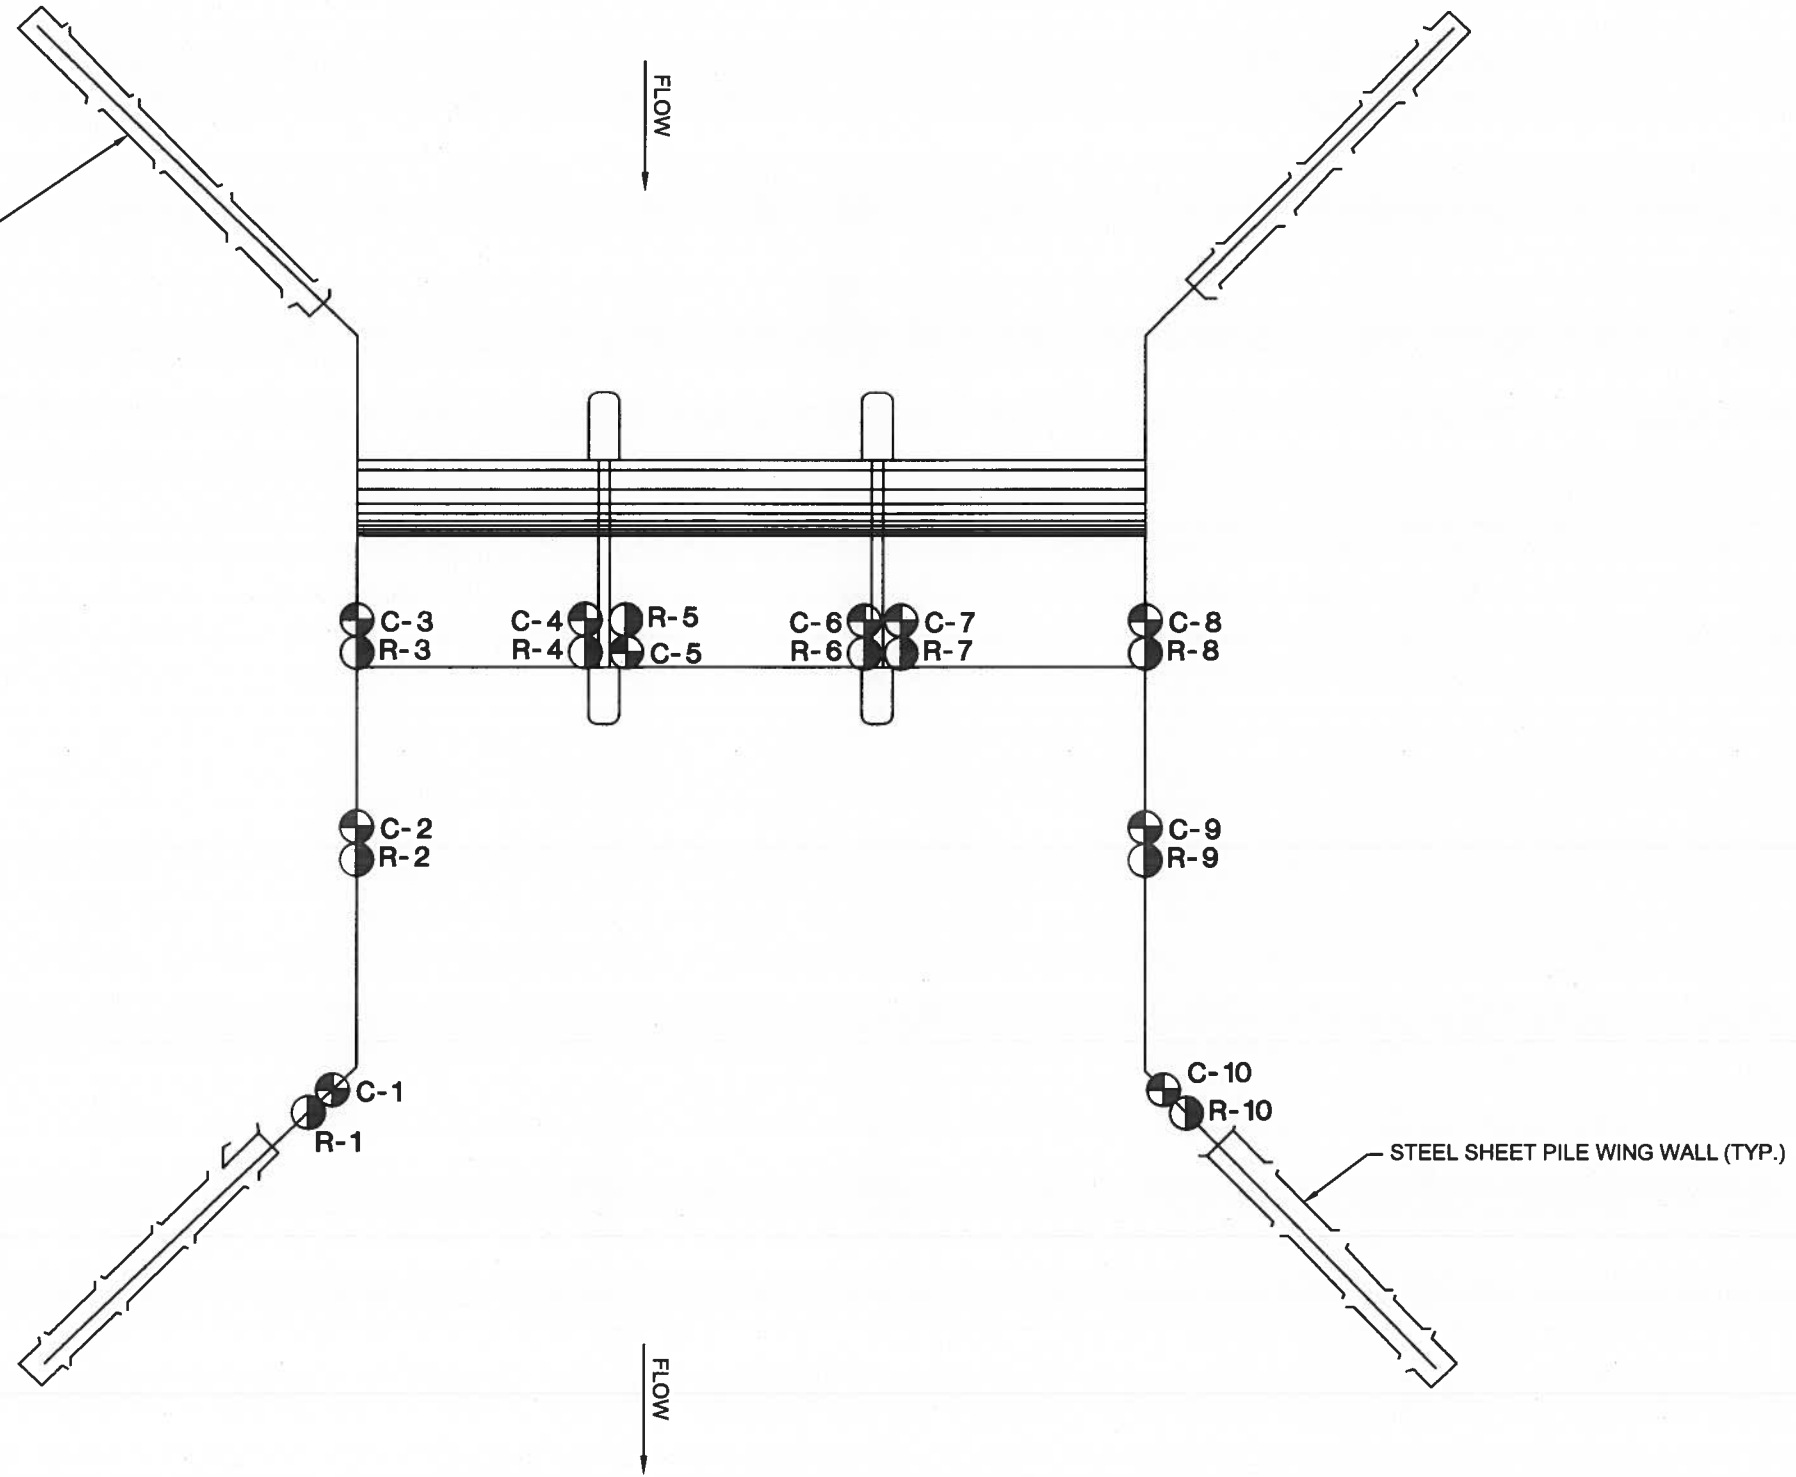
**CORE LOCATION PLAN**

The approximate plan view locations where the readings were obtained are shown on Figure 1.

A summary of the concrete core data including their length and general observations is presented as Table 2. Photographs of the core samples are included as Appendix II. The approximate core locations are schematically illustrated on a site plan shown on Figure 1. These locations were determined by estimating distances from existing site features and should be considered accurate only to the degree implied by the method of measurement used.'

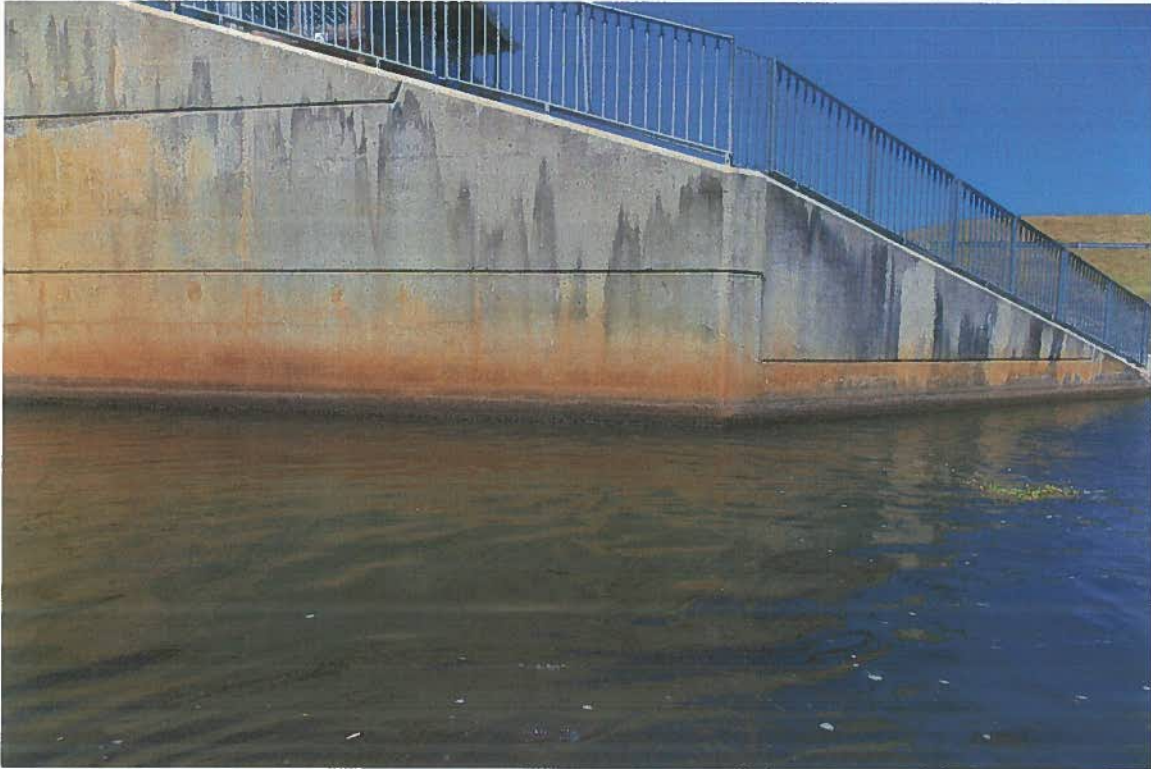
**Downstream - North Mid-Panel and Wing Wall.**

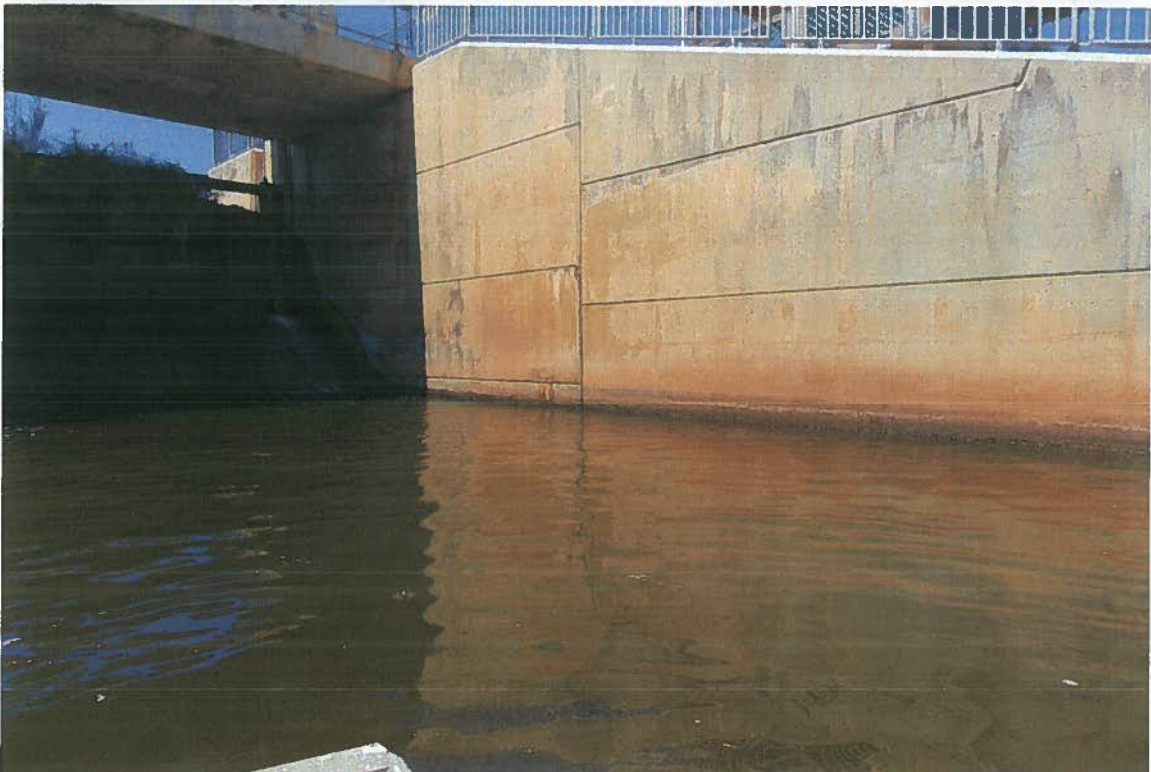
**Downstream - North Bay Wall and Mid-Panel Wall.**

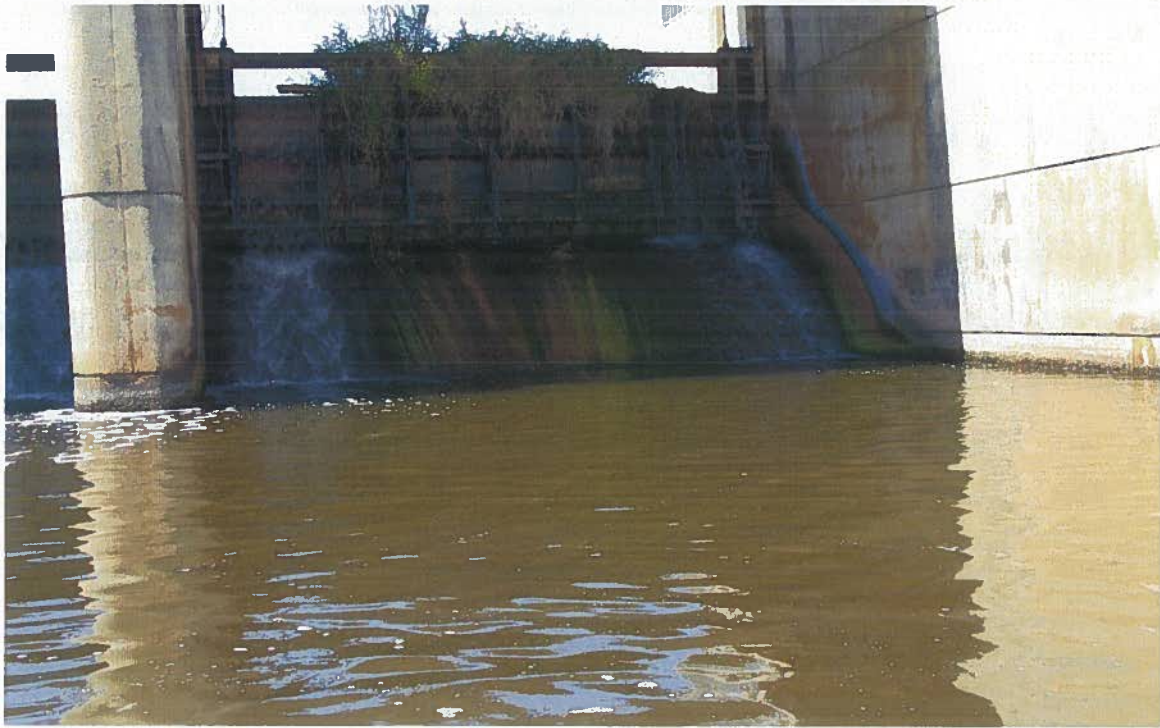
**Downstream - North Bay Weir.**

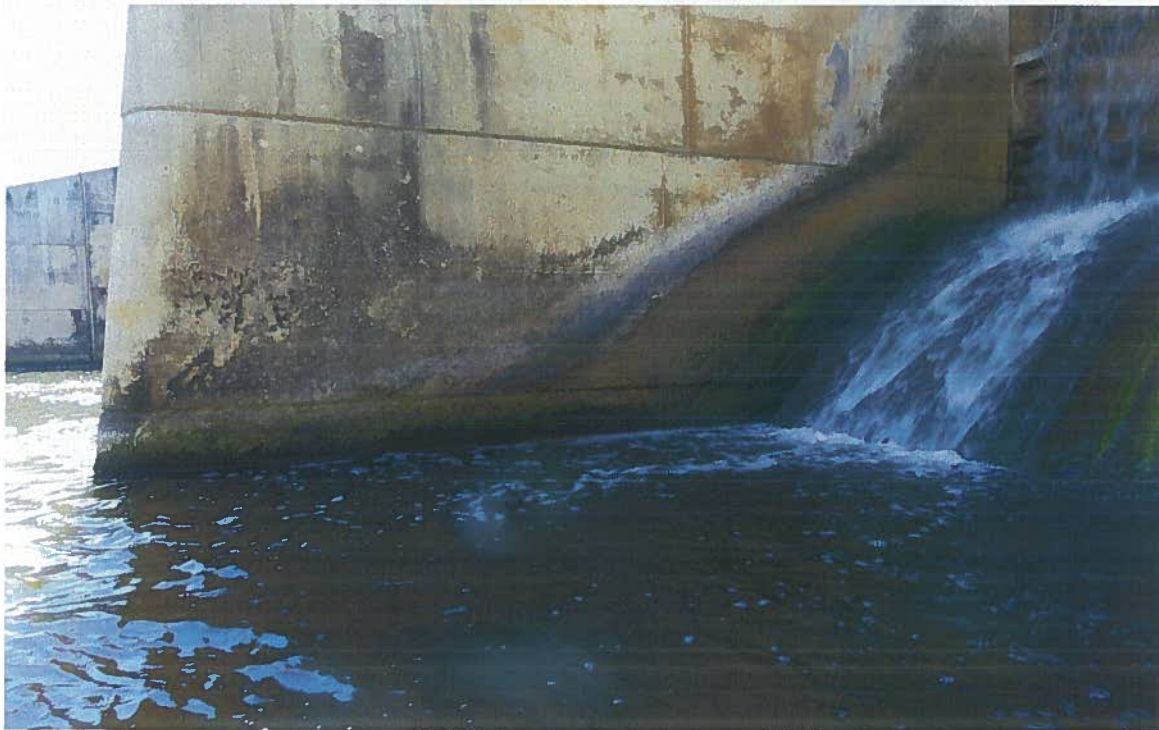
**Downstream - North Bay, South Interior Wall.**

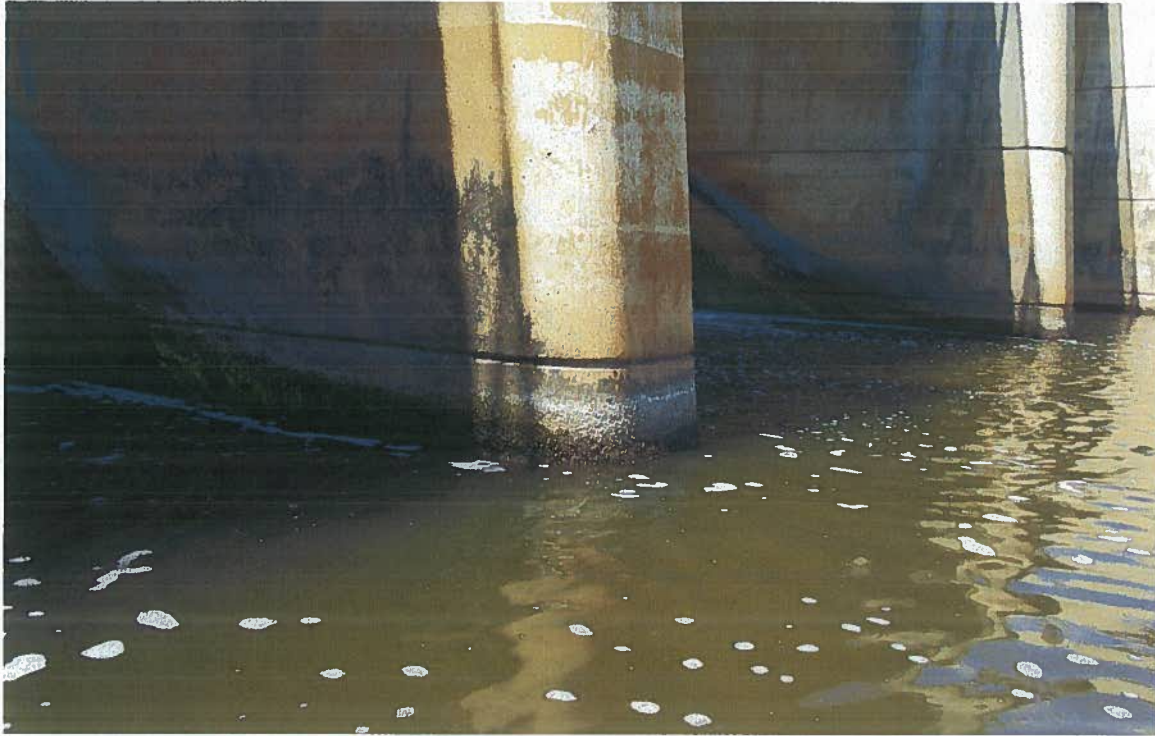
**Downstream - South Bay - North Interior Wall and Mid-Bay North Interior Wall.**

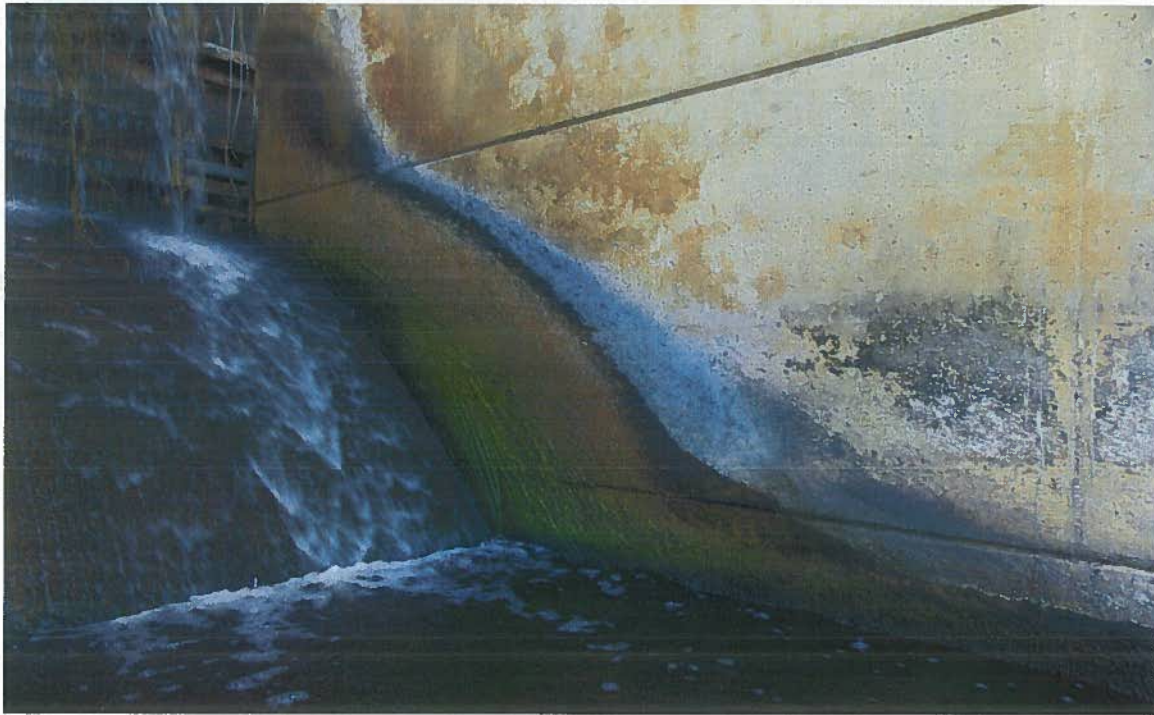
**Downstream - Mid Bay Weir and North Interior Wall.**

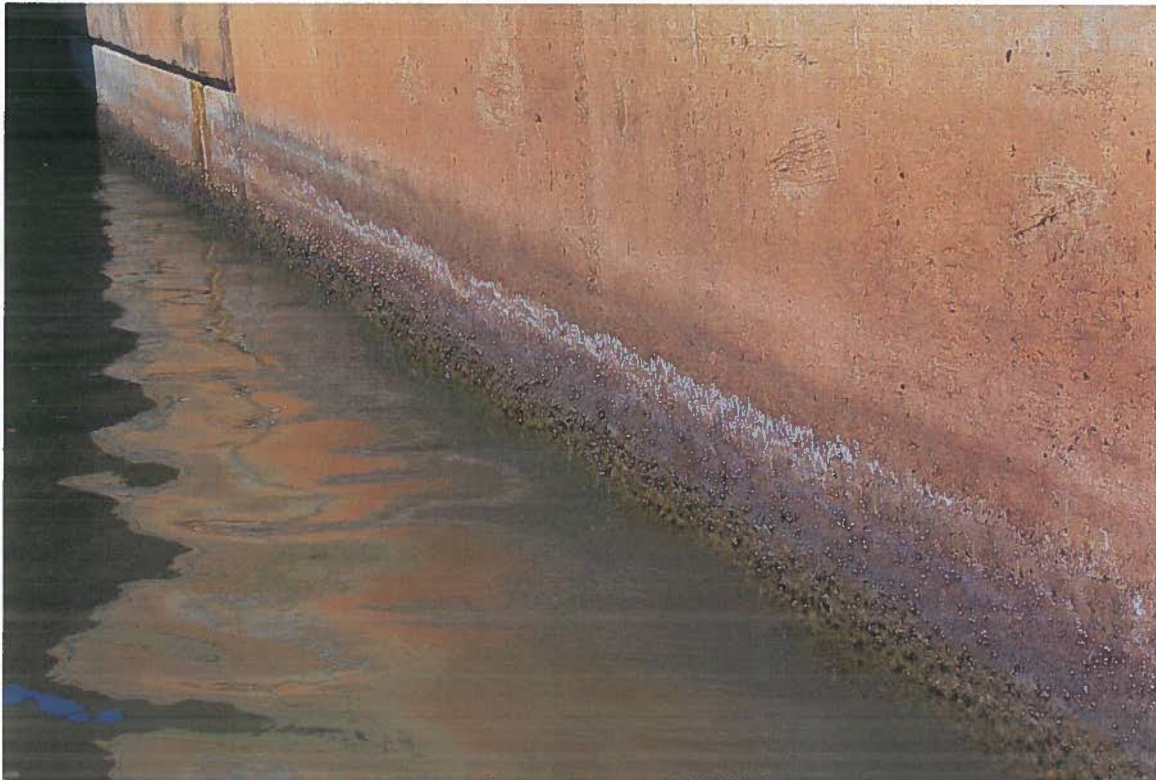
**Downstream - North Mid-Panel Wall.**

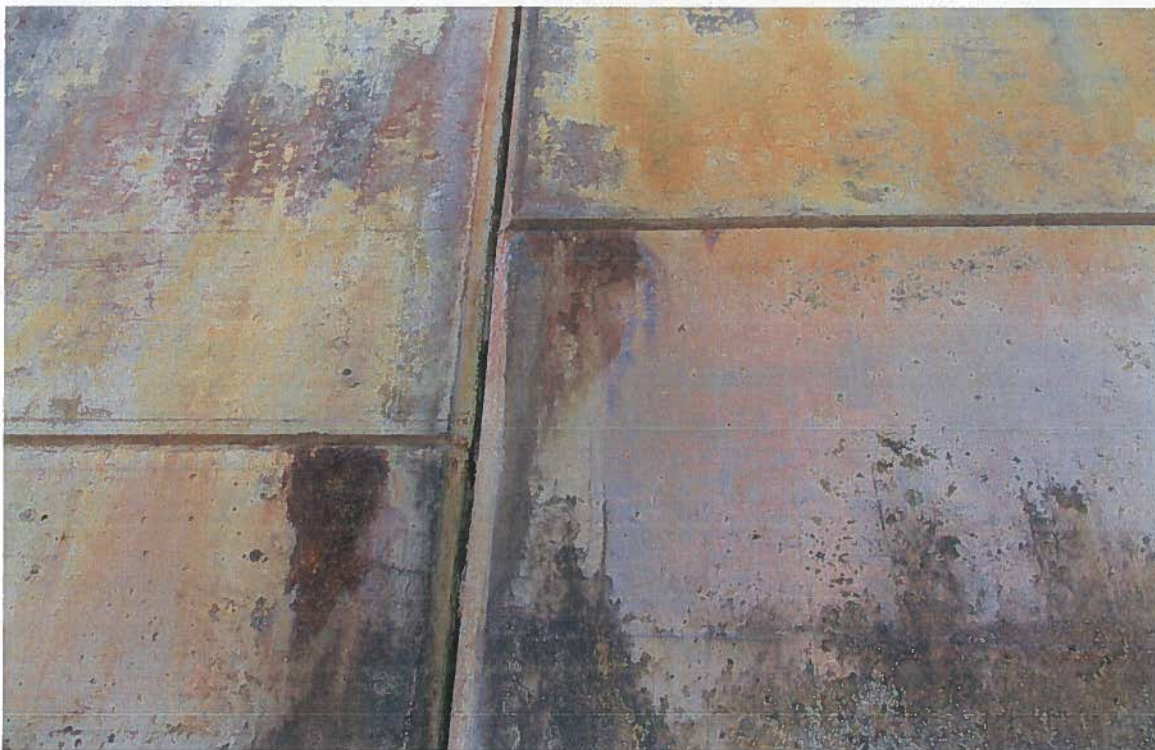
We note that while evaluation of the wall joint material was beyond our scope of work, we did observe seepage staining at some joint locations and degraded joint filler material. The provided "As built" plans referred to the "preformed joint material." Ardaman is not aware of the purpose of the joint filter and/or its importance. If deemed prudent by others, the joint filler should be replaced.

**Downstream - North Mid-Panel Wall. Note Joint Filler Deterioration.**

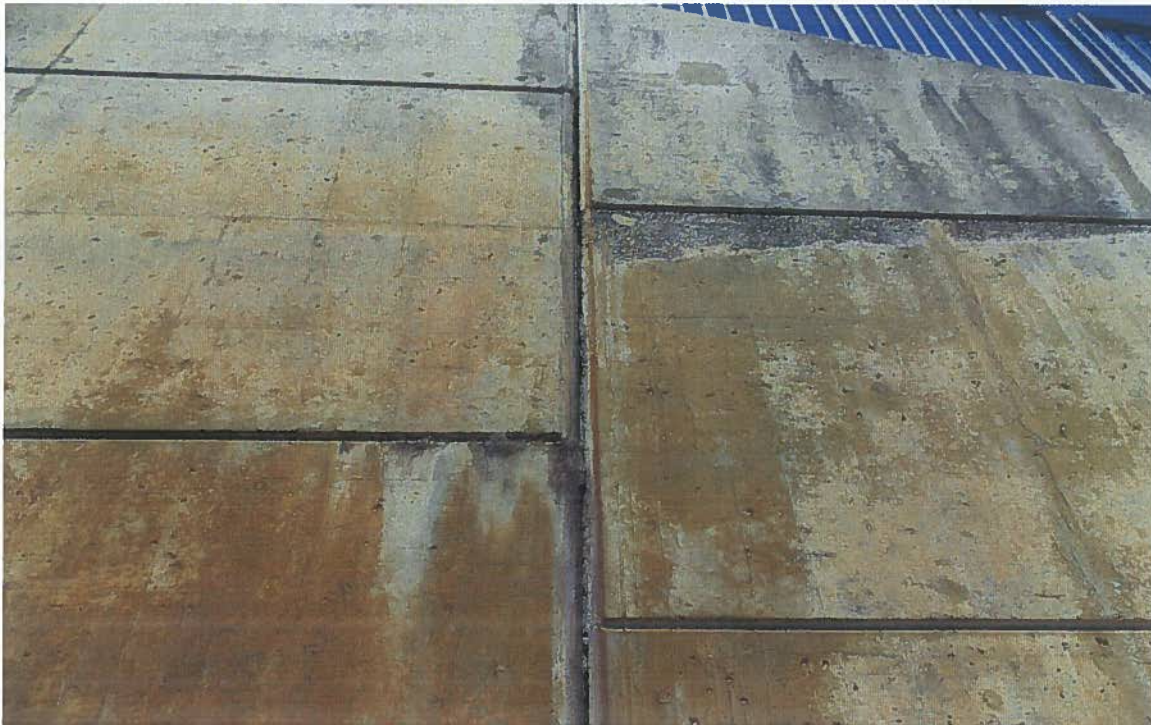
We note that some of the wall panels high above the downstream water level exhibited staining from seepage through the joints. These areas were too high to inspect from the work boats, but considering the age of the structure, the joint filler material has likely deteriorated to some degree allowing the observed seepage staining.

**Downstream - South Mid-Panel Wall. Note Seepage Staining and Joint Deterioration.**

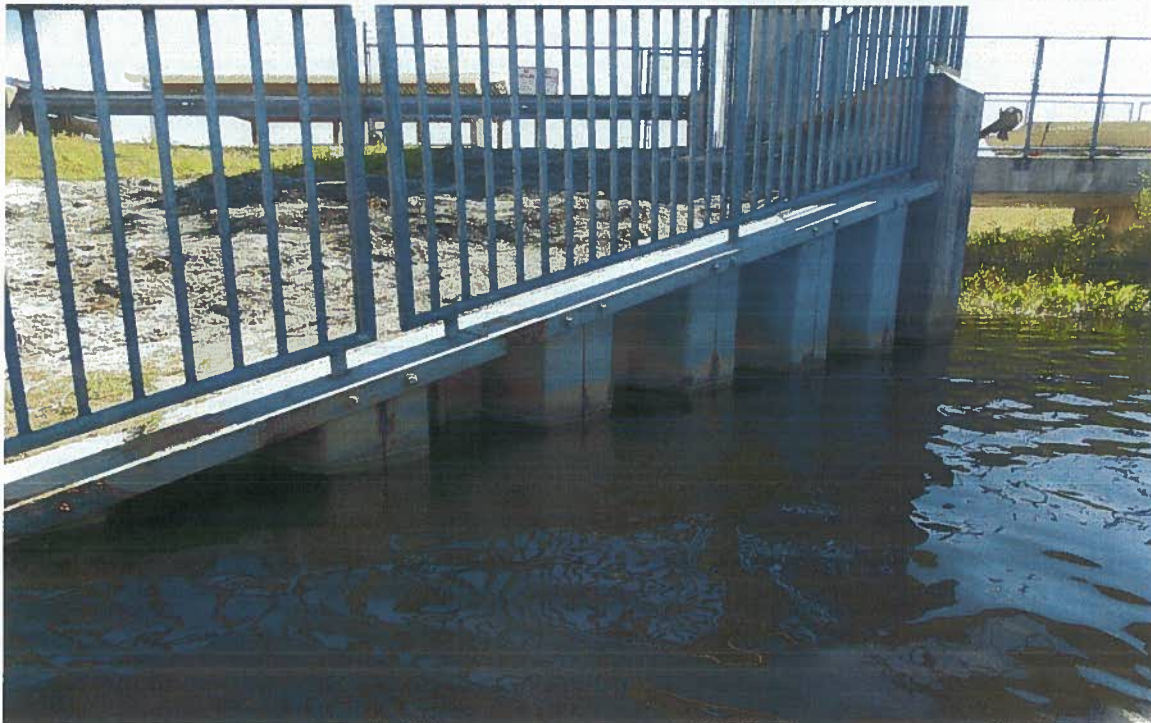
Relative to the steel sheet pile wing walls, the upstream walls appeared to be exhibiting greater than typical corrosion near the water line, especially the joints. The portions of the steel sheet pile walls that were below the water surface could not be observed relative to their condition. As stated previously, the downstream steel sheet piles were completely submerged.

**Upstream - North Steel Sheet Pile Wing Wall.**

We recommend that the corrosion be pressure washed, ground and/or sand blasted to remove the corrosion and then repaint/coat the prepared surface as needed. Depending on the severity of the corrosion that will only be evident after the corrosion is removed, joint reinforcement (i.e. welded metal plating) may be required.

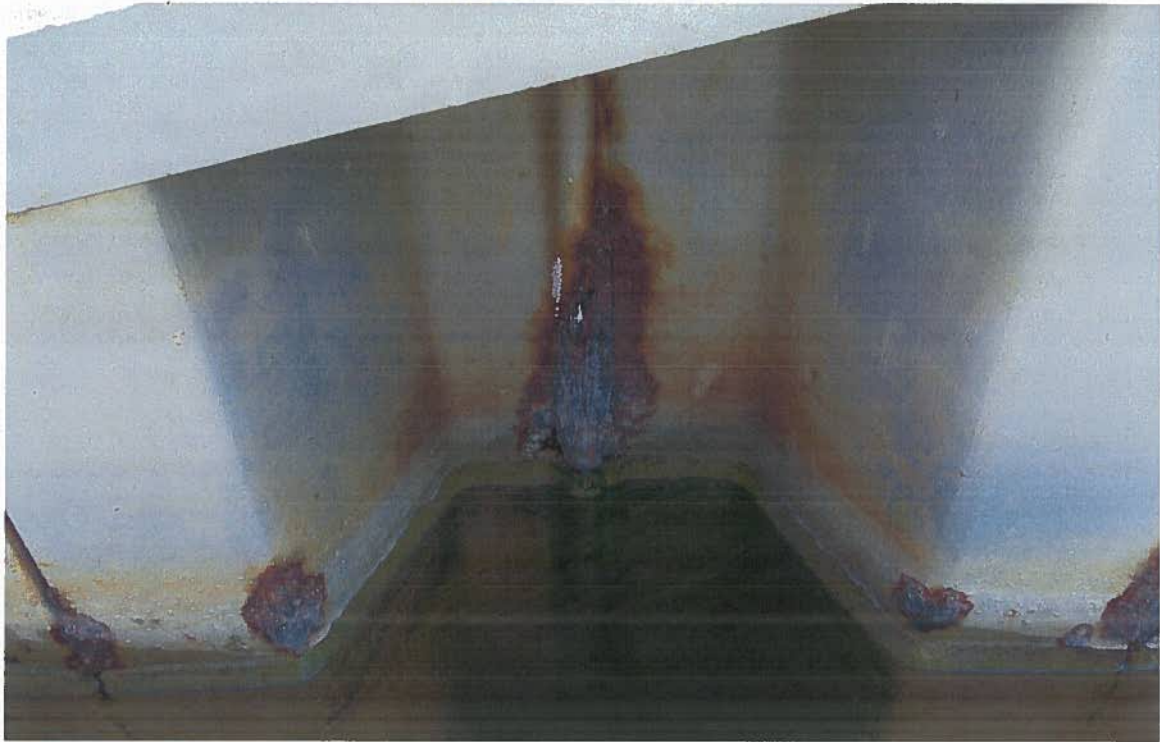
The upstream steel sheet pile wing walls are in a somewhat degraded condition considering the observed corrosion at or near the water line. Remediation of the walls is recommended. The downstream sheet pile walls could not be evaluated because they were submerged.

**Upstream - North Steel Sheet Pile Wall. Note Joint Corrosion.**

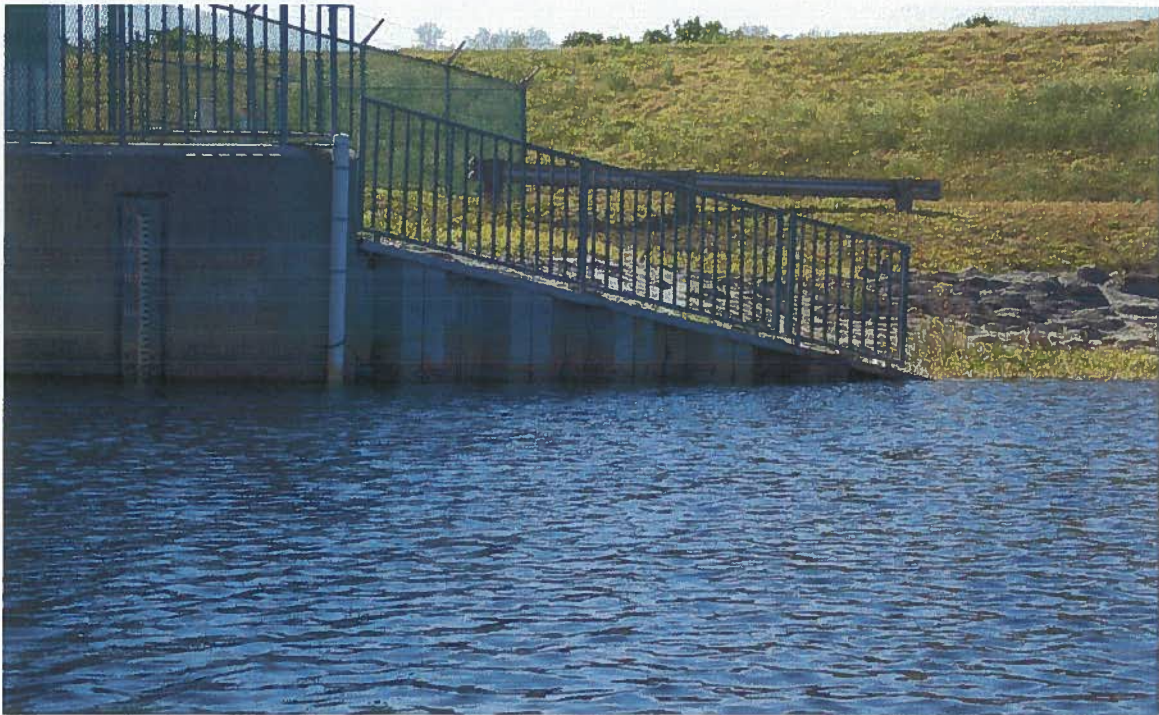
**Upstream - South Steel Sheet Pile Wing Wall.**

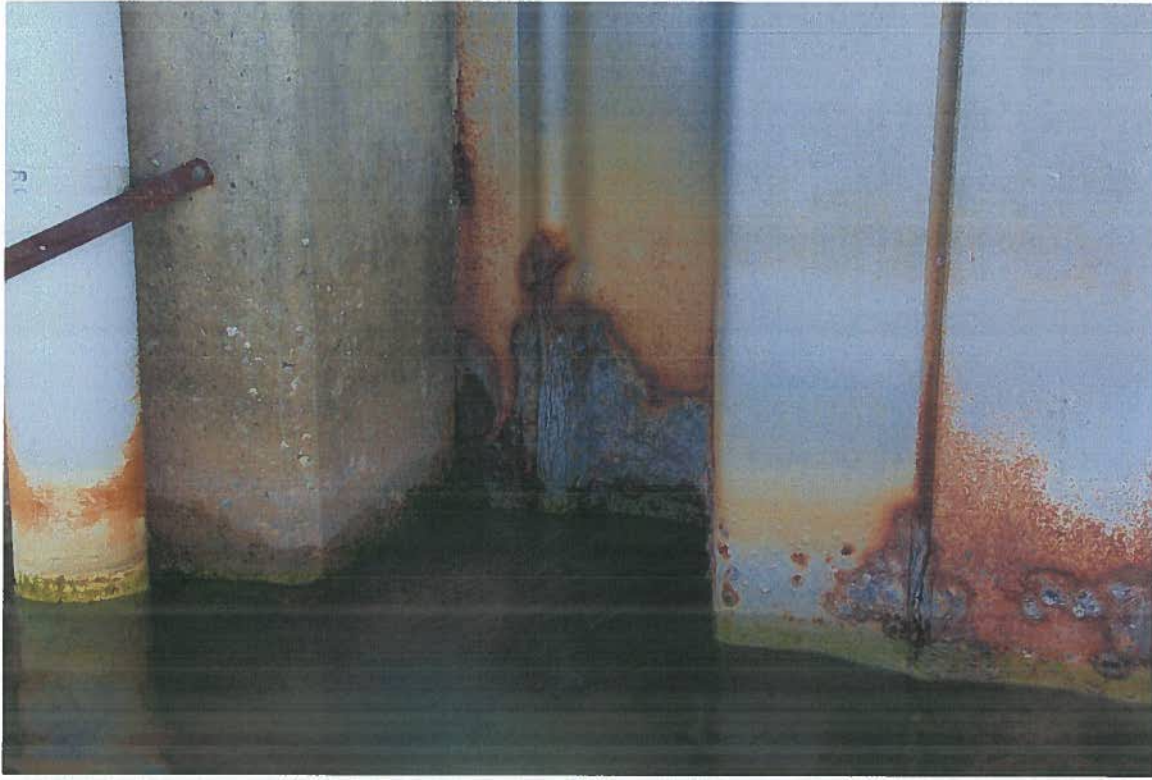
**Upstream - South Wing Wall.**
