Aultman Project 2020 – City of Canton, Ohio

Exhibit "A"		Aultman Project 2020			
Address	Sq. Footage	Garage	Testing		
619 Arlington Ave SW	1308.00	N/A	See Report		
621 Arlington Ave SW	1751.00	Double	See Report		
627 Arlington Ave SW	1488.00	Double	See Report		
631 Arlington Ave SW	1564.00	Double	See Report		
Parcel #224158	N/A	N/A	N/A		
639 Arlington Ave SW	1456.00	Quad	See Report		
643 Arlington Ave SW	1344.00	N/A	See Report		
647 Arlington Ave SW	1398.00	Single	See Report

ASBESTOS MATERIAL SURVEY

631 Arlington Avenue SW
Canton, Ohio 44706

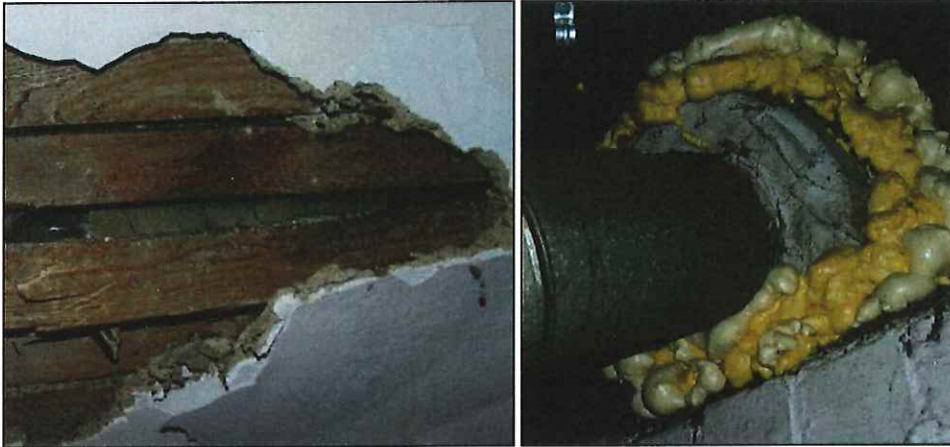
(Below) Asbestos-containing duct wrap (DWR1) on metal heating duct at ceiling in basement and behind 1st and 2nd floor plaster (PL1) walls and ceilings to 2nd floor heating ducts.

The Environmental Protection Agency (EPA) National Emission Standards for Hazardous Air Pollutants (NESHAP) requires that Regulated Asbestos Containing Material (RACM) that will be disturbed during demolition be removed. RACM is defined as; (a) friable ACM; (b) category I non-friable ACM that has become friable; (c) category I non-friable ACM that will be or has been subjected to sanding, grinding cutting or abrading; or (d) category II non-friable ACM that has a high probability of becoming or has become crumbled, pulverized, or reduced to powder by forces expected to act on the material in the course of demolition or renovation operation.

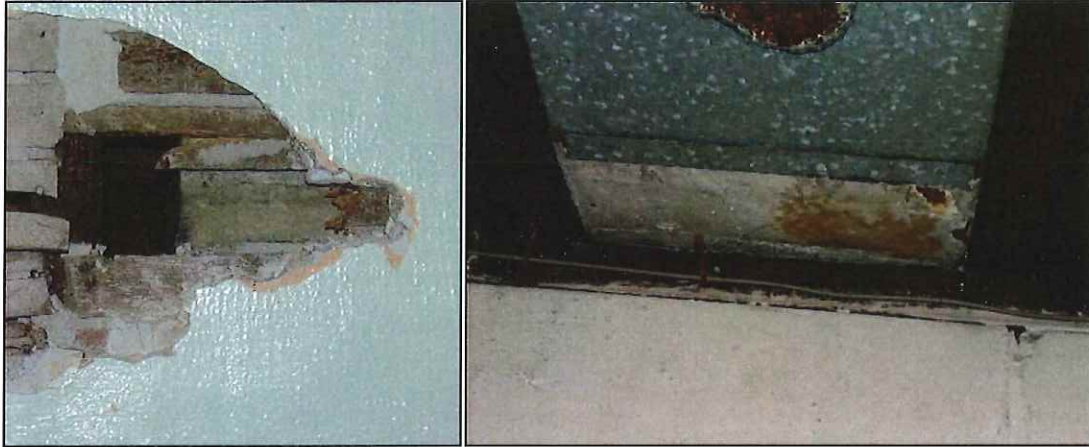
(Below) Asbestos-containing duct wrap (DWR1) on metal heating duct at ceiling in basement and behind 1st and 2nd floor plaster (PL1) walls and ceilings to 2nd floor heating ducts.

The Environmental Protection Agency (EPA) National Emission Standards for Hazardous Air Pollutants (NESHAP) requires that Regulated Asbestos Containing Material (RACM) that will be disturbed during demolition be removed. RACM is defined as; (a) friable ACM; (b) category I non-friable ACM that has become friable; (c) category I non-friable ACM that will be or has been subjected to sanding, grinding cutting or abrading; or (d) category II non-friable ACM that has a high probability of becoming or has become crumbled, pulverized, or reduced to powder by forces expected to act on the material in the course of demolition or renovation operation.

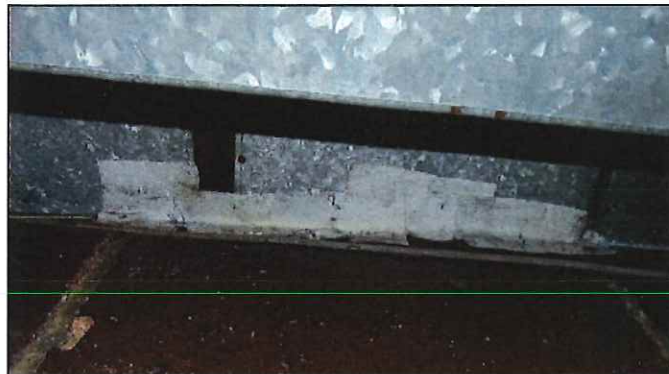
(Right) Asbestos-containing duct tape (DT1) on metal duct seam at ceiling in basement.

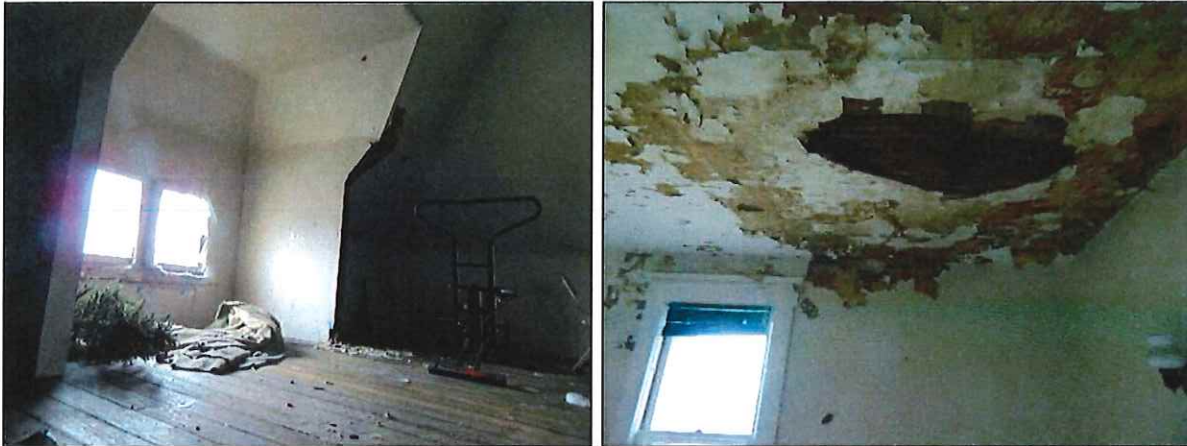
(Below) Asbestos-containing plaster (PL1) walls and ceiling on wood lath at 1st through 3rd floor walls and ceiling.

The Environmental Protection Agency (EPA) National Emission Standards for Hazardous Air Pollutants (NESHAP) requires that Regulated Asbestos Containing Material (RACM) that will be disturbed during demolition be removed. RACM is defined as; (a) friable ACM; (b) category I non-friable ACM that has become friable; (c) category I non-friable ACM that will be or has been subjected to sanding, grinding cutting or abrading; or (d) category II non-friable ACM that has a high probability of becoming or has become crumbled, pulverized, or reduced to powder by forces expected to act on the material in the course of demolition or renovation operation.

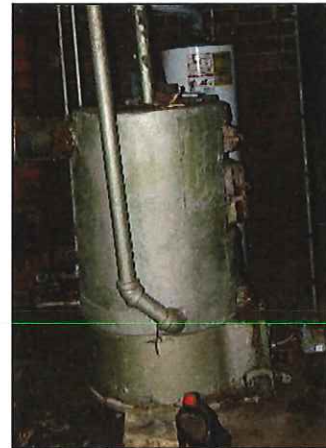
(Right) Asbestos-containing boiler insulation (BI1) on exterior of boiler in basement.

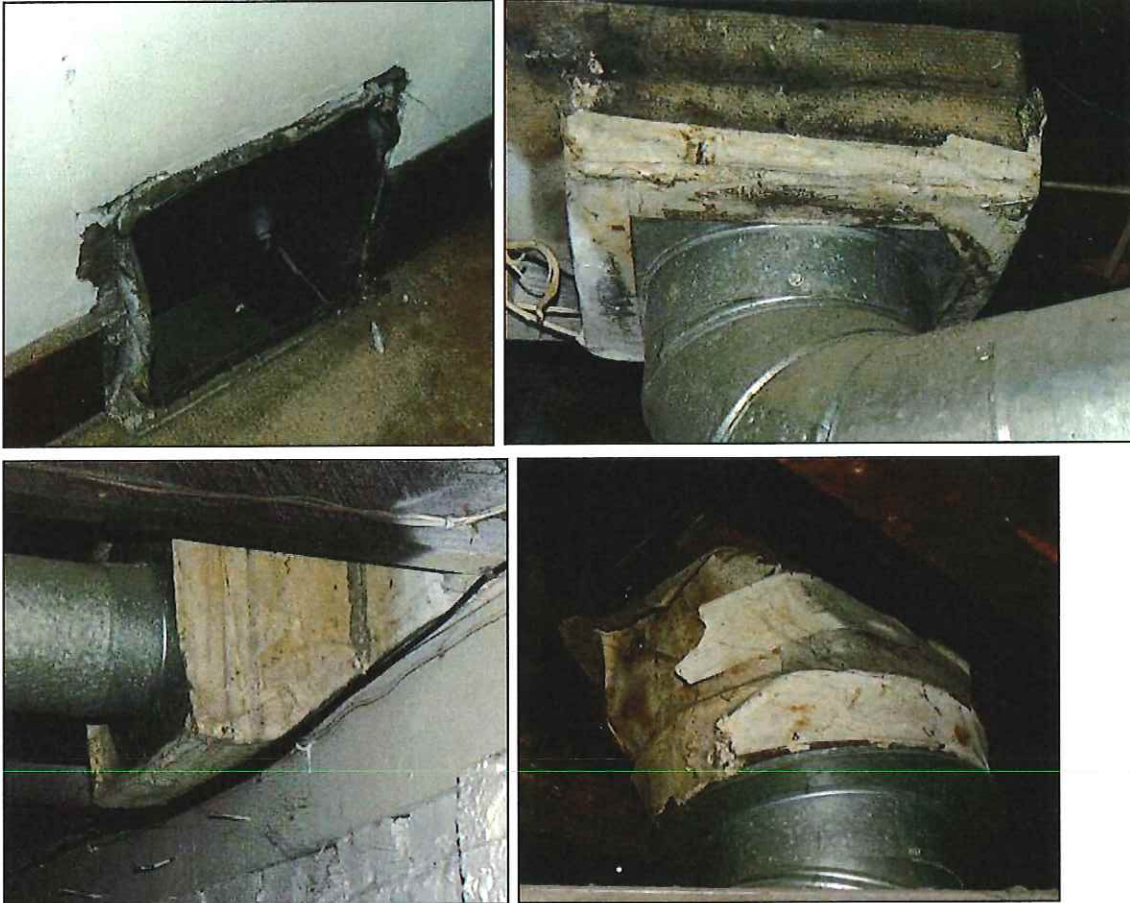
(Below) Asbestos-containing duct wrap (DWR1) on metal heating duct boots at ceiling in basement and behind 1st and 2nd floor plaster (PL1) walls and ceilings to 2nd floor heating ducts.

The Environmental Protection Agency (EPA) National Emission Standards for Hazardous Air Pollutants (NESHAP) requires that Regulated Asbestos Containing Material (RACM) that will be disturbed during demolition be removed. RACM is defined as; (a) friable ACM; (b) category I non-friable ACM that has become friable; (c) category I non-friable ACM that will be or has been subjected to sanding, grinding cutting or abrading; or (d) category II non-friable ACM that has a high probability of becoming or has become crumbled, pulverized, or reduced to powder by forces expected to act on the material in the course of demolition or renovation operation.

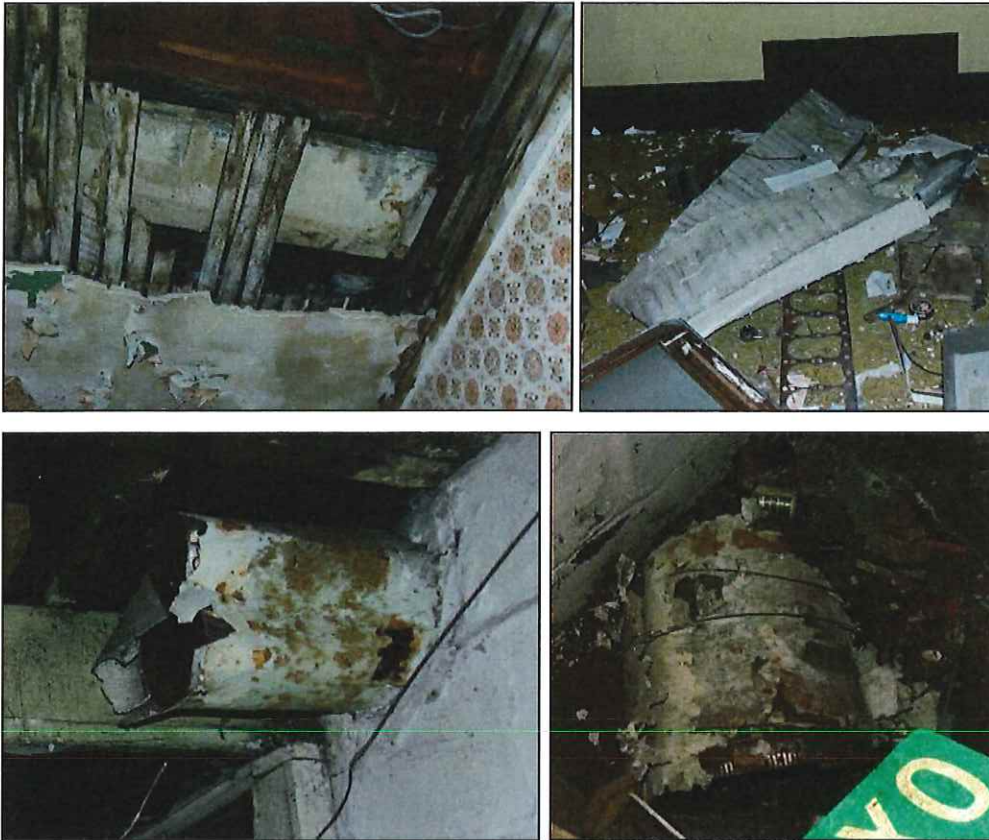
(Below) Asbestos-containing duct wrap (DWR1) on metal heating ducts in basement and behind 1st and 2nd floor plaster (PL1) walls and ceilings to 2nd and 3rd floor heating ducts. One section of duct on 1st floor has been removed and is on the ground. Also on ground as debris in basement

The Environmental Protection Agency (EPA) National Emission Standards for Hazardous Air Pollutants (NESHAP) requires that Regulated Asbestos Containing Material (RACM) that will be disturbed during demolition be removed. RACM is defined as; (a) friable ACM; (b) category I non-friable ACM that has become friable; (c) category I non-friable ACM that will be or has been subjected to sanding, grinding cutting or abrading; or (d) category II non-friable ACM that has a high probability of becoming or has become crumbled, pulverized, or reduced to powder by forces expected to act on the material in the course of demolition or renovation operation.

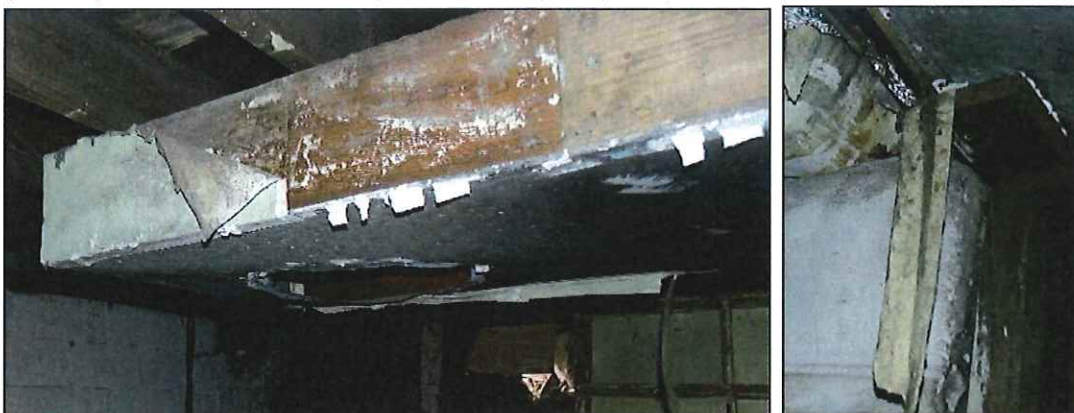
(Below) Asbestos-containing duct tape (DT1) on duct seams in basement.

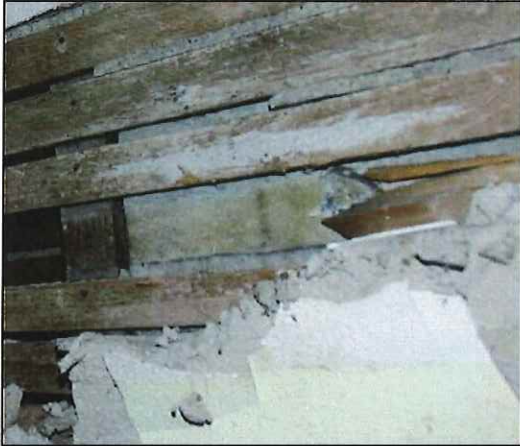
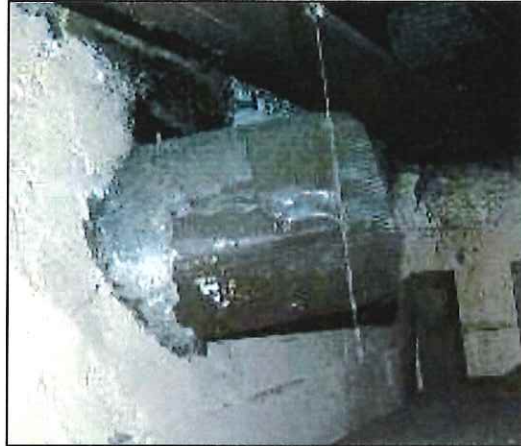
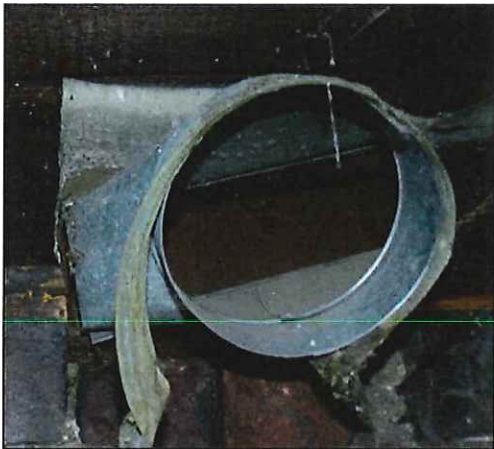
(Below) Asbestos-containing duct wrap (DWR1) on metal heating ducts in basement and behind 1st floor plaster (PL1) walls and ceilings to 2nd floor heating ducts.

The Environmental Protection Agency (EPA) National Emission Standards for Hazardous Air Pollutants (NESHAP) requires that Regulated Asbestos Containing Material (RACM) that will be disturbed during demolition be removed. RACM is defined as; (a) friable ACM; (b) category I non-friable ACM that has become friable; (c) category I non-friable ACM that will be or has been subjected to sanding, grinding cutting or abrading; or (d) category II non-friable ACM that has a high probability of becoming or has become crumbled, pulverized, or reduced to powder by forces expected to act on the material in the course of demolition or renovation operation.

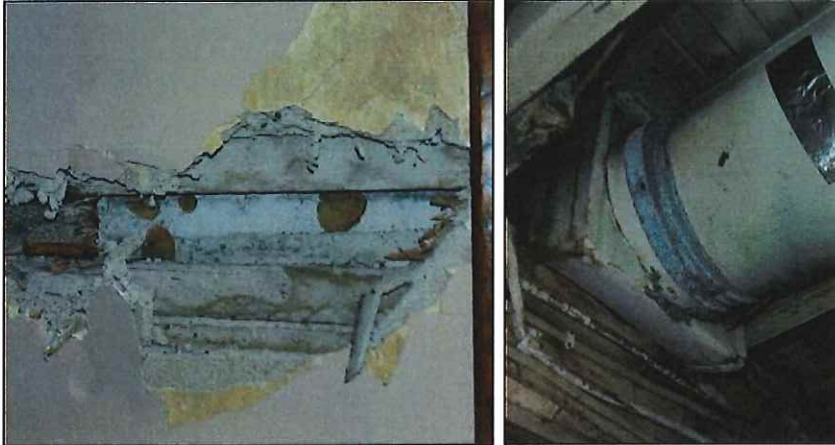
(Below) Asbestos-containing duct wrap (DWR1) on metal heating duct at ceiling in basement and behind 1st and 2nd floor plaster (PL1) walls and ceilings to 2nd floor heating ducts.

The Environmental Protection Agency (EPA) National Emission Standards for Hazardous Air Pollutants (NESHAP) requires that Regulated Asbestos Containing Material (RACM) that will be disturbed during demolition be removed. RACM is defined as; (a) friable ACM; (b) category I non-friable ACM that has become friable; (c) category I non-friable ACM that will be or has been subjected to sanding, grinding cutting or abrading; or (d) category II non-friable ACM that has a high probability of becoming or has become crumbled, pulverized, or reduced to powder by forces expected to act on the material in the course of demolition or renovation operation.

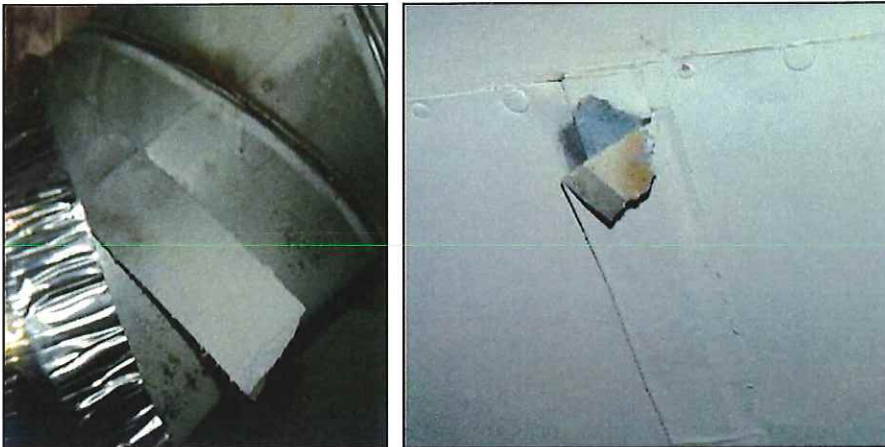
(Below) Asbestos-containing duct tape (DT1) on seams of metal heating duct at ceiling in basement
