COA AVIATION CAMPUS

Project Priorities

Existing Conditions, Program, Equipment

2019 07 10

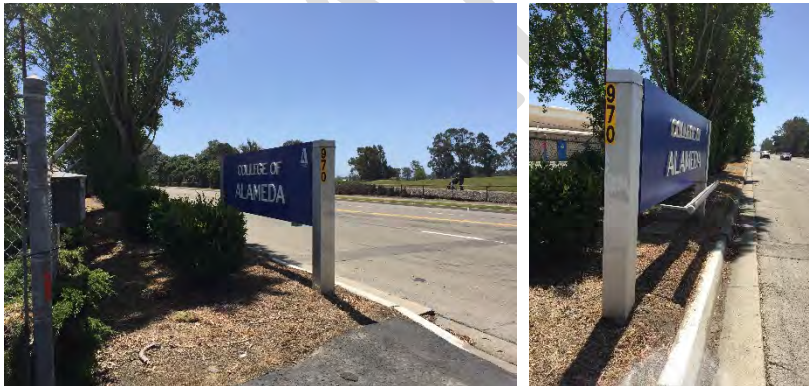
Existing District-standard campus entry sign has a light fixture but there is no site electrical available to connect.

College of Alameda sign at campus entry, no electrical connection for sign light

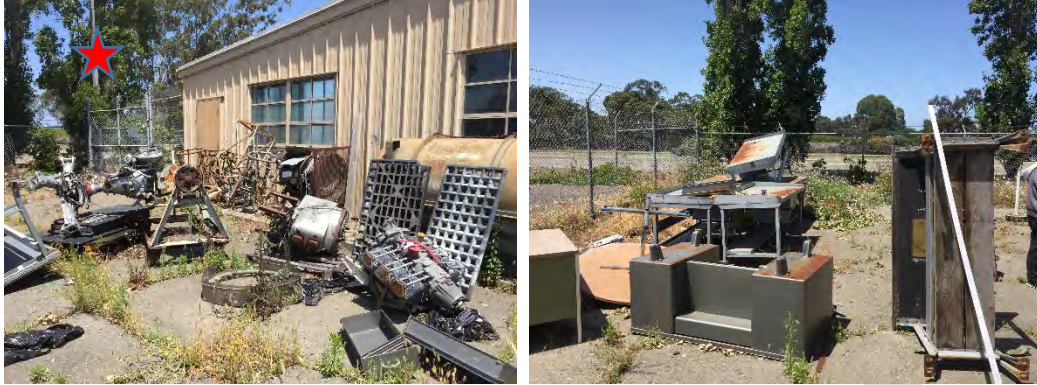
Misc discarded items stored near Hangar A

★ This site light does not function. The ground is also uneven near the pole due to tree roots.

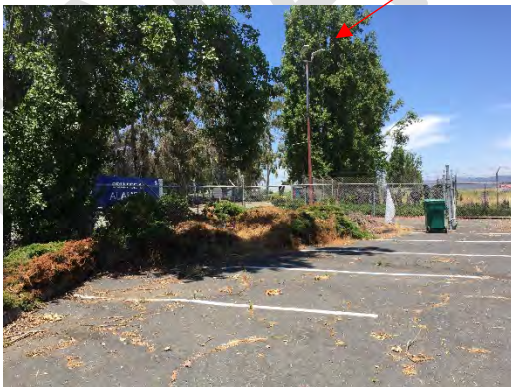
Light Pole at campus entry

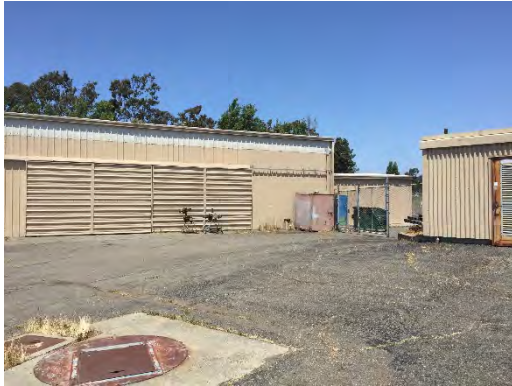
- **Site Drainage:** Both faculty and engineers report significant water intrusion to the interior of both Hangars on the side of each building containing the hangar doors (see also Building

Components, below). The paved yard suffers occasionally from ponding. The current drain system collects the water in a hole and then pumps it out to the street (see also Utilities, below). Weeds grow in the many cracks.

Paved yard, sump pump/lift station access cover

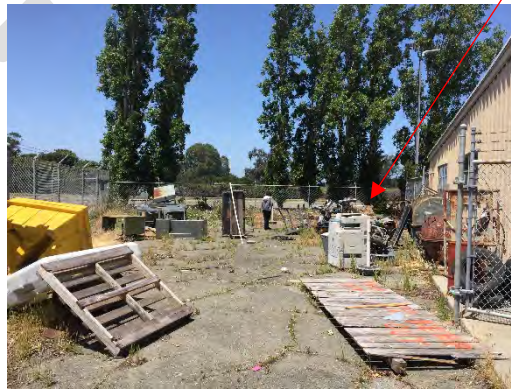
Theft is a significant problem. Per EC, the program files an average of two police reports per year. In addition to small tool theft, there was an incident in which thieves cut through the chain link facing Harbor Bay Parkway and stole an entire engine. A calibrated wrench costs about \$1000 – the program used to have 20, now has 6. “If we purchased a power washer, it would be gone within a week.” Fake cameras currently being used as a deterrent. Staff would like to be able to monitor all doors.

Engine theft access point at main road

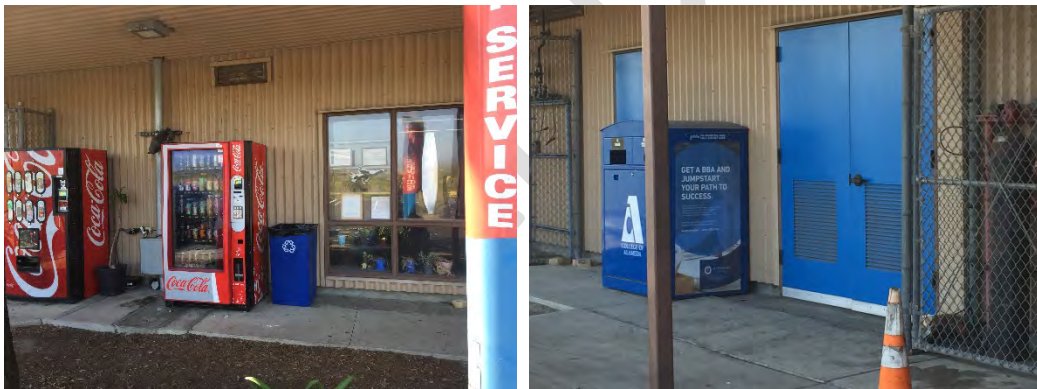
Vending near front door Cylinder supply, utility room access, recycling near front door

The cylinder supply system near the front door is abandoned and can be demolished.

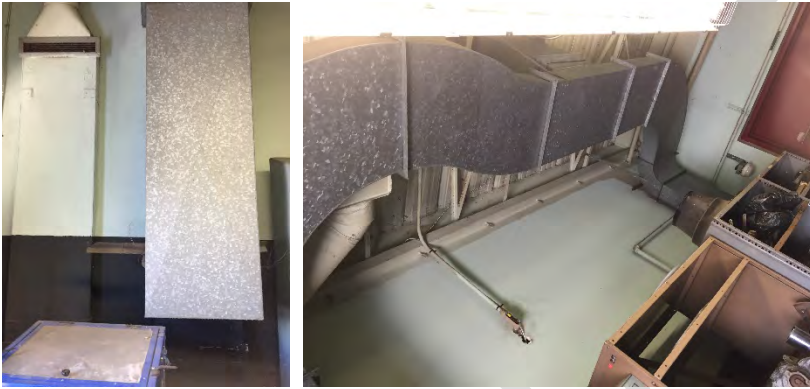
- **Corrosion Room:** per the FAA, must be a separate room. This area currently includes solvent tank and sand blasting equipment. Needs air quality improvement (filtration?). The corrosion room was created in Hangar A in 2018.

Ventilation and ductwork at corrosion room

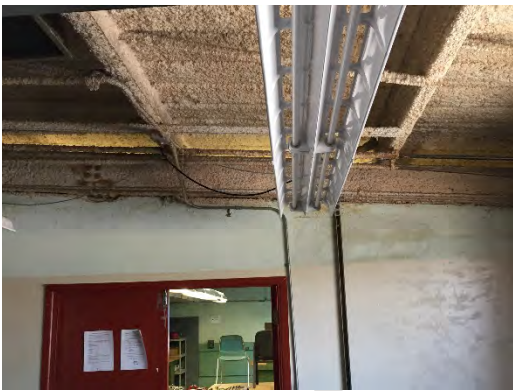
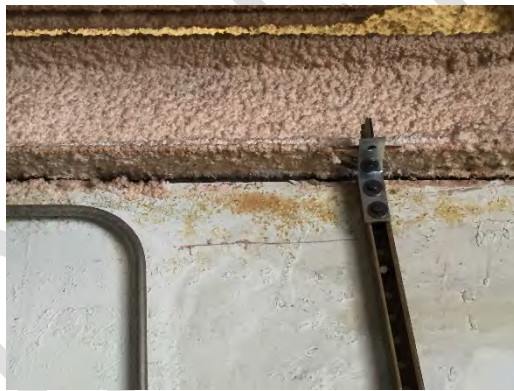
Structural reinforcement at informal partition between general classroom and Electrical Shop

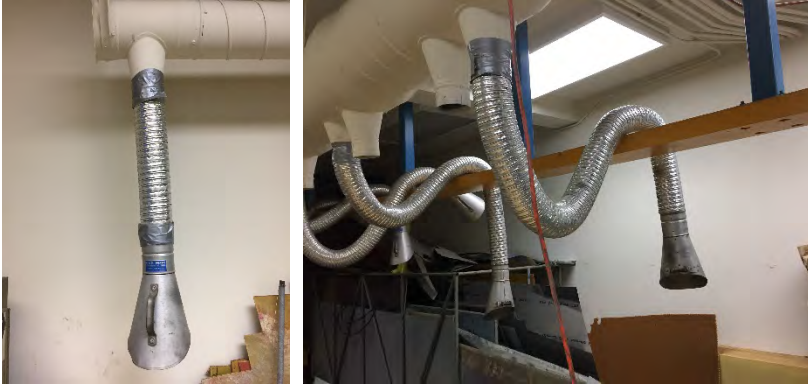
- **Composites Shop:** the AMT curriculum involves a lot of fiberglass work. The existing suction system was fabricated in-house. This space needs at least 15 snorkels, total. Ideally, the filtration system would be a built-in air filtration system, such as the one used by the AMT program at Solano CCD. Filtration system for this area is on the AEDA project equipment list but might need to be reclassified as building HVAC. The Composites Shop is in Hangar B.

House-made suction heads (snorkel) in Composites Lab.

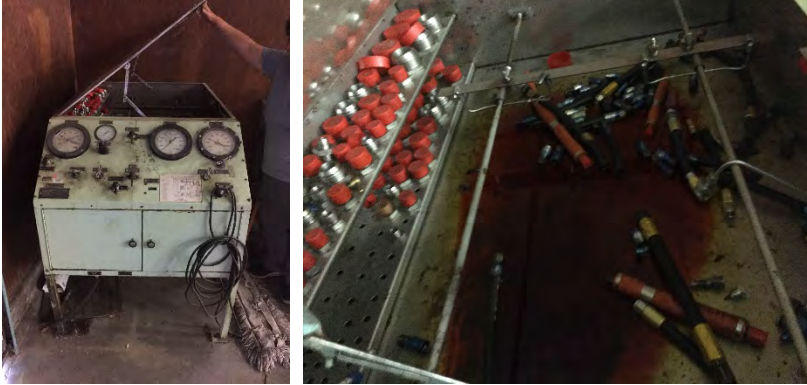
Equipment for testing psi for hydraulic lines fabricated as part of curriculum. Existing one doesn't work, is very old (per EC, from the 1950's), and parts are not available.

Existing hydraulic test stand, abandoned, exterior and interior

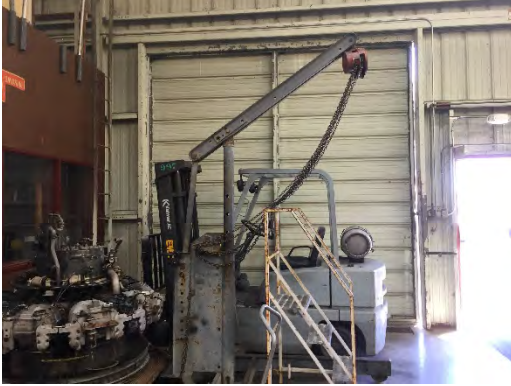
Existing method is to use a combination of portable hoist and forklift. This system should be replaced with an overhead hoist capable of lifting the largest loads.

Portable hoist, Hangar A Engine Area

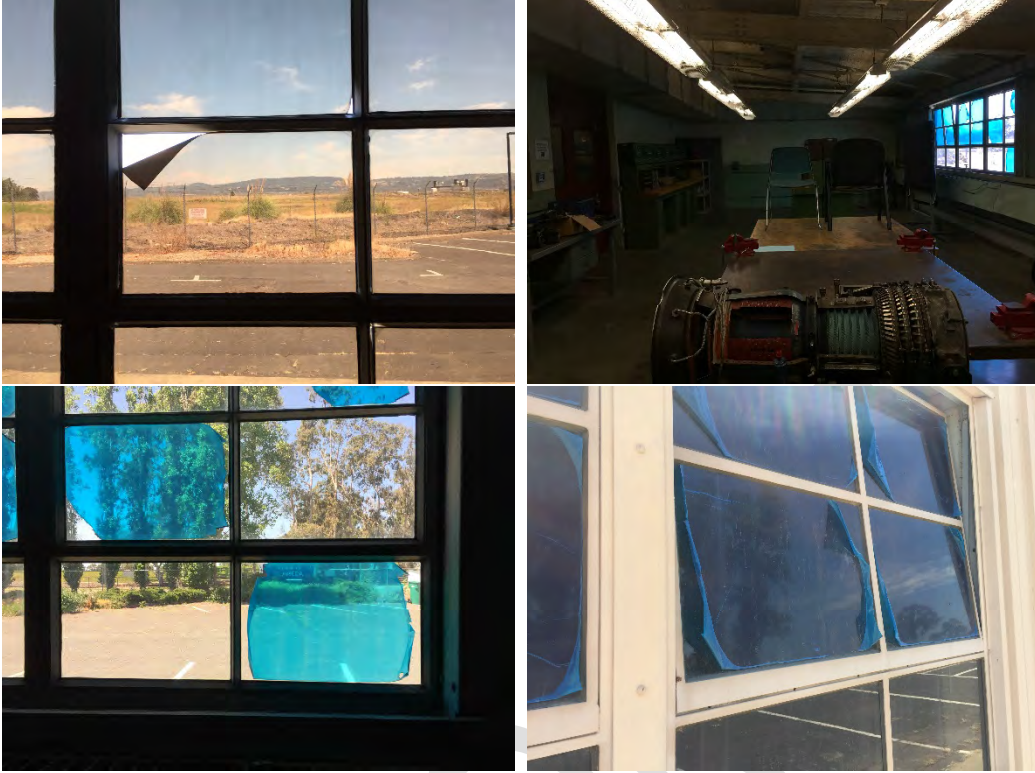
Glare is an issue at classrooms and shops at Hangar A. Classrooms and shops in Hangar B generally lack any windows.

Glare control at Hangar A general classroom, views from interior and exterior

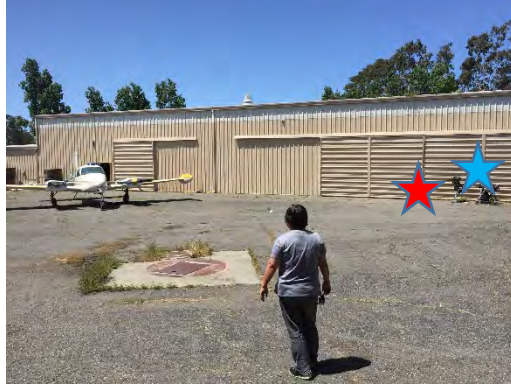
Two sets of hangar doors in Hangar A – one has not been functional in a very long time (“never” per one of the engineers). Carburetor and electrical work stations are relatively stationary. Engines get moved in and out but the hangar door adjacent to the Engine area does not get used much because the closing mechanism is unreliable. Most movable items (engines, sometimes also airplanes) go through the door on the propeller side because the door is in better condition. Hangar A might only need one hangar door but reliable functionality is essential.

Hangar Doors, Hangar A

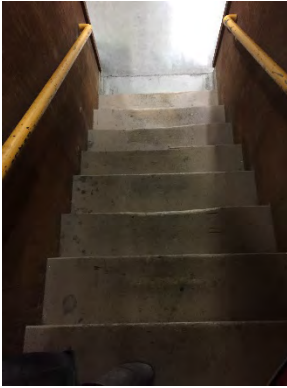
Access to the Hangar B mezzanine is a worn, wooden stair. (AEDA project intends to install an elevator).

Worn wood stair is sole indoor access to mezzanine

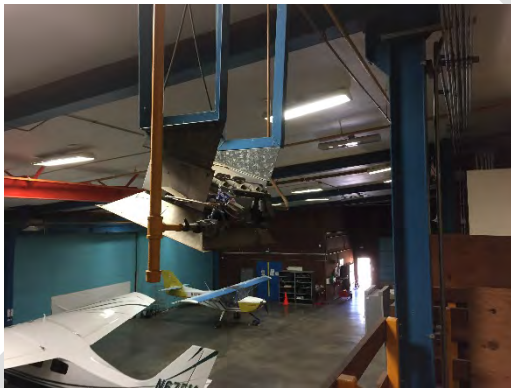
The existing space heaters are fired by natural gas but the vent pipes do not have an induced draft motor, which yields a carbon monoxide hazard. Existing heaters also emit sparks. Per the assistant chief engineer, the high bay space in Hangar B needs new space heater(s).

Overhead heating unit, Hangar B

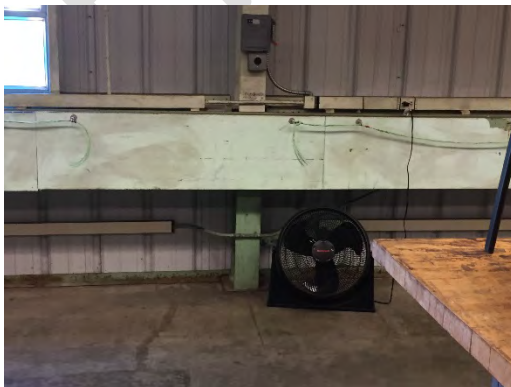
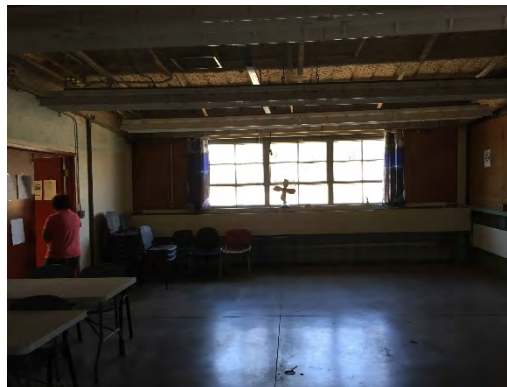
Heater and fan, general classroom, Hangar A Fan and curtains, general classroom, Hangar A

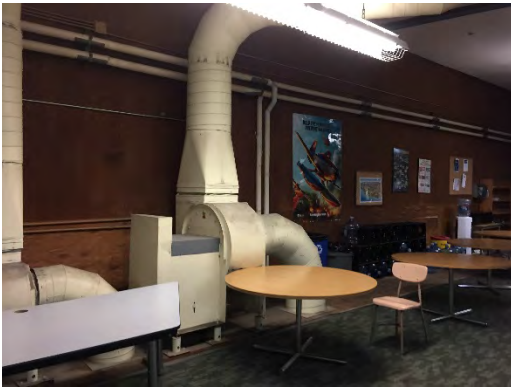
Two fans at the Hangar B mezzanine serving Rooms 102B, 103, and 104: if the program use remains the same, these need to be replaced. The motors are bad, the pulleys are bad, and they consume a huge amount of power.

HVAC at Hangar B mezzanine, over Composites Lab

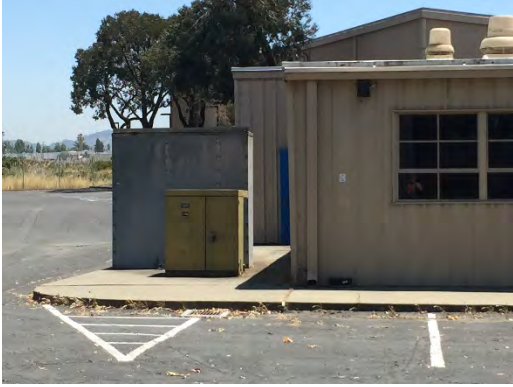
Panel breakers cannot be replaced (no longer manufactured). Main electrical room and MDP are located in the small tool room between the faculty offices at the high bay space in Hangar A. There is another MDP near the Electric Shop.

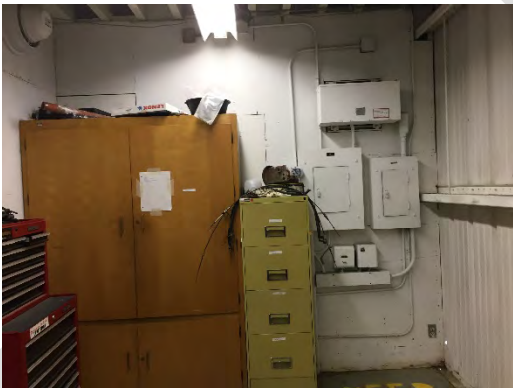
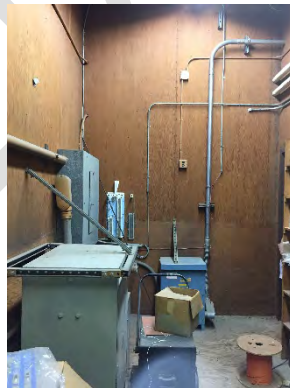
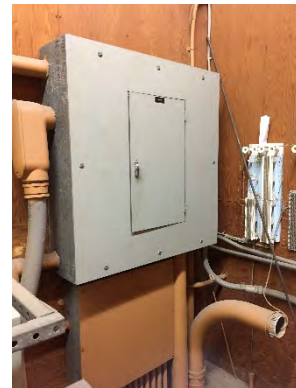
The assistant chief engineer notes that the electrical panel and transformer at the Hangar B mezzanine need to be re-indexed and perhaps refreshed and that the panels near Hangar B Room 104 are disorganized and that the panel doors are broken.

Electrical room at high bay space, Hangar A Electrical room at mezzanine, Hangar B

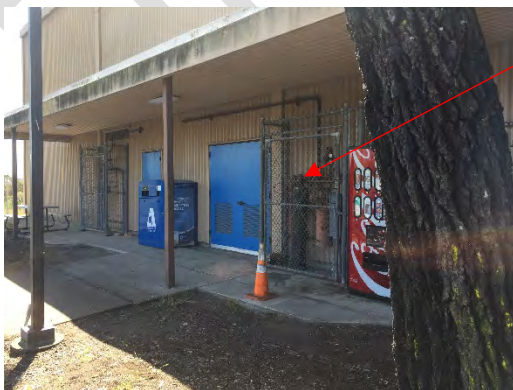
The cylinder tank supply system at the exterior of the Hangar B entry is not used and can be removed in its entirety.

Cylinder tank supply system
