# HAZARDOUS BUILDING MATERIAL SURVEY REPORT MERRITT COLLEGE - HORTICULTURE COMPLEX OAKLAND, CALIFORNIA

Peralta Community College District  
College of Alameda – Building B Demolition Project  
333 East Eight Street, Oakland, CA 94606

Terraphase Engineering Inc.  
1404 Franklin Street, Suite 600  
Oakland, California 94612

November 19, 2020

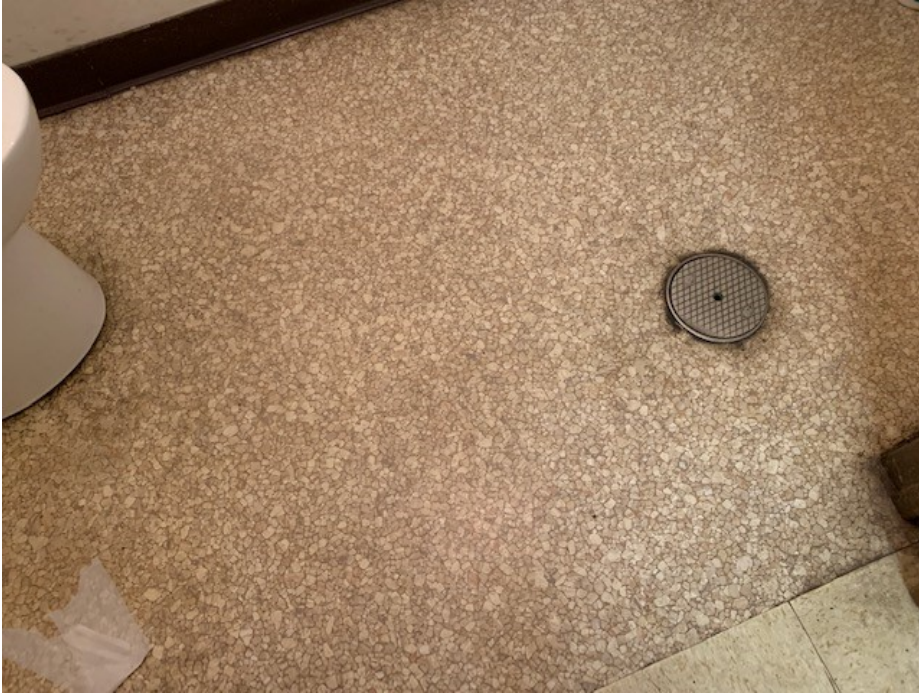
- Tan pebble pattern sheet flooring (sample numbers 1021-10 and 1021-11) located in the Headhouse office restroom was reported by the laboratory as containing 15% asbestos in the sheet flooring and less than 1% asbestos in the mastic. The sheet flooring and mastic were observed to be in good condition, encompasses approximately 20 square feet, and are classified as a RACM.

**Photograph 3:**  
View depicting asbestos-containing sheet flooring in Headhouse.

- The ACMs, LCPs, and LBPs observed to be in good condition or intact can be “managed in place” unless the materials are disturbed, repaired, or removed. Prior to demolition or renovation activities, the owner(s) of the building should retain a California-licensed abatement contractor to perform the abatement/remediation of the ACMs, LCPs, and LBPs as needed, and prior to disturbance.

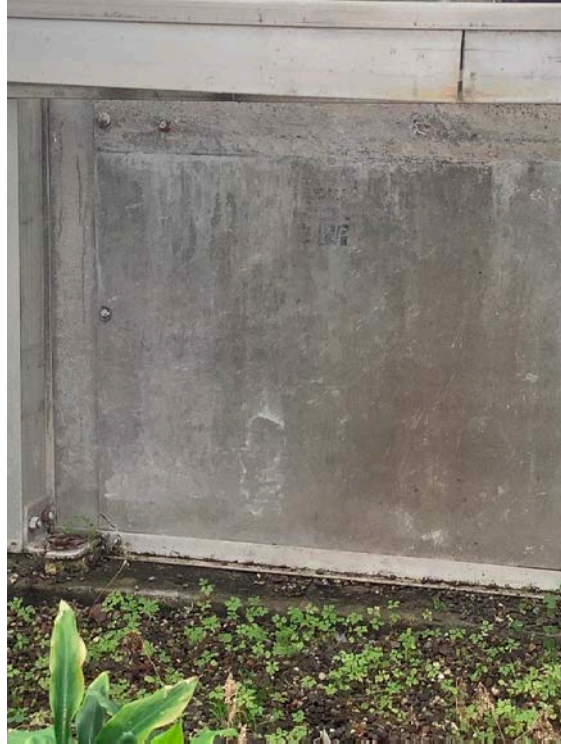
- Gray cementitious wall panels (sample numbers 1021-59 and 1021-60) located in the Greenhouse were reported by the laboratory as containing between 2% and 12% asbestos. The cementitious Transite™ panels were observed to be in good condition, encompasses approximately 550 square feet, and are classified as a Category II non-friable ACM.

**Photograph 11:**  
View depicting the interior Transite wall panels of the Greenhouse.
