Asbestos & Lead Based Paint Assessment

City of Spartanburg 748 Baltimore Street Spartanburg, South Carolina 29301

Project Number: 0118-14

September 4, 2018

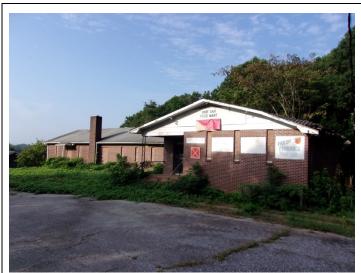
Photo 1 – 748 Baltimore Street in Spartanburg, South Carolina

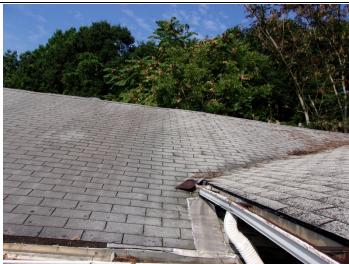
Photo 2 – Roof shingles & felt on the grocery, doctors office & apartment roofs

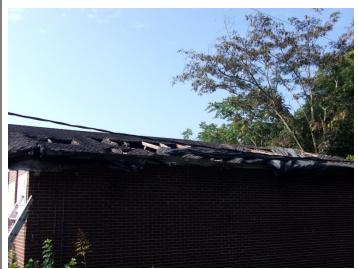
Photo 3 – Roof shingles & felt on the grocery roof

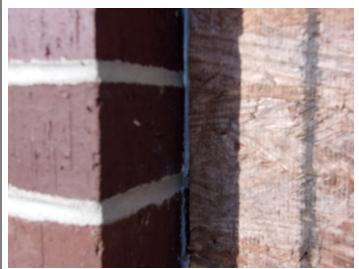
Photo 4 – Door caulk

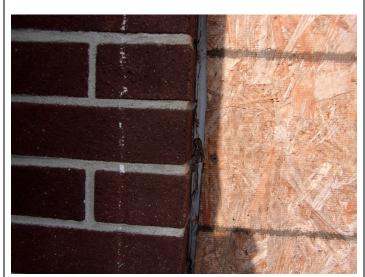
Photo 5 – Window caulk

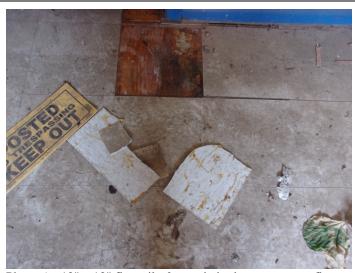
Photo 6 – 12" x 12" floor tile & mastic in the grocery top floor entrance

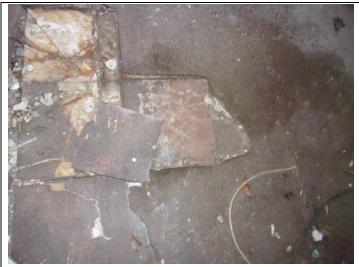
- Approximately 425 SF of brown roll vinyl floor with no mastic in the former grocery store - 1st floor.
- Approximately 50 SF of brown square roll pattern vinyl floor with no mastic in the former grocery store - bathrooms.

Photo 7 – Brown roll vinyl floor with no mastic over 12" x 12" floor tile & mastic in the grocery – top floor

- 1. Abate the asbestos containing materials in the doctor's office, apartment and basement prior to renovation or demolition.
- 2. Demolish the former grocery store with ACM in place and dispose of the waste stream as friable Regulated Asbestos Containing Materials (RACM) and delivered to an asbestos approved hazardous waste landfill for disposal.

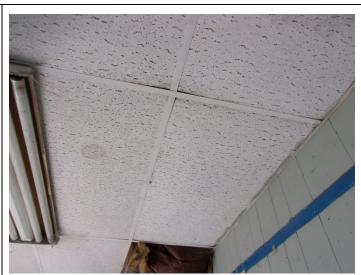
Photo 8-2' x 4' ceiling tile in the grocery section

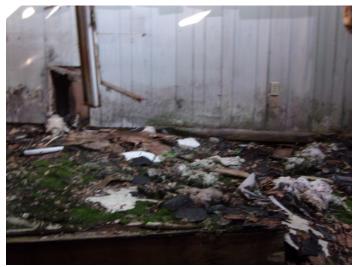
Photo 9 – Tan square pattern roll vinyl floor & mastic in the grocery top floor section on the partition floor

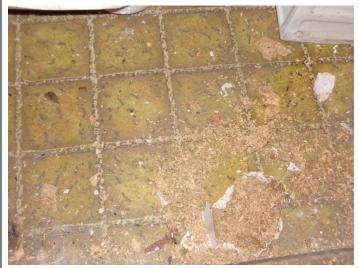
Photo 10- Brown square roll pattern vinyl floor with no mastic in the grocery section bathrooms

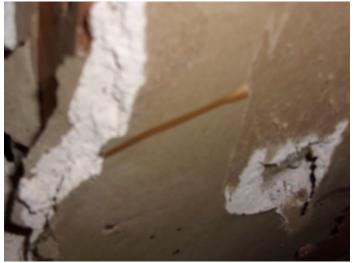
- Approximately 160 SF of brown mastic behind wall panels in the former grocery store bathrooms and kitchen.
- Approximately 2,165 SF of 12" x 12" tan floor tile & black mastic in the basement.

Photo 11 – Brown mastic behind wall panels in the grocery section bathroom & kitchen

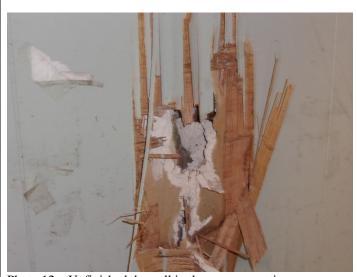
Photo 12 – Unfinished drywall in the grocery section

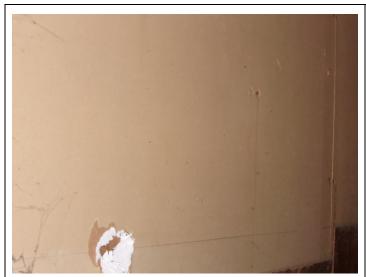
Photo 13 – Unfinished drywall in the grocery section

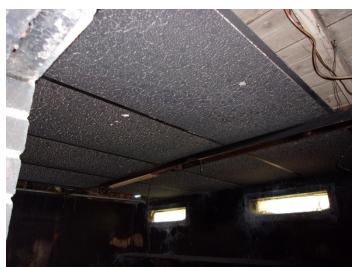
Photo 14 – 2' x 4' ceiling tile sin the basement

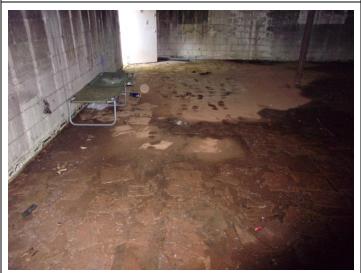
Photo 15 – 12" x 12" tan floor tile & black mastic in the basement

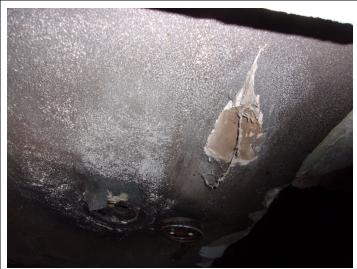
- Approximately 175 SF of drywall with joint compound & tape ceilings in the basement bathrooms.
- Approximately 960 SF of 12" x 12" tan floor tile with fiberboard & black mastic in the doctor's office right side suite bottom layer & top layer throughout.

Photo 16 - Drywall with joint compound & tape in the basement bathrooms

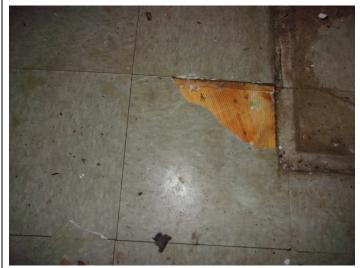
Photo 17 - 12" x 12" light green floor tile & mastic in the doctor's office - right side suite (top layer)

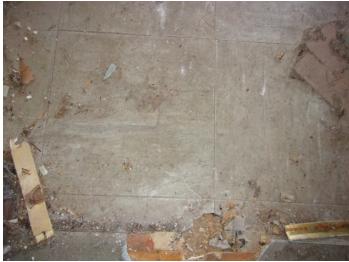
Photo 18 – 12" x 12" tan floor tile with fiberboard & black mastic in the doctor's office- right side suite (bottom layer & top layer throughout)

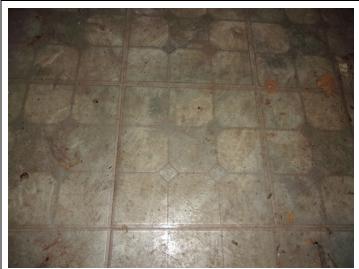
Photo 19-12"x 12" square pattern self-stick floor tile & mastic in the doctor's office - kitchen & full bathroom

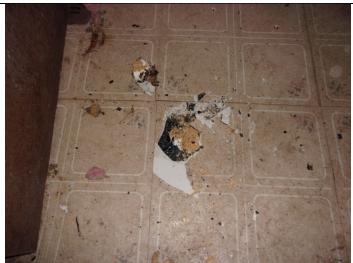
- Approximately 25 SF of the mastic associated with the 2^{nd} layer of floor tile in the doctor's office $\frac{1}{2}$ bathroom.
- Approximately 60 SF of the mastic associated with the 12" x 12" tan speckled floor tile in the doctor's office front lobby and reception area.

Photo 20 - 12" x 12" beige with flowers pattern self-stick floor tile over 2nd layer of floor tile & mastic in the doctor's office - 1/2 bathroom

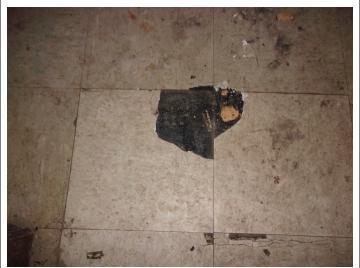
Photo 21 – 12" x 12" tan speckled floor tile & mastic in the doctor's office - front lobby & reception area

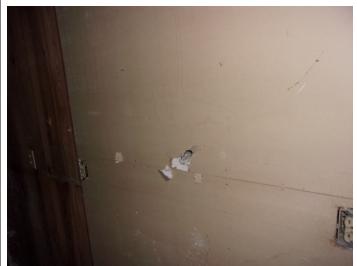
Photo 22- Unfinished drywall throughout the doctor's office

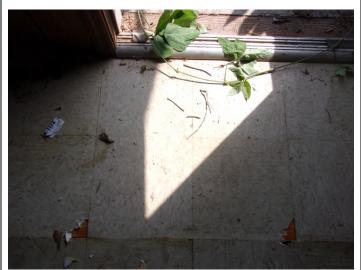
Photo 23 - 12" x 12" tan speckled floor tile & mastic in the apartment (patch)

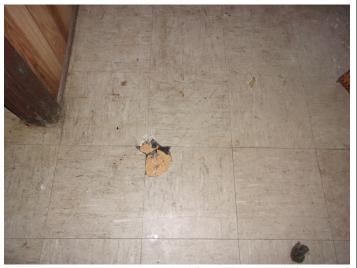
- Approximately 730 SF of 12" x 12" grey streaked floor tile & mastic in the apartment.

Photo 25 - 12" x 12" grey streaked floor tile & mastic in the apartment

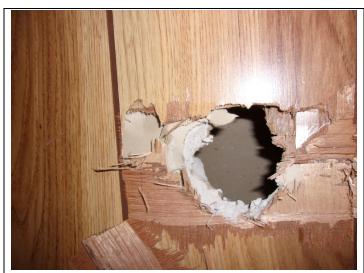
Photo 25 – Unfinished drywall under wooden wall panels in the apartment
