**Limited AHERA Asbestos
Survey**

**Brown Early Childhood
Education Center
520 W 5th St
Portales, NM 88130**

**Asbestos Consulting, LLC
March 4th, 2019**

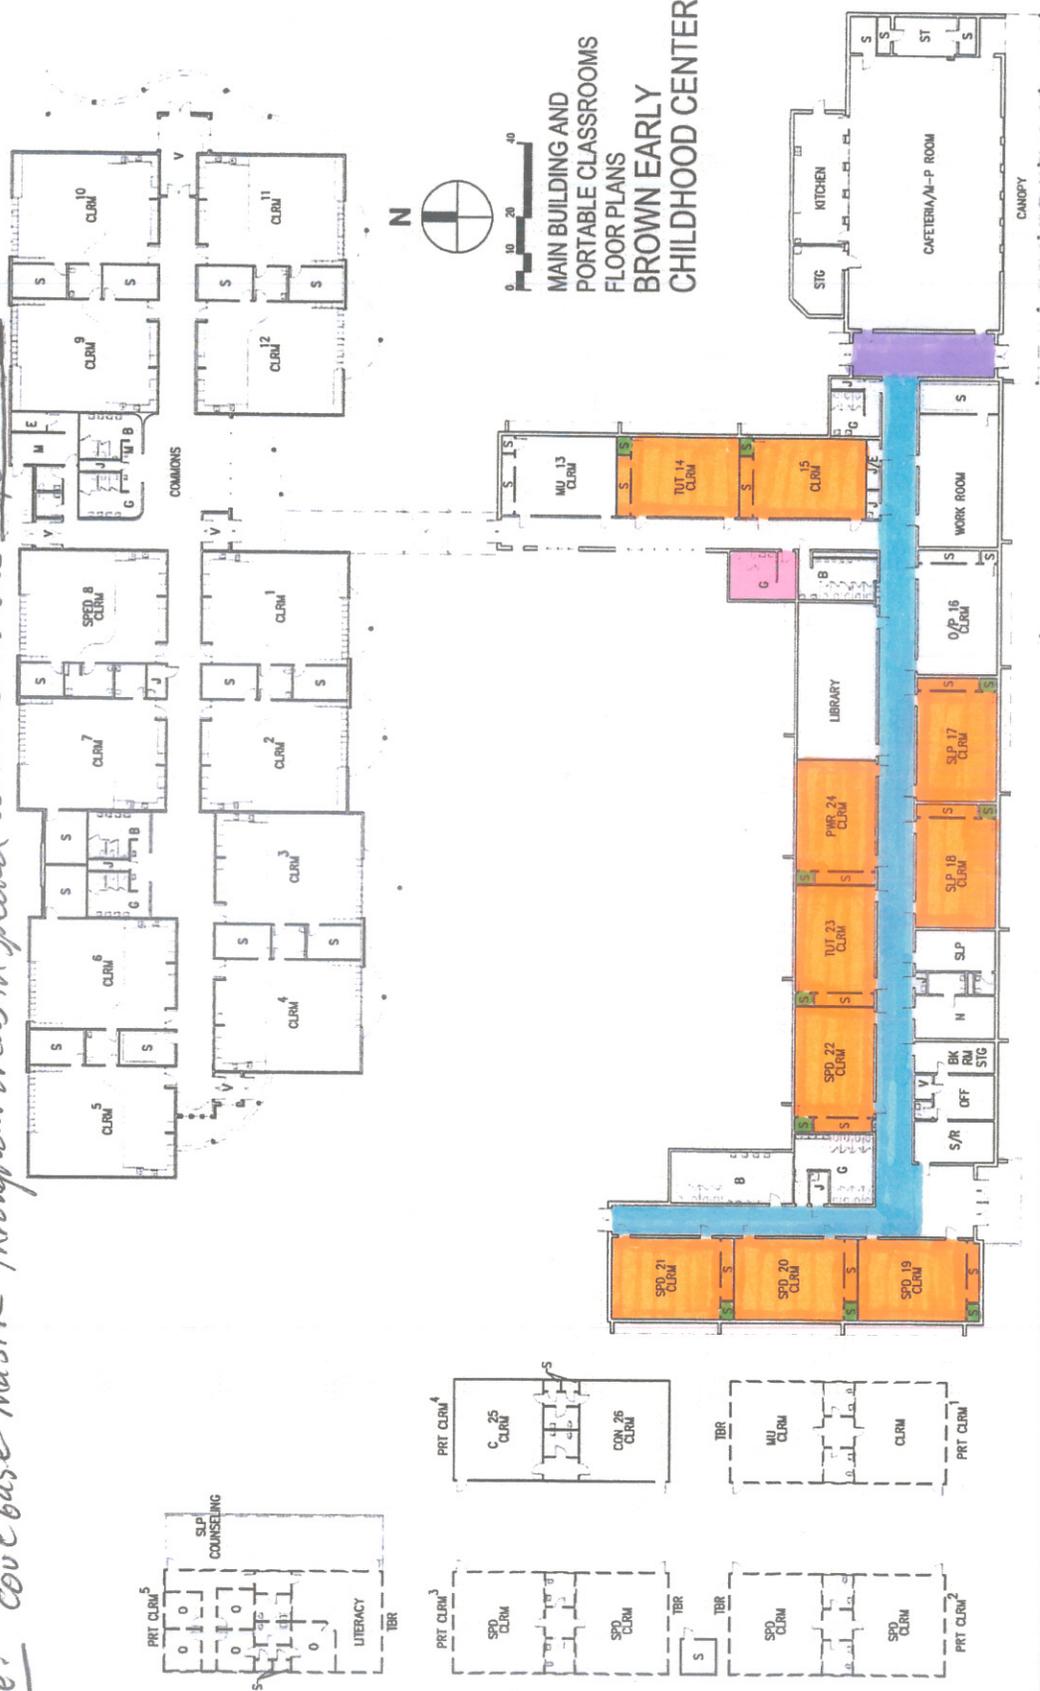
Acw Note: Cove base mastic throughout areas in speed contains asbestos 2,630 LNFt - 6'

- = Carpet and tile over asbestos containing mastic 3,885 sqft
- = 9x9 tile mastic containing asbestos 475 sqft
- = Tan 12x12 Tile mastic containing asbestos 216 sqft

- A. Before renovation can occur, all asbestos containing building materials greater than one percent, that will be impacted during renovation, must be removed by a Licensed Asbestos Contractor following all EPA, OSHA and State of New Mexico rules and recommendations due to the fact that disturbance may cause the asbestos to become regulated.
- B. If any suspect materials are encountered during renovation activities that do not show to have been tested, they should not be disturbed and should be considered asbestos containing until determined otherwise.
- C. All asbestos containing materials will have to be disposed of at an EPA/Solid Waste Asbestos certified landfill.
