JUDITH L. THOMAS  
BAY AREA PLANT CONSULTANTS  
Arboricultural Consultant, Horticultural Advisor  
83 Mission Hills Street  
Oakland CA 94605-4612  
1(510) 568-2960 (phone), 1(510) 878-2744 (fax)  
<http://bayareaplantconsultants.blogspot.com>

## SECOND MERRITT COLLEGE CHILDCARE CENTER ARBORIST REPORT

Arborist Report – Judy Thomas

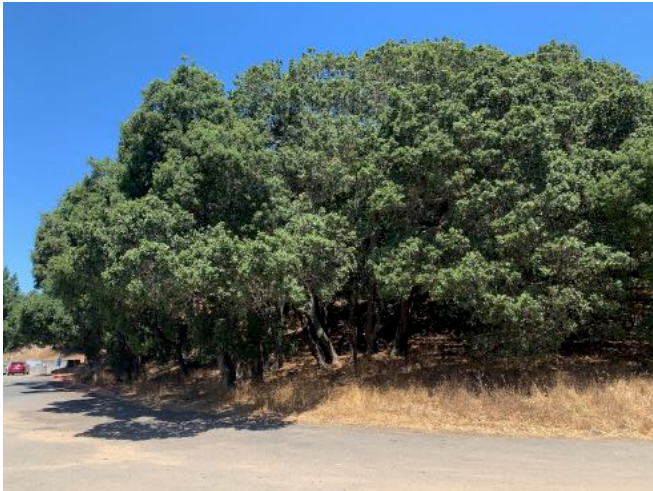
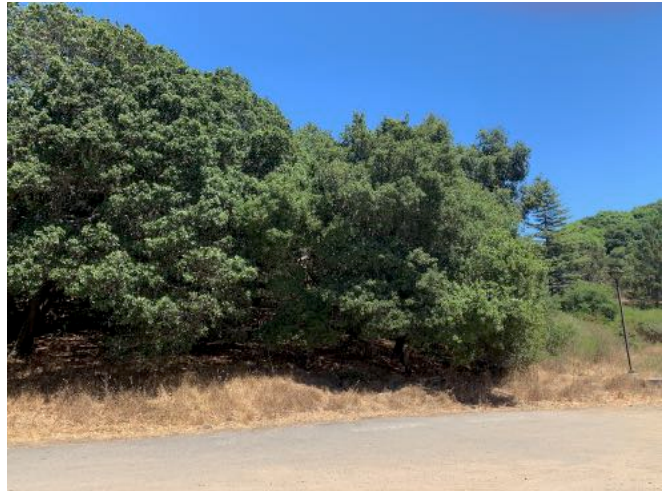
It is my opinion and conclusion that, the oak grove shown in the site plans and in images #1 and #2 in the upper portion of the site will require protection from construction activity. According to Matheny, N.P. and J.R. Clark. 1998, *Trees and Development: A Technical Guide to Tree Preservation During Land Development*, coast live oaks have a good tolerant to construction impacts but are sensitive to the addition of fill soil around the base of the trunks. They are intolerant of frequent summer irrigation, and the bark is sensitive to sunburn following pruning, if they are over-pruned. Images #3 and #4 shown that the ground beneath these trees slopes down to the existing parking lot.

Images #1 and #2 are of the oak grove above the proposed Childcare Center location. Any retaining wall near these trees should be constructed using piers and grade beams. If the parking lot remains in the same location, then all that would be needed would be to fence these trees off with temporary chain link fencing during the construction process.

If a long temporary chain link fence is erected at the bottom of the slope next to the existing parking lot around the oak grove, and if construction activity doesn't extend into the oak grove, the trees should be **protected**<sup>3</sup>. Should a retaining wall be required behind the Childcare Center in that area, it can be constructed using pier and grade beams, to avoid any large roots extending out into the parking lot. In general, the area of the roots to be protected extends away from the trunks of the trees to a distance of 1-1.5' for every inch of trunk diameter on each tree. So the single fence at the edge of the parking lot should work for all of the trees.

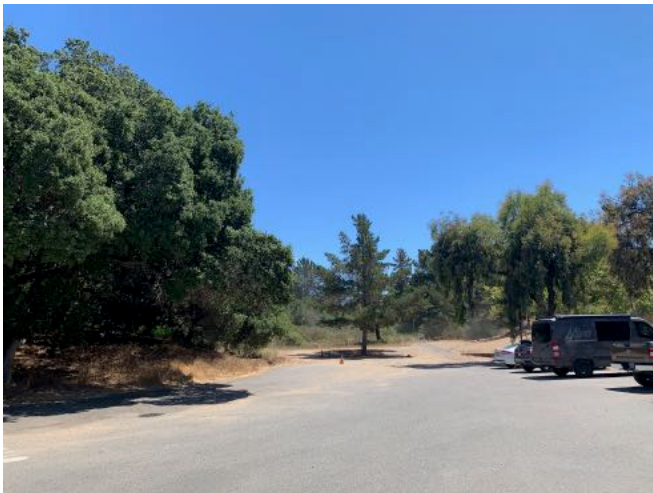
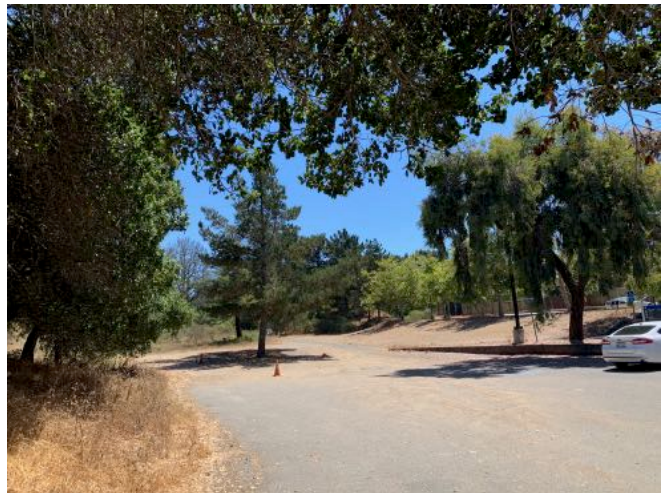
Images #3 and #4 show the oak grove on the left, and a redwood and a red ironbark eucalyptus in the middle of the construction zone - that will need to be removed.

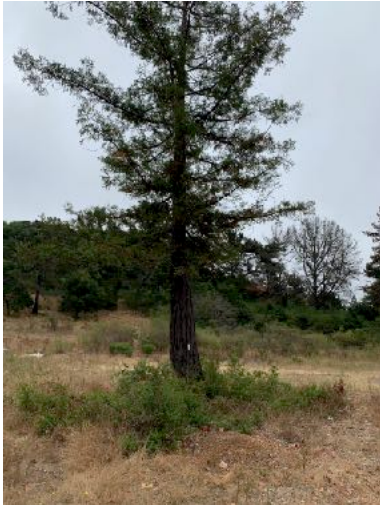
Image #5 is tree #11, the coast redwood in the middle of the proposed construction site that must be removed. It has suffered from lack of water for many years. The Monterey pines above it are on the road to the Environmental Education Center. Some of them are dead, as can be seen in image #10.

I recommend that the coast redwood #11 be removed, as it is in the middle of the construction zone. I don't recommend that it be replaced, as there are many seedling oaks in the area outside the construction zone that can replace the lost tree canopy. A permit for its removal may be required by the City of Oakland, but community colleges may be exempt from this rule.

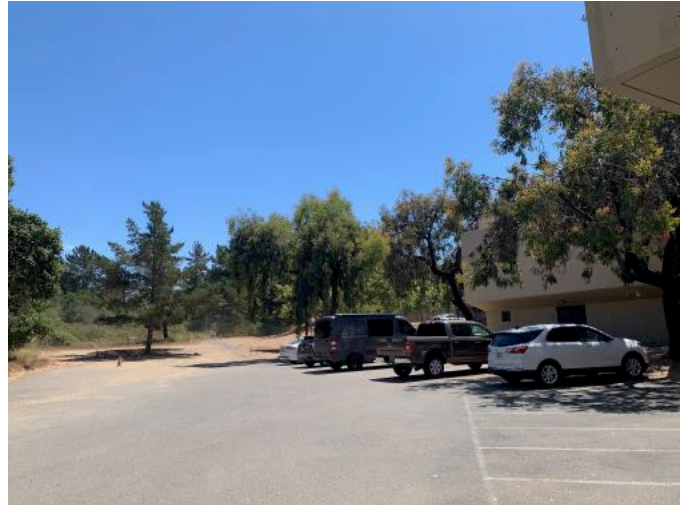
Image #6 shows the same redwood, the eucalyptus near it that needs to be removed, and two additional eucalyptus specimens next to Building F, the gym.

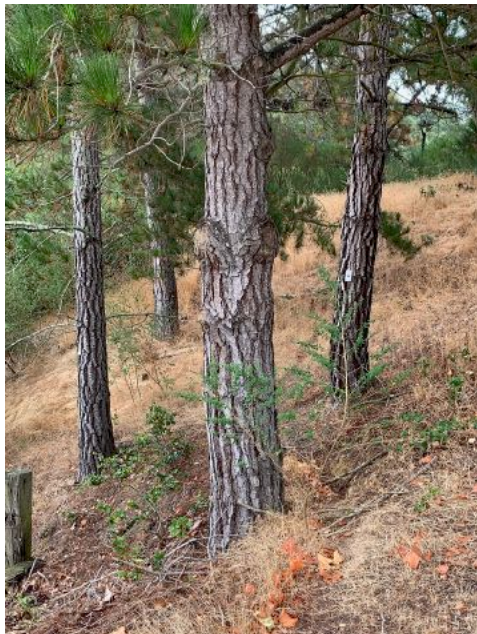
Image #7 is of tree #9, a Monterey pine and the trees surrounding it, on the slope above the road leading to the gym. These trees are to be retained, as is detailed in the chart above.

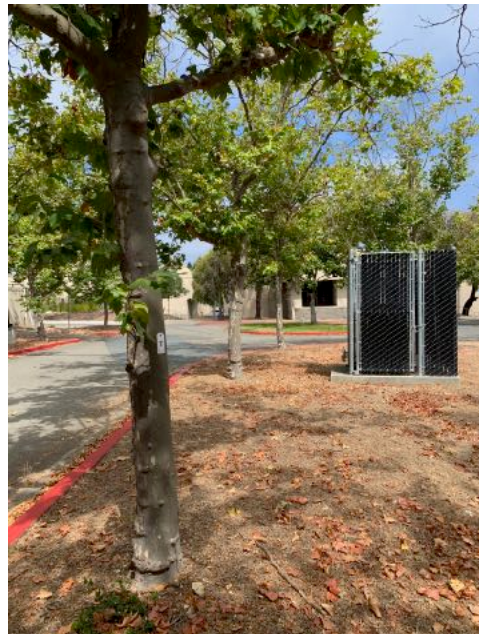
Image #8 is of some of the *Platanus acerifolia* (London plane trees) on the entry road to the gym. Tree #7 is shown, along with others near the traffic circle at the end of the road.

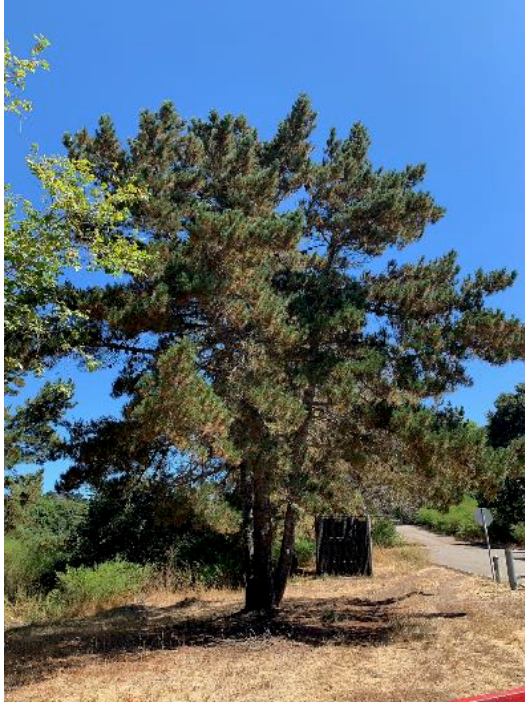
Image #9 is of the *Pinus radiata* (Monterey pine) #40 near the intersection of the back road to the Environmental Education Center and the road to the back of the gym. This tree is to be retained.

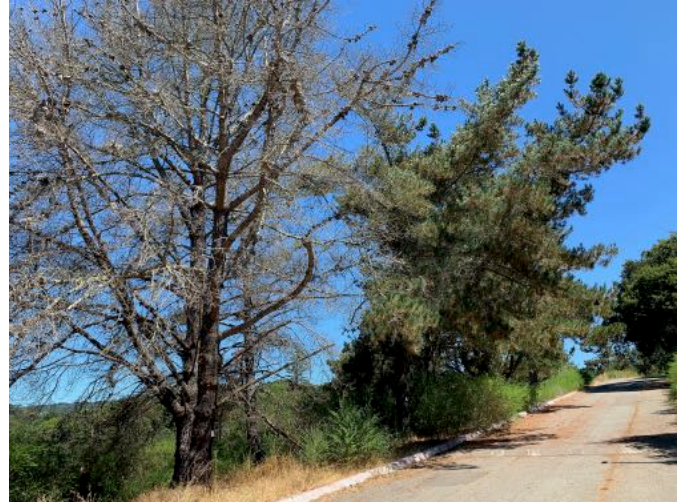
Image #10 is of some of the *Pinus radiata* (Monterey pines) on the road to the Environmental Education Center. Some of these should be removed, either because they are dead or because they pose a fire hazard to the Childcare Center below. The French broom shrubs that are growing beneath them should all be removed, as they have created a “fire ladder” for flames on the ground to climb up into the trees.

I recommend that the Monterey pines #8, #9, #10 and #12 be removed, as they are in the middle of the proposed 10,000 square foot Childcare Center. Tree #33 may also require removal for the same reason. Trees #42 to #48 along the upper road to the Environmental Education Center should also be removed, as some of them are dead or are in poor condition. The area along the upper road is a fire hazard; so the french broom in the area should also be removed. No permits are required for their removal, as they are not required for this species by the City of Oakland.
