LIMITED HAZARDOUS MATERIALS SURVEY

ROOFS AND EXTERIOR AREAS OF VIRGINIA HOSPITAL CENTER

ECS PROJECT NO. 47:1424-A

NOVEMBER 22, 2019

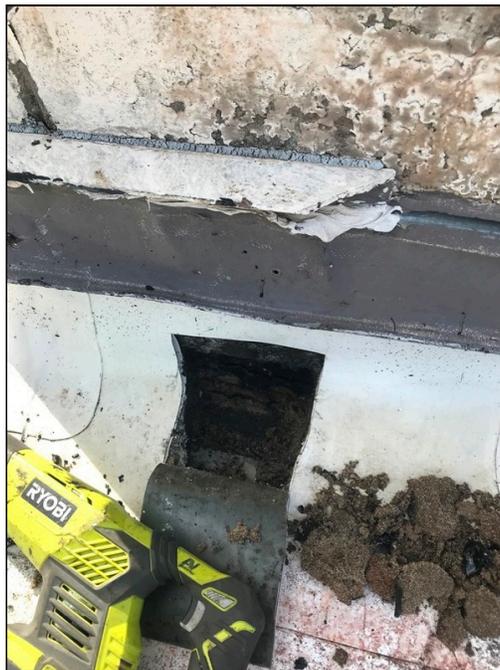
Asbestos-containing multiple layered flashing caulk was observed on the parapet wall adjacent to the southern multiple story section of the building. The asbestos-containing multiple layered flashing caulk appeared to be isolated to the connecting building parapet wall. Including a 20% contingency factor, approximately 50 linear feet of asbestos-containing multiple layered flashing caulk is associated with the parapet wall.

2 - View of Asbestos-Containing Multiple Layered Flashing Caulk on the Connecting Building Parapet Wall. Sample No. 61.

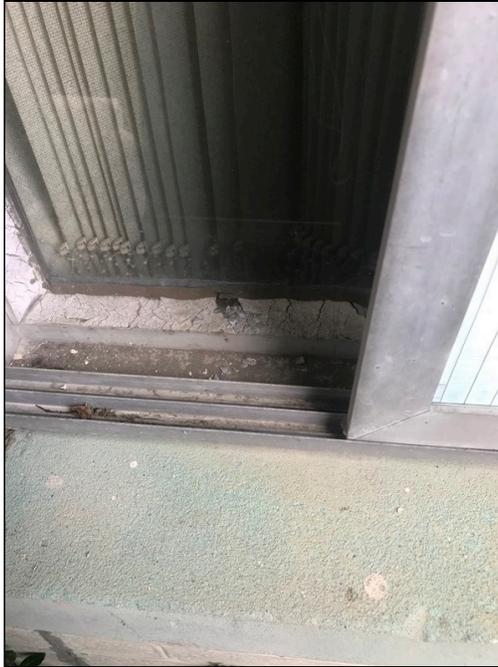
The asbestos-containing exterior gray window glazing was observed on the majority of exterior windows. Including a 20% contingency factor, approximately 6,000 linear feet of asbestos-containing exterior gray window glazing is located on exterior windows of the northern one-story and two-story sections of the building.

3 - View of Asbestos-Containing Gray Window Glaze on Exterior Windows. Sample No. 125.

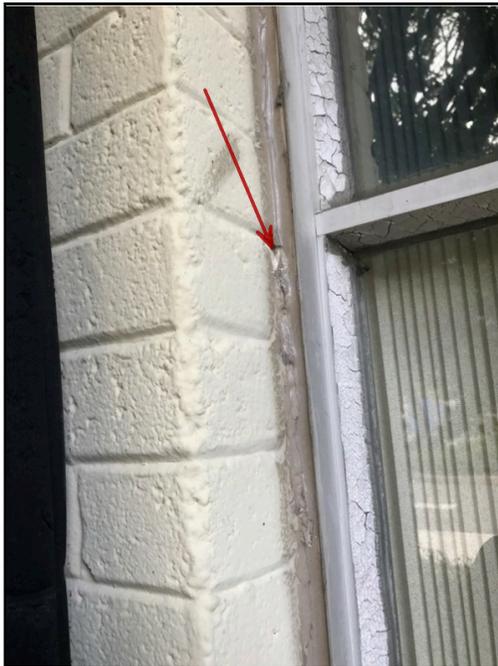
The asbestos-containing exterior white window caulk was observed on the majority of exterior windows. Including a 20% contingency factor, approximately 3,000 linear feet of asbestos-containing exterior white window caulk is located on exterior windows of the northern one-story and two-story sections of the building.

4 - View of Asbestos-Containing White Window Caulk on Exterior Windows. Sample No. 127-B.

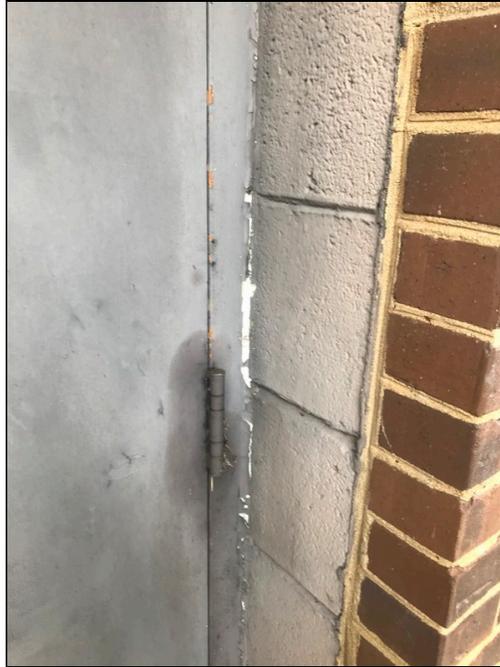
The asbestos-containing exterior tan door caulk was observed on several exterior doors. Including a 20% contingency factor, approximately 500 linear feet of asbestos-containing exterior tan door caulk is located on exterior doors around the northern one-story and two-story sections of the building.

5 - View of Asbestos-Containing Tan Door Caulk on Exterior Doors. Sample No. 149.

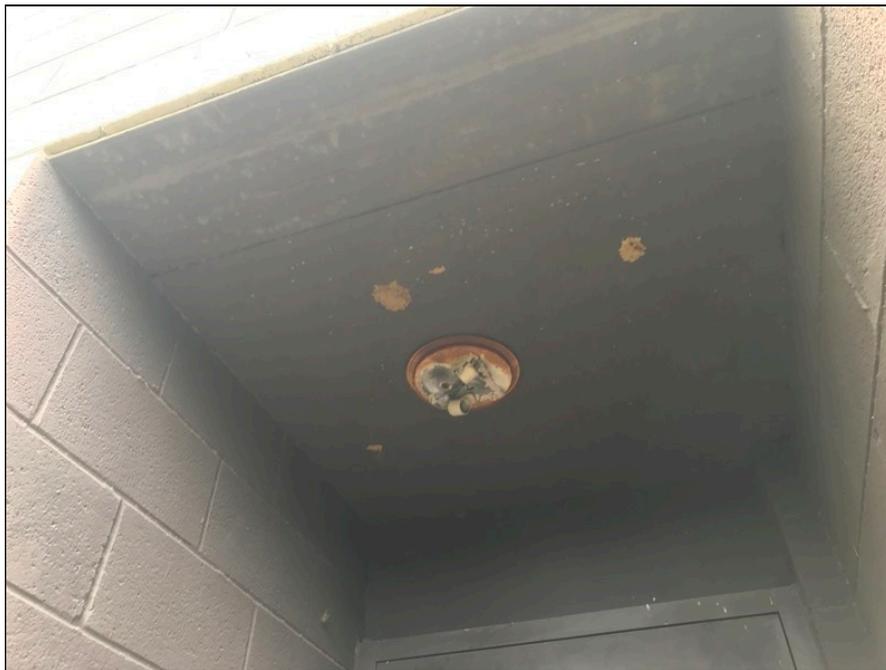
An asbestos-containing light shield insulation was observed underneath the several exterior soffits of the building. The asbestos-containing light shield insulation on one of the southeast soffits was observed in a damaged condition. Approximately 6 pieces of light shield insulation were observed on exterior soffits.

6 - View of Damaged Asbestos-Containing Light Shield Insulation on Exterior Soffits. Sample No. 164.

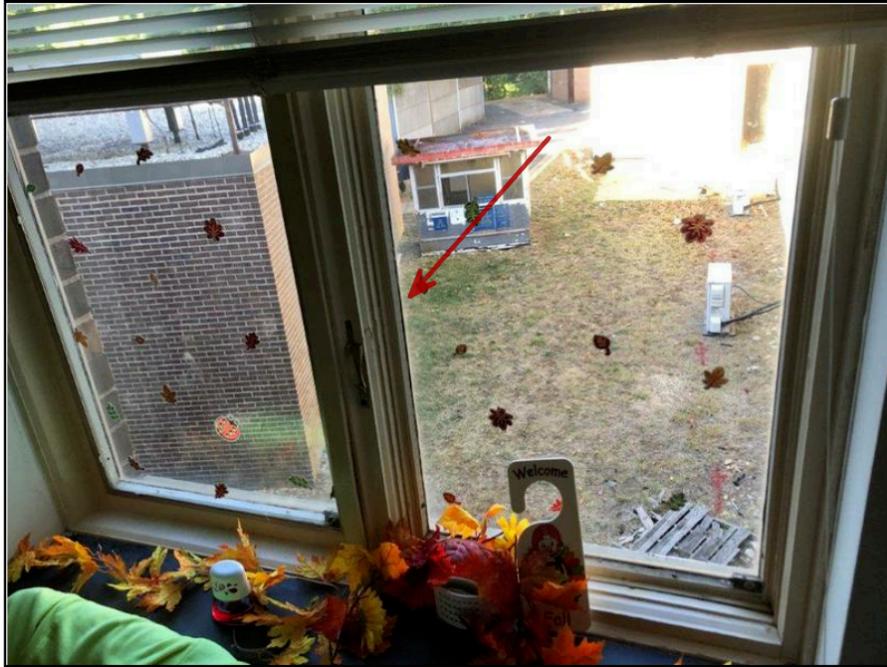
The section of building which connects the northern one-story and two-story sections with the southern multiple story section of the building appeared to have a distinct window system which is unique to the connecting building. The interior black window glaze on the connecting building windows was reported to contain asbestos. The windows are approximately four feet wide by six feet tall. Including a 20% contingency factor, approximately 275 linear feet of interior black window glazing was observed.

7 - View of Asbestos-Containing Interior Black Window Glazing on Connecting Building Windows. Sample No. 179.

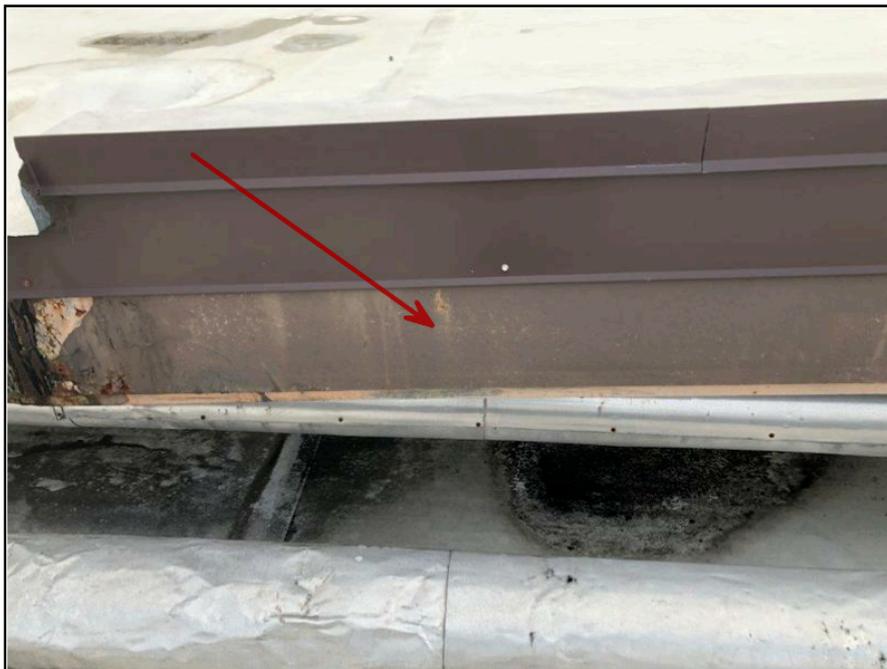
8 - View of Lead Based Paint on a Red Metal Beam on the Roof. XRF Reading No. 1031.

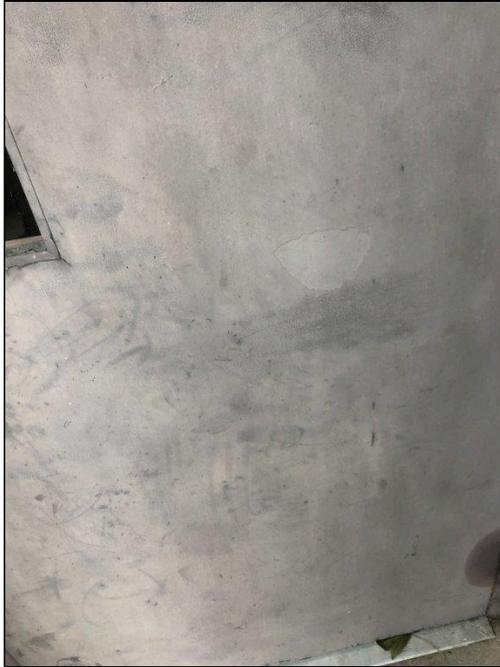
9 - View of Lead Based Paint on a Dark Gray Metal Door. XRF Reading Nos. 1050 and 1051.

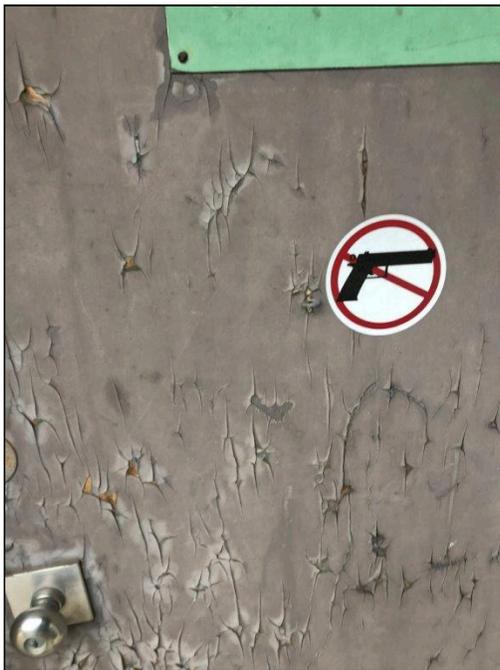
10 - View of Lead Based Paint on a Brown Metal Door. XRF Reading No. 1056.

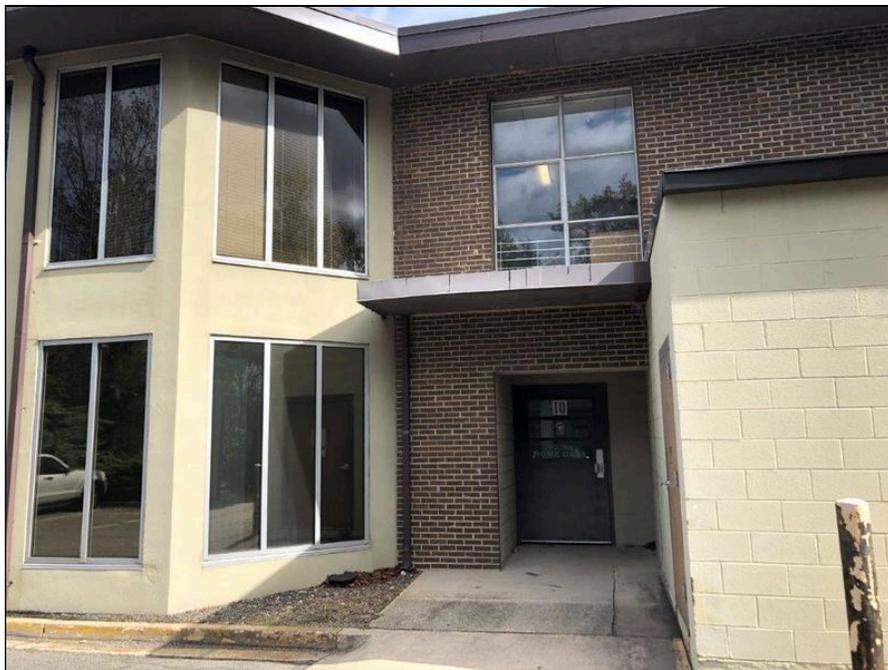
11 - View of Lead Based Paint on a Brown Metal Door. XRF Reading No. 1077.
