4301 BALL BILLYE	D'ATTIEET, 1		70.0100   11 11 11.11DATE	ANTICLOCATING.COM
Project: M-0618-0201-5302 ( N. Oakland & N. Pershing )	Prepared	By: Stephen Ro	ussell	Date: 2018-01-12
City: Arlington	State: VA	State: VA		Test Hole: 1 of
General Location: 8 N. Oakland St.				
		UTILITY IN	FORMATION	
Utility Size: 2 1/2"	Material:	P.E.		Good Condition: YES
Utility Type: Gas Line				Utility Owner: Washington Gas
	ΑI	DDITIONAL UTI	LITY INFORMATION	
Utility Size: 2"	Material:	Steel		See Test Hole No.:
Utility Type: Electric Conduit				Utility Owner: Dominion
		SITE CO	NDITIONS	
Field Condition: Grass Area			Pavement thickness:	
Ground Condition: Brown Soil				
	FIRST 8	SECOND BEN	CHMARK INFORMATION	ı
1st Elevation:	n: 1st Benchmark Description:			
BM Check:				
2nd Elevation:	2nd Benchmark Description:			
Elevation Datum:				
		FIELD MARKE	R INFORMATION	
Type set: 60 D Nail			Elevation: 215.45'	
Offset/Direction: Nail is set C/L of the Configuration	n.

<b>Project:</b> M-0618-0201-5302 ( N. Oakland & N. Pershing )	Prepared By: Robb Lloyd	<b>Date:</b> 2018-04-04
City: Arlington	State: VA	Test Hole: 11 of

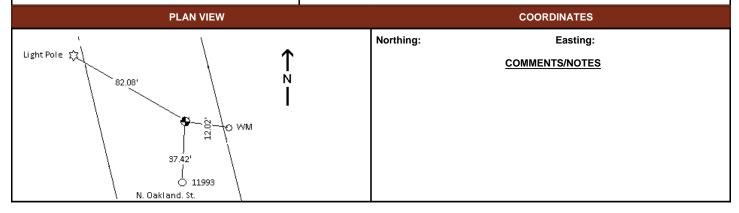
4501 DALY DRIVE   C	CHANTILLY, VA 20151   703	.378.0100   WWW.MIDATL	ANTICLOCATING.COM		
<b>Project:</b> M-0618-0201-5302 ( N. Oakland & N. Pershing )	Prepared By: Cody Brown	wn	<b>Date:</b> 2018-04-05		
City: Arlington	State: VA		Test Hole: 15 of		
General Location: 133 N Oakland St.	•				
	UTILITY I	NFORMATION			
Utility Size: 1 1/4"	Material: Paper Wrappe	d Steel	Good Condition: YES		
Utility Type: Gas Line			Utility Owner:		
	ADDITIONAL UT	ILITY INFORMATION			
Utility Size:	Material:		See Test Hole No.:		
Utility Type: None			Utility Owner:		
	SITE C	ONDITIONS			
Field Condition: Asphalt Road					
Ground Condition: Brown Soil					
	FIRST & SECOND BE	NCHMARK INFORMATION			
1st Elevation: 220.06'	1st Benchmark Description: 580				
BM Check: -0.04'	•				
2nd Elevation: 243.39'	2nd Benchmark Description: 11997				
Elevation Datum:	•				
	FIELD MARK	ER INFORMATION			
Type set: Mag Nail		Elevation: 231.29'	ilevation: 231.29'

Offset/Direction: Nail is set C/L of the Utility.		•			
	PROI	FILE VIEW			
		field measurement: 2.32'	Elevation: <u>228.97'</u>		
	Bottom of ut	ility field measurement: No	ne Elevation: None		
Facing: West Utility Width/Spa	ncing:
