ASBESTOS INSPECTION REPORT

COMMERCIAL PROPERTY

**505 9TH AVE. NORTH
MYRTLE BEACH, SC**

23 July 2019

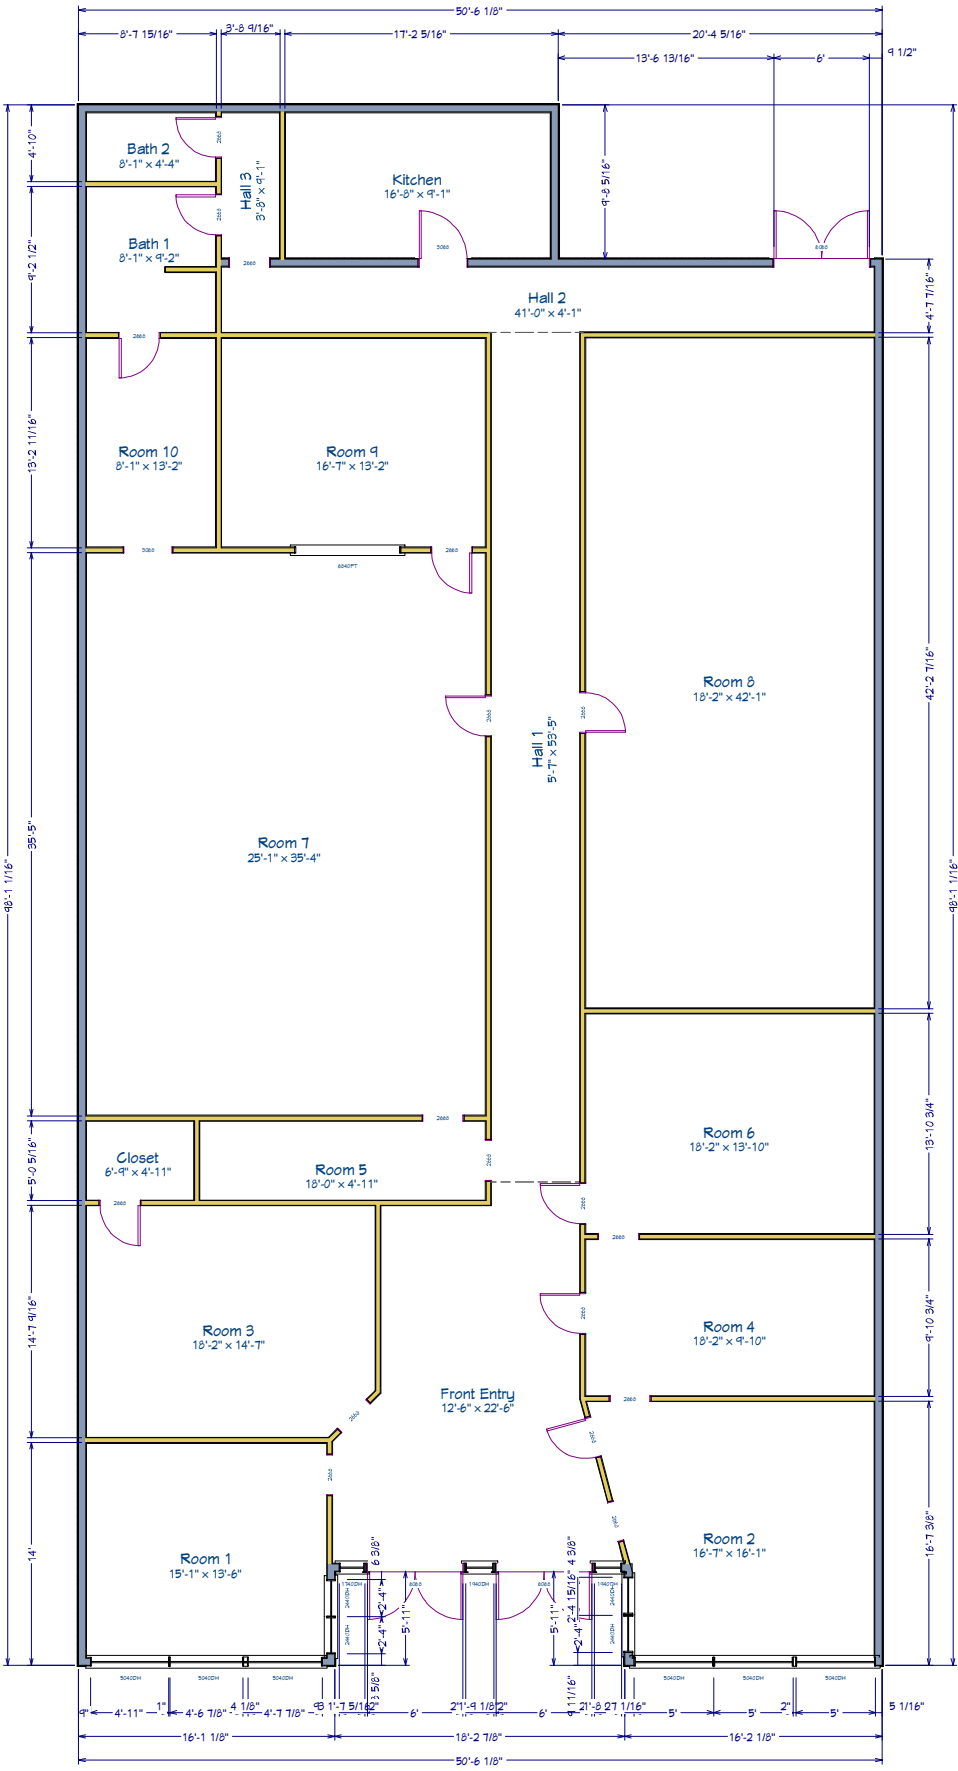
*HA1 9x9 Floor Tiles w/Mastic
Floor Tiles Exposed and Painted
4% Chrysotile Present in Floor Tiles
5% Chrysotile Present in Mastic
Approx. 2,784 sq ft

*HA1 9x9 Floor Tiles w/Mastic
Floor Tiles Covered by HA2 Carpet w/Mastic
4% Chrysotile Present in Floor Tiles
5% Chrysotile Present in Mastic
Approx. 1,652 sq ft

*HA1 9x9 Floor Tiles w/Mastic
Floor Tiles Covered by Non-Suspect Ceramic Tile
4% Chrysotile Present in Floor Tiles
5% Chrysotile Present in Mastic
Approx. 216 sq ft

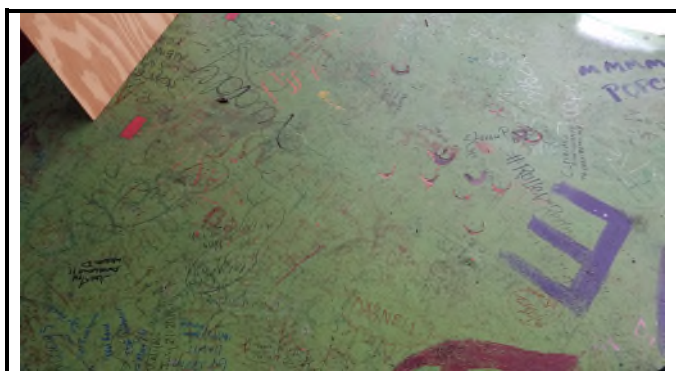
***HA1 – 9x9 Floor Tiles – 4% Chrysotile Present in Floor Tile, 5% Chrysotile Present in Mastic**

Picture 21 – **HA1 Painted 9x9 Floor Tiles w/Mastic*
4% Chrysotile in Tile, 5% Chrysotile in Mastic

***These materials are currently classified as Friable and Non-Friable Asbestos Containing Building Materials (ACBMs), however, may become Friable depending on removal process and will need to be removed by a South Carolina Licensed Abatement Contractor.**

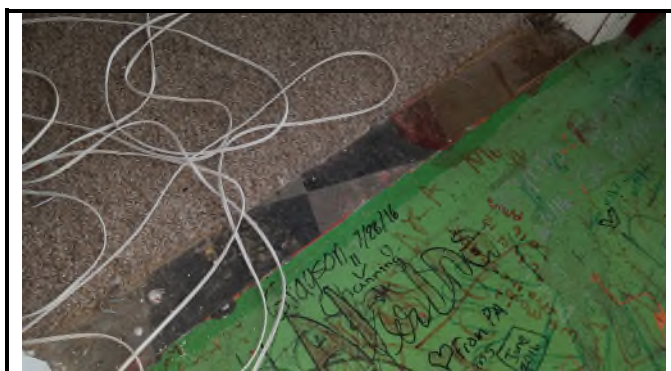
Picture 22 – **HA1 Painted 9x9 Floor Tiles w/Mastic and *HA1 Non-Painted 9x9 Floor Tiles*
4% Chrysotile in Tile, 5% Chrysotile in Mastic

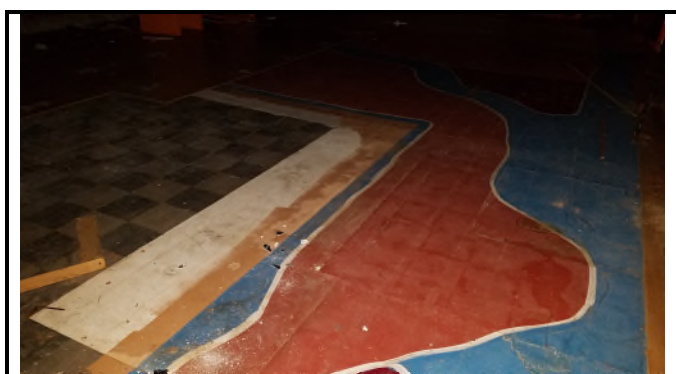
Picture 23 – **HA1 Painted 9x9 Floor Tiles w/Mastic and *HA1 Non-Painted 9x9 Floor Tiles*
4% Chrysotile in Tile, 5% Chrysotile in Mastic

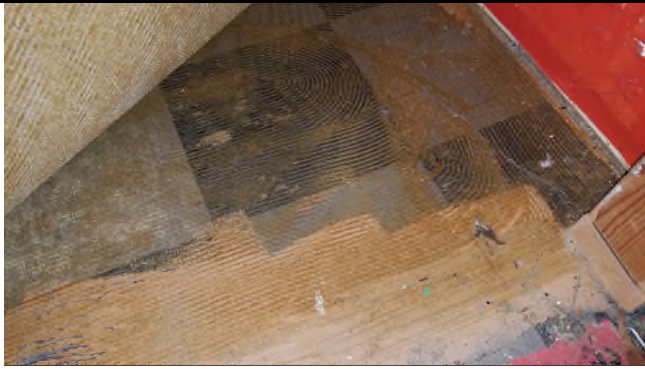
Picture 25 – **HA1 Non-Painted 9x9 Floor Tiles w/Mastic underneath *HA2 Carpet w/Mastic 4% Chrysotile in Tile, 5% Chrysotile in Mastic*

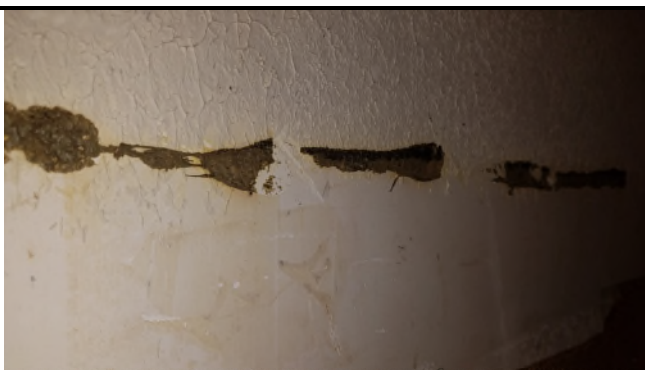
***HA60 – Wall Mastic – 5% Chrysotile Present in Mastic**

Picture 41 – *HA60 Wall Mastic
5% Chrysotile Present in Mastic

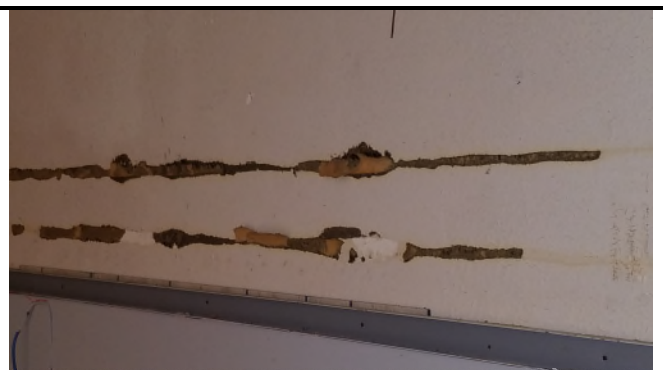
Picture 42 – *HA60 Wall Mastic
5% Chrysotile Present in Mastic

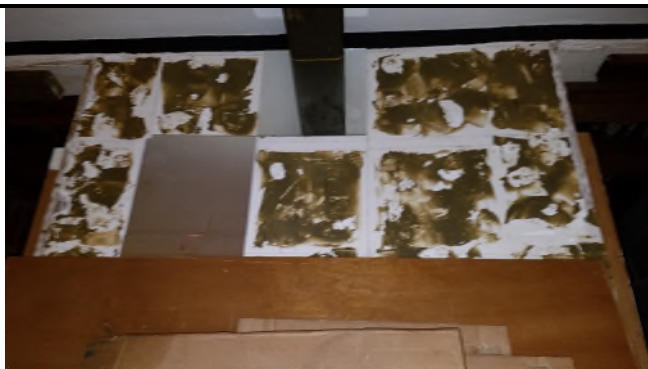
Picture 43 – *HA60 Wall Mastic
5% Chrysotile Present in Mastic

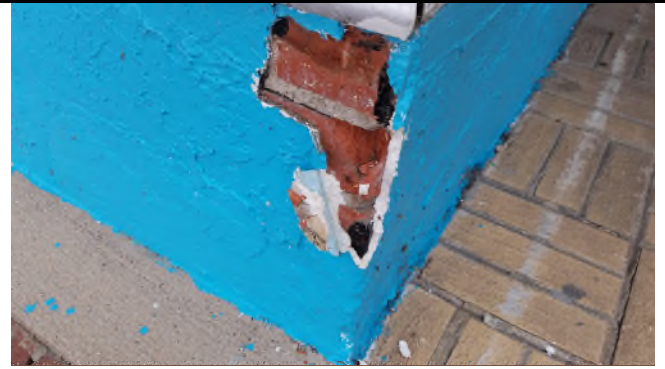
***HA90 – Exterior Wall Covering – 7% Chrysotile Present in Black Adhesive-Like Material**

Picture 50 – *HA90 Exterior Wall Covering
7% Chrysotile Present in Black Adhesive-Like Material

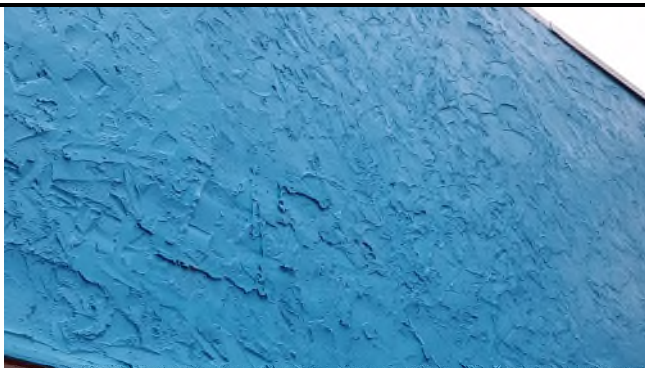
Picture 51 – *HA90 Exterior Wall Covering
7% Chrysotile Present in Black Adhesive-Like Material
