ENVIRONMENTAL SERVICE GROUP JOB # AS-1906

ASBESTOS INSPECTION REPORT

COMMERCIAL PROPERTY

**507 9TH AVE. NORTH
MYRTLE BEACH, SC**

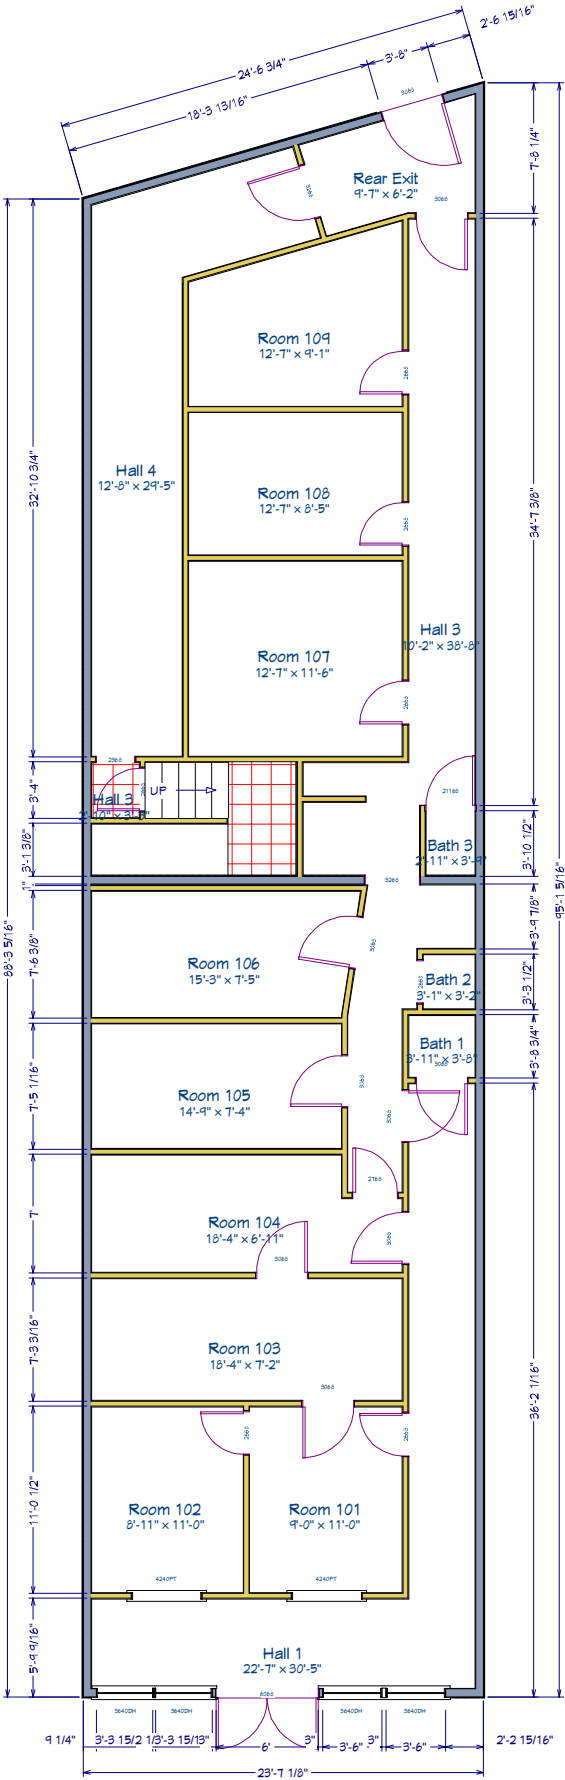
*HA2 9x9 Floor Tiles w/Mastic
3% Chrysotile Present in Floor Tiles
NAD in Mastic
Approx. <75 Sq Ft

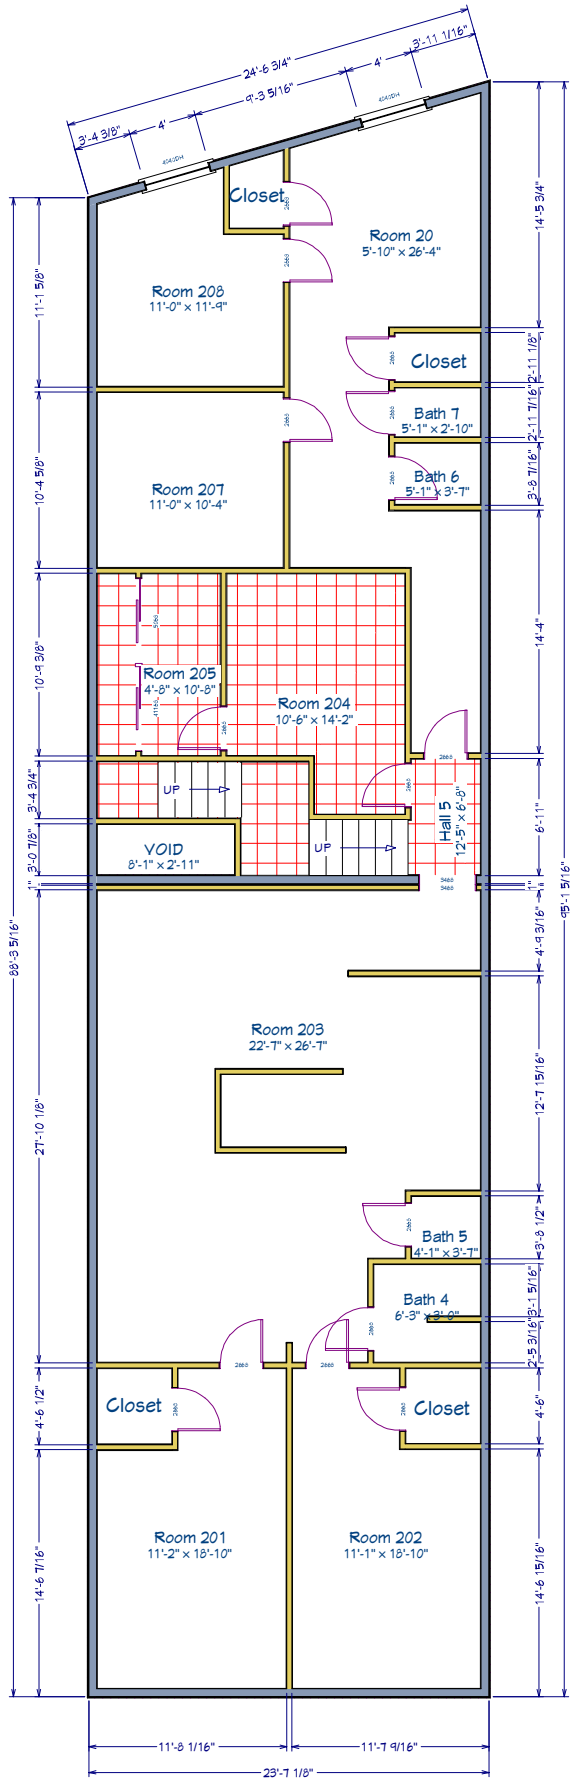
*HA2 9x9 Floor Tiles w/Mastic
3% Chrysotile Present in Floor Tiles
NAD in Mastic
Approx. 396 Sq Ft

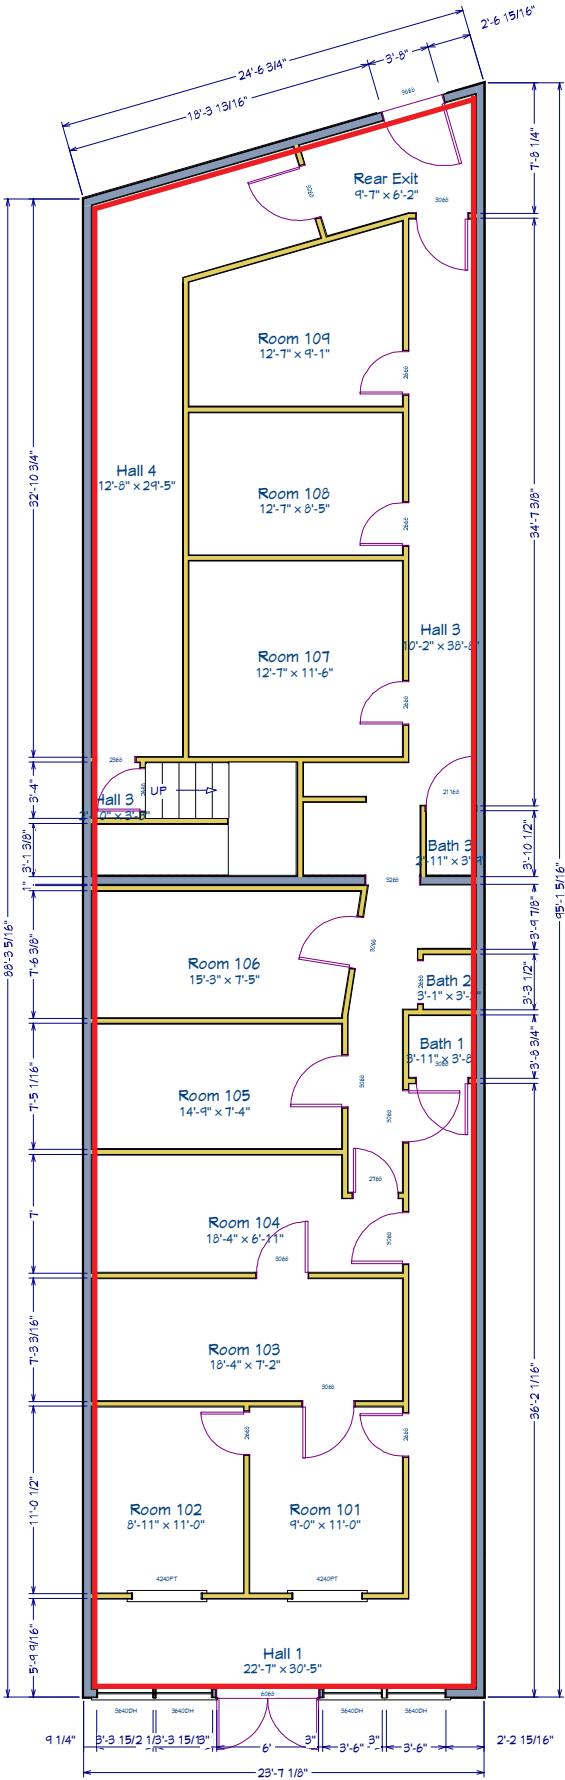
*HA21 Interior Stucco Wall
Covering (Original Finish)
2% Chrysotile Present in Chalky
Joint Compound-Like Material
Approx. 2,480 Sq Ft
*The majority of this material has
been covered/encapsulated by
Furred Sheetrock Walls*

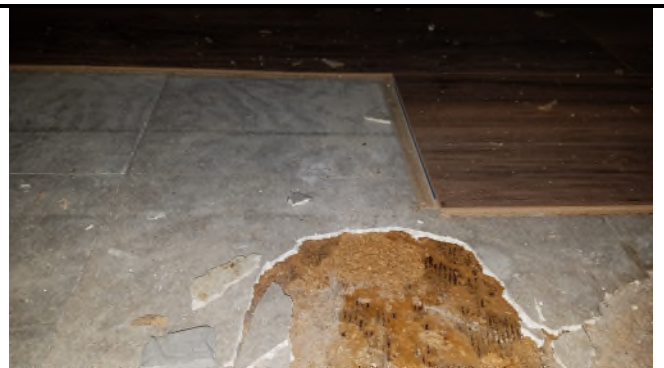
Picture 24 – *HA1 12x12 Floor Tiles w/Mastic (underneath Laminate Flooring)

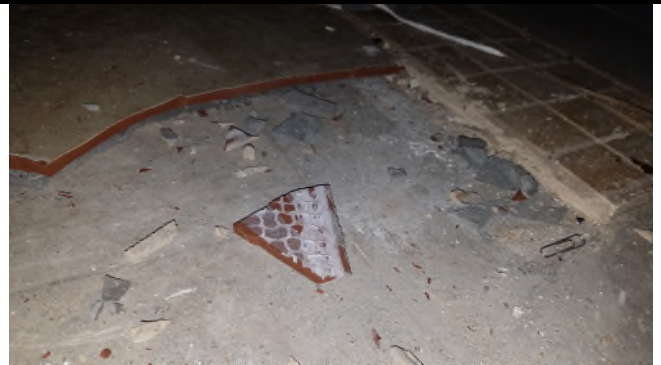
Picture 26 – *HA1 12x12 Floor Tiles w/Mastic
(underneath Ceramic Tile)

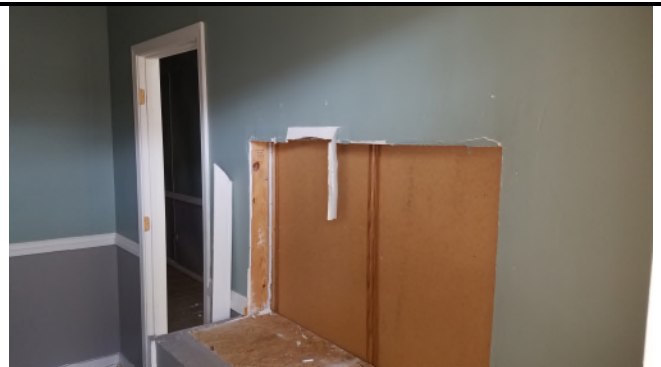
Picture 28 – *HA20 Sheetrock Walls

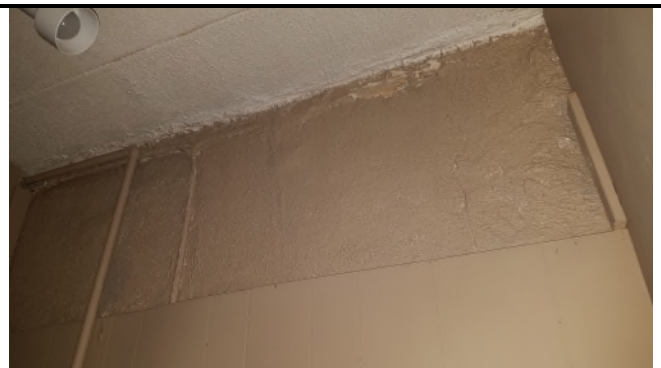
***HA21 – Interior Stucco Wall Covering – 2% Chrysotile in Chalky Joint Compound-Like Material**

Picture 30 – *HA21 Interior Stucco Wall Covering
2% Chrysotile in Joint Compound-Like Material

***These materials are currently classified as Friable and Non-Friable Asbestos Containing Building Materials (ACBMs) that may become Friable depending on removal process and will need to be removed by a South Carolina Licensed Abatement Contractor.**

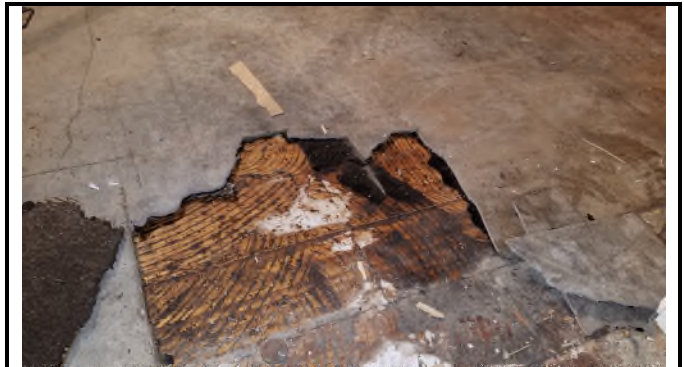
***HA1 – 9x9 Floor Tiles – 3% Chrysotile Present in Floor Tile, NAD in Mastic**

Picture 58 – **HA2 9x9 Floor Tiles w/Mastic
3% Chrysotile Present in Floor Tiles
Mastic NAD*

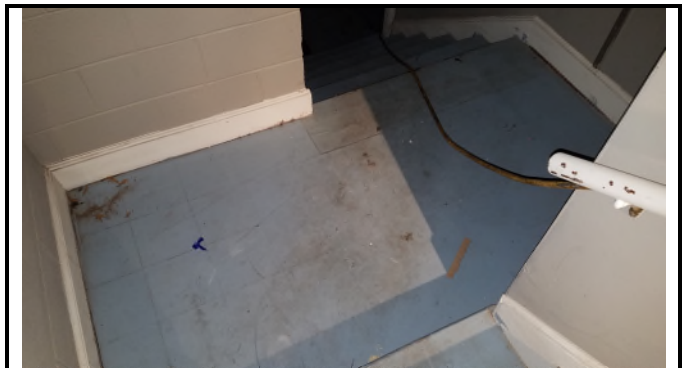
Picture 60 – **HA2 9x9 Floor Tiles w/Mastic
3% Chrysotile Present in Floor Tiles
Mastic NAD*

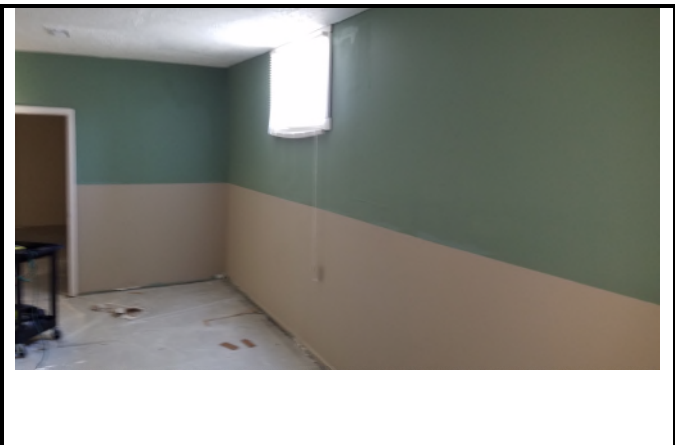
Picture 61 – *HA22 Sheetrock Walls

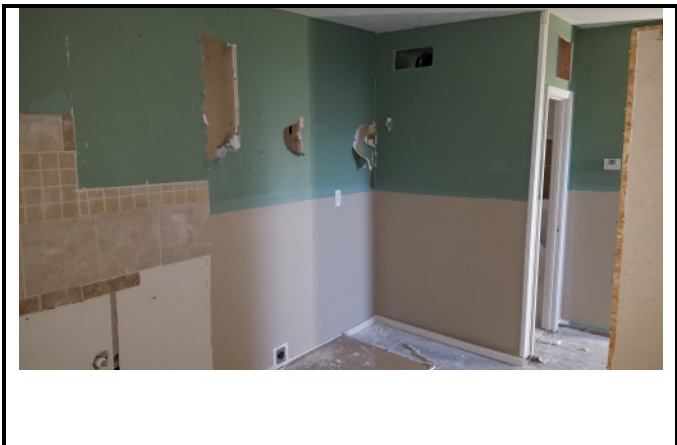
Picture 62 – *HA22 Sheetrock Walls

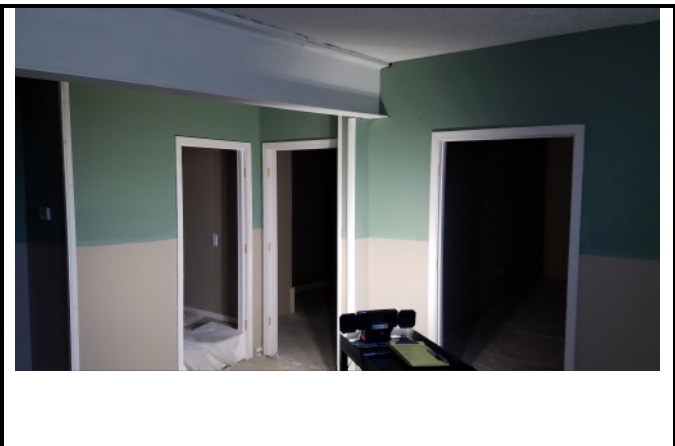
Picture 63 – *HA22 Sheetrock Walls

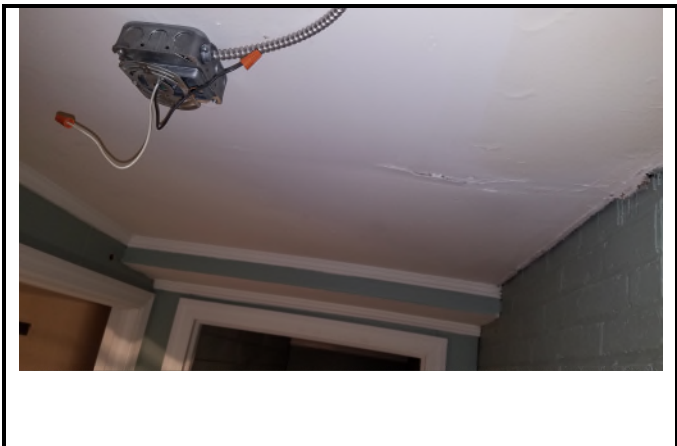
Picture 64 – *HA32 Sheetrock Ceilings

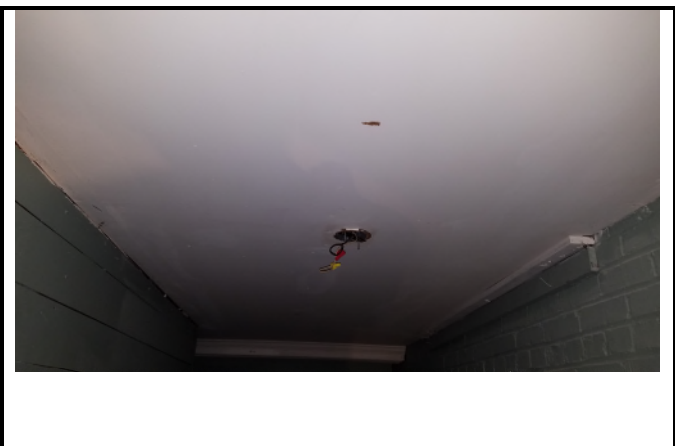
Picture 65 – *HA32 Sheetrock Ceilings

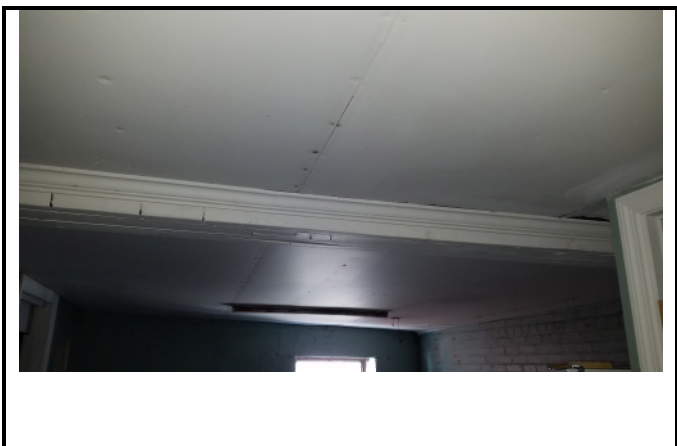
Picture 66 – *HA32 Sheetrock Ceilings

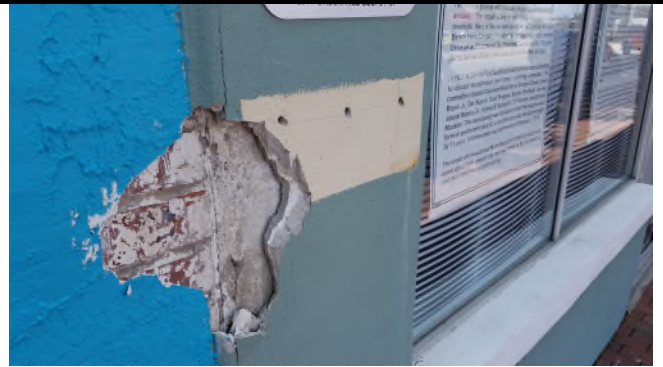
Picture 74 – *HA50 Exterior Wall Covering

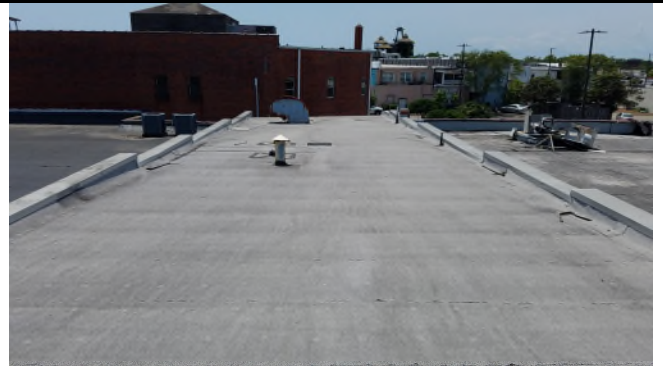
Picture 76 – Roofing Materials (view from Front to Back)

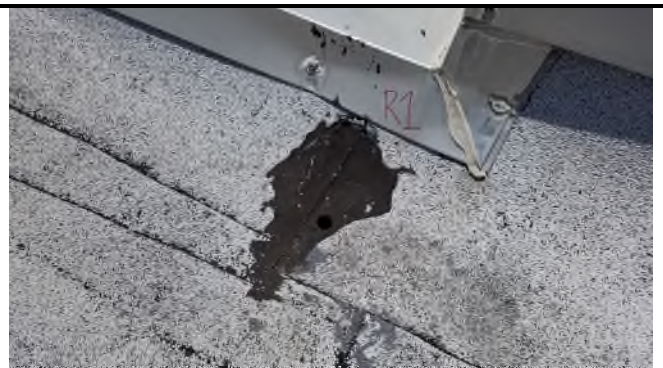
Picture 78 – *HA80 Roofing Materials – Core Sample R1
