ENVIRONMENTAL SERVICE GROUP JOB # AS-1907

ASBESTOS INSPECTION REPORT

COMMERCIAL PROPERTY

**509 9TH AVE. NORTH
MYRTLE BEACH, SC**

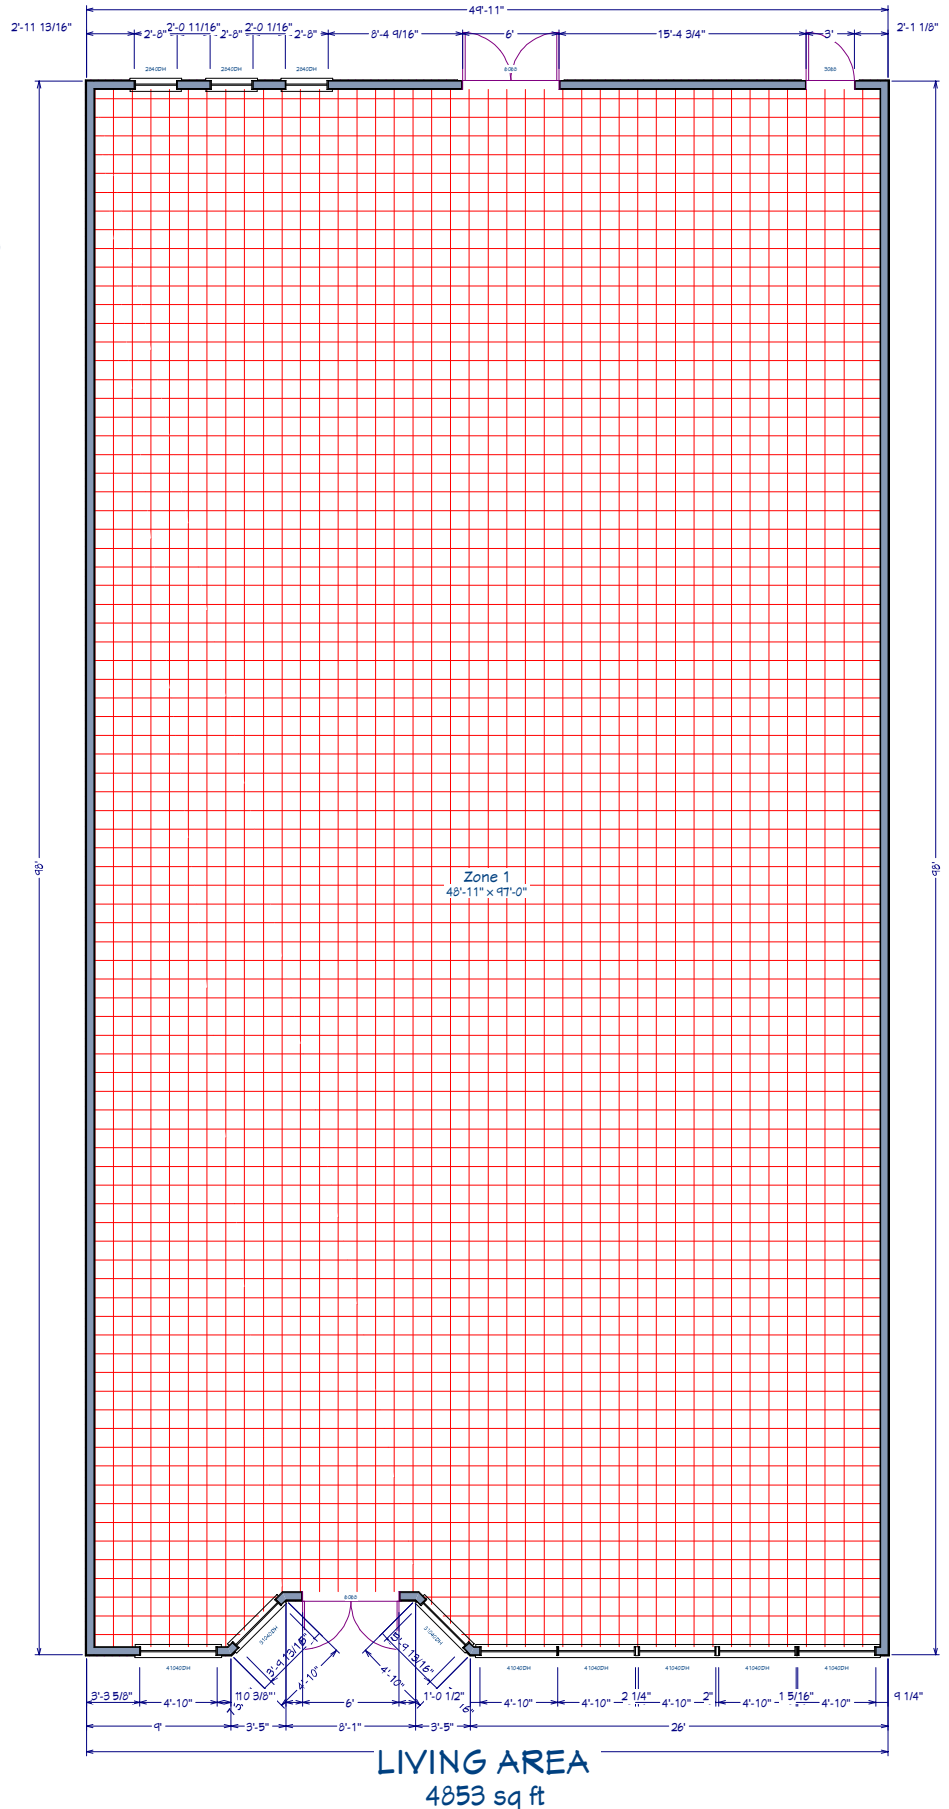
ACBM Site Plan - Ground Level - Flooring Materials

- *HA1 9x9 Floor Tiles w/Mastic (Bottom Layer)
- *HA2 9x9 Floor Tiles w/Mastic (Middle Layer)
- *HA3 12x12 Floor Tiles w/Mastic (Top Layer)

5% Chrysotile Present in HA1 Floor Tiles
2% Chrysotile Present in HA1 Mastic
Approx. 4,850 sq ft
5% Chrysotile Present in HA2 Floor Tiles
7% Chrysotile Present in HA2 Mastic
Approx. 4,250 sq ft
NAD in HA3 Floor Tiles
NAD in HA3 Mastic
Positive by Association w/HA1 & HA2
Approx. 2,150 sq ft

***These materials are currently classified as Friable Asbestos Containing Building Materials (ACBMs) and will need to be removed by a South Carolina Licensed Abatement Contractor.**

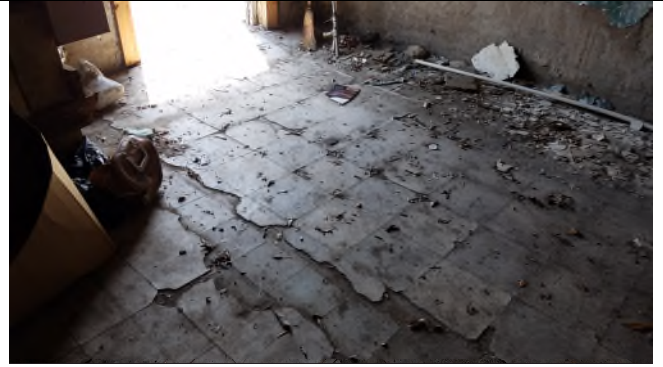
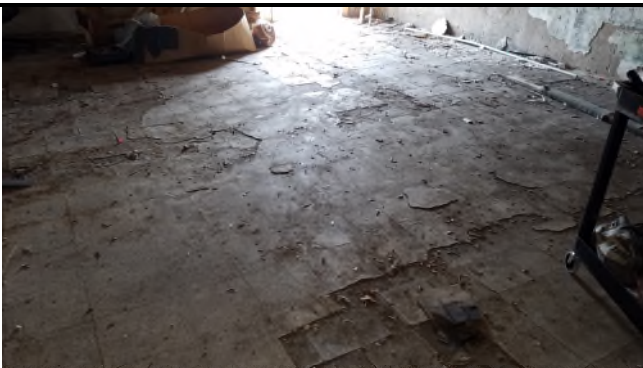
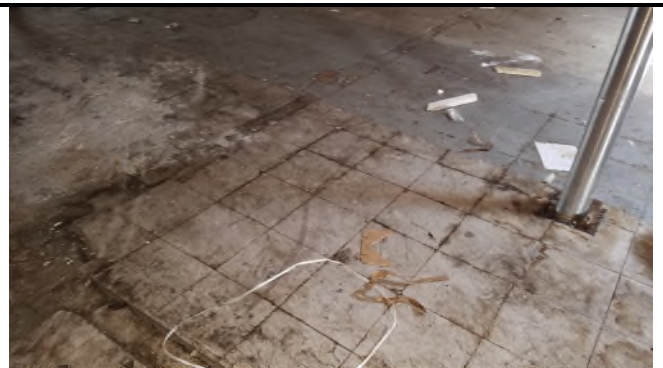
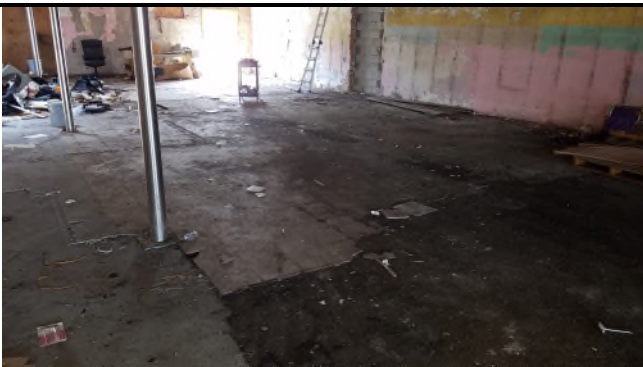
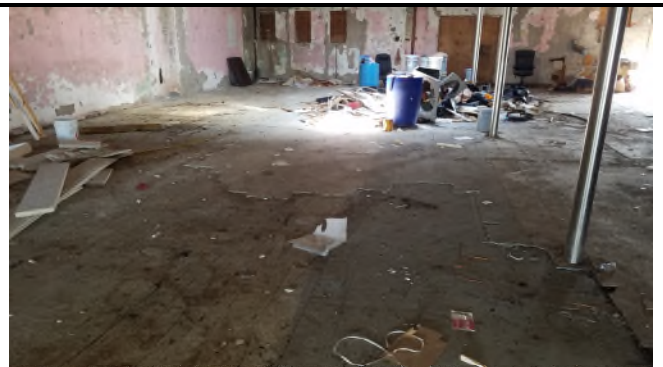
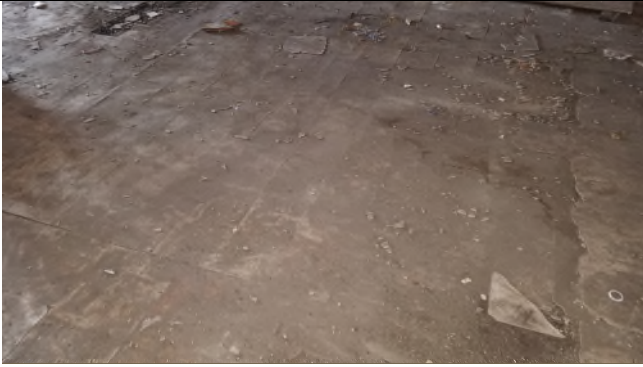
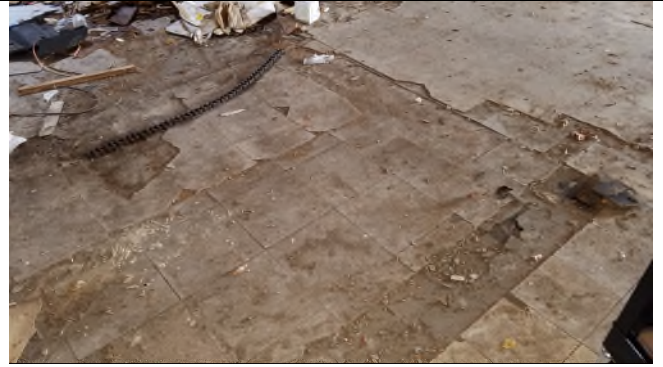
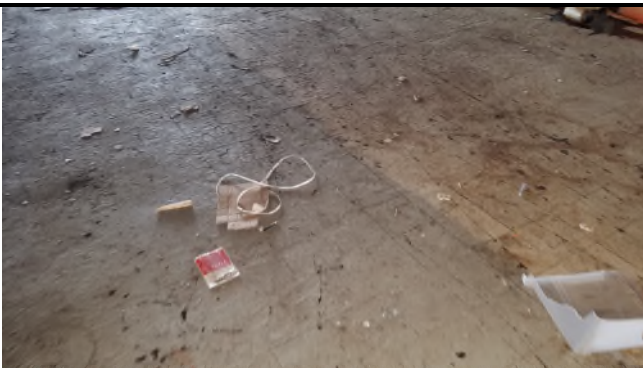
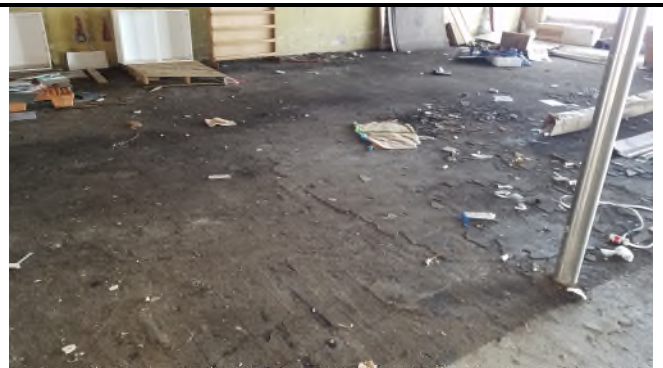
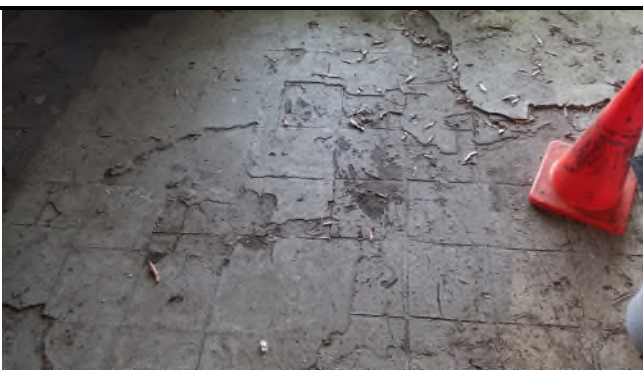
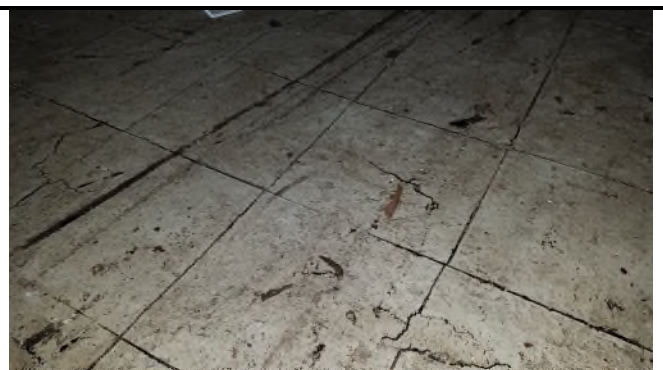
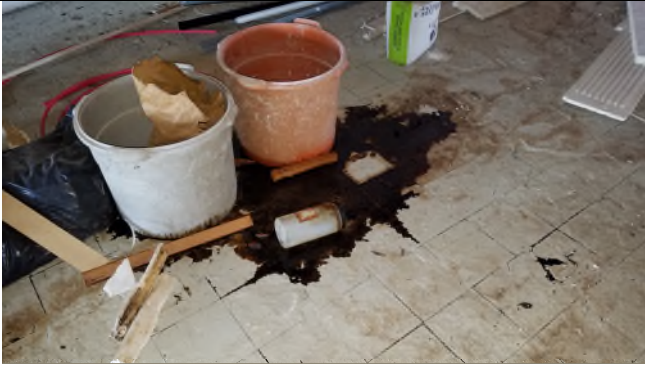
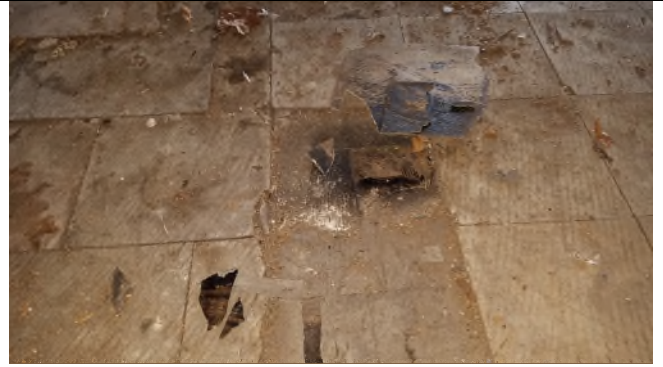
***HA1 – 9x9 Floor Tiles (Bottom Layer) – 5% Chrysotile Present in Floor Tile, 2% Chrysotile in Mastic**

***HA2 – 9x9 Floor Tiles (Middle Layer) – 5% Chrysotile Present in Floor Tile, 7% Chrysotile in Mastic**

***HA3 – 12x12 Floor Tiles (Top Layer) – Positive by Association with HA1 and HA2**

Picture 8 – *HA1 9x9 Floor Tiles, *HA2 9x9 Floor Tiles and *HA3 12x12 Floor Tiles w/Mastic (3 Layers)

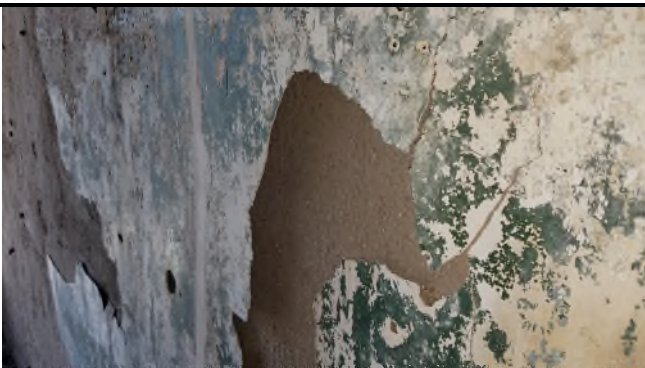
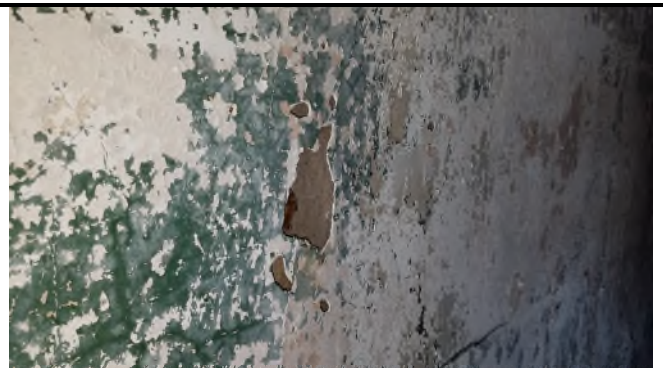
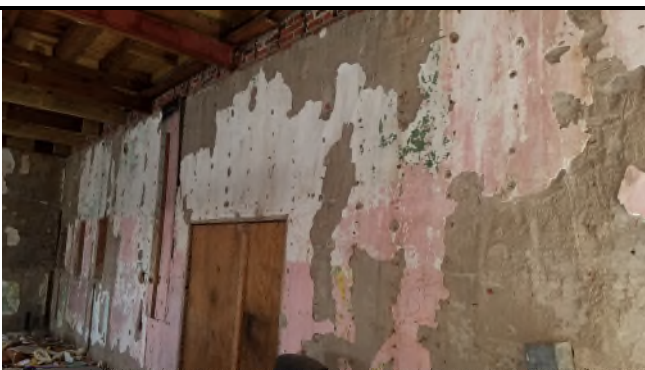
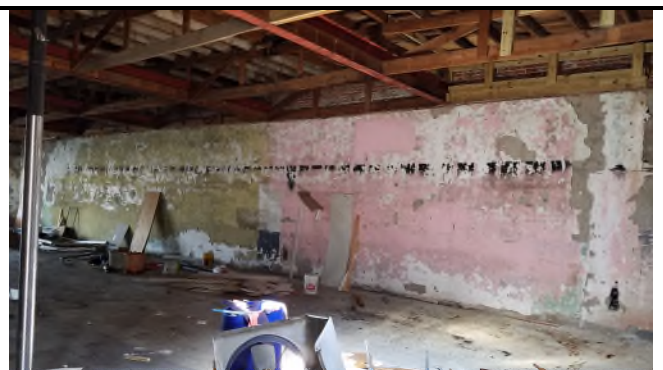
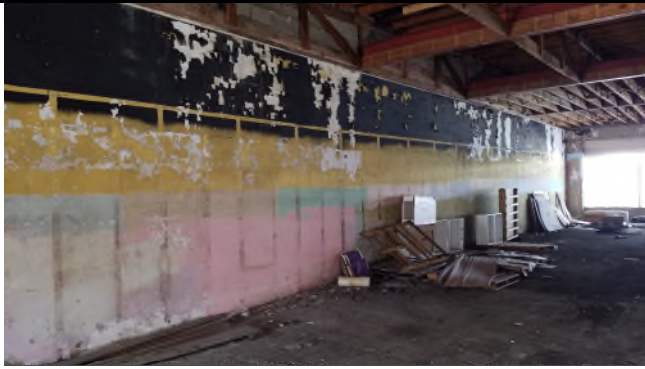
Picture 21 – *HA20 Plaster Wall Covering

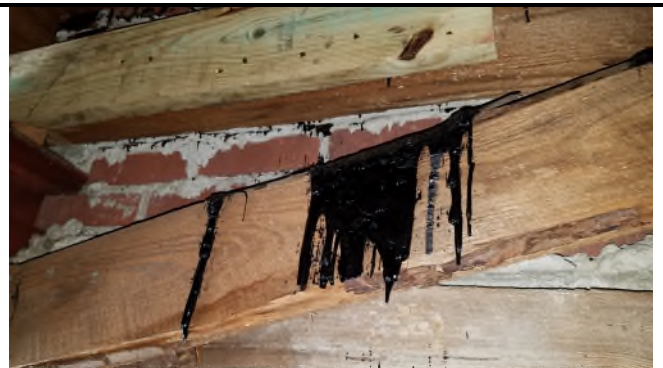
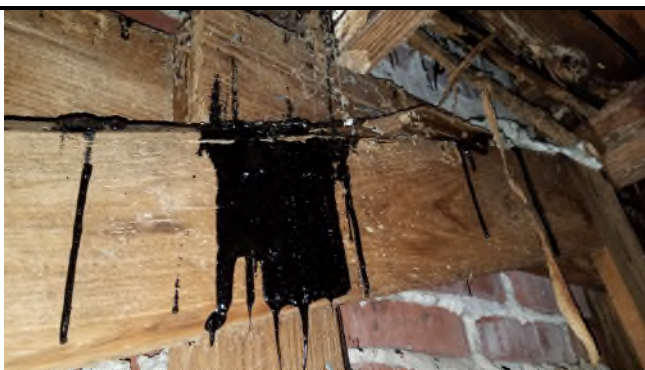
Picture 28 – *HA81 Roofing Tar
