ENVIRONMENTAL SERVICE GROUP JOB # AS-1752

ASBESTOS INSPECTION REPORT
COMMERCIAL PROPERTY
513 9TH AVE N.
MYRTLE BEACH, SC

09 August 2017

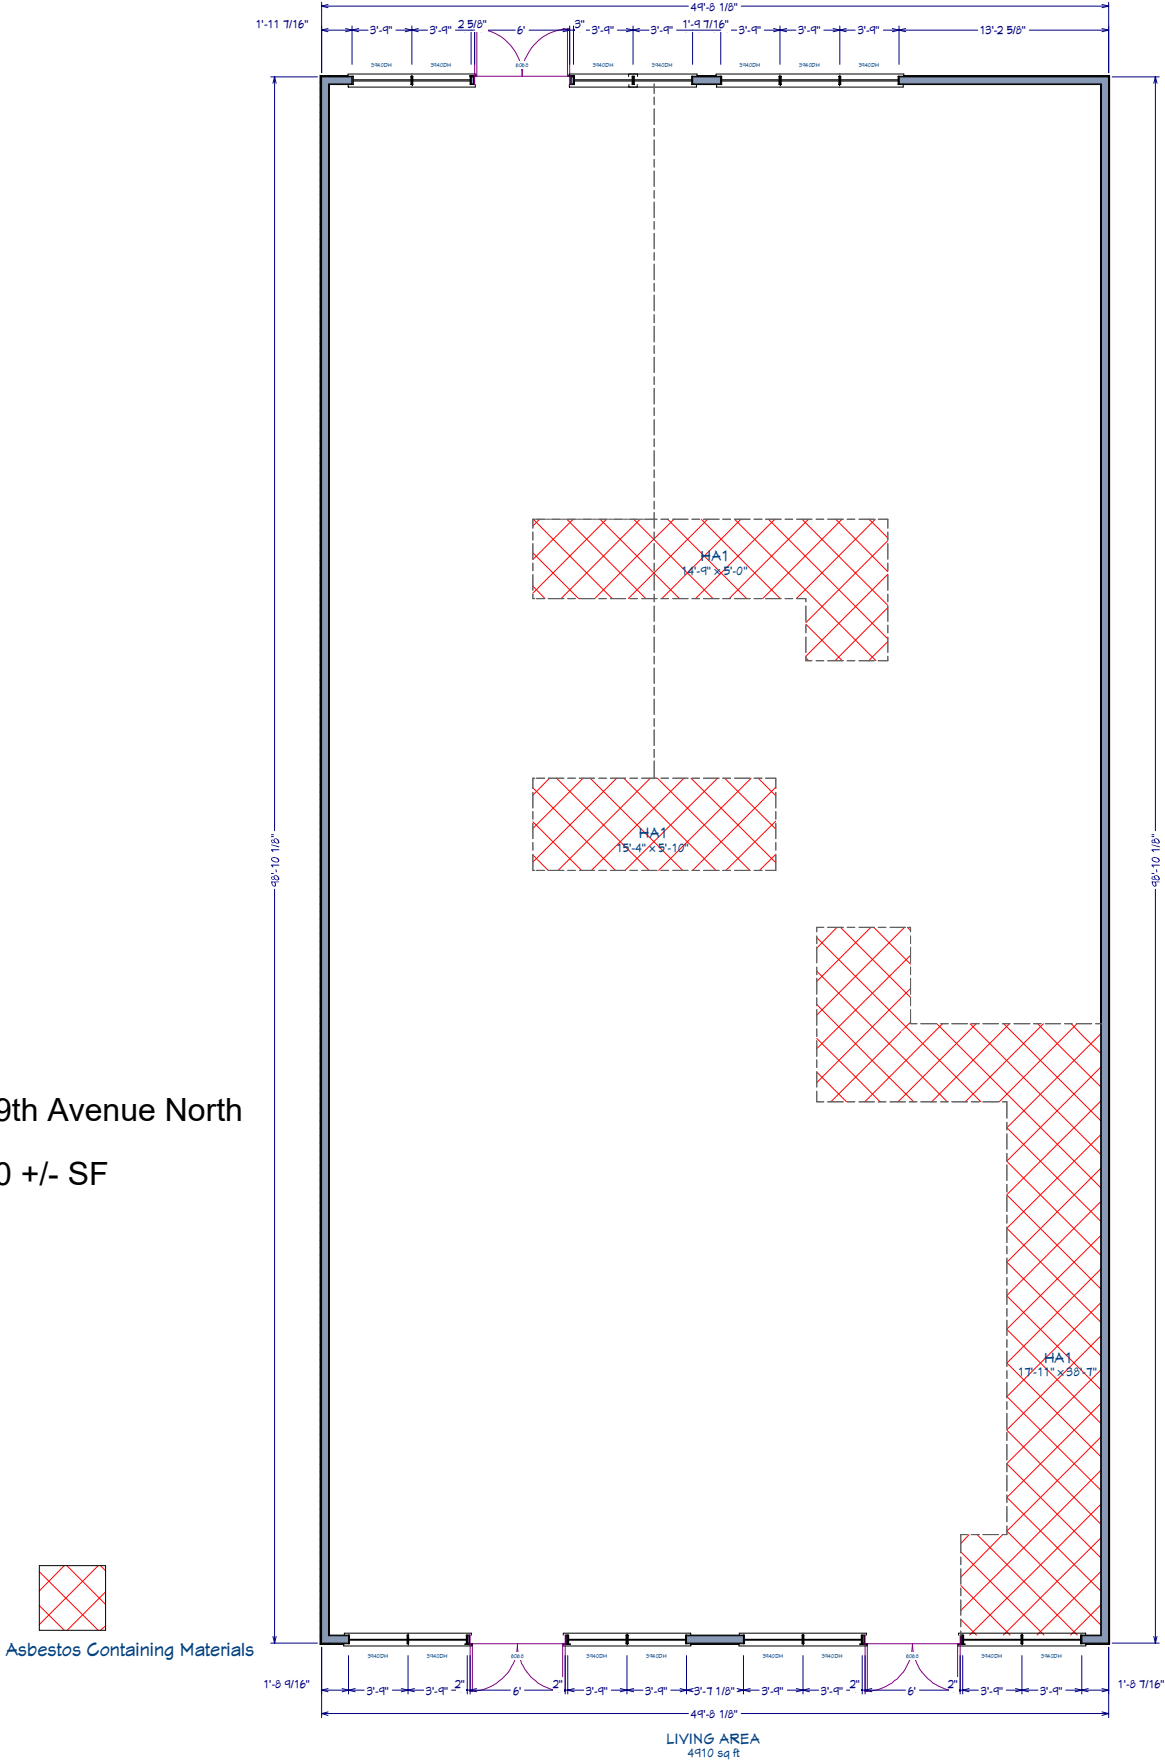
513 9th Avenue North
4,910 +/- SF

A visual description of building materials found within the facility would include floor coverings of non-suspect bare concrete throughout the entire structure, with the exception of areas designated on site plan within this report, that contain *Double-Layered 12x12 Vinyl Tiles w/Mastic. Ceiling coverings would consist of a non-suspect exposed wooden truss system and wooden substrate for the roof. Interior walls were concrete with a *Plaster Skim Coat. There was no insulation observed within the interior wall cavities. Exterior walls are non-suspect painted concrete block and brick & mortar. Exterior/internal doors were metal/glass and wood, and did not contain materials suspect of being ACBMs. The roof consisted of a flat roof design with *Rubber Membrane, *Asphalt Patching/Flashing, and a white paint-like coating.

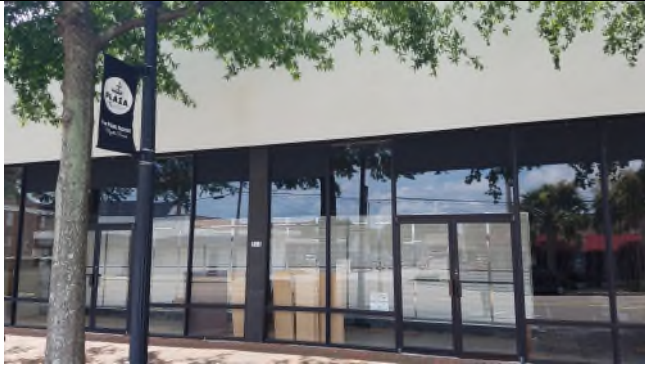
Picture 1 – Front of Building

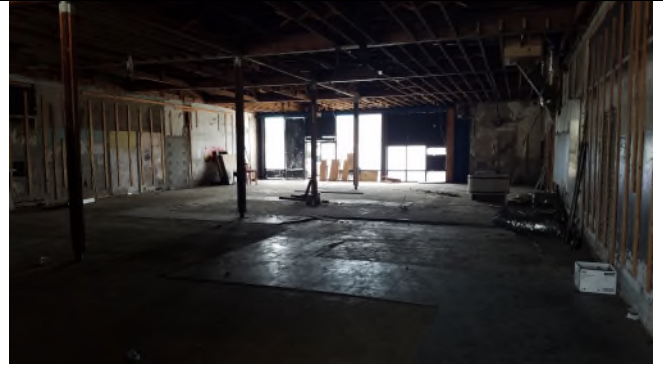
Picture 2 – Interior (View From Front Door)

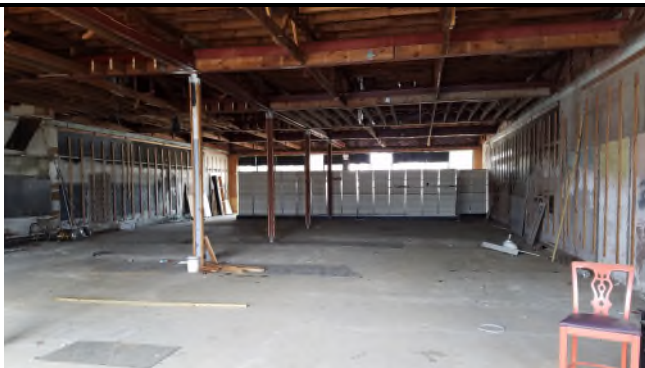
Picture 3 – Interior (View From Back Door)

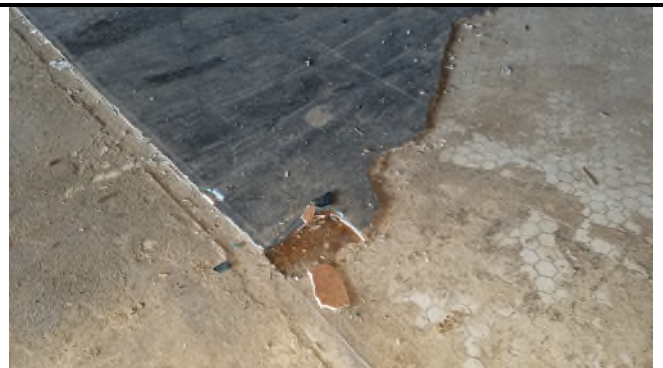
HA1 – Double-Layered 12x12 Vinyl Floor Tiles w/Mastic (10% Chrysotile in Mastic)

HA #	AC M	MATERIAL DESCRIPTION	CATEGORY	FRIABLE F/NF	QUANTITY SQ FT±	NO. SAMPLE TAKEN	PRESENT CONDITION	POTENTIAL FOR DISTURBANCE	COMMENTS
1	P	DOUBLE-LAYERED 12X12 FLOOR TILES W/MASTIC	MISC	F	775 SQ FT±	3	D	LPD*	10% CHRYSOTILE
	LOCATION: DESIGNATED AREAS						NOTE: MATERIAL IS CURRENTLY FRIABLE BUT STILL HAS LPD*		
20	ND	CONCRETE WALLS W/PLASTER SKIM COAT	SURF	NF	2,000 SQ FT±	5	SD	PD	ND
	LOCATION: PERIMETER WALLS						NOTE:		
50	ND	HVAC TAPE MASTIC	MISC	NF	<50 SQ FT±	3	D	LPD	ND
	LOCATION: HVAC DUCTWORK						NOTE:		
80	ND	ROOFING MATERIALS	MISC	NF	4,950 SQ FT±	3	G	LPD	ND
	LOCATION: ENTIRE ROOF						NOTE:		
	LOCATION:						NOTE:		
	LOCATION:						NOTE:		
	LOCATION:						NOTE:		
	LOCATION:						NOTE:

Picture 4 – **HA1 Double-Layered 12x12 Vinyl Tiles w/Mastic (Designated Areas Only – See Site Plan)**

It is recommended that notification of the presence of ACMs be provided to personnel engaged in day-to-day activities within the structure.

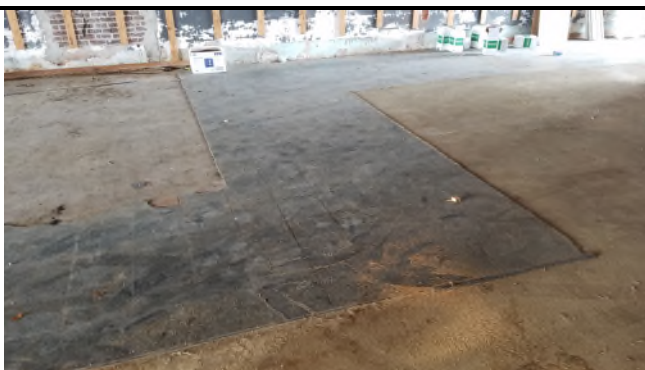
Picture 5 – **HA1 Double-Layered 12x12 Vinyl Tiles w/Mastic (Designated Areas Only – See Site Plan)**

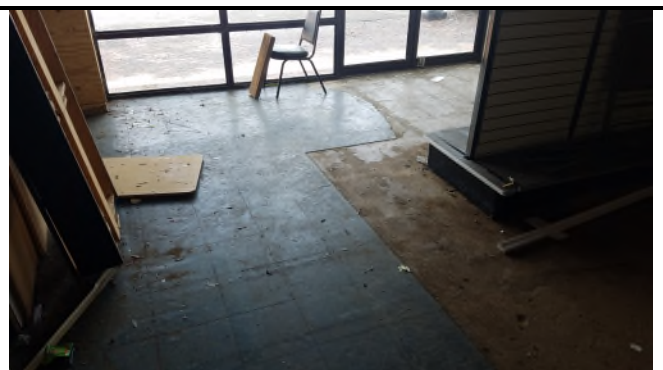
Picture 6 – **HA1 Double-Layered 12x12 Vinyl Tiles w/Mastic (Designated Areas Only – See Site Plan)**

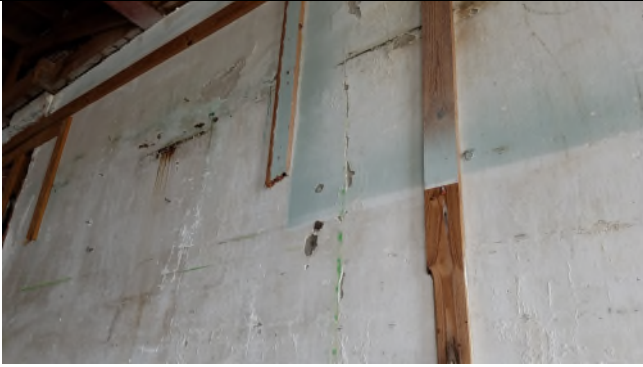
Picture 7 – HA20 Plaster Skim Coat on Concrete Block Walls

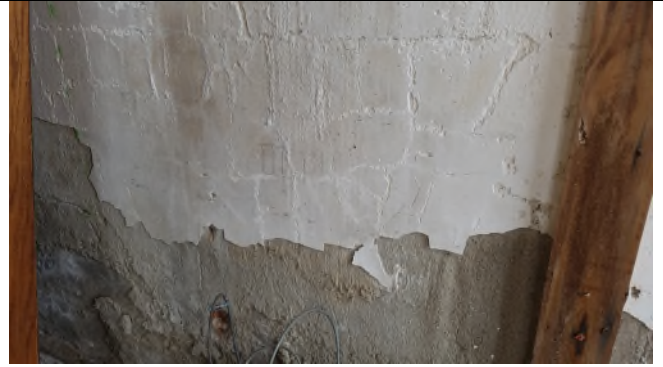
Picture 8 – HA20 Plaster Skim Coat on Concrete Block Walls

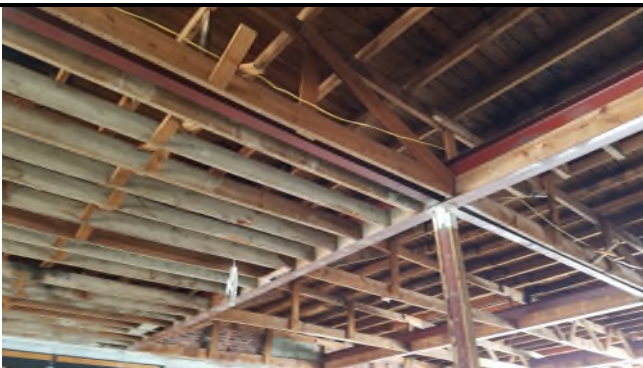
Picture 9 – Non-Suspect Exposed Ceiling Structure

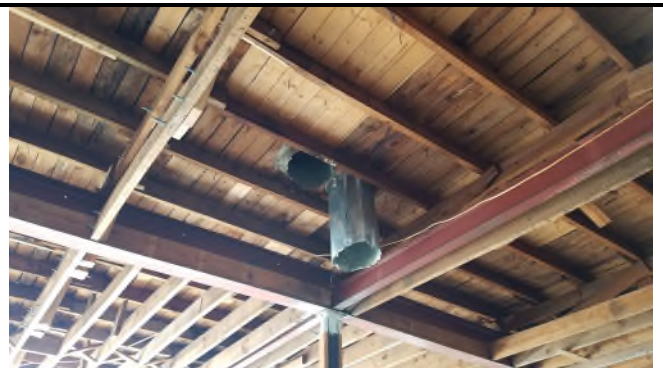
Picture 10 – HA50 HVAC Tape Mastic

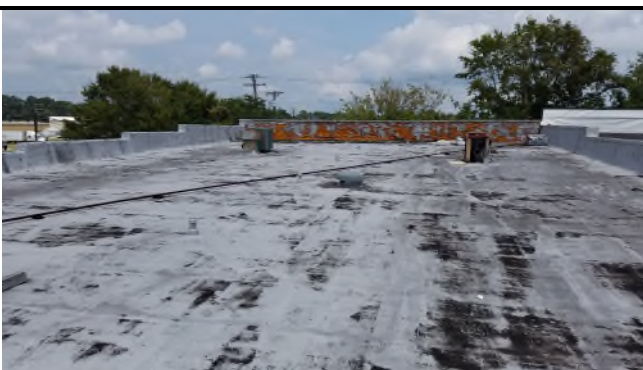
Picture 11 – HA80 Roofing Materials

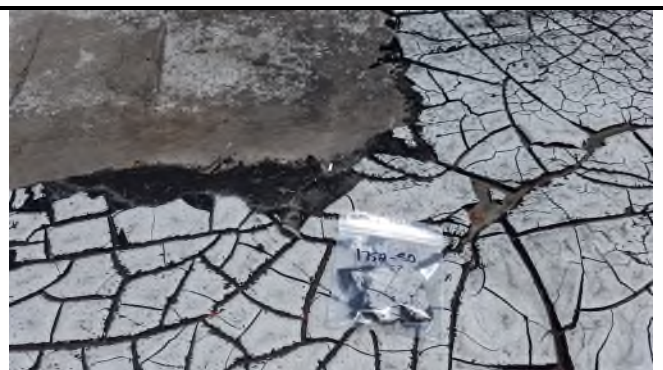
Picture 12 – HA80 Roofing Materials
