Asbestos & Lead Based Paint Assessment

City of Spartanburg
135 Burke Avenue
Spartanburg, South Carolina 29306

Project Number: 0521-99

October 29, 2021

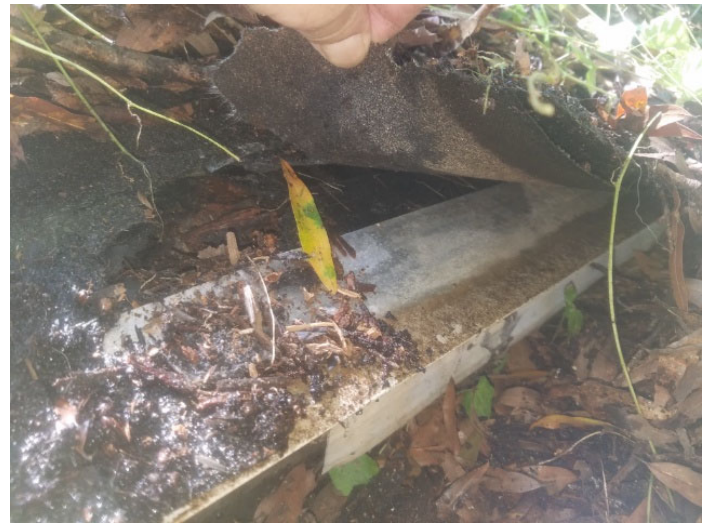
Photo 2 – One layer of shingle and felt

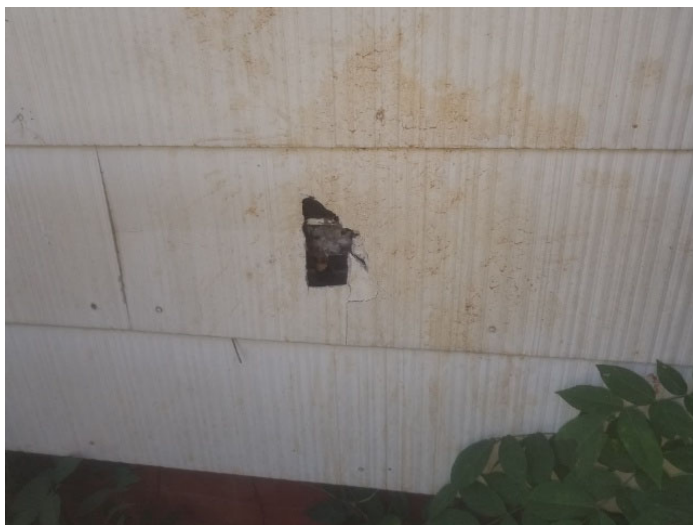
- Approximately 236 SF middle gray speckle roll vinyl floor in the in the middle right room.
- Approximately 1,500 SF of transite siding.
- Approximately 6 LF of tar on two chimneys – assumed positive.

Photo 3 – White transite with felt

1. Abate the asbestos containing materials in the structure prior to renovation or demolition.
2. Follow applicable asbestos regulations during renovation or demolition of the structure. You should be aware that stringent requirements are imposed upon anyone renovating or demolishing a structure in which ACM will be disturbed. This work must be performed in accordance with OSHA asbestos regulations, 29 CFR 1910 & 1926, and NESHAP asbestos regulations 40 CFR 61, subpart M. South Carolina regulations require the accreditation of personnel who work in the asbestos field and notification and permitting fees for asbestos removal projects. There is a 10 working day notification period required prior to abatement of asbestos in a facility. Failure to take proper precautions and actions to protect human health and the environment can result in penalties, danger to personnel, and construction delays.

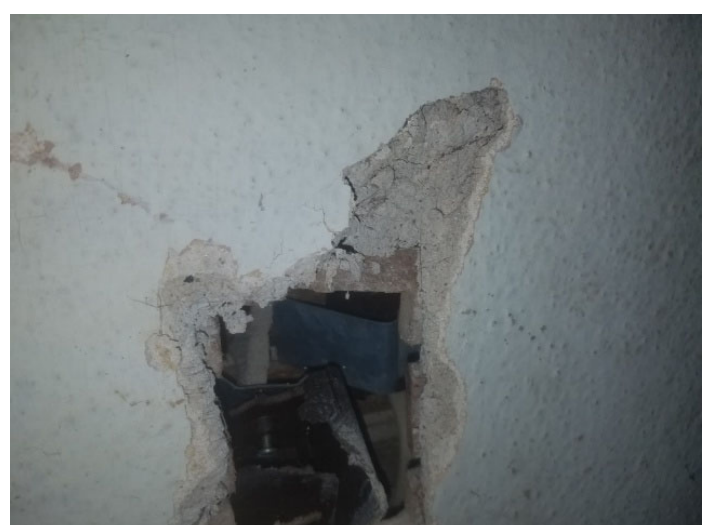
Photo 4 – Plaster throughout walls

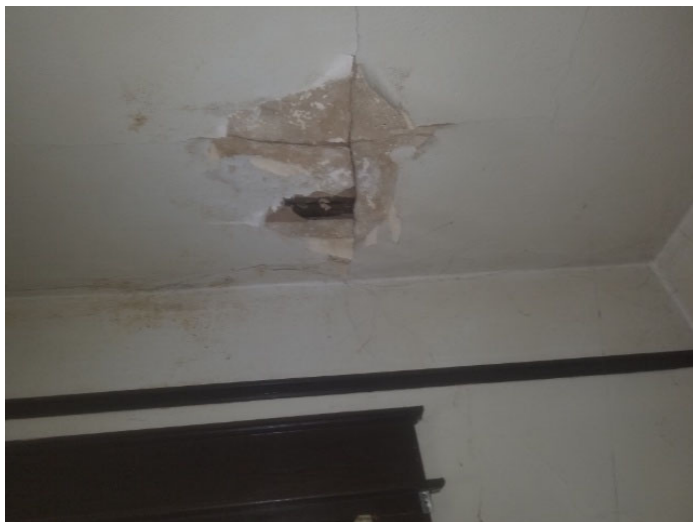
Photo 5 – Plaster throughout ceilings

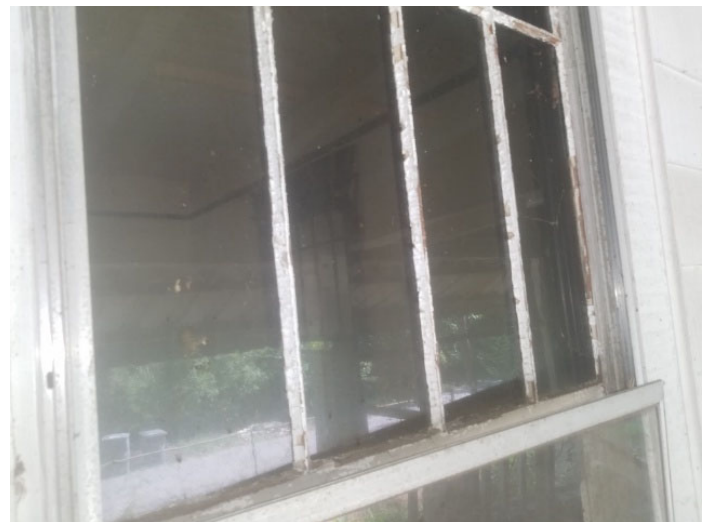
Photo 6 – Glazing found on wood windows

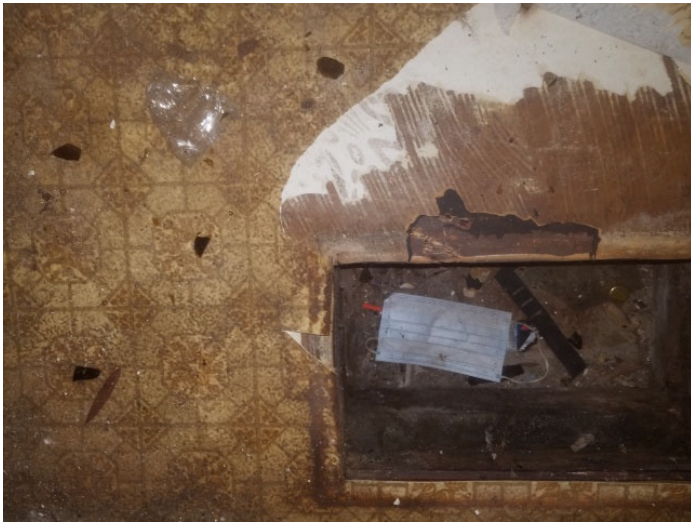
Photo 7 – Tan and brown roll vinyl flooring with second layer of tan and red flooring in front right room

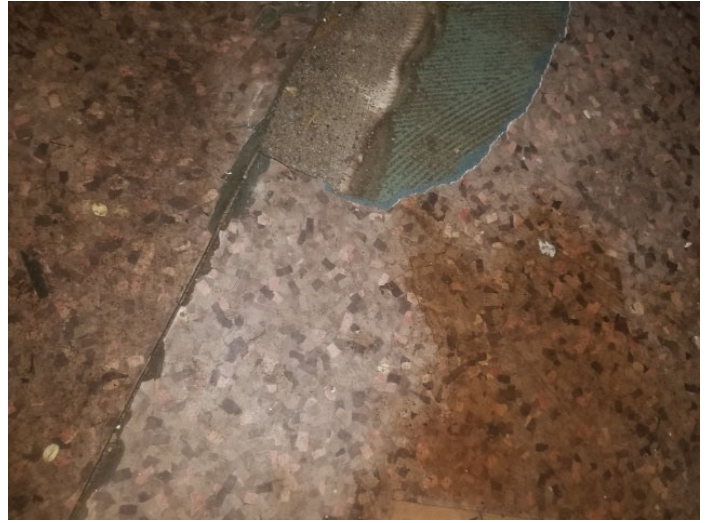
Photo 8 – Pink and brown speckle roll vinyl flooring in front left room

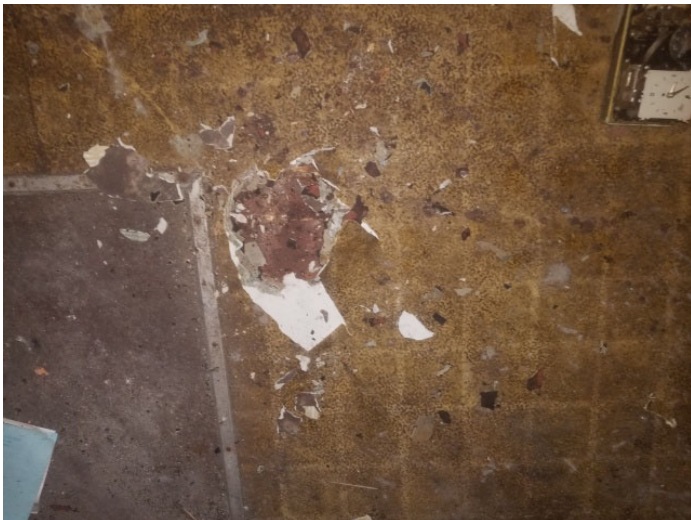
Photo 9 – Brown square vinyl flooring over gray spec roll vinyl over third layer with red bottom in middle room

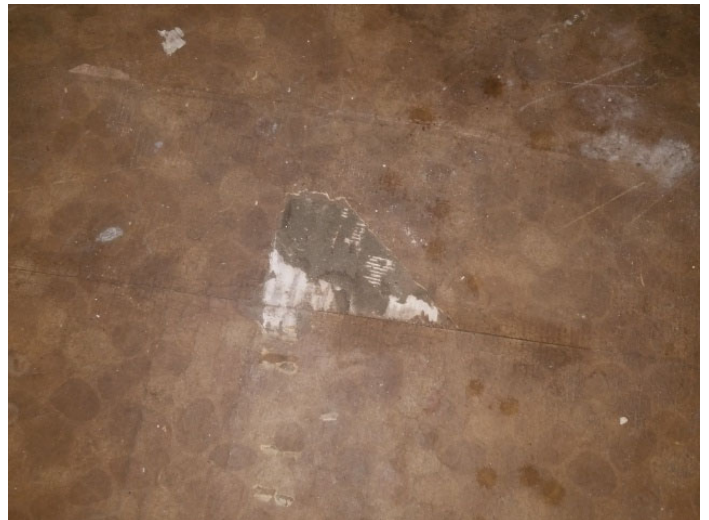
Photo 10 – Brown pebble pattern roll vinyl in middle left room

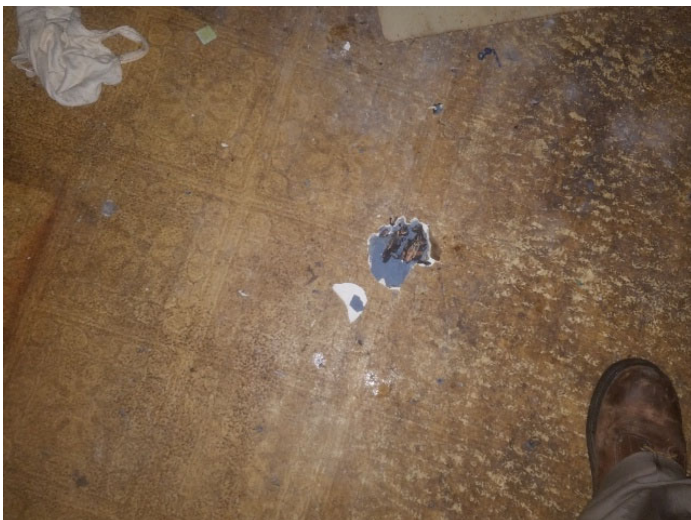
Photo 11 – Yellow large square pattern with blue felt in kitchen

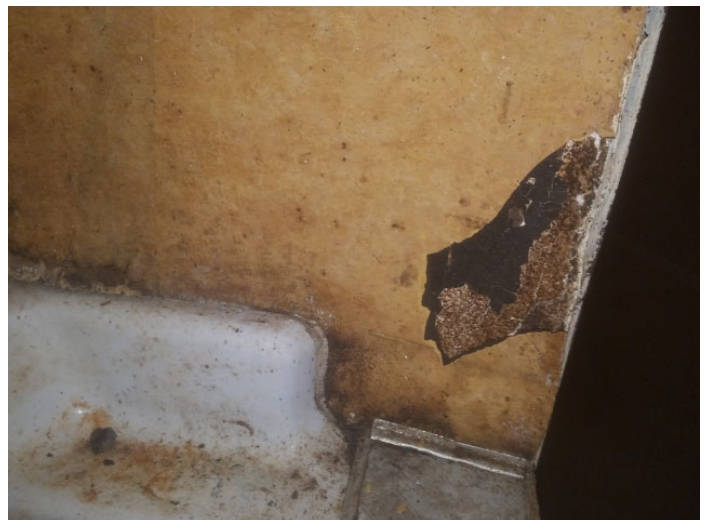
Photo 12 – Back splash located in the kitchen

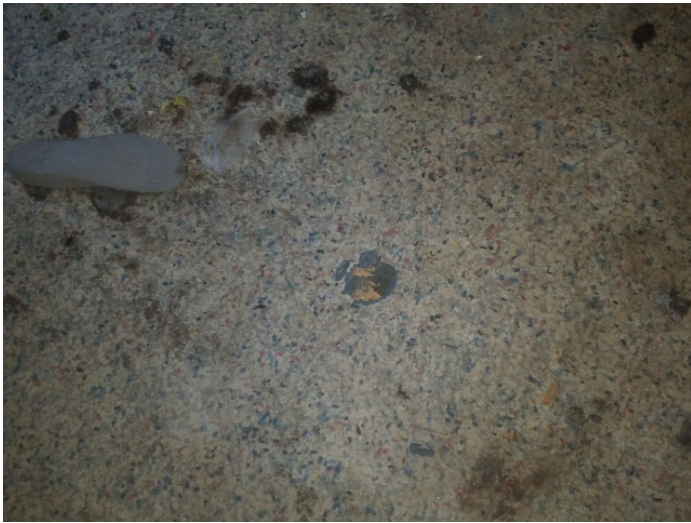
Photo 13 – Multi-color speckled roll vinyl flooring in left back room

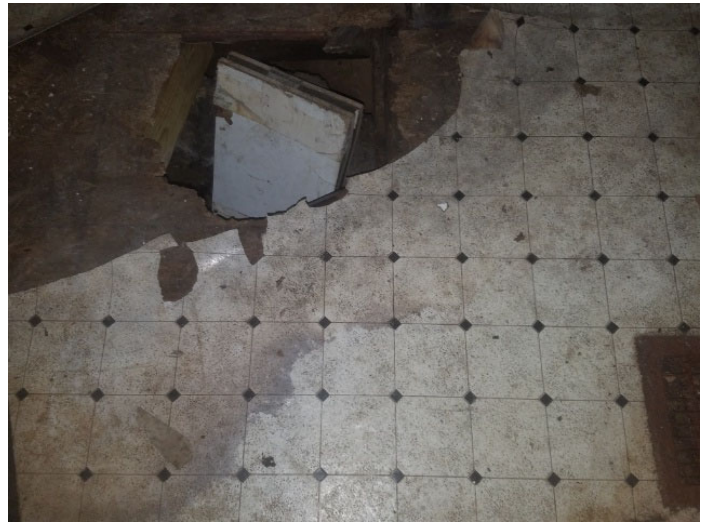
Photo 14 – White square with black diamond patterned roll vinyl in bathroom

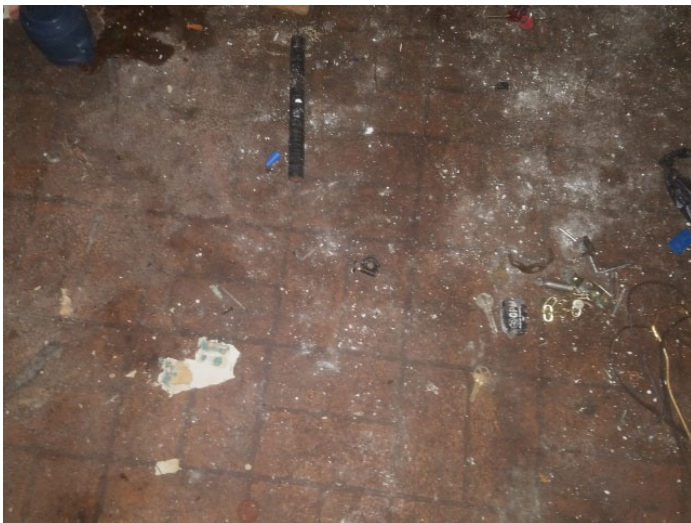
Photo 15 – Brown brick roll vinyl flooring in enclosed back porch

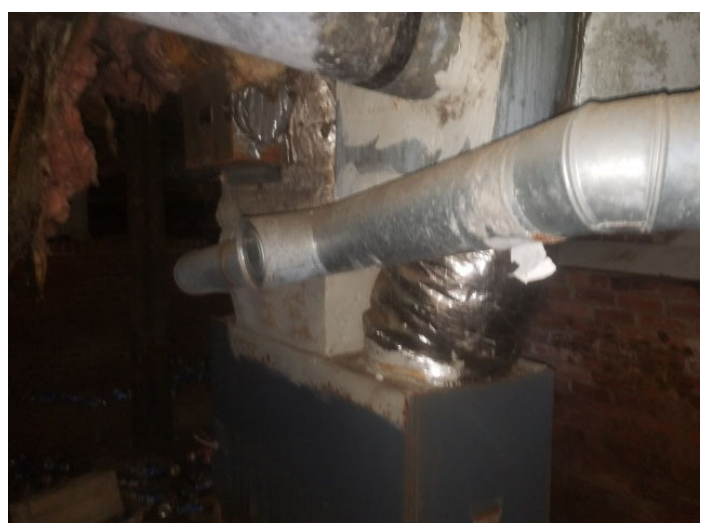
Photo 16 – HVAC tape in the basement area

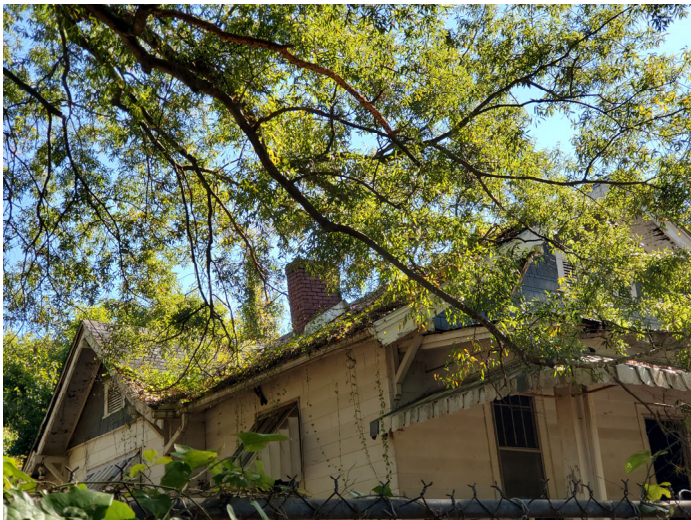
Photo 17 – Left chimney with tar assumed ACM.

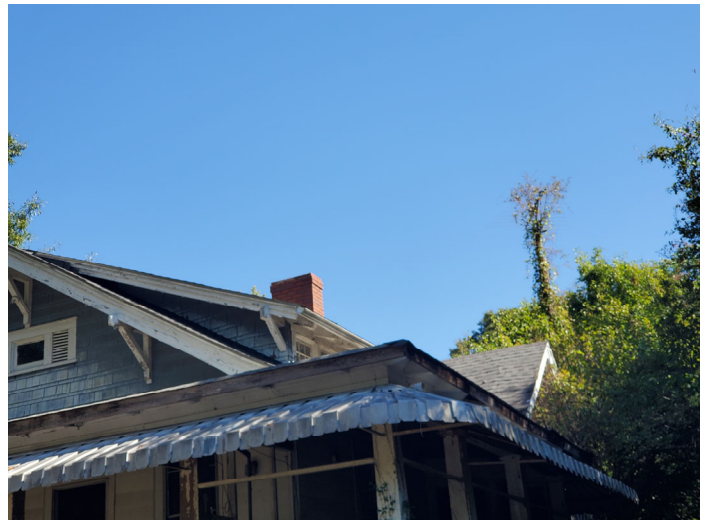
Photo 18 - Right chimney with tar assumed ACM.
