## **Asbestos & Lead Based Paint Assessment**

City of Spartanburg  
177 West Wood Street  
Spartanburg, South Carolina 29303

Project Number: 0521-99

October 29, 2021

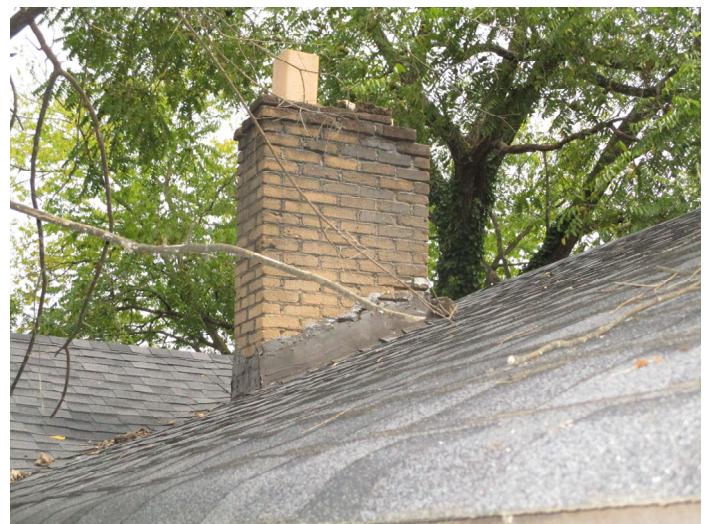
| Sample No. | Location | Sample Description | Analytical Results | Friable/Non Friable | Condition | Quantity |
|---|---|--|---|---|---|---|
| <b>Assumed</b> | <b>1 Chimney</b> | <b>Tar on Chimney</b> | <b>Assumed</b> | <b>Non-Friable</b> | <b>Good</b> | <b>6 LF</b> |

Photo 2 – Assumed asbestos containing chimney tar.

1. Abate the asbestos containing materials in the structure prior to renovation or demolition.
2. Follow applicable asbestos regulations during renovation or demolition of the structure. You should be aware that stringent requirements are imposed upon anyone renovating or demolishing a structure in which ACM will be disturbed. This work must be performed in accordance with OSHA asbestos regulations, 29 CFR 1910 & 1926, and NESHAP asbestos regulations 40 CFR 61, subpart M. South Carolina regulations require the accreditation of personnel who work in the asbestos field and notification and permitting fees for asbestos removal projects. There is a 10 working day notification period required prior to abatement of asbestos in a facility. Failure to take proper precautions and actions to protect human health and the environment can result in penalties, danger to personnel, and construction delays.

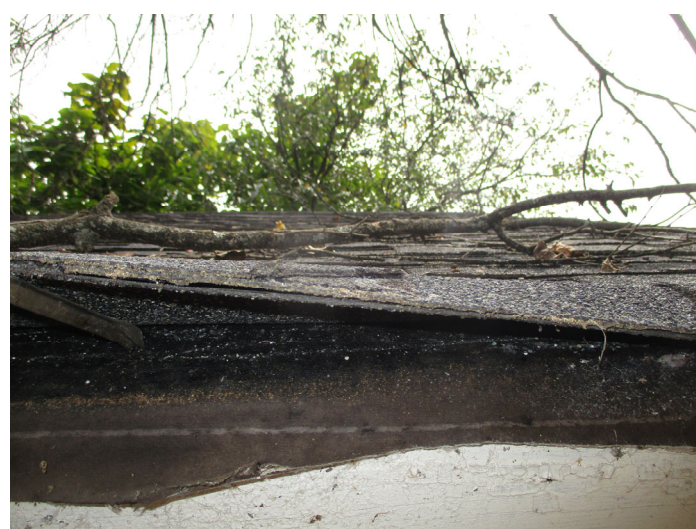
| Sample No. | Location | Sample Description | Analytical Results | Friable/Non Friable | Condition | Quantity | |
|---|---|---|---|---|---|---|---|
| 1 | Roof | 1 layer of shingles, 1 layer of felt | PLM - NAD | Non-Friable | Good | 2,900 SF | |

Photo 3 – One layer of shingle and one layer of felt.

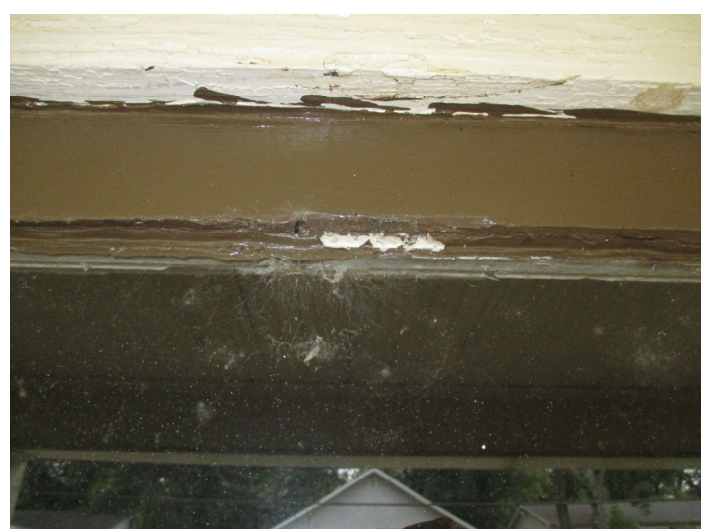
| Sample No. | Location | Sample Description | Analytical Results | Friable/Non Friable | Condition | Quantity | |
|---|---|---|---|---|---|---|---|
| 8 | Wood windows | Window glazing | PLM - NAD | Non-Friable | Good | 10 EA | |

Photo 4 – Window glazing on wood windows.

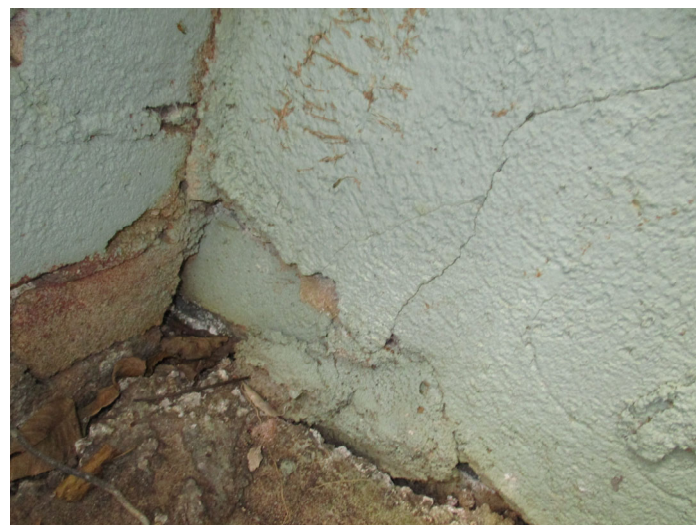
| Sample No. | Location | Sample Description | Analytical Results | Friable/Non Friable | Condition | Quantity | |
|---|---|---|---|---|---|---|---|
| 4 | Exterior walls | Texture over brick | PLM - NAD | Friable | Good | 3,000 SF | |

Photo 5 – Textured finish on exterior walls.

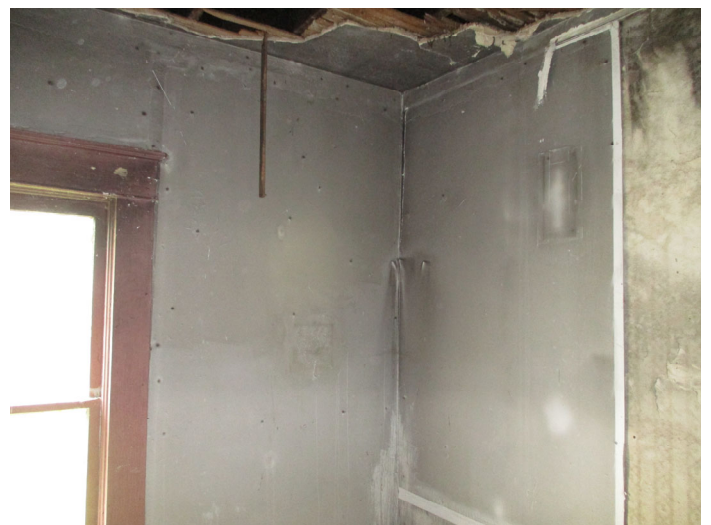
| Sample No. | Location | Sample Description | Analytical Results | Friable/Non Friable | Condition | Quantity | |
|---|---|---|---|---|---|---|---|
| 13 | Walls scattered throughout | Drywall and joint compound | PLM - NAD | Friable | Damaged | 1,500 SF | |

Photo 6 – Drywall and joint compound on walls scattered throughout.

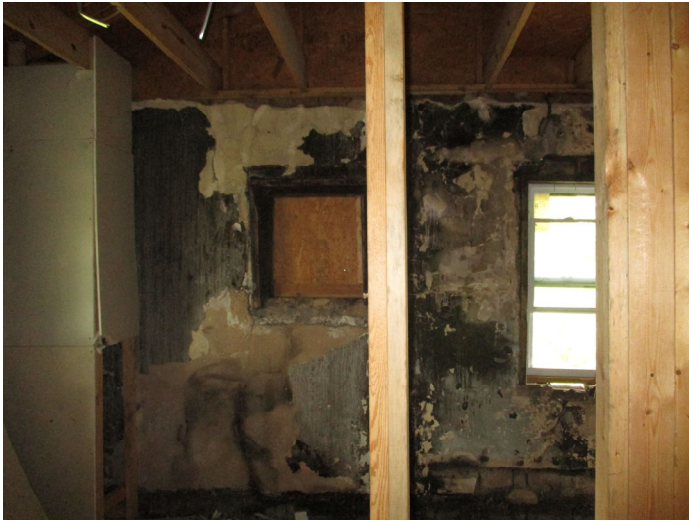
| Sample No. | Location | Sample Description | Analytical Results | Friable/Non Friable | Condition | Quantity | |
|---|---|---|---|---|---|---|---|
| 16 | Walls throughout | Plaster with finish | PLM - NAD | Friable | Significantly damaged | 3,900 SF | |

Photo 7 – Plaster with finish throughout walls.

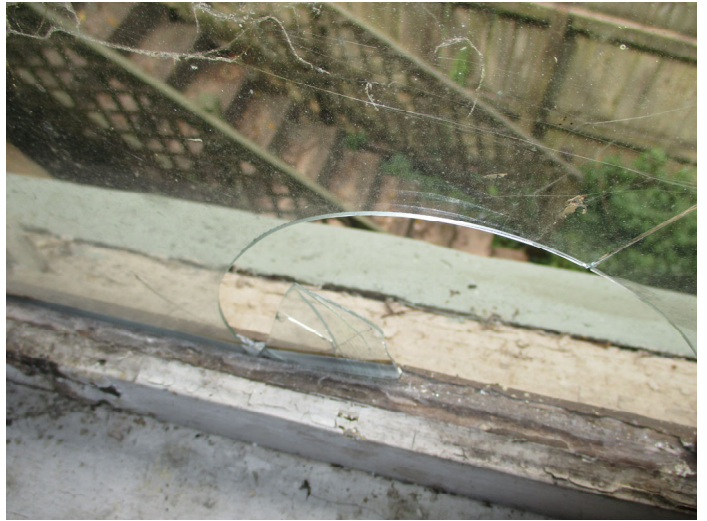
Photo 8 – Window glazing on wood windows

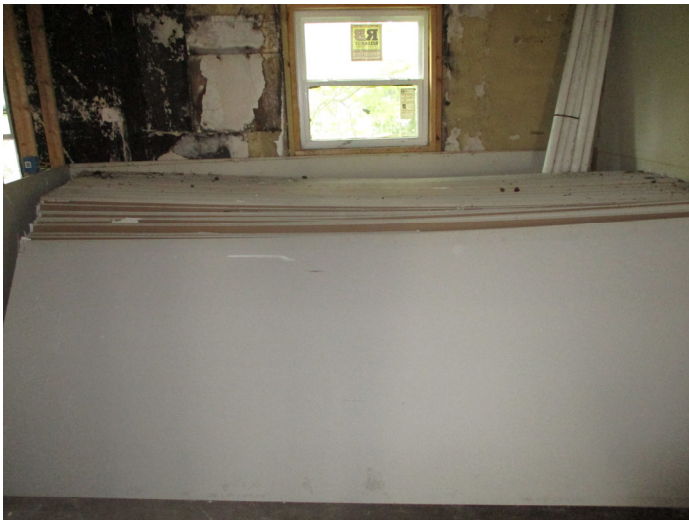
| Sample No. | Location | Sample Description | Analytical Results | Friable/Non Friable | Condition | Quantity | |
|---|---|---|---|---|---|---|---|
| 11 | Stacks of drywall - sporadic | Unfinished drywall | PLM - NAD | Friable | Good | 5,200 SF | |

Photo 9 – Stacks of drywall located sporadically throughout.

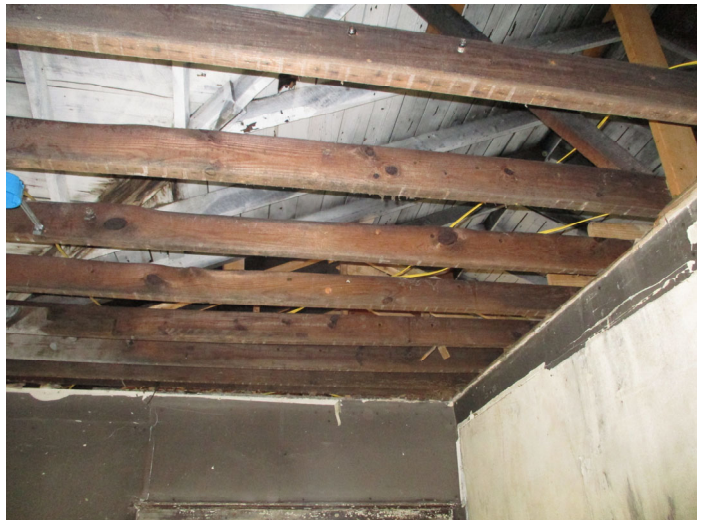
Photo 10 – Exposed ceiling joists.

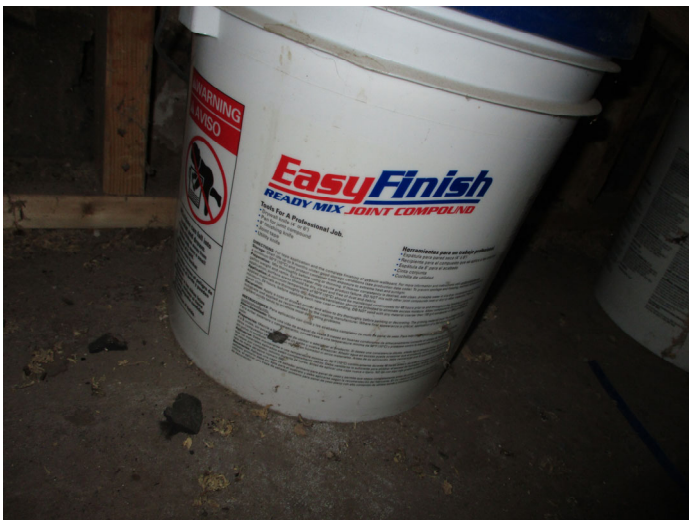
Photo 11 – 5 gallons of joint compound material observed in unfinished basement.

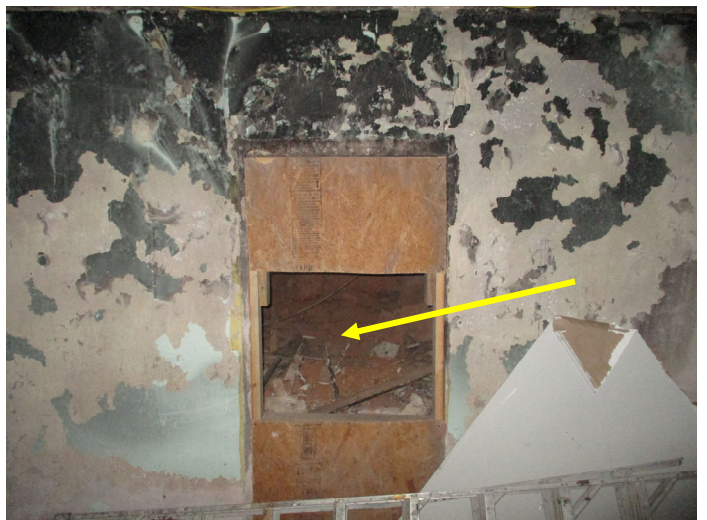
Photo 12 – Multiple types of layered vinyl flooring observed in porch crawlspace.

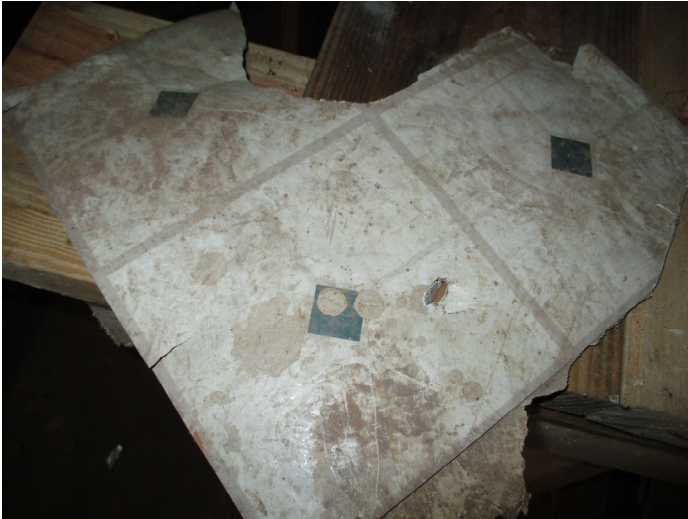
| Sample No. | Location | Sample Description | Analytical Results | Friable/Non Friable | Condition | Quantity |
|---|---|--|---|---|---|---|
| 23 | Crawlspace under front porch debris | Vinyl flooring, first layer square white with black diamond and second layer tan | PLM - NAD | Non-Friable | Good | 200 SF |

Photo 13 – Two layers of flooring. Square and diamond patten top layer, tan second layer located in crawlspace.

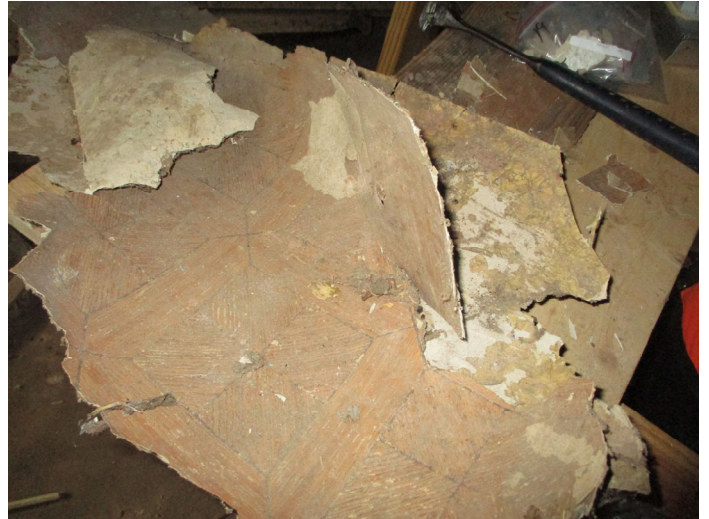
| Sample No. | Location | Sample Description | Analytical Results | Friable/Non Friable | Condition | Quantity |
|---|---|--|---|---|---|---|
| 26 | Crawlspace under front porch debris | Square wood pattern and tan marble under wood pattern vinyl flooring | PLM - 18% chry | Non-Friable | Good | 200 SF |

Photo 14 – Asbestos containing square wood pattern flooring over tan marble flooring located in crawlspace.

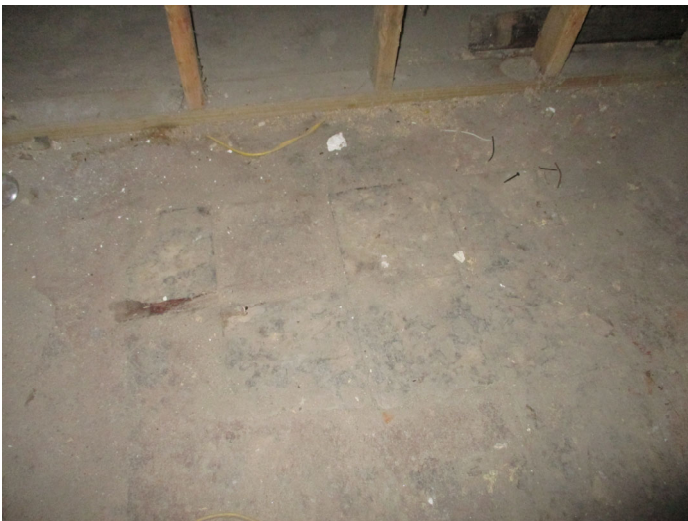
| Sample No. | Location | Sample Description | Analytical Results | Friable/Non Friable | Condition | Quantity |
|---|---|--|---|---|---|---|
| 29 | Unfinished basement floor sporadic (back left corner) | 9"x9" floor tile & mastic | PLM - 8% chry (flooring), <1% chry (mastic) | Non-Friable | Good | 50 SF |

Photo 15 – Asbestos containing 9"x9" floor tile & mastic located in the back left corner in the basement.

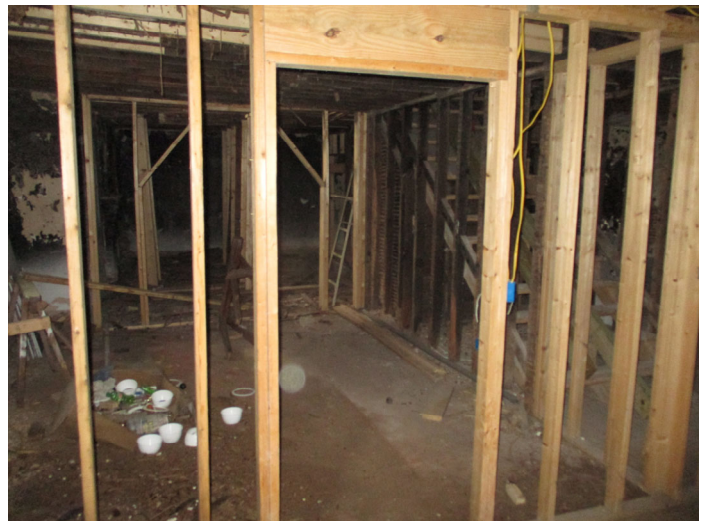
Photo 16 – Unfinished basement area with building material debris.
