Asbestos & Lead Based Paint Assessment

City of Spartanburg
183 Boundary Drive
Spartanburg, South Carolina 29303

Project Number: 0521-99

October 29, 2021

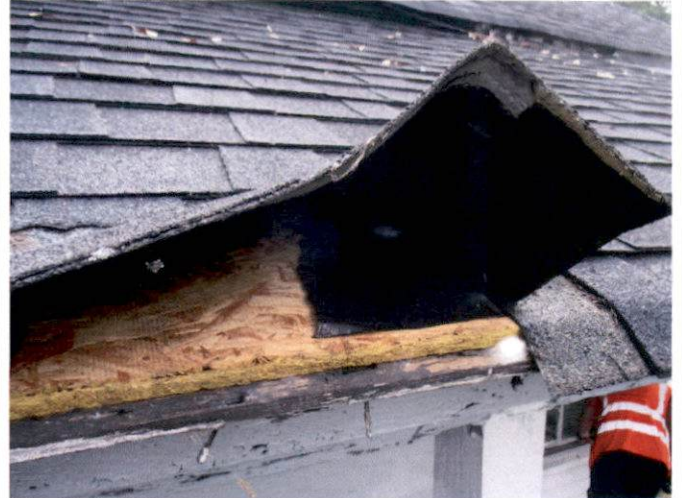
Photo 2 – One layer of shingle and felt

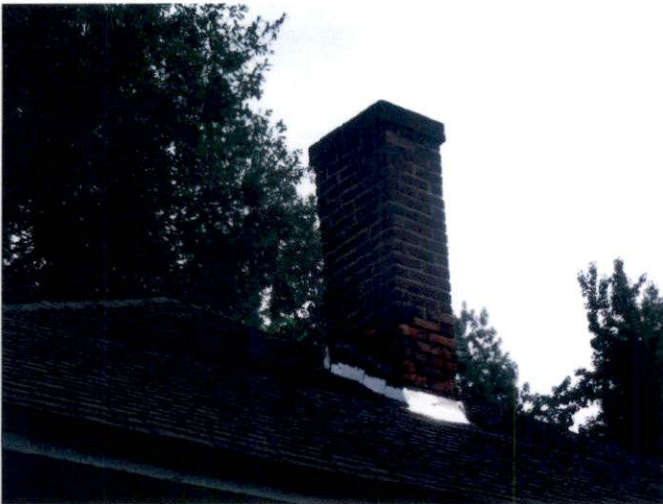
Photo 3 – Assumed asbestos containing tar on chimney.

1. Abate the asbestos containing materials in the structure prior to renovation or demolition.
2. Follow applicable asbestos regulations during renovation or demolition of the structure. You should be aware that stringent requirements are imposed upon anyone renovating or demolishing a structure in which ACM will be disturbed. This work must be performed in accordance with OSHA asbestos regulations, 29 CFR 1910 & 1926, and NESHAP asbestos regulations 40 CFR 61, subpart M. South Carolina regulations require the accreditation of personnel who work in the asbestos field and notification and permitting fees for asbestos removal projects. There is a 10 working day notification period required prior to abatement of asbestos in a facility. Failure to take proper precautions and actions to protect human health and the environment can result in penalties, danger to personnel, and construction delays.

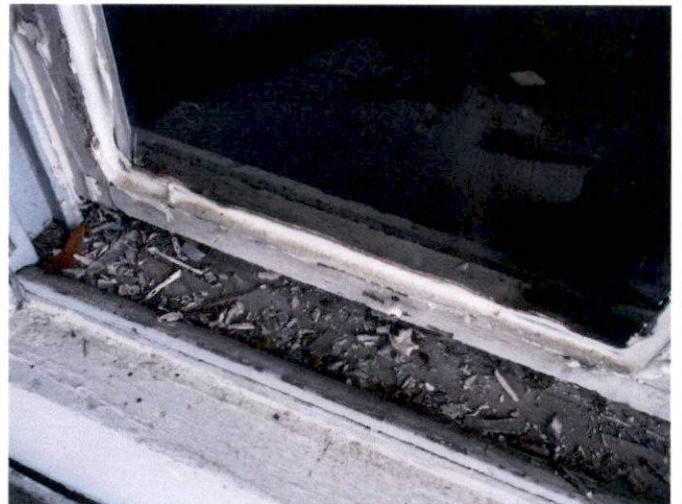
Photo 4 – Glazing debris located in window troughs

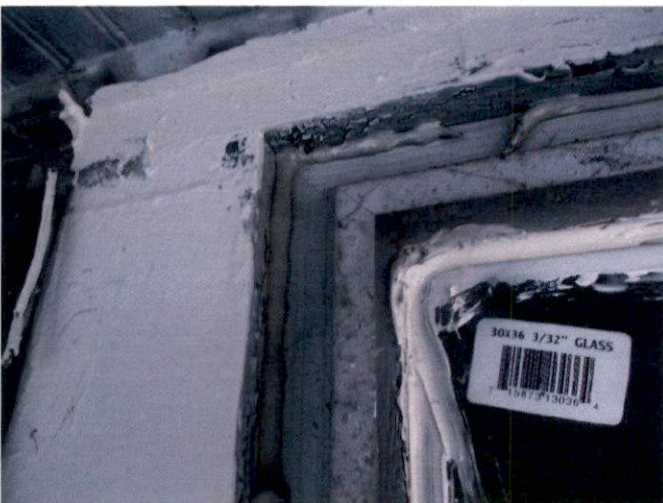
Photo 5 – Gray caulk located around aluminum casing of windows.

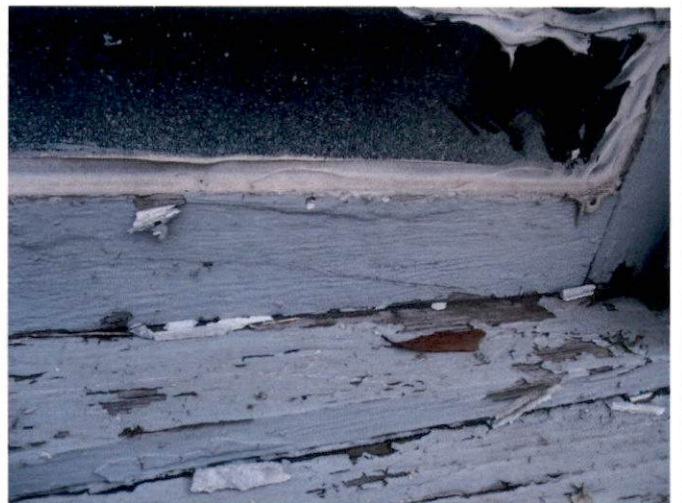
Photo 6 – White caulk located on wooden windows.

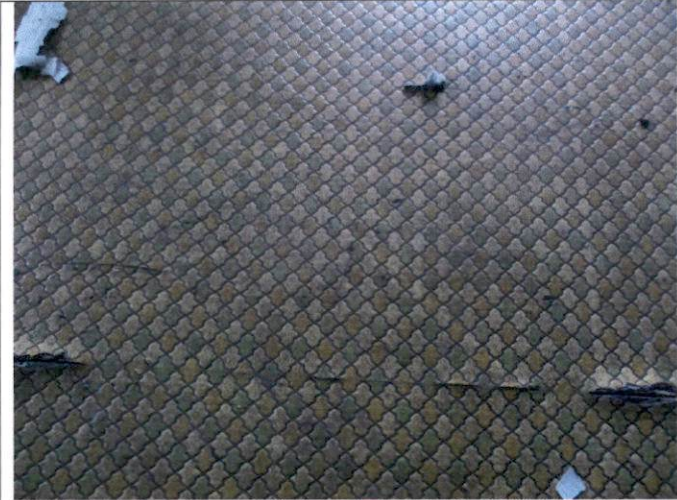
Photo 7 – Two layers of yellow roll vinyl with adhesive located in dining room and hallway.

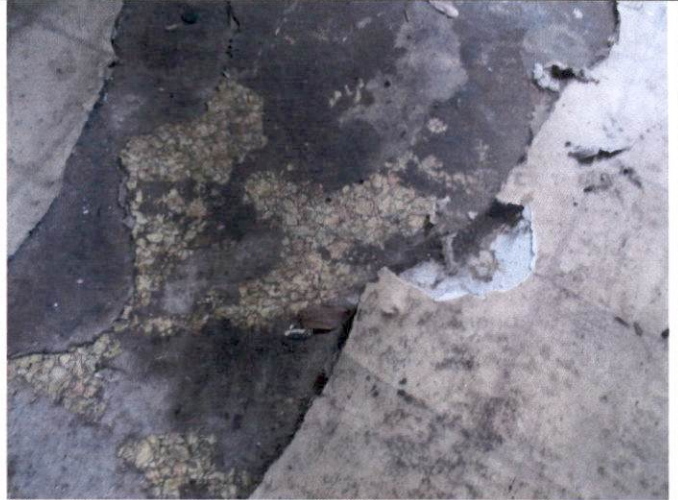
Photo 8 – Tan square roll vinyl flooring over tan/brown marble with green roll vinyl with adhesive in kitchen.

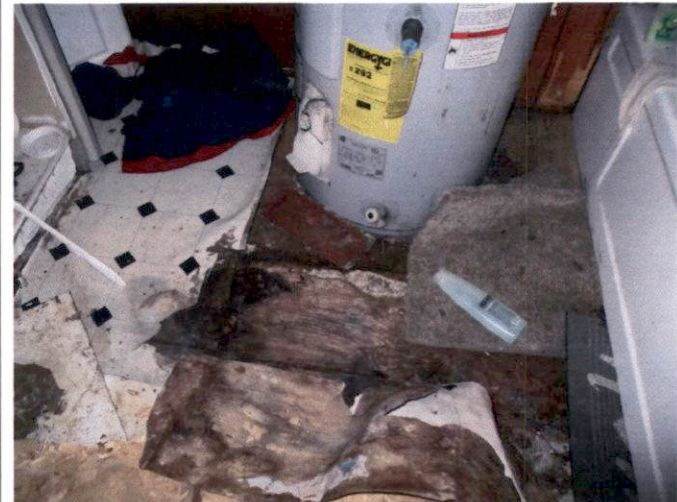
Photo 9 – Square and diamond pattern flooring over tan roll vinyl located in bathroom floor and shelves.

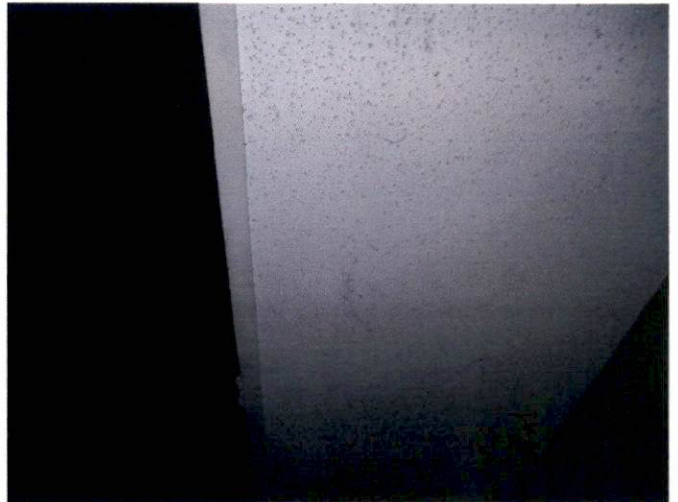
Photo 10 – Pinhole 2x4 ceiling tile located in back left room ceiling.

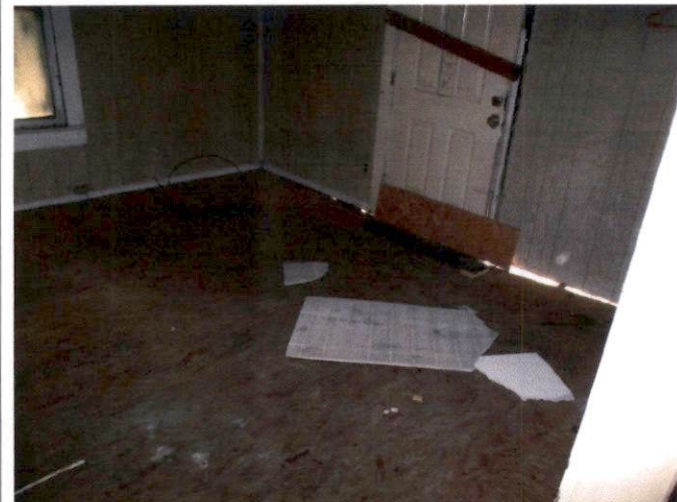
Damage to the rear joists of the structure was observed during the time of the assessment. The damage to the joist has led to sagging floors in the kitchen and rear room of the residence. The building was fully assessed; however, if additional ACM is discovered during demolition activities, Apex recommends that work activities stop until the suspect building materials may be sampled and analyzed.

Photo 11 – Floors located in the rear of the house are sagging due to damaged floor joists.
