## **Asbestos & Lead Based Paint Assessment**

City of Spartanburg  
190 North Thompson Street  
Spartanburg, South Carolina 29301

Project Number: 0521-99

October 29, 2021

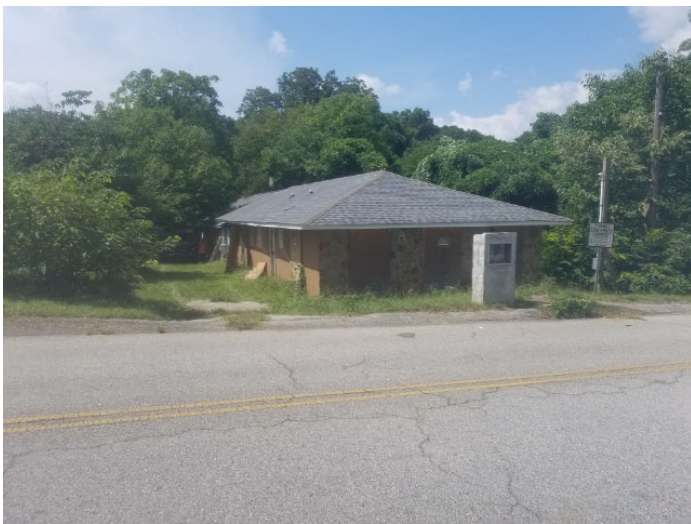
Photo 1 – 190 North Thompson Street in Spartanburg, South Carolina 29301

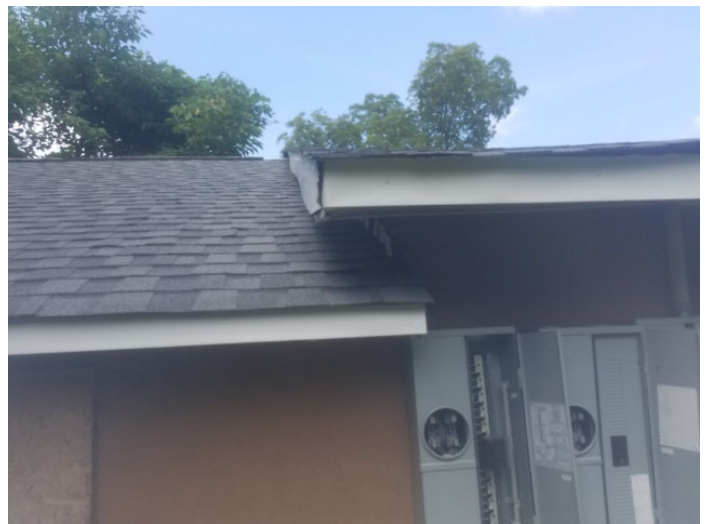
Photo 2 – Two sections of roofing material.

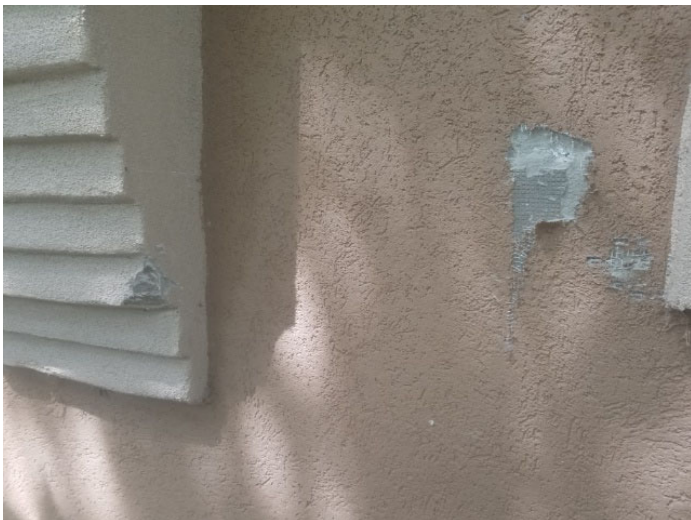
Photo 3 – Stucco and concrete exterior walls (EIFS).

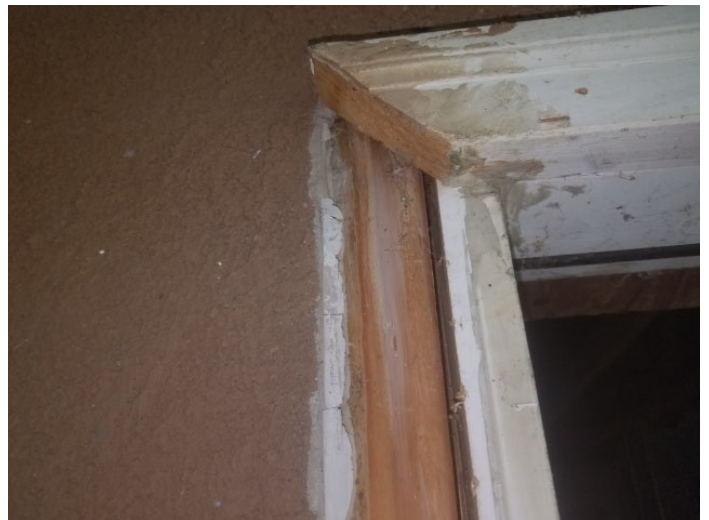
Photo 4 – Caulk located on exterior of door trim.

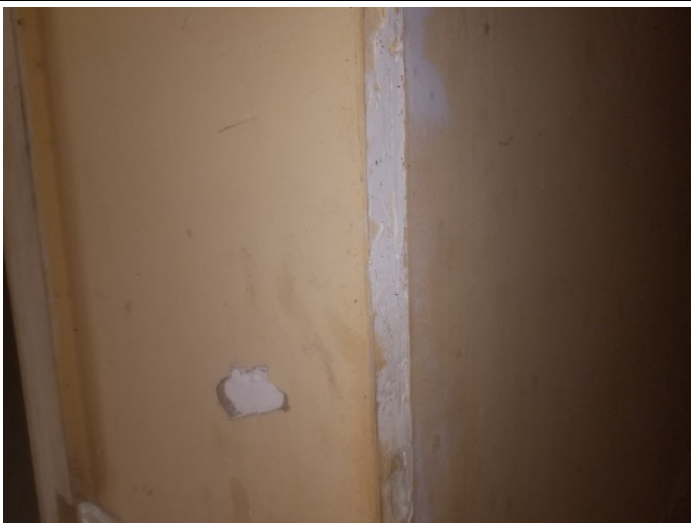
Photo 5 – Drywall sporadically throughout unit walls and ceilings.

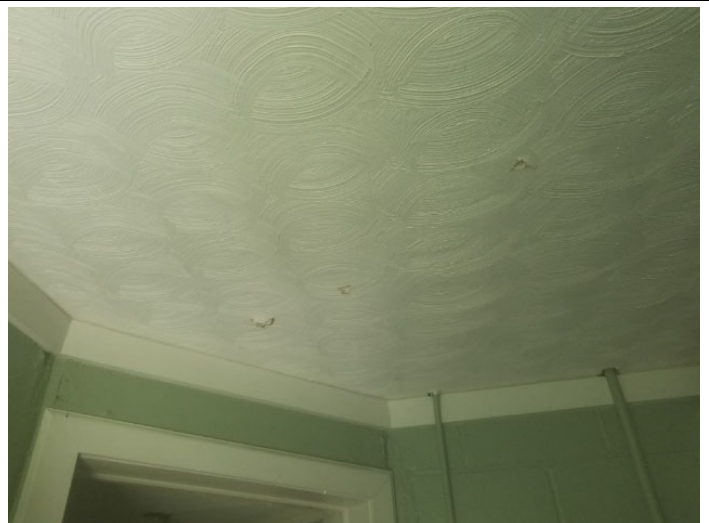
Photo 6 – Swirl ceiling texture in Unit 2, kitchen and hall.

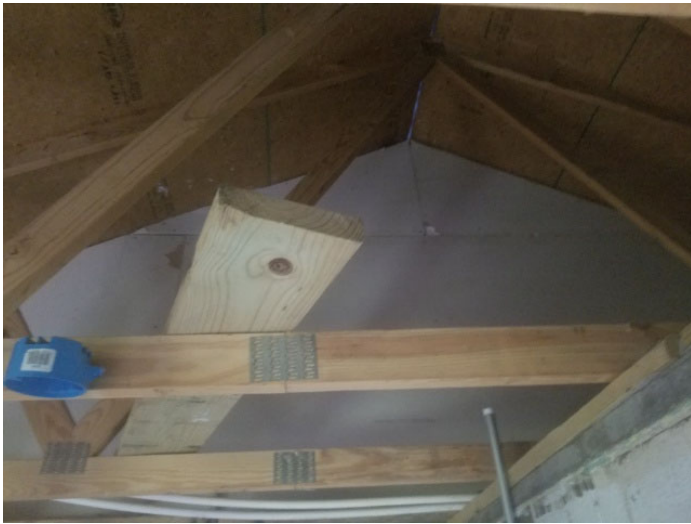
Photo 7 – Unfinished drywall in attic.

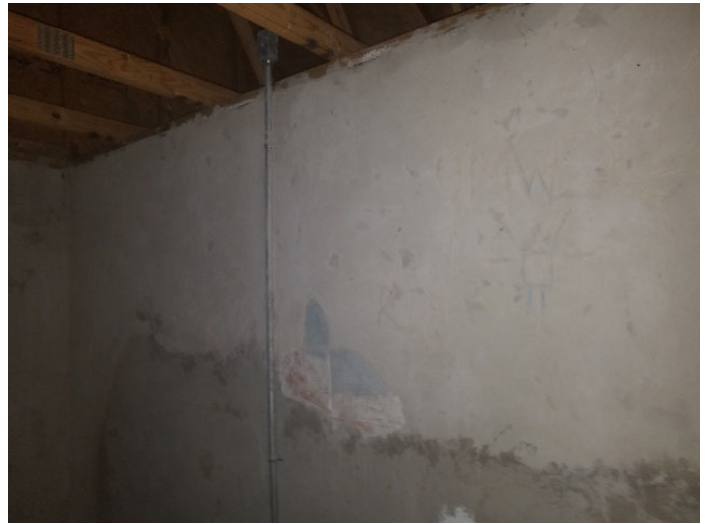
Photo 8 – Textured walls in unit 4 bedrooms.

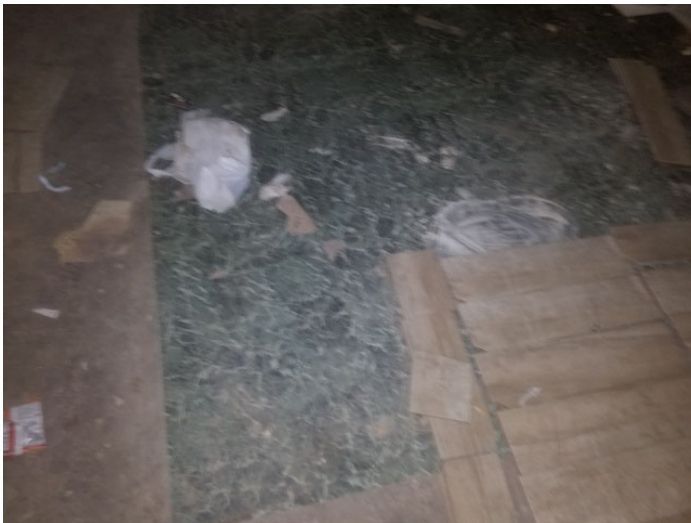
Photo 9 – Green marble floor tile located in unit 1 den and unit 4 hallway and kitchen.

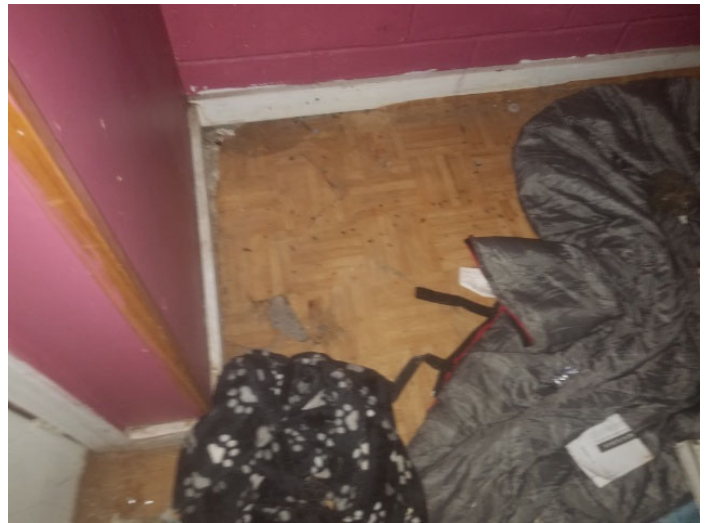
Photo 10 – Wood pattern roll vinyl flooring located in unit 1 bedroom.

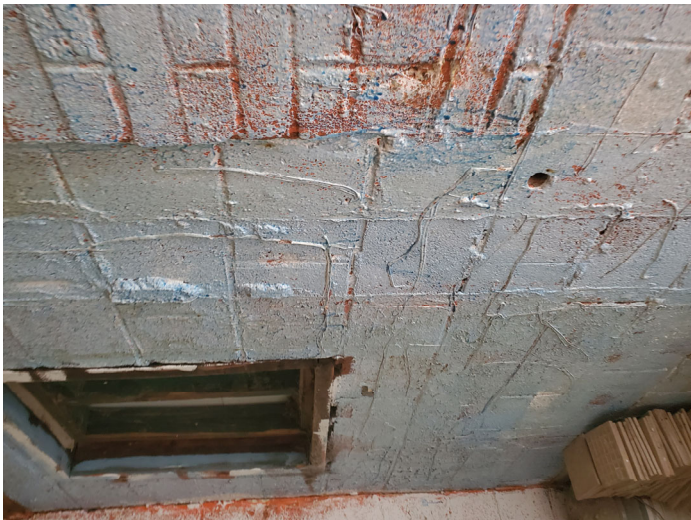
Photo 11 – Hard caulk located in unit 4 laundry room

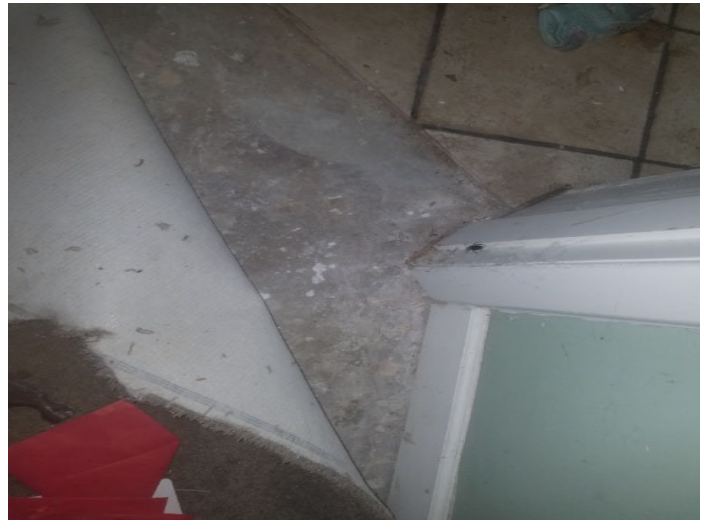
Photo 12 – Concrete floor under carpet.
