Asbestos & Lead Based Paint Assessment

City of Spartanburg
441 Tryon Street
Spartanburg, South Carolina 29301

Project Number: 0521-99

August 26, 2021

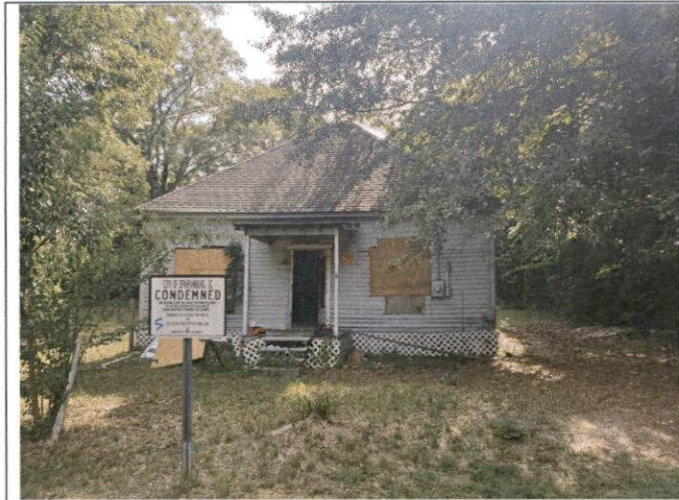
Photo 1 – 441 Tryon Street in Spartanburg, South Carolina 29301

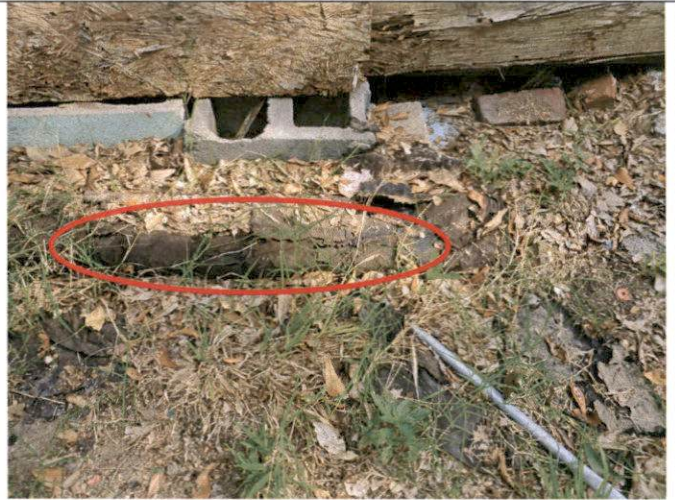
Photo 2 – Roll of black felt roofing material located on the ground near the house.

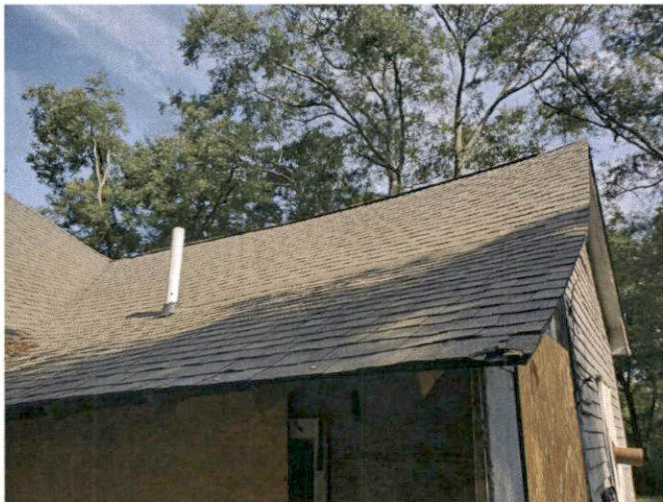
Photo 3 – Two layers of shingles with no felt paper.

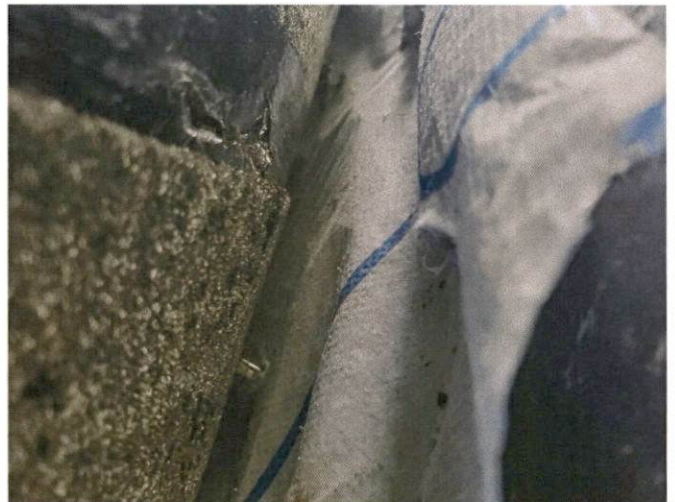
Photo 4 – Woven plastic material under shingles. Non - suspect ACM

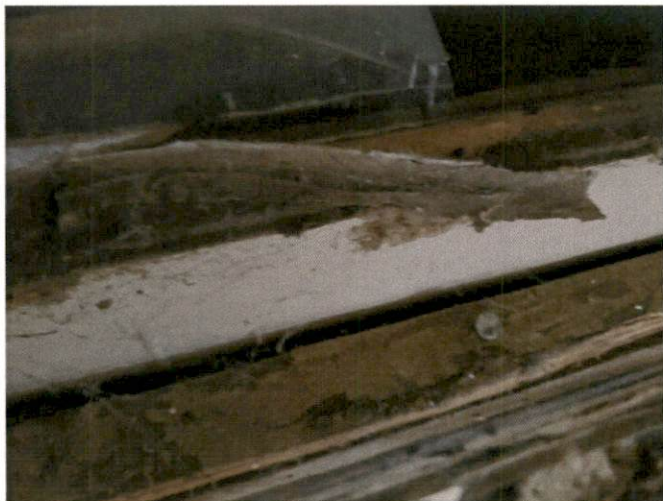
Photo 5 – Interior window caulk found on the living room wood window.

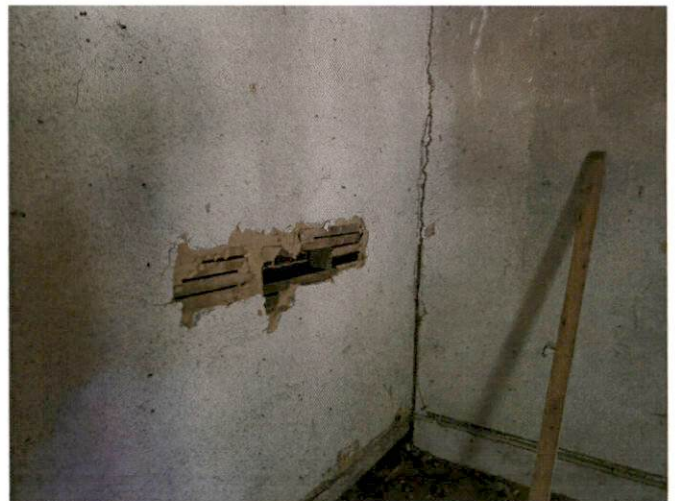
Photo 6 – Plaster, ceiling/wall texture and finish on ceiling and walls throughout.

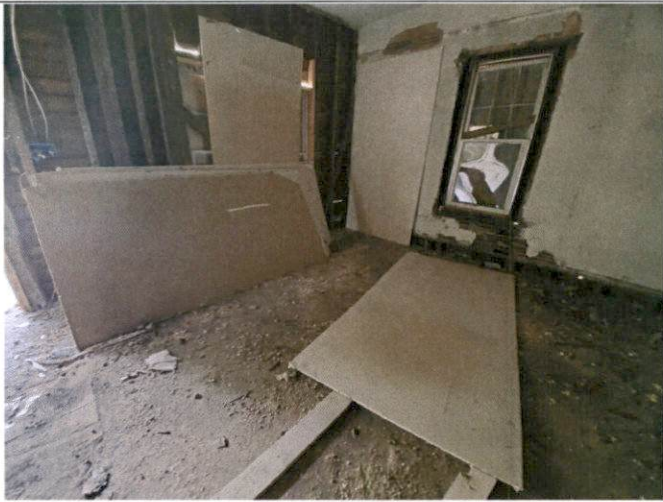
Photo 7 – Unfinished drywall throughout the building.

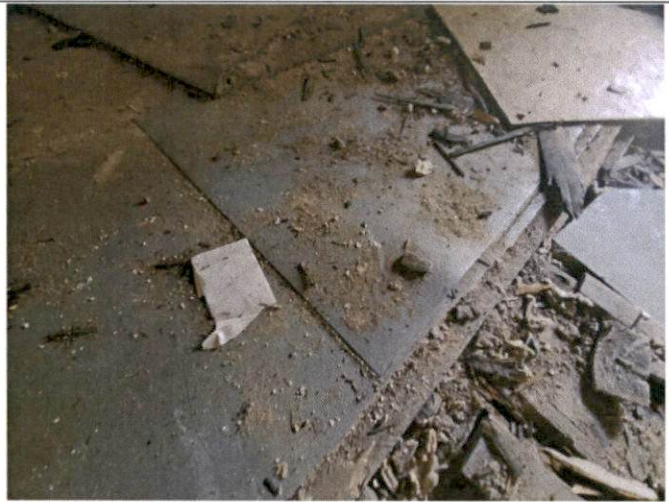
Photo 8 – Dark grey with specks roll vinyl with no mastic located in the living room.

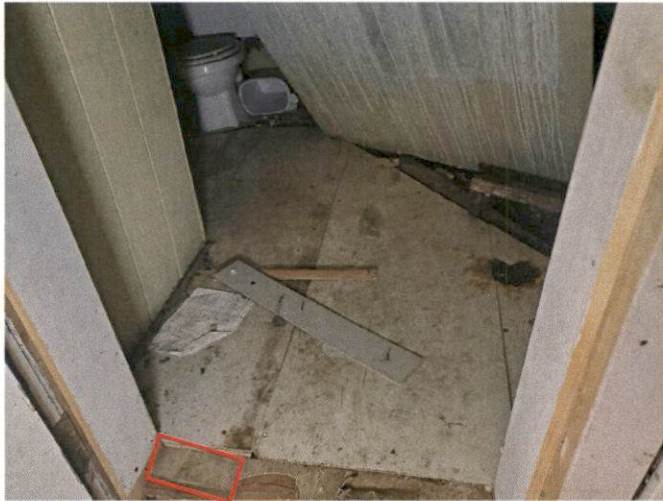
Photo 9 – Cream roll vinyl flooring located in bathroom.

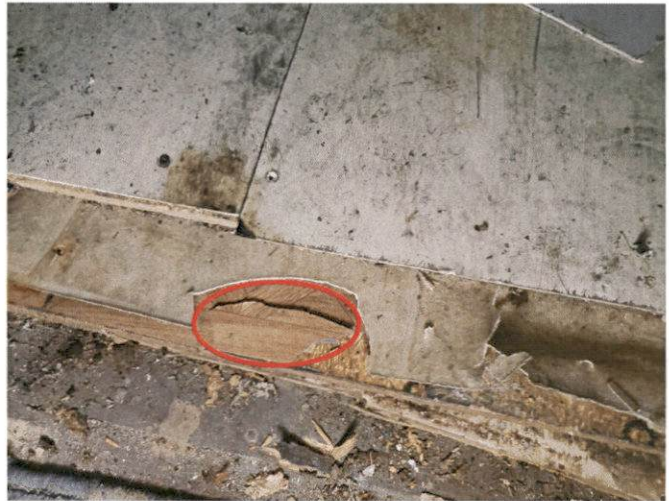
Photo 10 – 12x12 self-stick wood square pattern under cream colored roll vinyl flooring in the bathroom.

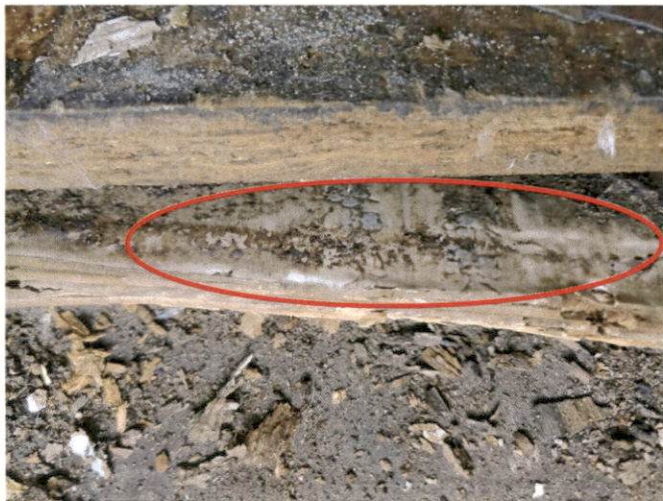
Photo 11 – White with blue flowers pattern roll vinyl flooring under wood flooring in the bathroom.

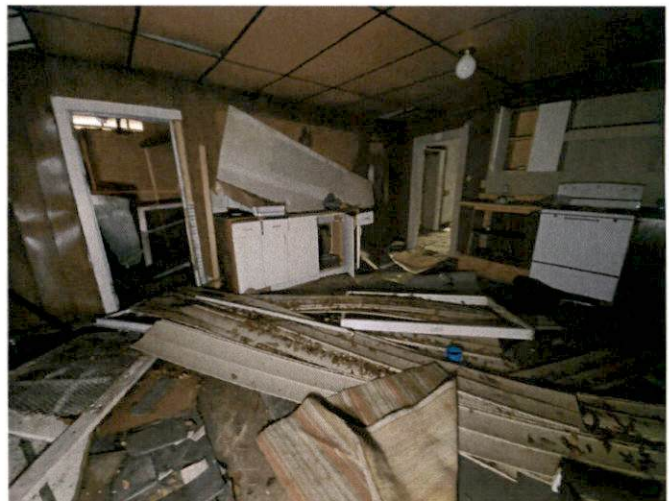
Photo 12 – Household debris throughout.

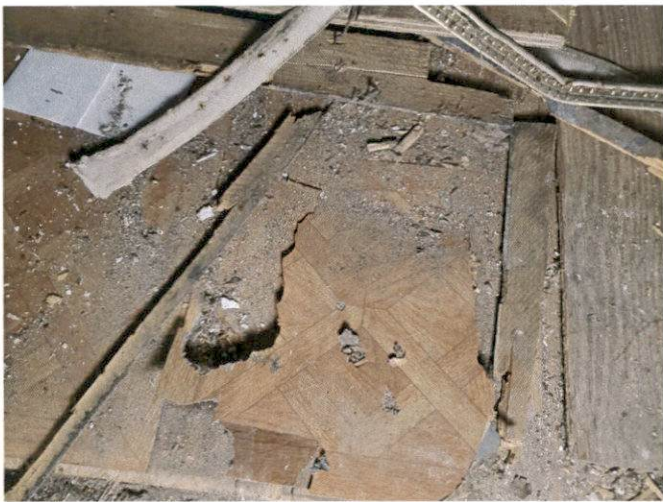
Photo 13 – 12x12 self-stick square pattern located in kitchen.

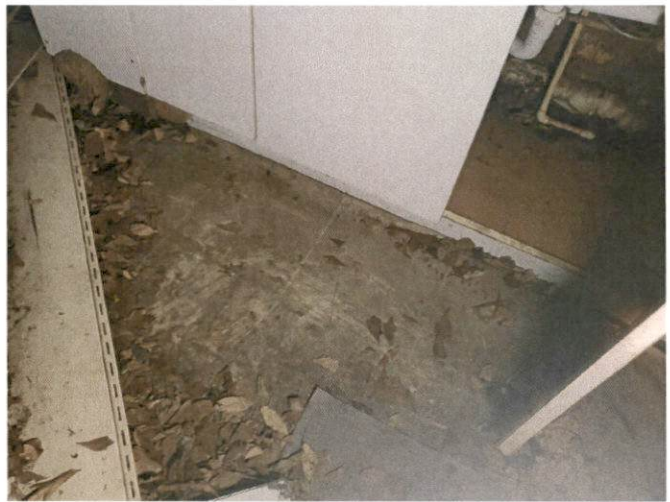
Photo 14 – Tan square pattern roll vinyl patch in front of kitchen sink.

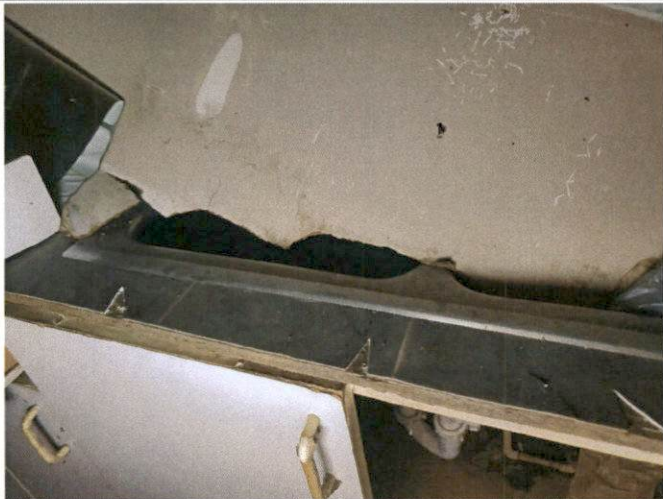
Photo 15 – Grey roll vinyl with adhesive located on kitchen counter.

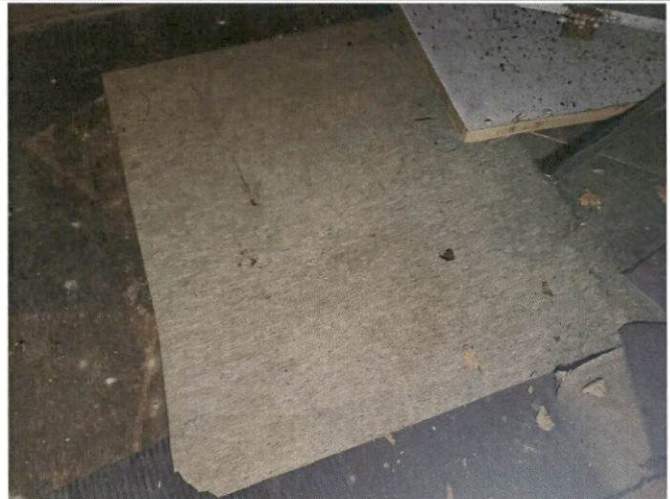
Photo 16 – Tan speckled roll vinyl with adhesive patch in kitchen.

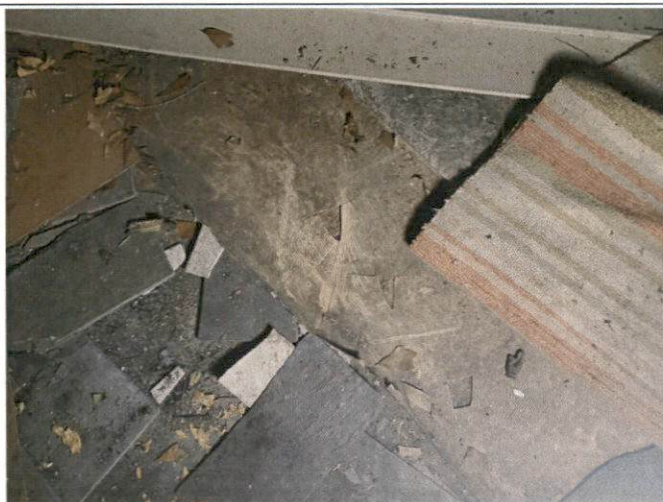
Photo 17 – Tan squared diamond pattern roll vinyl flooring with adhesive located in kitchen.

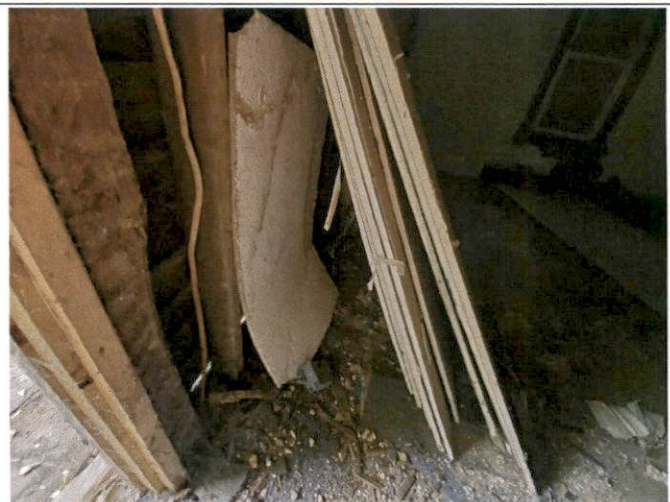
Photo 18 – 2x4 ceiling tile located behind drywall in living room.

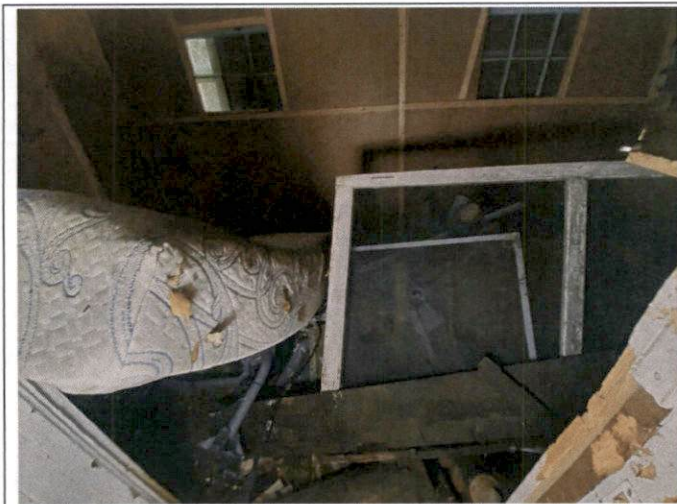
Photo 19 – Household debris located in back room off of the kitchen.

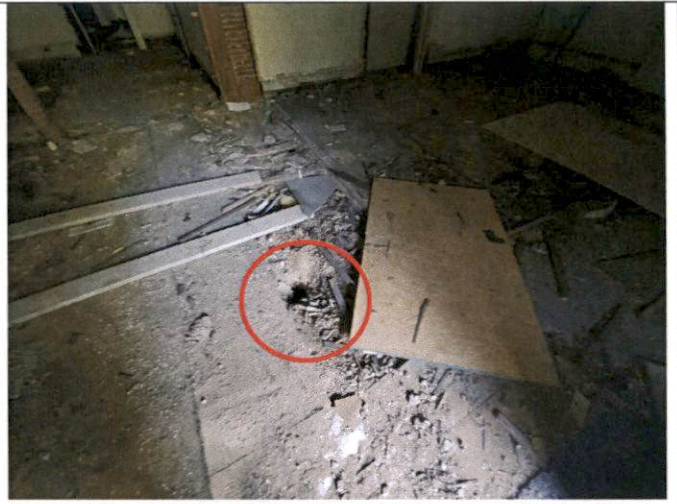
The front porch floor boards were observed to be unstable and the living room floor was observed to have a hole at the front entrance. Building material and household debris was observed throughout the building. The building was fully assessed; however, if additional ACM is discovered during demolition activities, Apex recommends that work activities stop until the suspect building materials may be sampled and analyzed.

Photo 20 – Hole located inside of entry way into the living room.
