Asbestos & Lead Based Paint Assessment

City of Spartanburg
571 Bee Street
Spartanburg, South Carolina 29301

Project Number: 0521-99

October 29, 2021

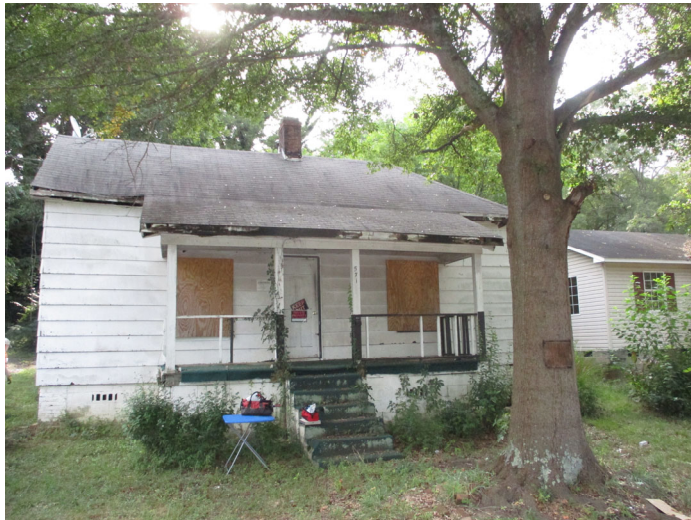
Photo 1 – 571 Bee Street in Spartanburg, South Carolina 29301

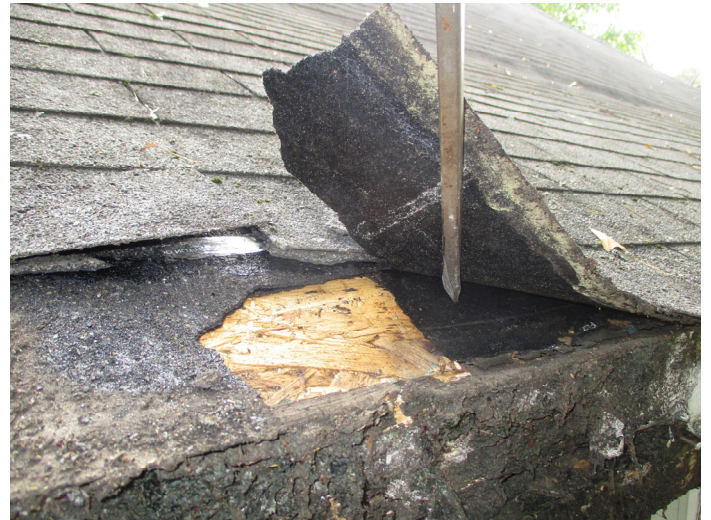
Photo 2 – One layer of shingle and felt

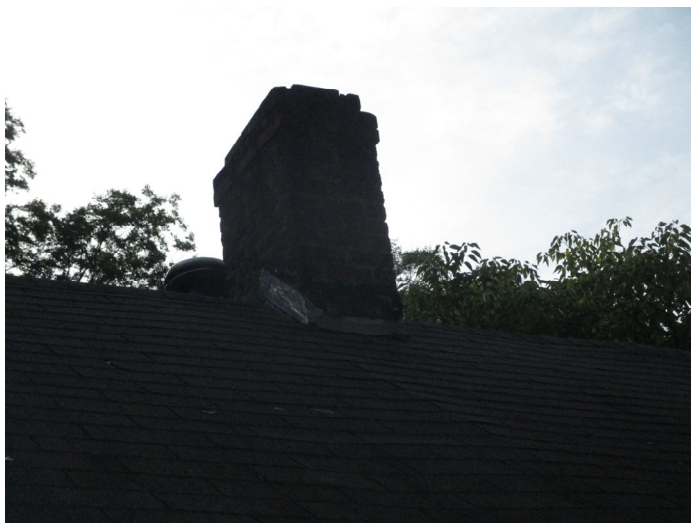
Photo 3 – Chimney tar assumed asbestos containing material.

1. Abate the asbestos containing materials in the structure prior to renovation or demolition.
2. Follow applicable asbestos regulations during renovation or demolition of the structure. You should be aware that stringent requirements are imposed upon anyone renovating or demolishing a structure in which ACM will be disturbed. This work must be performed in accordance with OSHA asbestos regulations, 29 CFR 1910 & 1926, and NESHAP asbestos regulations 40 CFR 61, subpart M. South Carolina regulations require the accreditation of personnel who work in the asbestos field and notification and permitting fees for asbestos removal projects. There is a 10 working day notification period required prior to abatement of asbestos in a facility. Failure to take proper precautions and actions to protect human health and the environment can result in penalties, danger to personnel, and construction delays.

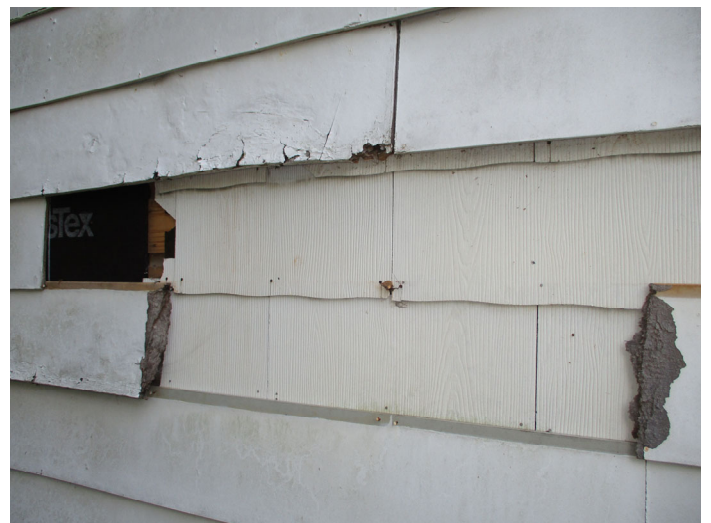
Photo 4 – White transite siding asbestos containing material.

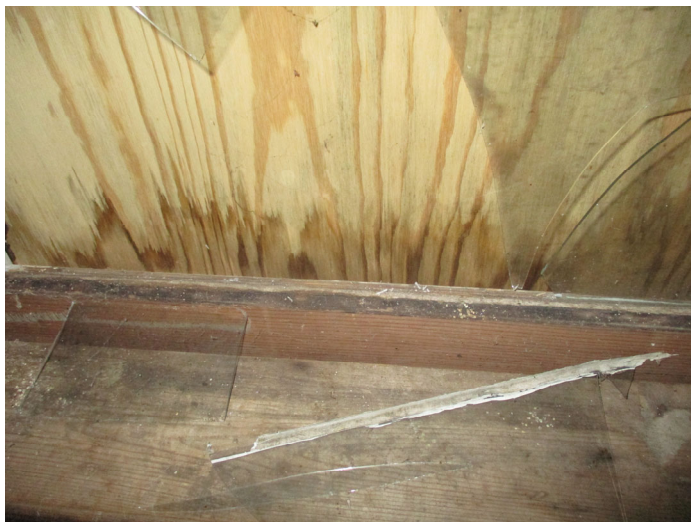
Photo 5 – Glazing found on wood windows

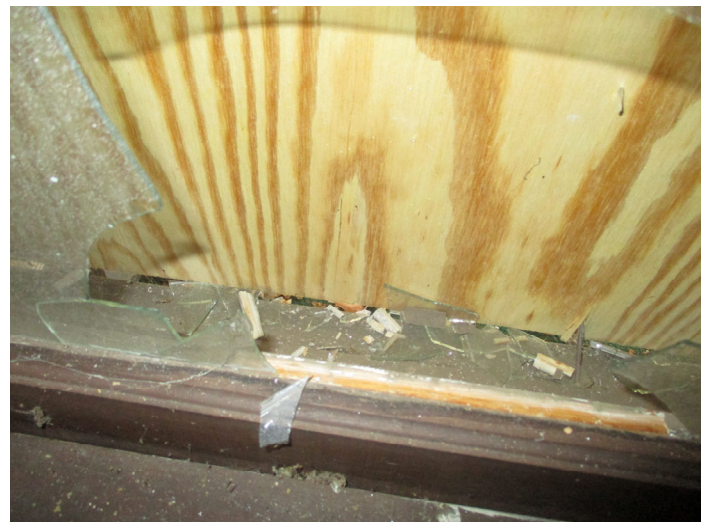
Photo 6 – Glazing found on wood windows

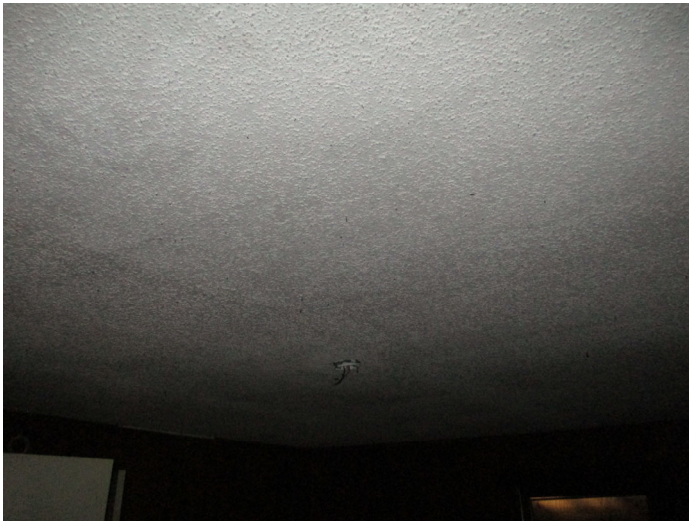
Photo 7 – Ceiling texture throughout.

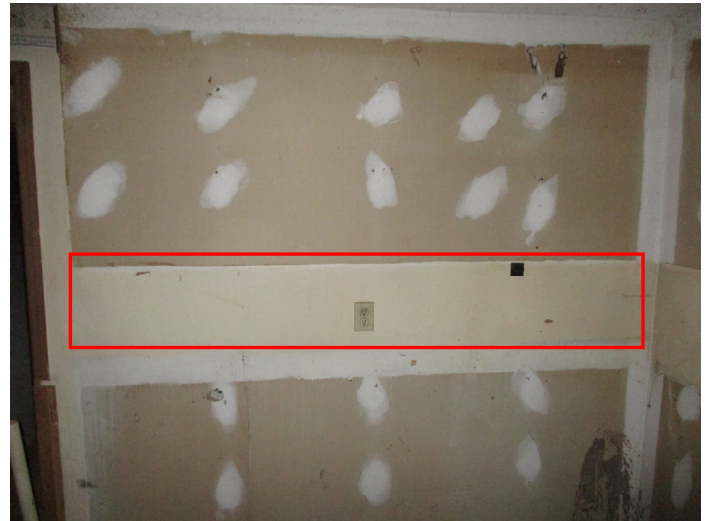
Photo 8 – Beige drywall mud located on ceilings and walls is asbestos containing material.

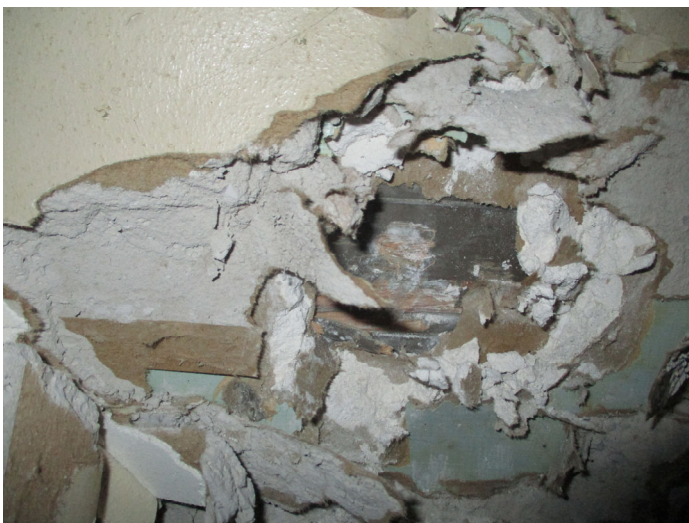
Photo 9 – Second layer of unfinished drywall scattered throughout.

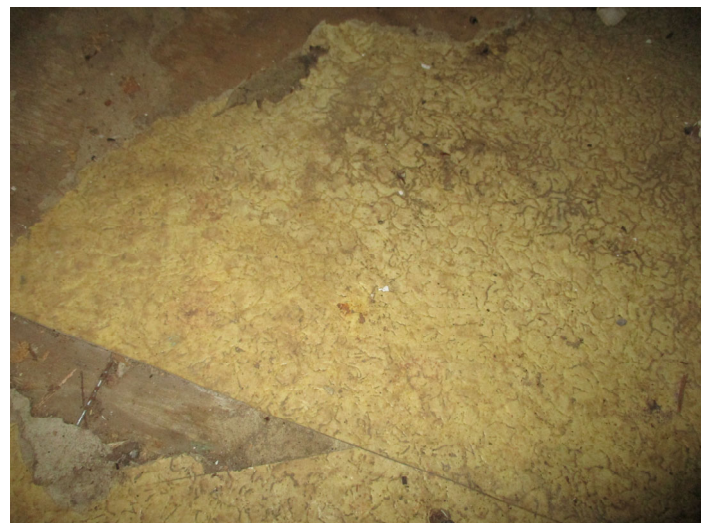
Photo 10 – Tan ripple pattern roll vinyl floor & mastic located in the front right and middle left room.

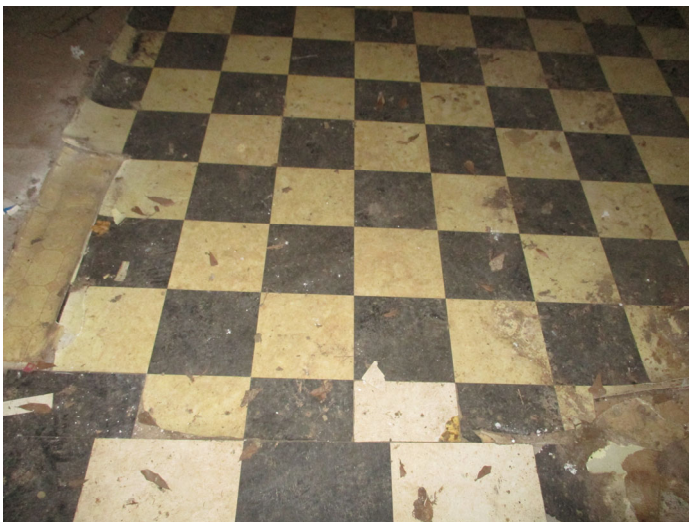
Photo 11 – Black and white roll vinyl floor & mastic located in the kitchen

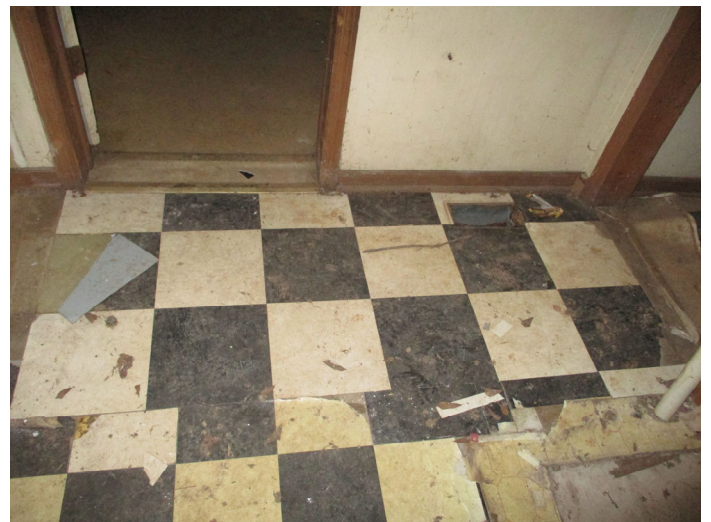
Photo 12 – Back and white 12"x12" self-stick floor tiles located in the kitchen

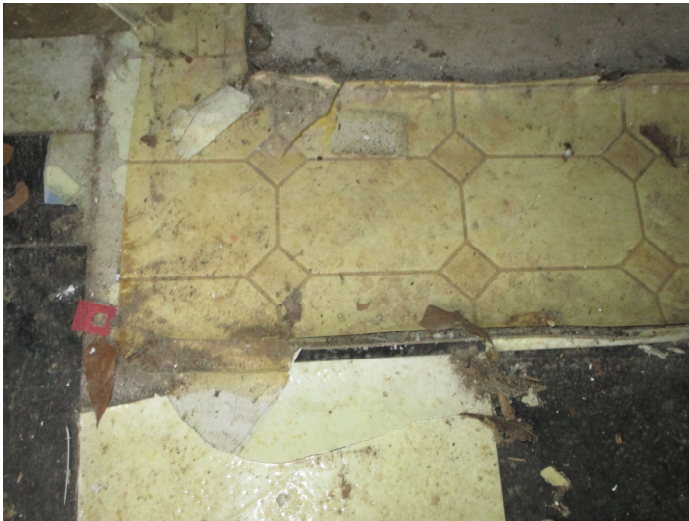
Photo 13 – Tan octagon and diamond roll vinyl floor & mastic located in the kitchen and hallway (2nd layer).

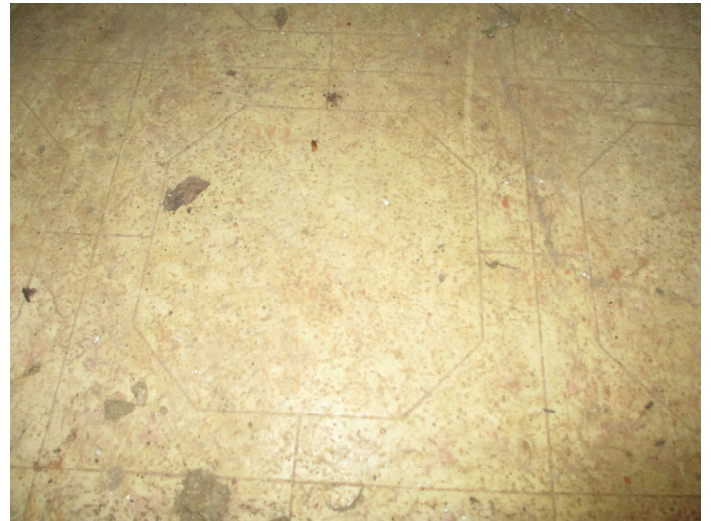
Photo 14 – Large tan square roll vinyl floor & mastic located in the hallway (top layer) and kitchen threshold.

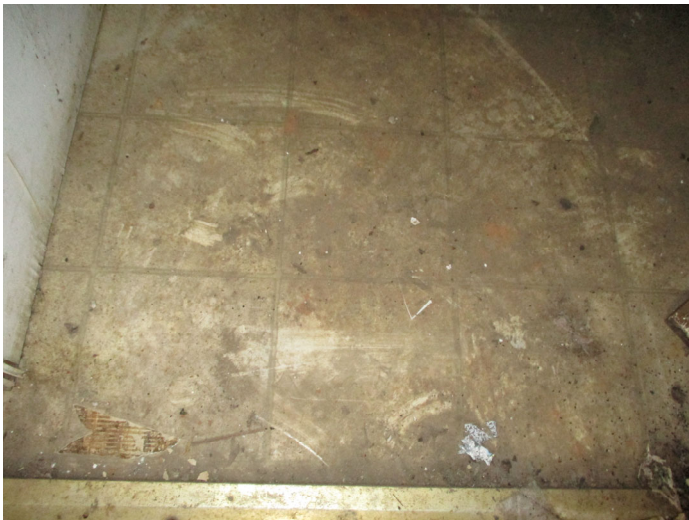
Photo 15 – Plain tan square roll vinyl floor with no adhesive located in the bathroom.

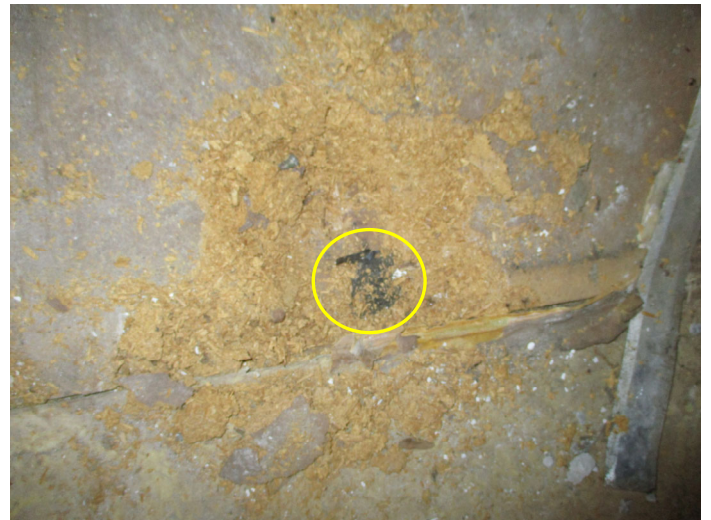
Photo 16 – Black felt paper under top layer of wood floor located in back left room.

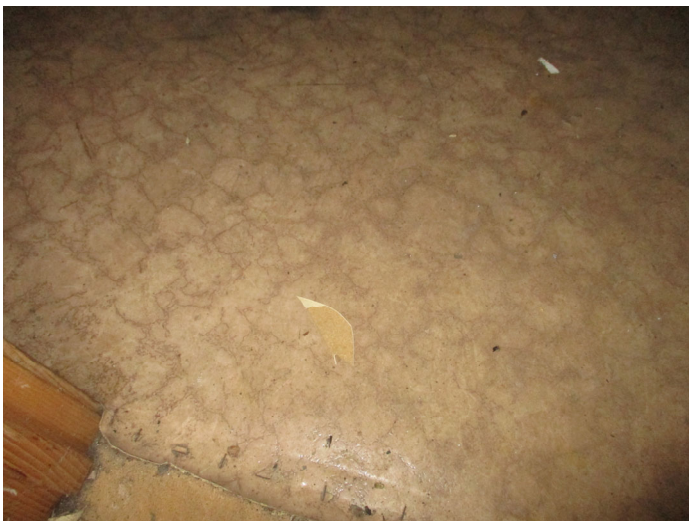
Photo 17 – Brown pebble roll vinyl floor & mastic in the back left room closet.
