Asbestos & Lead Based Paint Assessment

City of Spartanburg
741 Hayne Street
Spartanburg, South Carolina 29301

Project Number: 0521-99

October 29, 2021

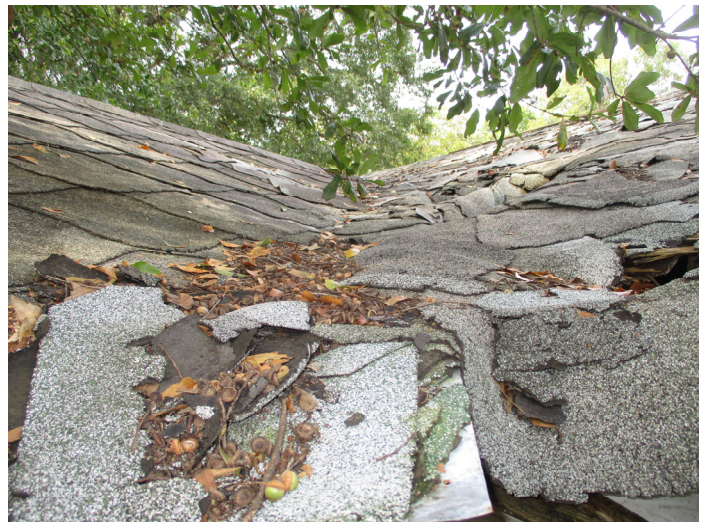
Photo 2 – Four layers of shingles with tar and no felt.

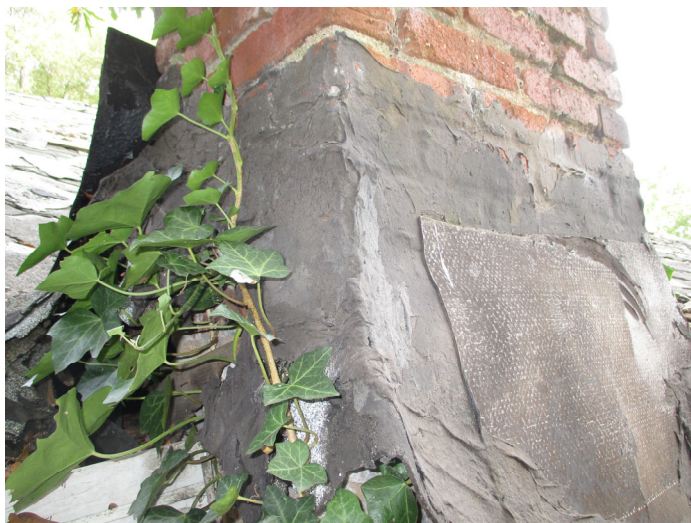
Photo 3 – Tar on chimney.

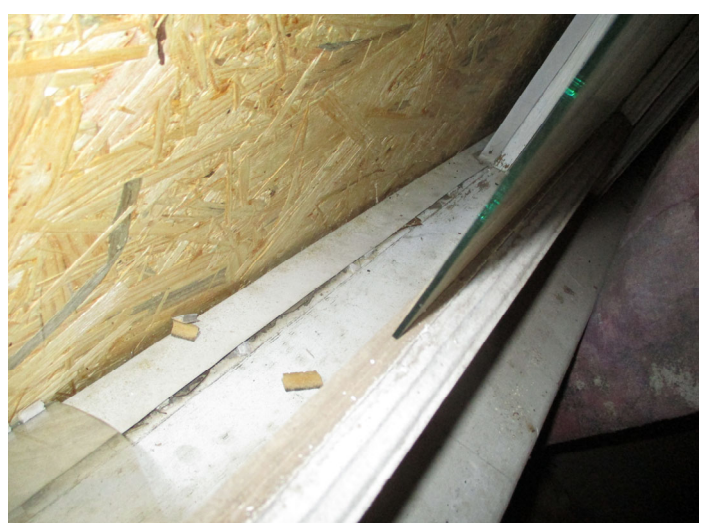
Photo 4 – Glazing on wood windows.

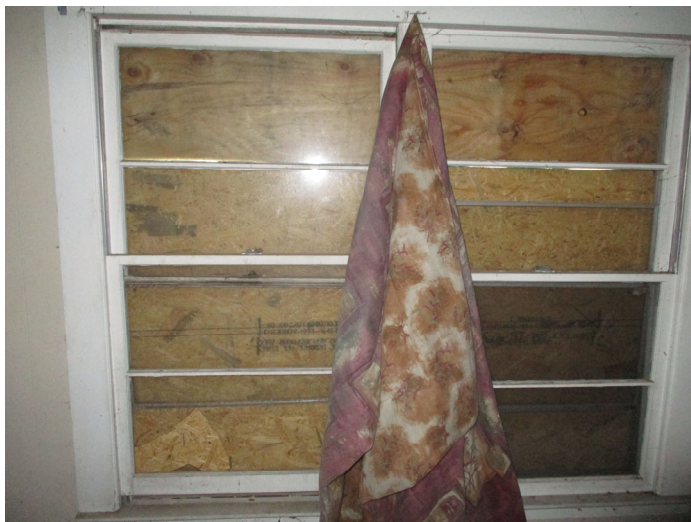
Photo 5 – Typical view of wood windows.

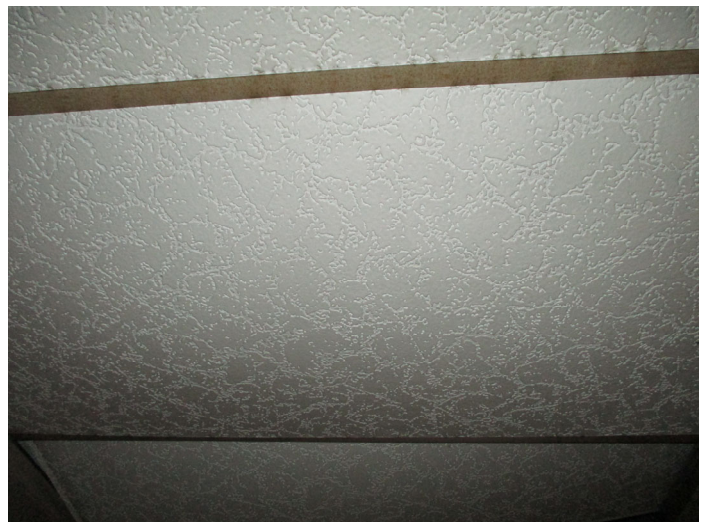
Photo 6 – 2'x4' fissure pattern ceiling tile.

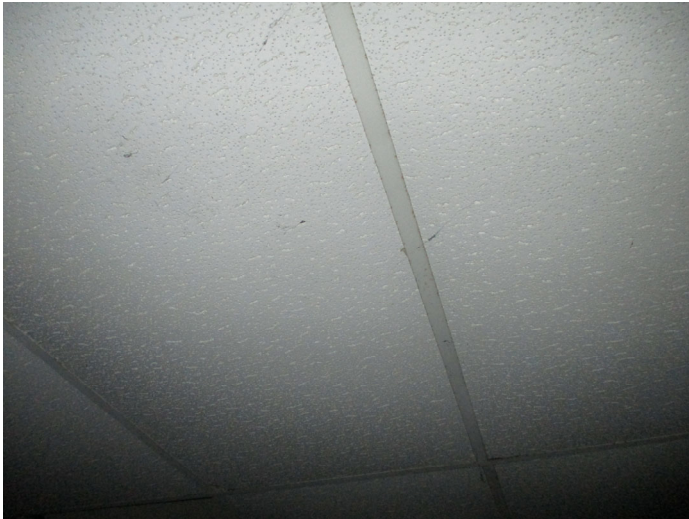
Photo 7 – 2'x4' worm hole pattern ceiling tile sporadically throughout.

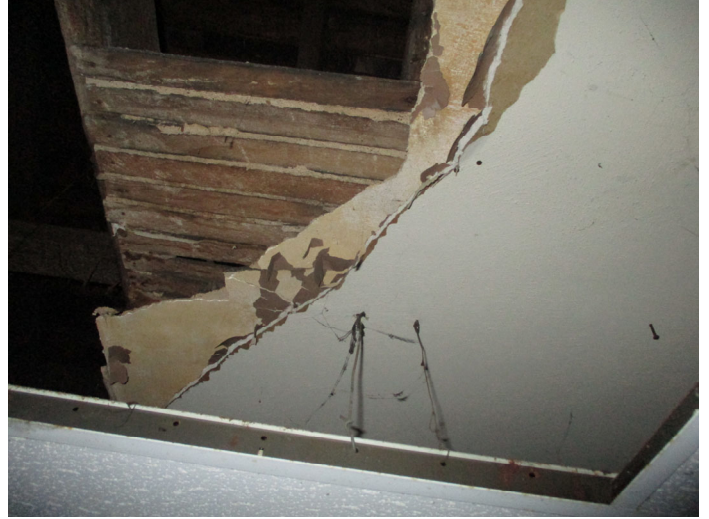
Photo 8 – Plaster on ceiling under 2'x4' ceiling tiles sporadically throughout.

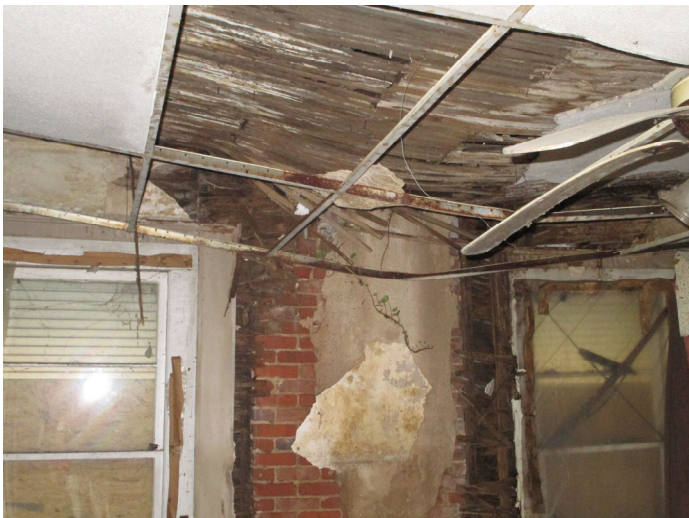
Photo 9 – Plaster with finish and drywall walls throughout.

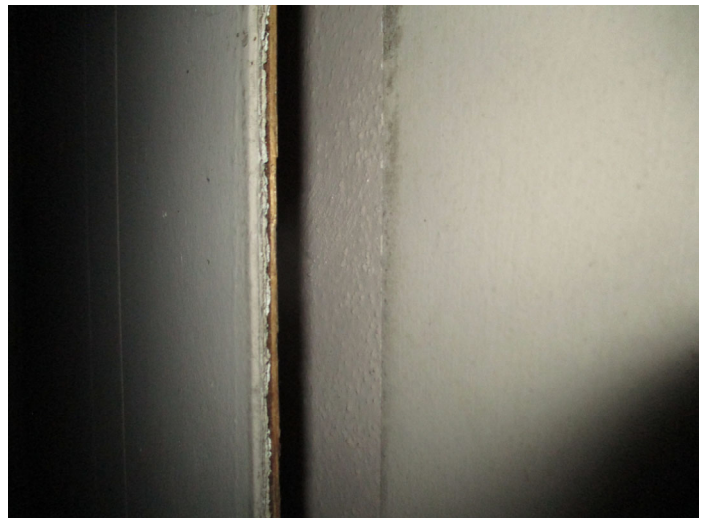
Photo 10 – Wood paneling over plaster walls

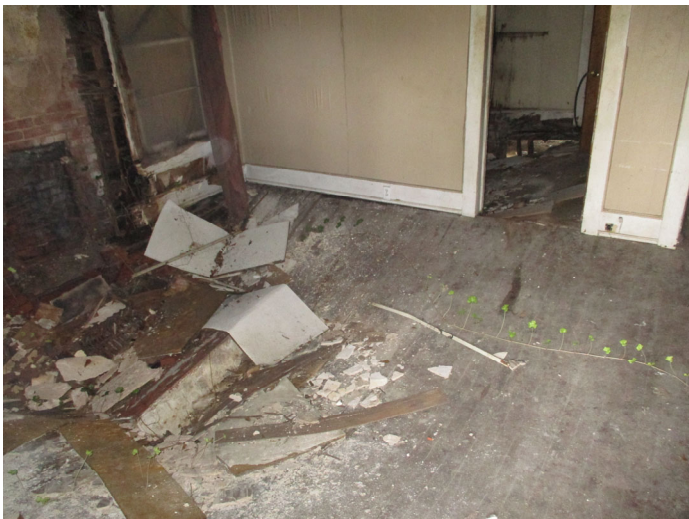
The foundation was observed to have significant damage to structural beams throughout the left side of the residence. Several floors in the building were collapsed at the time of the assessment. A limited assessment was conducted due to safety concerns. Sampling was performed in areas Apex could safely access suspect materials through exterior openings and in debris piles. Apex recommends that the residence be demolished in place and materials be treated and disposed of as friable, regulated ACM.

Photo 11 – Structural damage to left front room.

1. Demolish the residence with ACM in place and dispose of the waste stream as friable Regulated Asbestos Containing Materials (RACM) and delivered to an asbestos approved hazardous waste landfill for disposal.

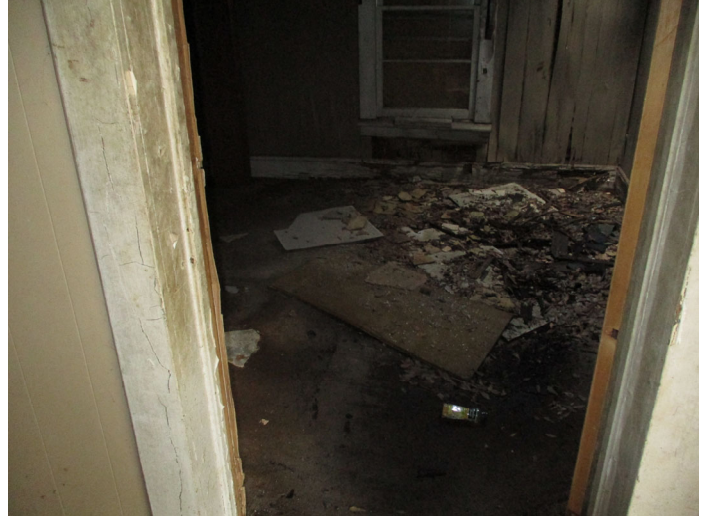
- Approximately 1,400 SF contaminated and unassessed suspect ACM within the residence and associate debris piles.

Photo 12 – Building debris throughout.

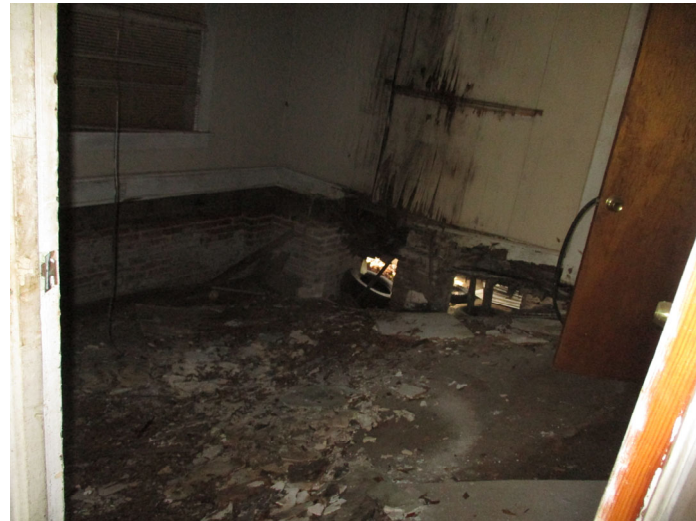
Photo 13 – Structural damage to left rear room. Room was not assessed.

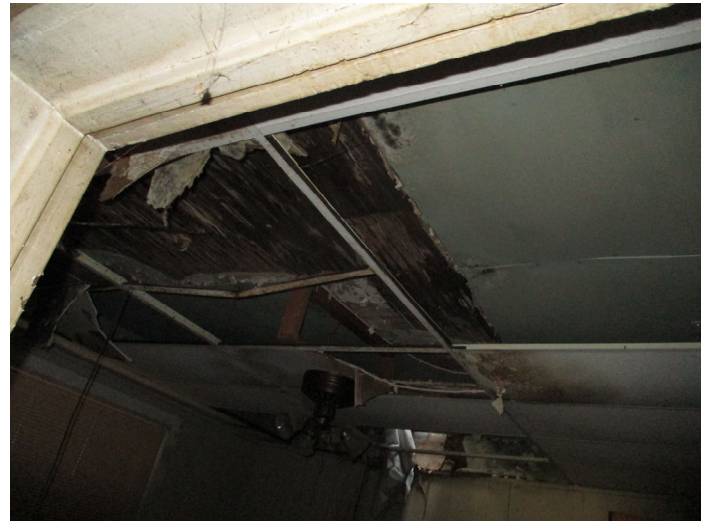
Photo 14 – Wood ceiling above ceiling grid and plaster.

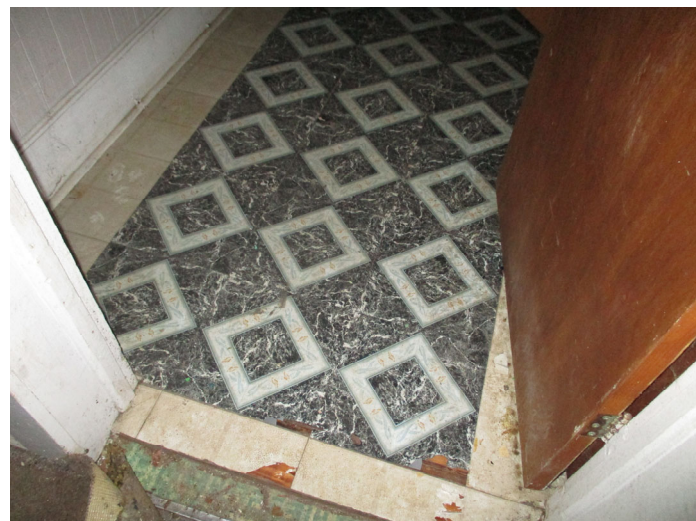
Photo 15 – 12"x12" black and white marble pattern and 12"x12" tan square pattern in bathroom.

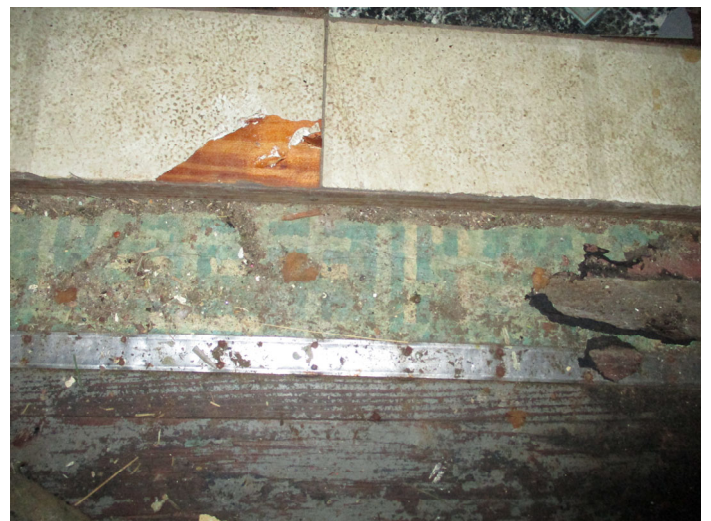
Photo 16 – Tan and blue vinyl flooring under thin wood floor in bathroom.

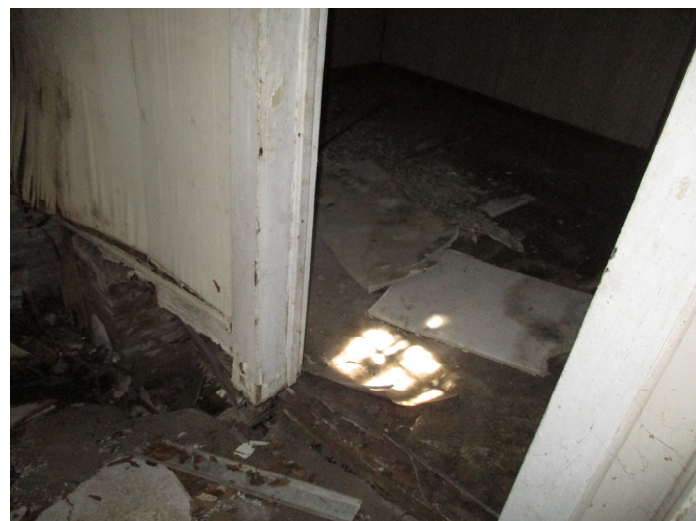
Photo 17 – Damage to floor entering into the kitchen.

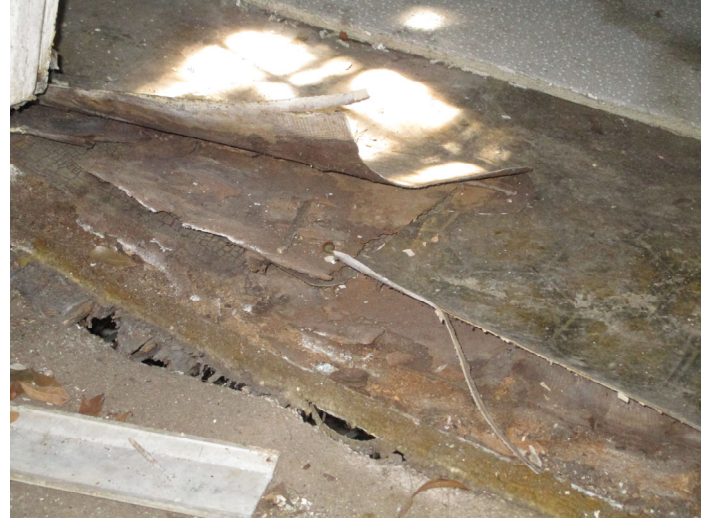
Photo 18 – Vinyl flooring in kitchen inaccessible due to unstable floor.
