Asbestos & Lead Based Paint Assessment

City of Spartanburg
437 Arch Street
Spartanburg, South Carolina

Project Number: 0815-163

February 29, 2016

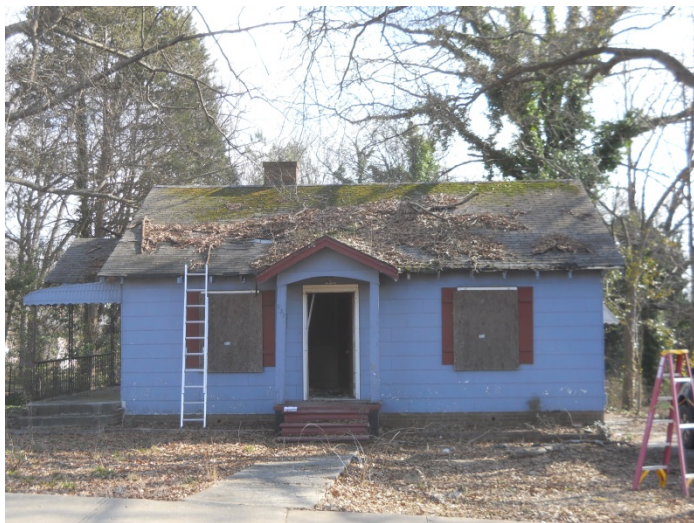
Photo 1 -- 437 Arch Street in Spartanburg, SC.

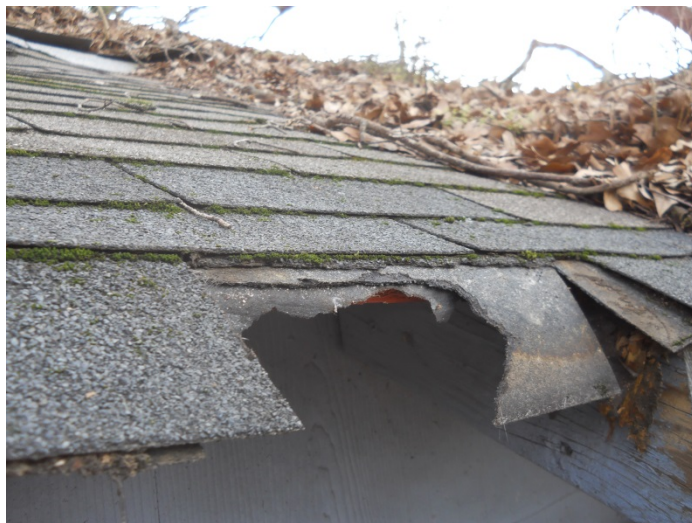
Photo 2 – Roof shingles & felt on house.

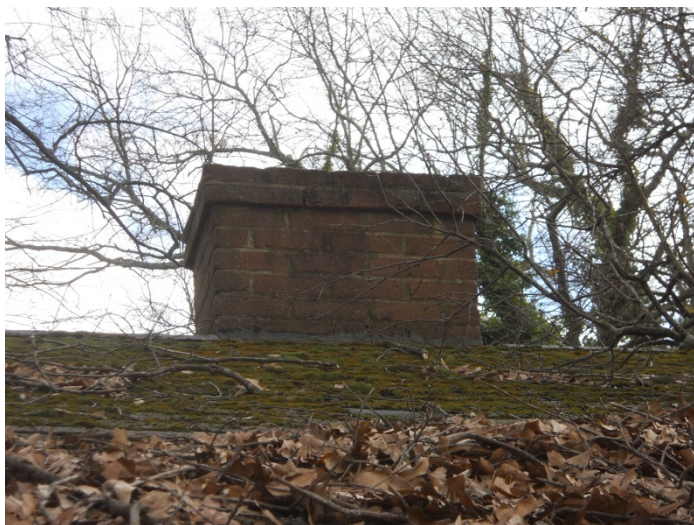
- Approximately 2,100 SF of exterior cement board siding.
- Approximately 115 SF of tan 9" x 9" floor tile (2nd layer) in the hallway.
- Approximately 165 SF of grey 9" x 9" floor tile in the front left bedroom (top layer) & in the bathroom (2nd layer).
- Approximately 6 LF of chimney mastic on 1 chimney - assumed.

Photo 3 – Chimney mastic assumed positive on house roof.

1. Abate the asbestos containing materials in the structure prior to renovation or demolition.

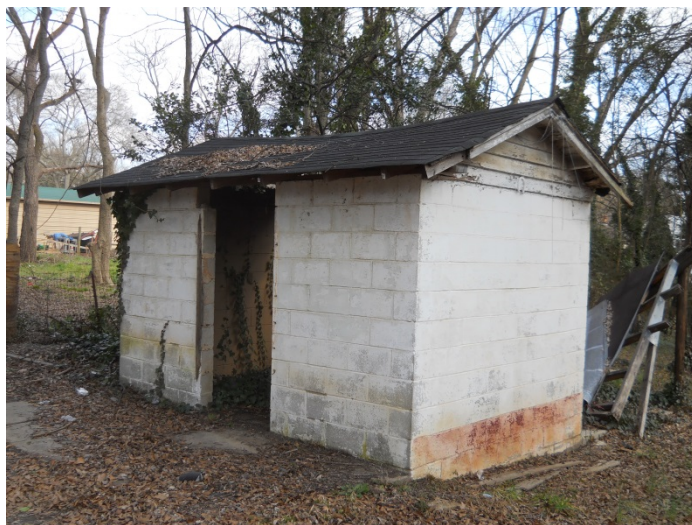
Photo 4 – Small Shed A.

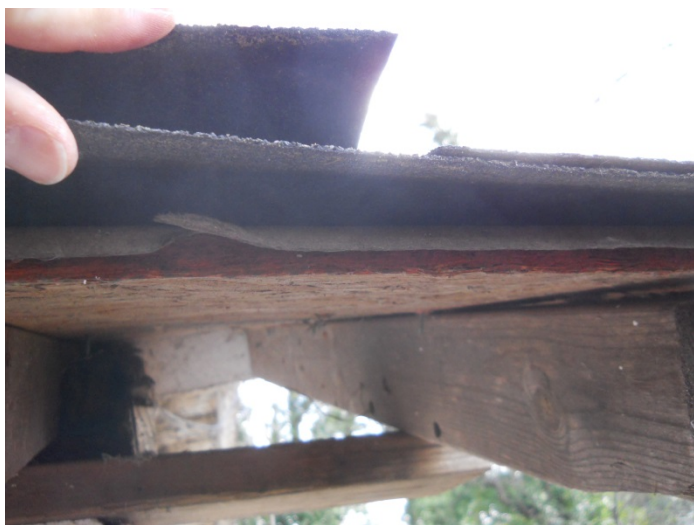
Photo 5 – Roof shingles & felt on Small Shed A.

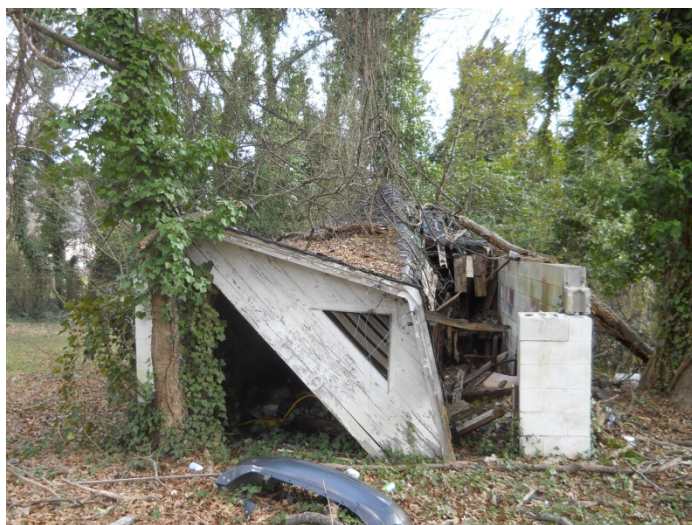
Photo 6 – Collapsed Big Shed B.

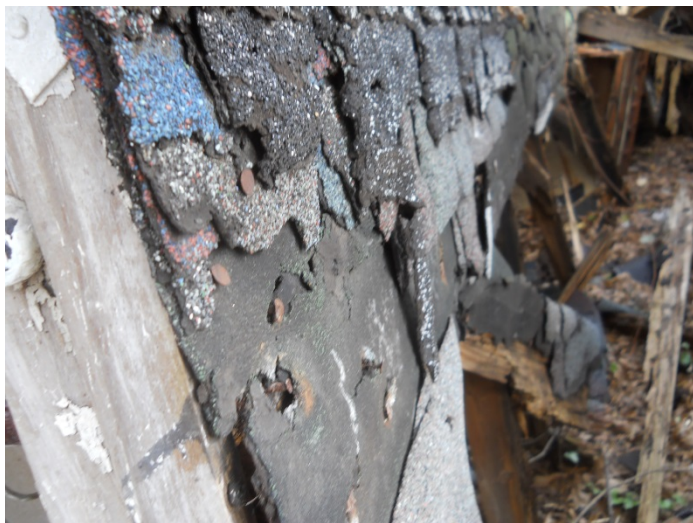
Photo 7 – Roof shingles & felt on Big Shed B.

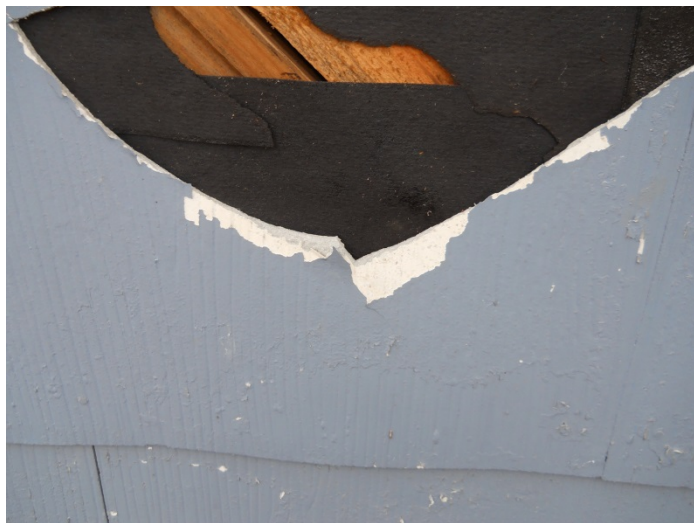
Photo 8 – Cement board siding & felt beneath on house.

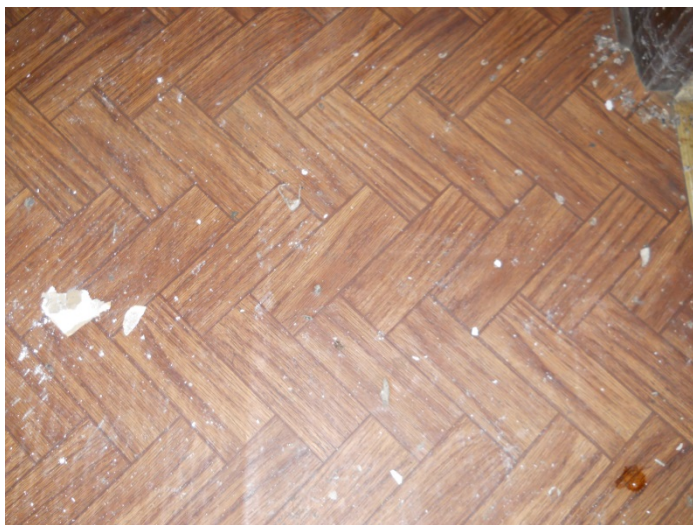
Photo 9 – Top layer of wood pattern vinyl floor with no mastic in back porch, kitchen & hallway.

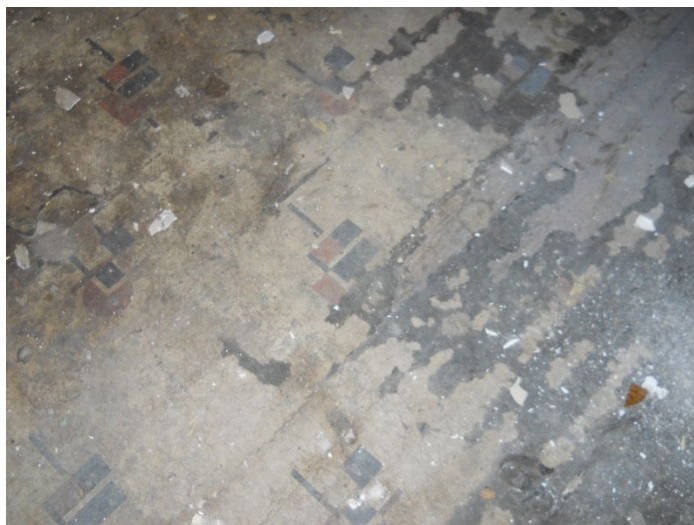
Photo 10 – Residual vinyl floor in kitchen.

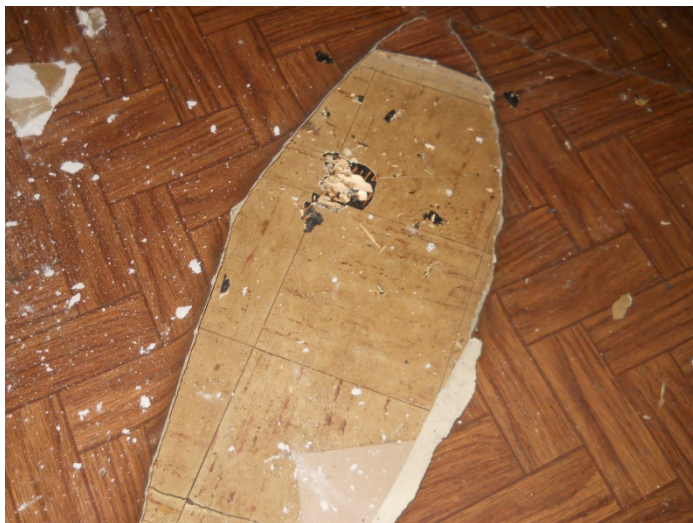
Photo 11 – 2nd layer of tan 9" x 9" floor tile with mastic & felt in the hallway.

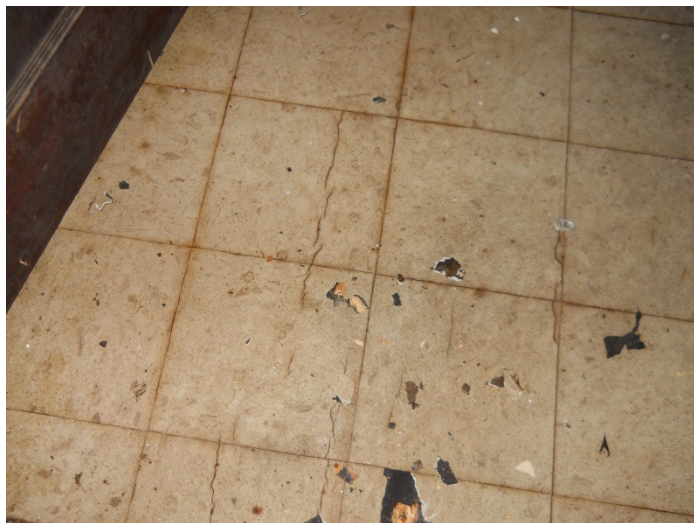
21						
22	Top layer in front left bedroom & 2nd layer in bathroom	Grey 9" x 9" floor tile with mastic & felt	PLM 5% chry (tile) NAD (mastic & felt)	Non-Friable	Good	165 SF
23			TEM			
24			<1% chry (mastic & felt)

Photo 12 – Top layer of grey 9" x 9" floor tile with mastic & felt in the front left bedroom & 2nd layer in bathroom.

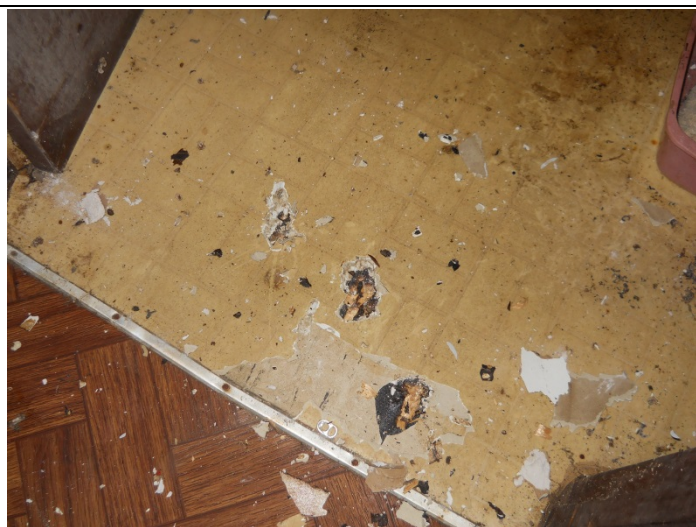
Photo 13 – Top layer cream square pattern vinyl floor with no mastic in the bathroom.

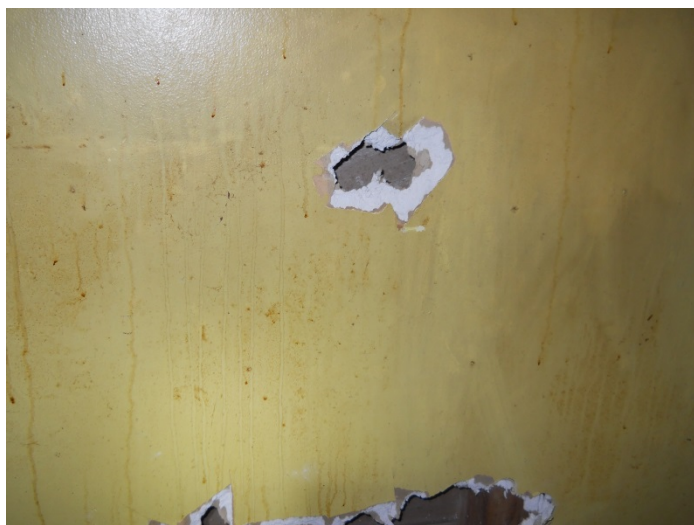
Photo 14 – Drywall with joint compound & tape.

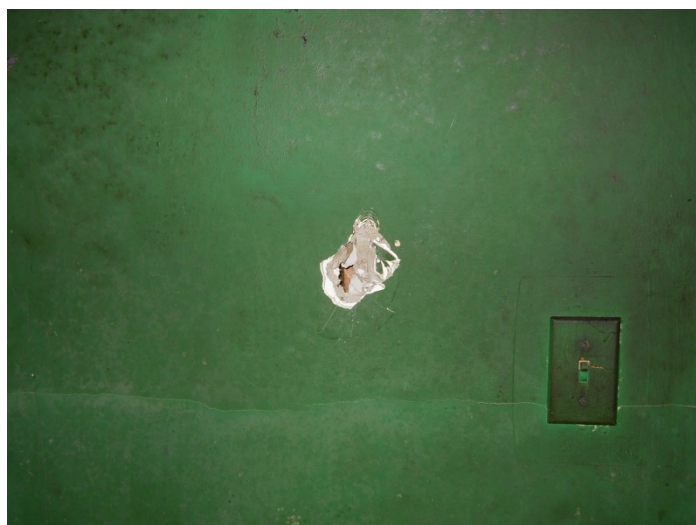
Photo 15 – Plaster with finish.

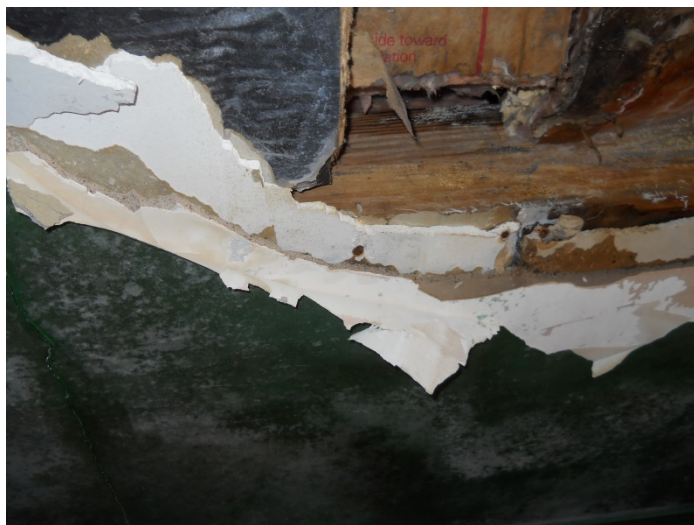
Photo 16 – Plaster with finish over drywall with joint compound & tape.
