## **Asbestos & Lead Based Paint Assessment**

City of Spartanburg  
438 Arch Street  
Spartanburg, South Carolina

Project Number: 0815-163

December 15, 2015

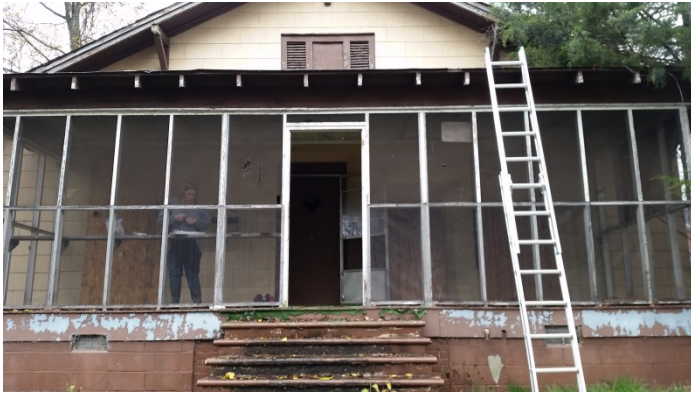
Photo 1 -- 438 Arch Street in Spartanburg, SC.

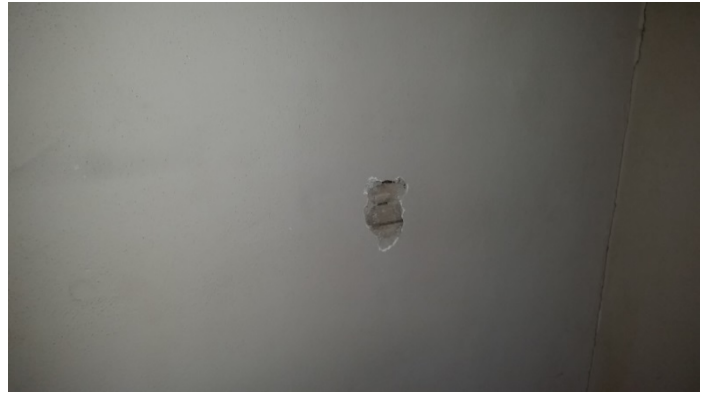
Photo 2 – Plaster with finish.

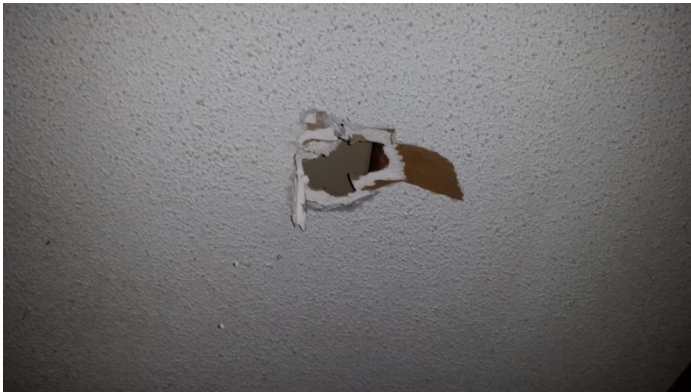
Photo 3 – Ceiling texture over drywall.

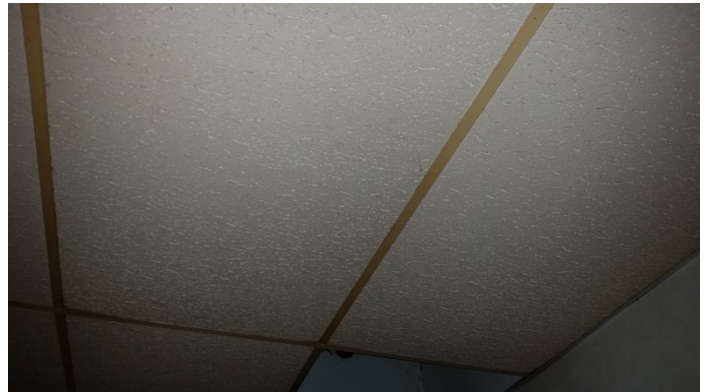
Photo 4 – 2' x 4' Ceiling tile.

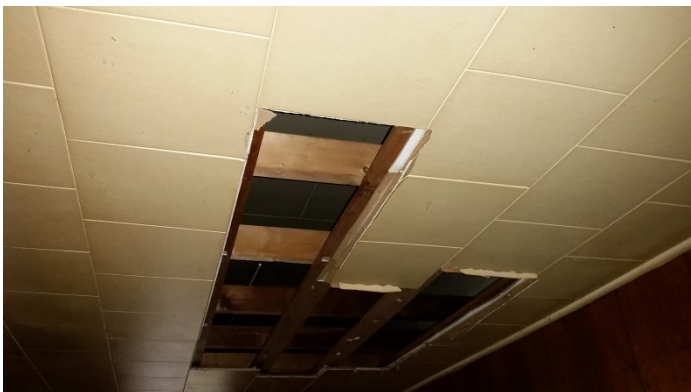
Photo 5 – 1' x 1' ceiling tile.

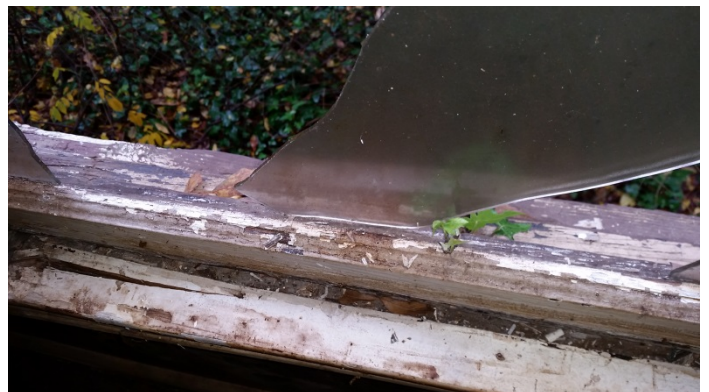
- Window glazing on exterior windows, 10 window units.

Photo 6 – Window glazing.

1. Abate the asbestos containing materials in the structure prior to renovation or demolition.
2. Follow applicable asbestos regulations during renovation or demolition of the structure. You should be aware that stringent requirements are imposed upon anyone renovating or demolishing a structure in which ACM will be disturbed. This work must be performed in accordance with OSHA asbestos regulations, 29 CFR 1910 & 1926, and NESHAP asbestos regulations 40 CFR 61, subpart M. South Carolina regulations require the accreditation of personnel who work in the asbestos field and notification and permitting fees for asbestos removal projects. There is a 10 working day notification period required prior to abatement of asbestos in a facility. Failure to take proper precautions and actions to protect human health and the environment can result in penalties, danger to personnel, and construction delays.

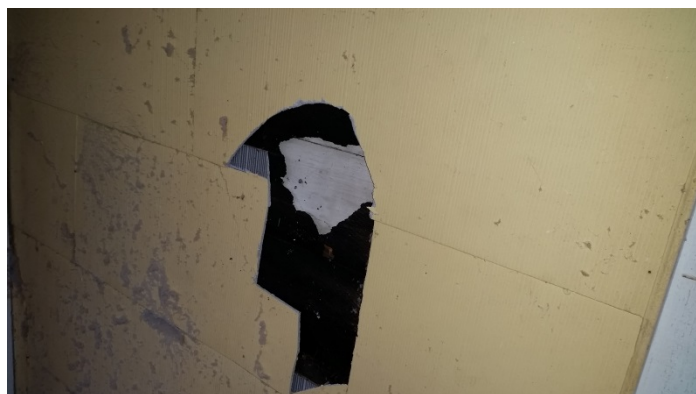
- Transite siding & felt paper beneath, 2,000 SF.
- Roof/chimney mastic assumed positive on 1 chimney, 6 LF.

Photo 7 – Transite siding & felt paper beneath.

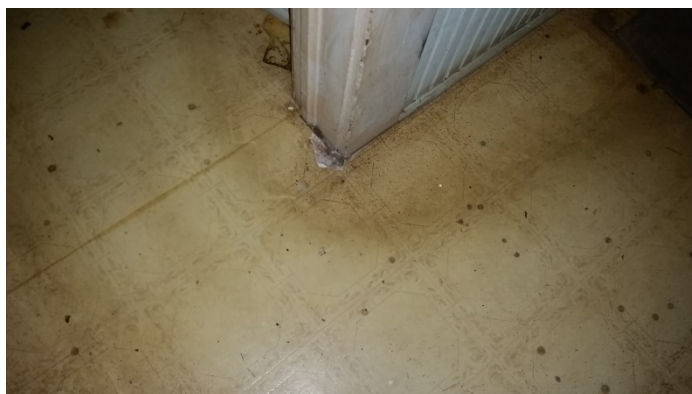
Photo 8 – Yellow linoleum flooring & mastic in the kitchen..
