Preliminary Engineering Assessment (PEA)

Gulfside Pavilion at Casino Beach

Pensacola Beach, FL 32561

June 3, 2021

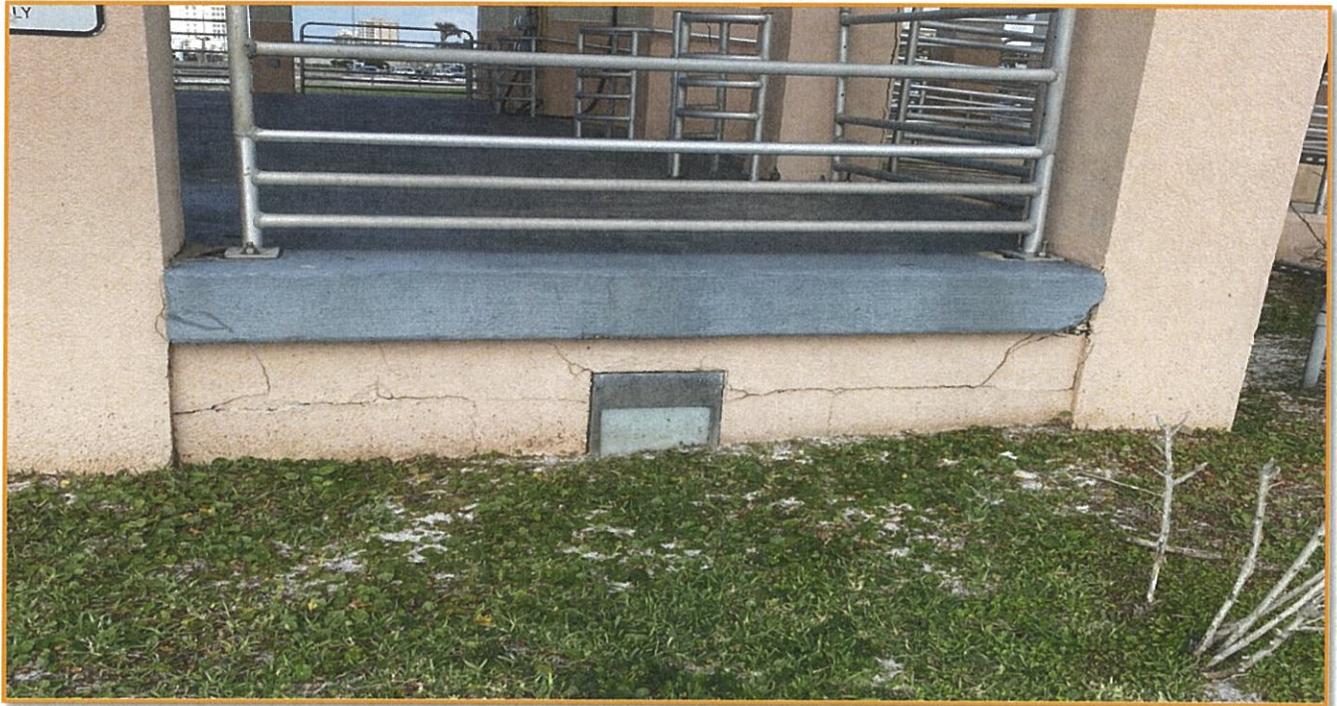
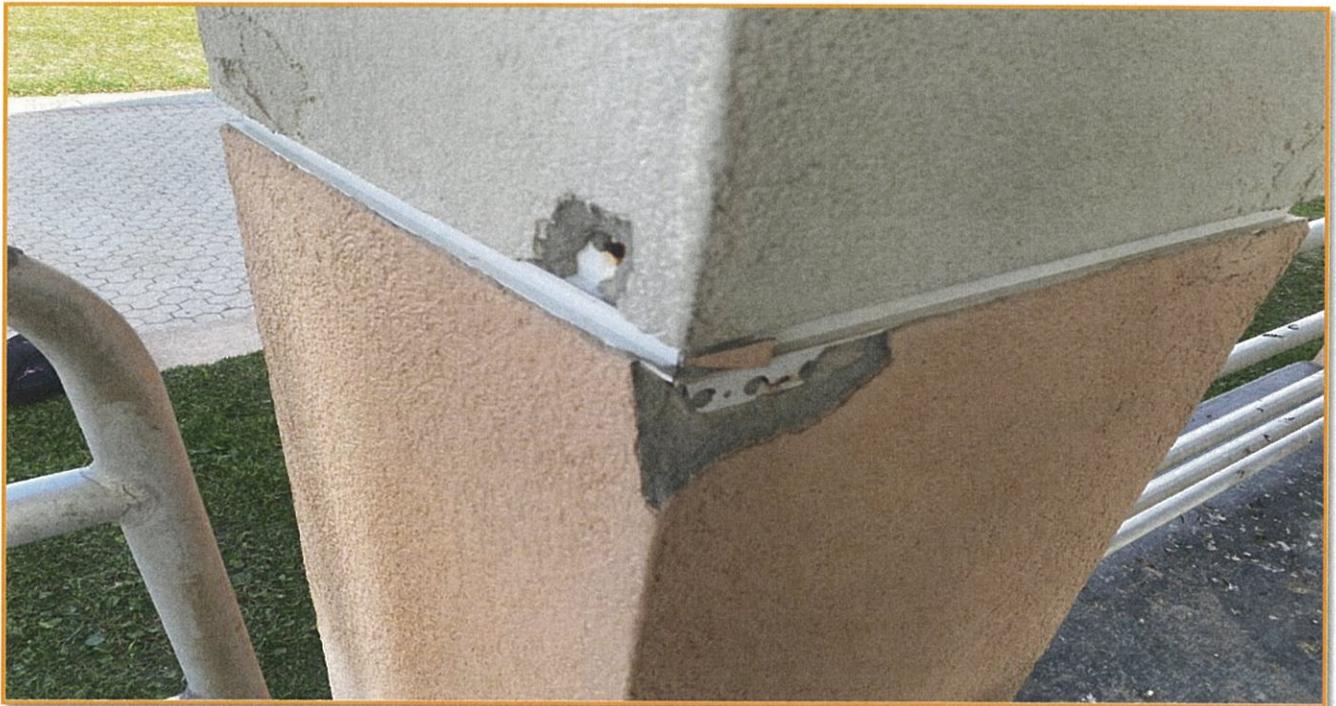
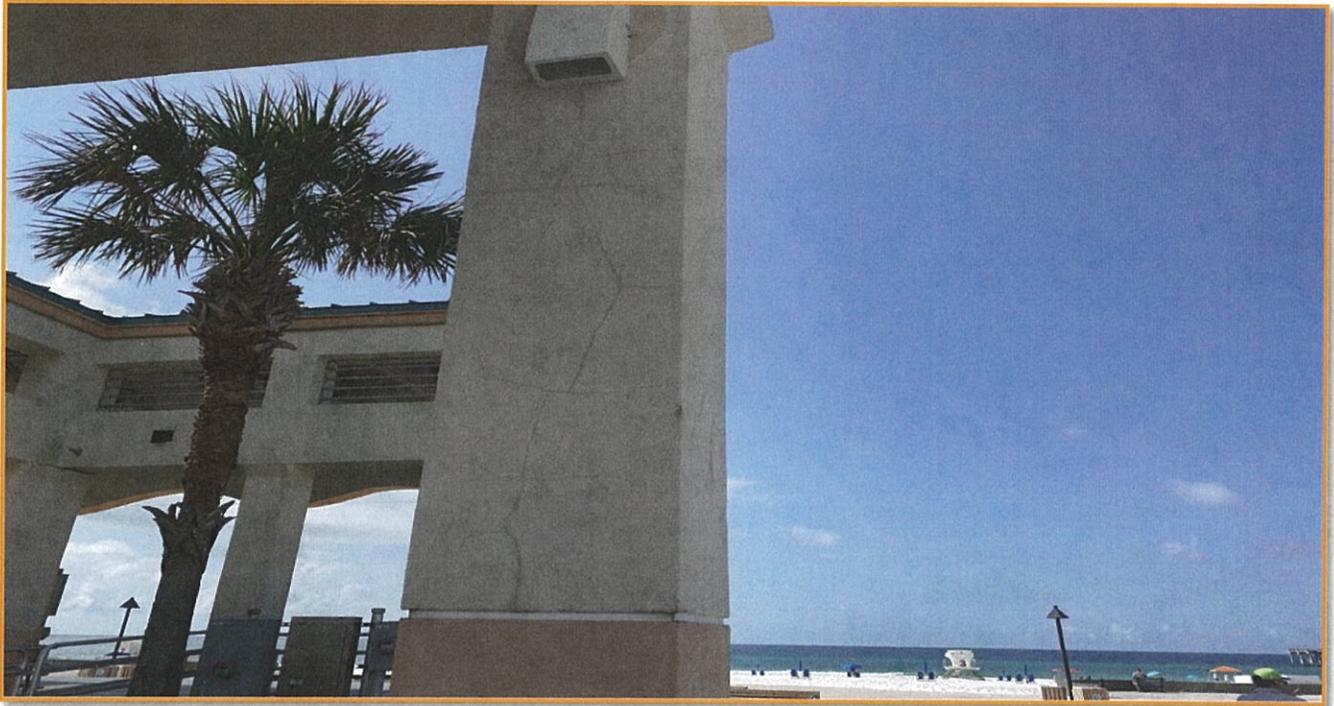
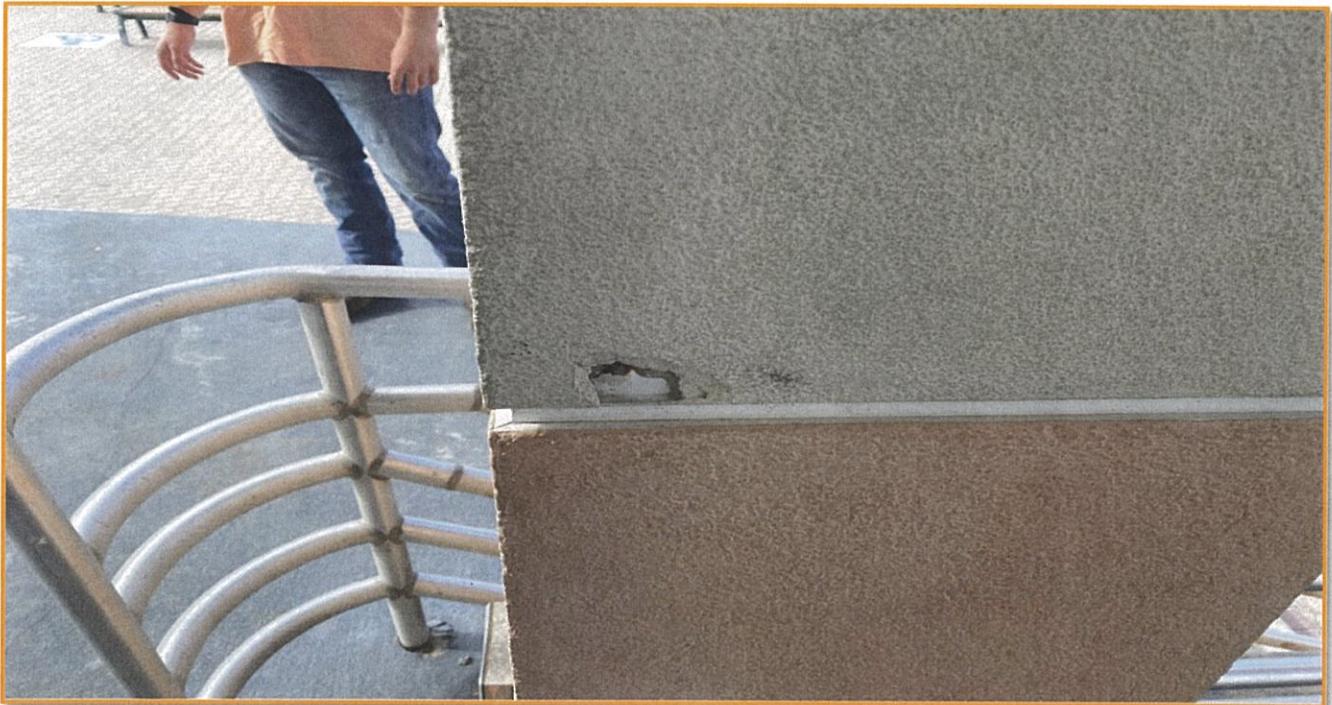
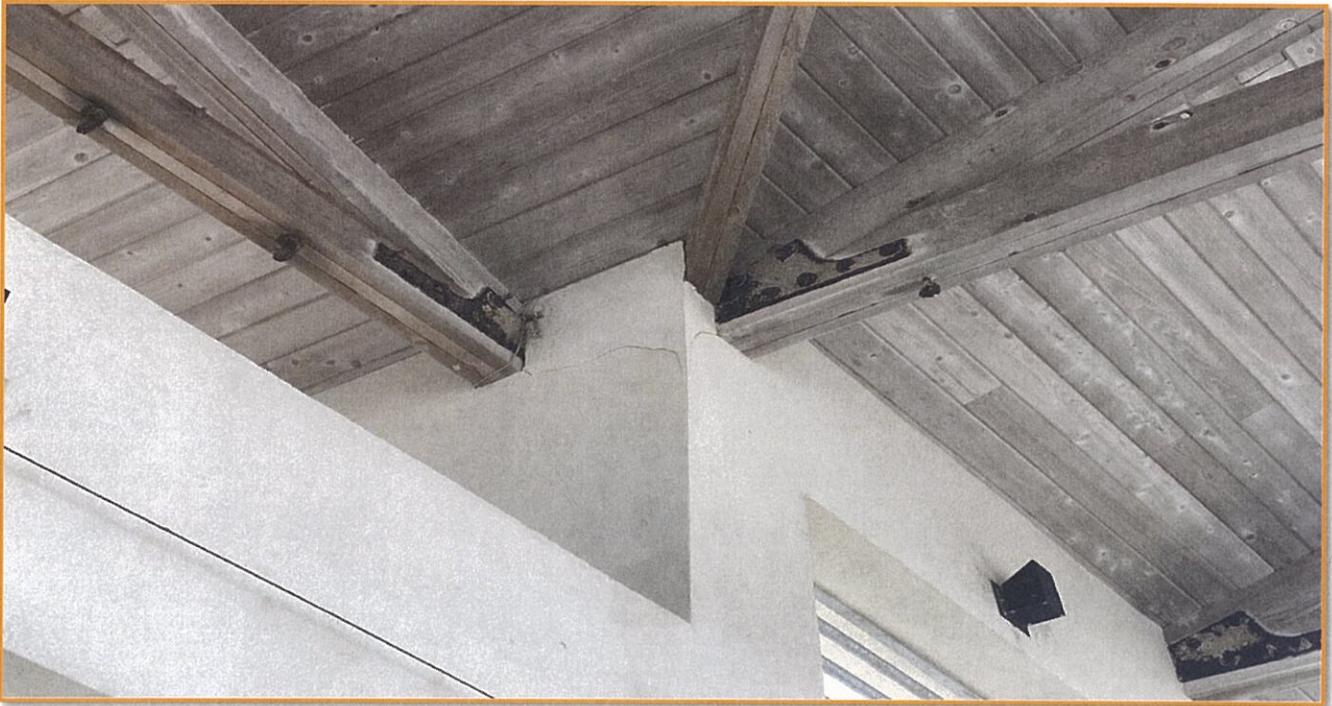
Damage to the Beach Pavilion was caused by forceful impacts from flying debris during the storm. The damages were limited to the exterior façade, which includes the stucco covering and EIFS capitals. Several areas of stucco covering were observed as having either notable impact damage or severe cracking caused by storm-related damage. The EIFS capitals located near the tops of the columns were also impact damaged. **Table 2.1** provides a detailed breakdown of all damaged components observed during the inspection.

Location	Observed Damage	Condition Assessment Recommendations	Quantity	Reference Image
Stucco Façade	Impact damage and cracking	Remove and Replace	330 SF of exterior stucco demolition 330 SF of double-ply weather barrier 36.7 SY of stucco mesh metal lath 36.7 SY of 3 coat stucco with float finish 330 SF of paint and waterproofing	Figure 2.2.1.1 Figure 2.2.1.2 Figure 2.2.1.3 Figure 2.2.1.4 Figure 2.2.1.5
EIFS Capitals	Impact damage	Remove and Replace	56 SF of EIFS demolition 56 SF of weather barrier 56 SF of EIFS drainage/vent cavity 56 SF of 1" EPS insulation 6.2 SY of EIFS metal lath substrate 56 SF of leveling base coat 56 SF of sealing base coat	Figure 2.2.2.1

The damage sustained to the **Gulfside Pavilion at Casino Beach** was limited to the exterior façade coverings. While limited to just two (2) building assemblies, replacing said building assemblies will be a major effort. Some of the impacted stucco is at ground level making those relatively easy to repair, but the noted cracking and impact damages further up in the structure will be harder to make. The affected coverings need to be demolished down to an acceptable substrate and rebuilt accordingly. Once the stucco has been replaced, it needs to be painted with like aesthetic. Replacing the EIFS capitals will be harder given their height and irregular shape. These too need to be removed and replaced as they are susceptible to moisture damage. All repairs need to color match existing conditions to the best possible end.
