**ASBESTOS SURVEY REPORT  
FOR  
CROSSROADS SCHOOL  
THIRD & JEFFERSON STREETS  
GRIFFIN, GEORGIA 30223**

**July 7, 2008**

**Prepared For:  
Attn: Mr. William Wilson  
Spalding County, Georgia  
P.O. Box 1087  
Griffin, Georgia 30224**

**Prepared By:  
Life Environmental Services, Inc.  
P.O. Box 98217  
Atlanta, GA 30359**

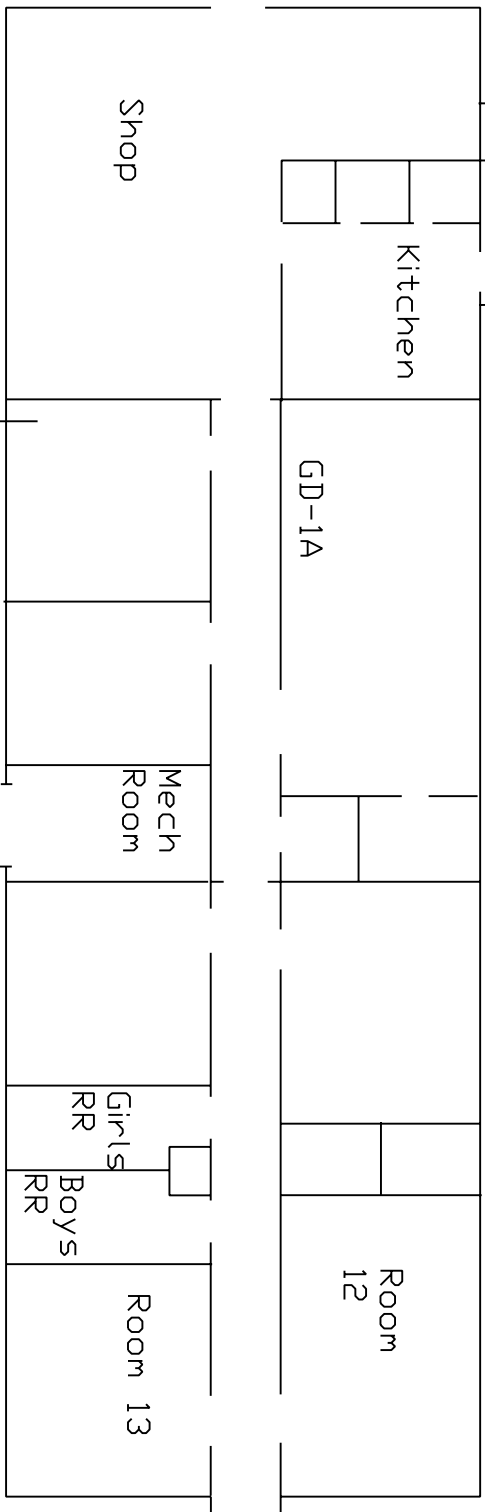
Bldg 5021

\*TSI-2A,2B,2C samples taken from under metal jacket in corner of room 19

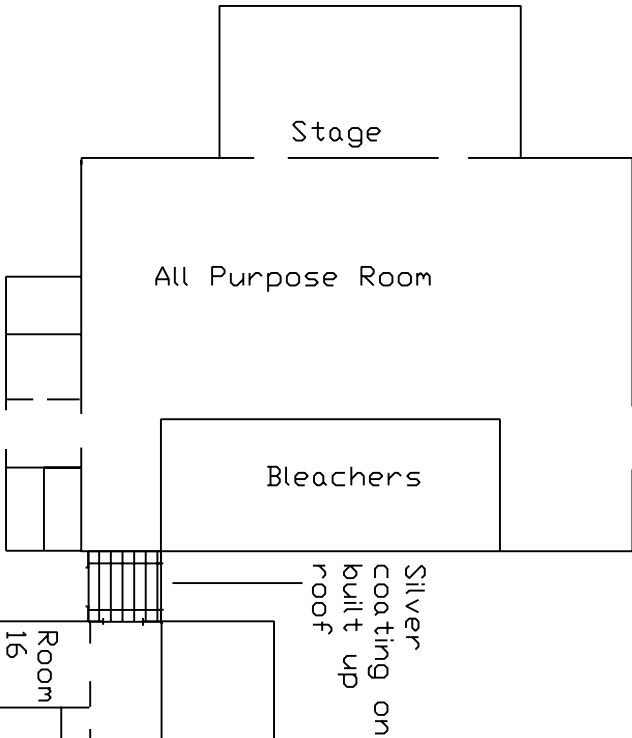
Bldg 5010  
<Gym>

- Wallboard/Jt. Cmpd. in Bldgs. 7010 & 8010 contains 2% Chrysotile asbestos.
- Stipple ceiling in Bldgs. 7010 & 8010 contains 2% Chrysotile asbestos.
- Window glazing in Bldgs. 5020, 5021 & 7010 contains 2% Chrysotile asbestos.
- TSI under metal jacket in Room 19, Bldg. 5021 contains 10% Chrysotile asbestos
- Cement board ceiling and Fire door in Mechanical Room 19, Bldg. 7010 is asbestos containing material
- Silver coating on built up roof between Bldgs. 7010 & 5010 is asbestos containing material
- 4x10 Boiler in Bldg. 7010 and 2 boilers in Bldgs. 5020/5021 are presumed to be asbestos containing material.

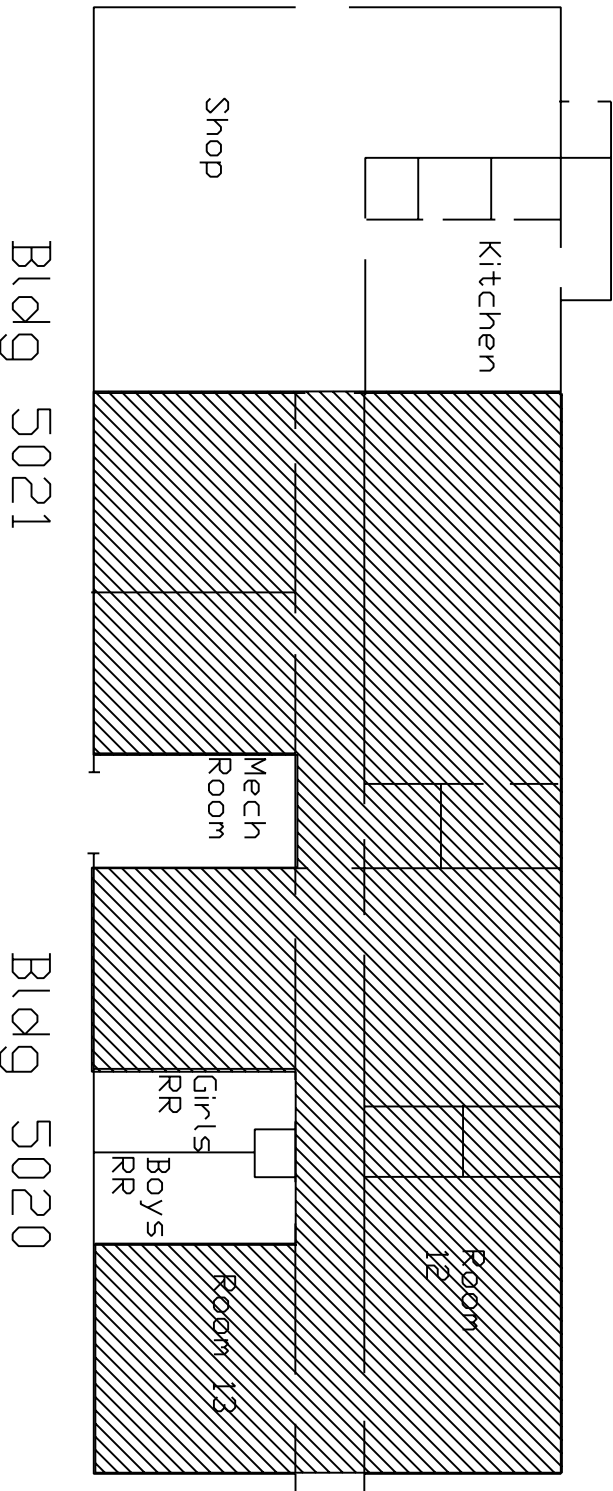
Bldg 5021

- Wallboard/Jt. Cmpd. in Bldgs. 7010 & 8010 contains 2% Chrysotile asbestos
- Stipple ceiling in Bldgs. 7010 & 8010 contains 2% Chrysotile asbestos
- Window glazing in Bldgs. 5020, 5021 & 7010 contains 2% Chrysotile asbestos
- TSI under metal jacket in Room 19, Bldg. 5021 contains 10% Chrysotile asbestos
- Cement board ceiling and Fire door in Mechanical Room 19, Bldg. 7010 is asbestos containing material
- Silver coating on built up roof between Bldgs. 7010 & 5010 is asbestos containing material
- 4x10 Boiler in Bldg. 7010 and 2 boilers in Bldgs. 5020/5021 are presumed to be asbestos containing material

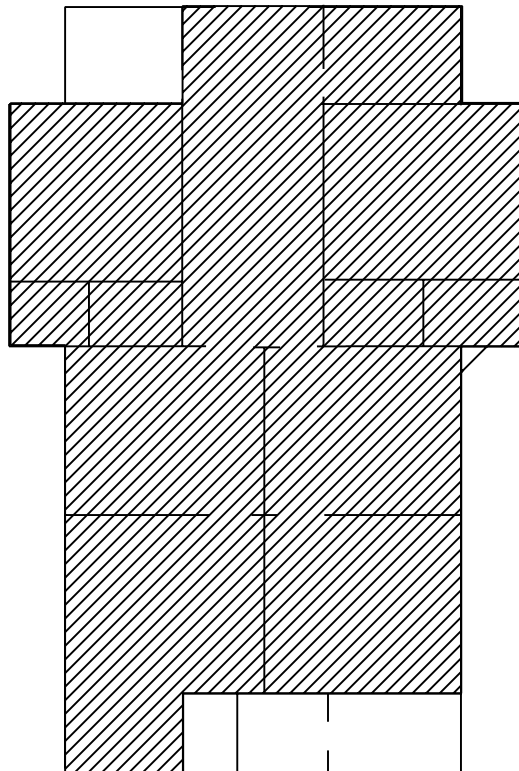
## Bldg 8010

-4x10 Boiler in Bldg. 7010 and 2 boilers in Bldgs. 5020/5021 are presumed to be asbestos containing material.
