Life Environmental Services, Inc.

August 2, 2016

RE: Lead In Paint Survey: Old Fairmont School Bldgs. 5010, 7010, & 8010

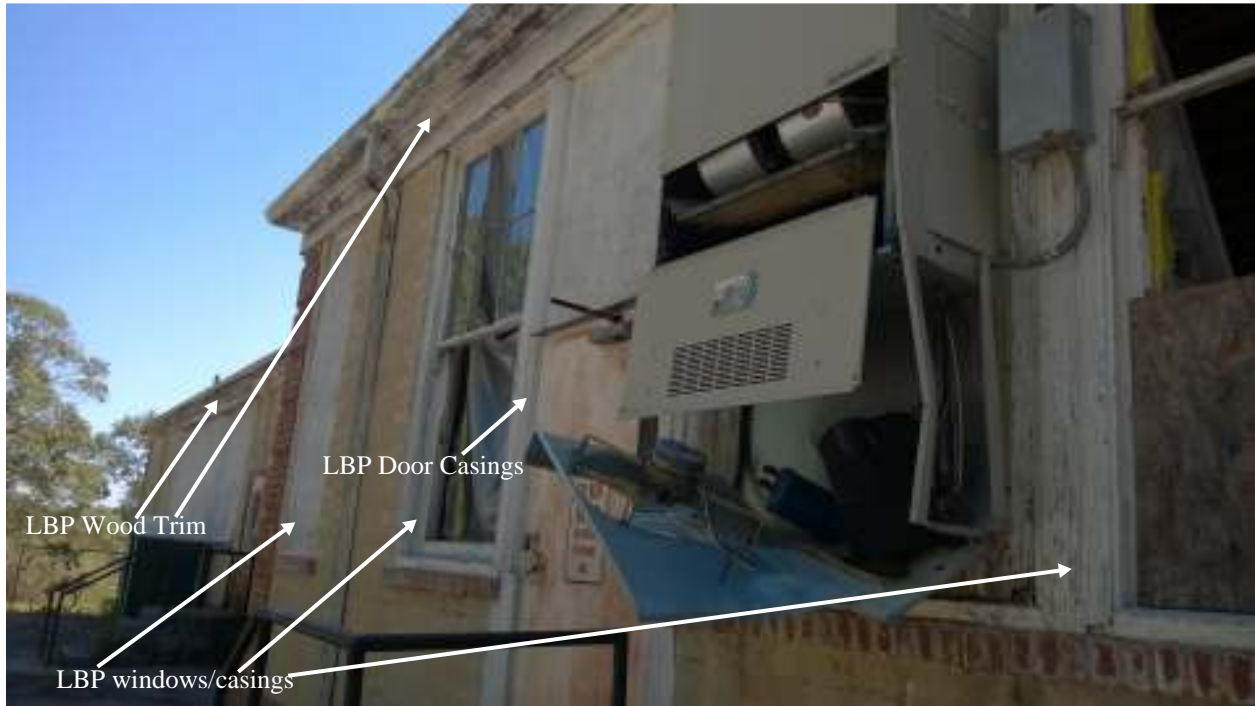
Photo #1: Exterior Side B of Bldg. 8010 LBP locations.

If any more than 6 ft² of paint on **exterior** substrates of Bldgs. 5010, & 8010 (7010 will be demolished) will be disturbed, the contractor who will disturb these coatings, must be RRP licensed by the State of Georgia and follow RRP rules when disturbing the paint.

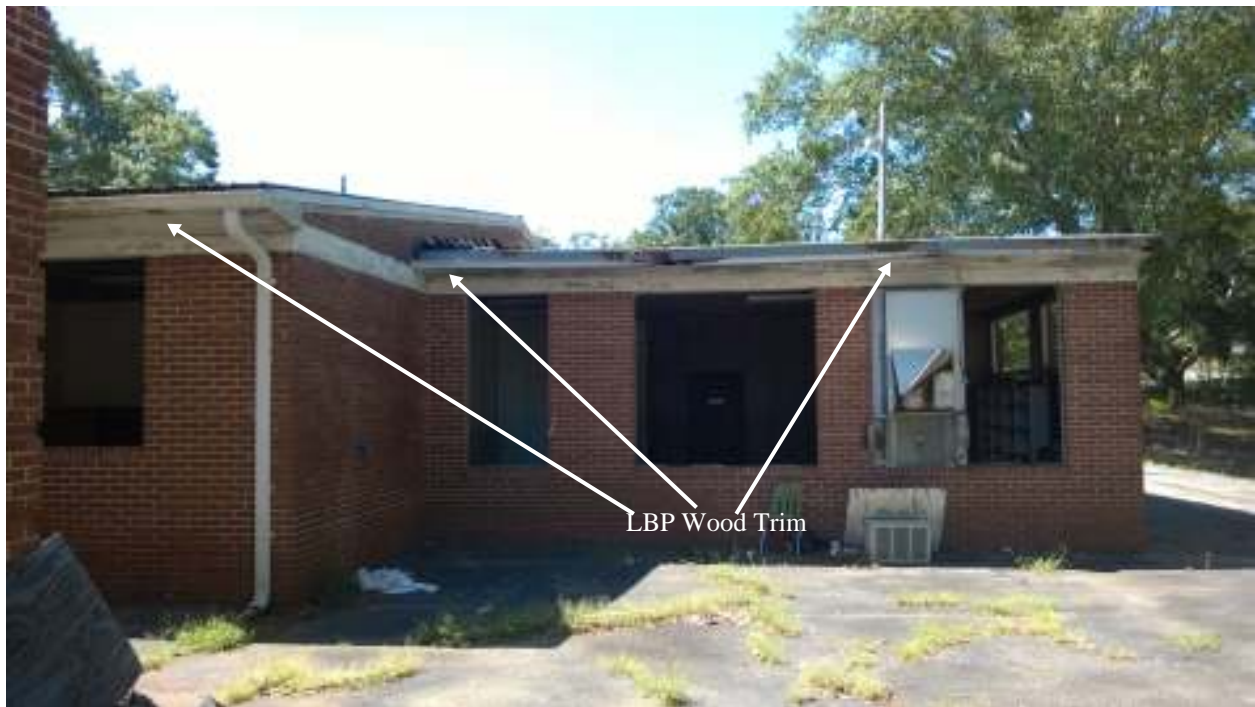
Photo #2: Exterior Side C of Bldg. 7010 LBP locations.

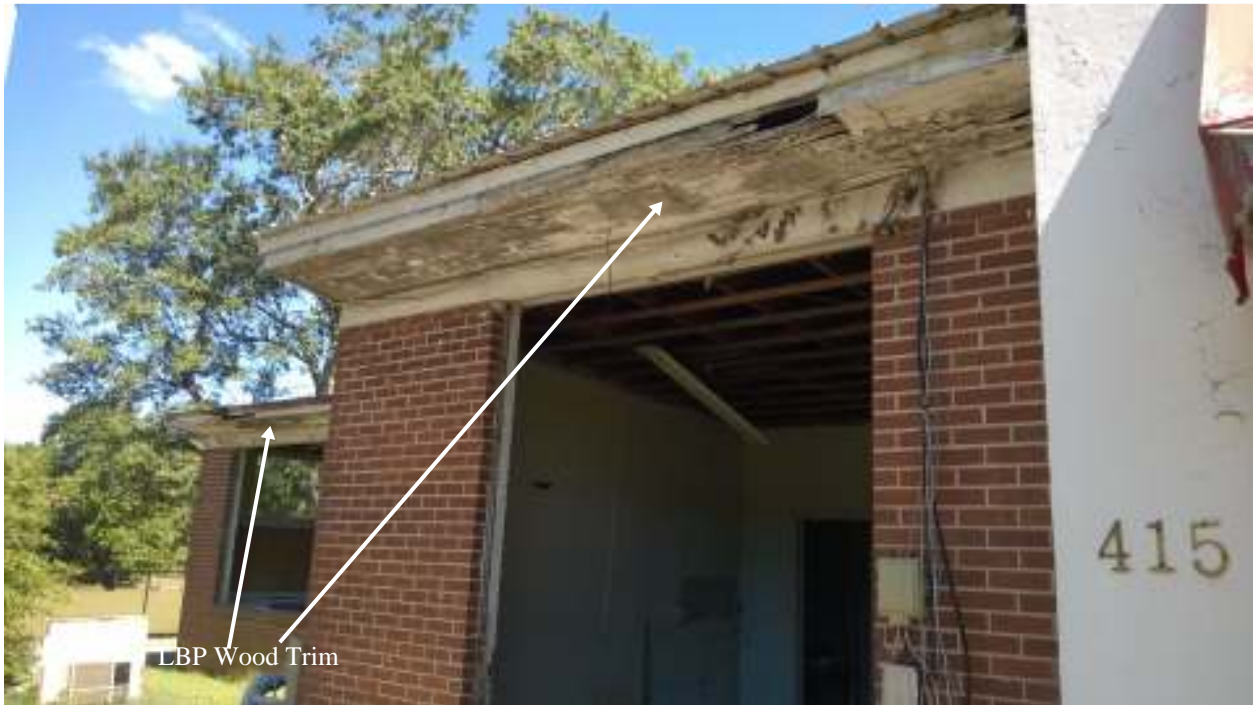
Photo #3: Exterior Side A of Bldg. 7010 LBP locations.

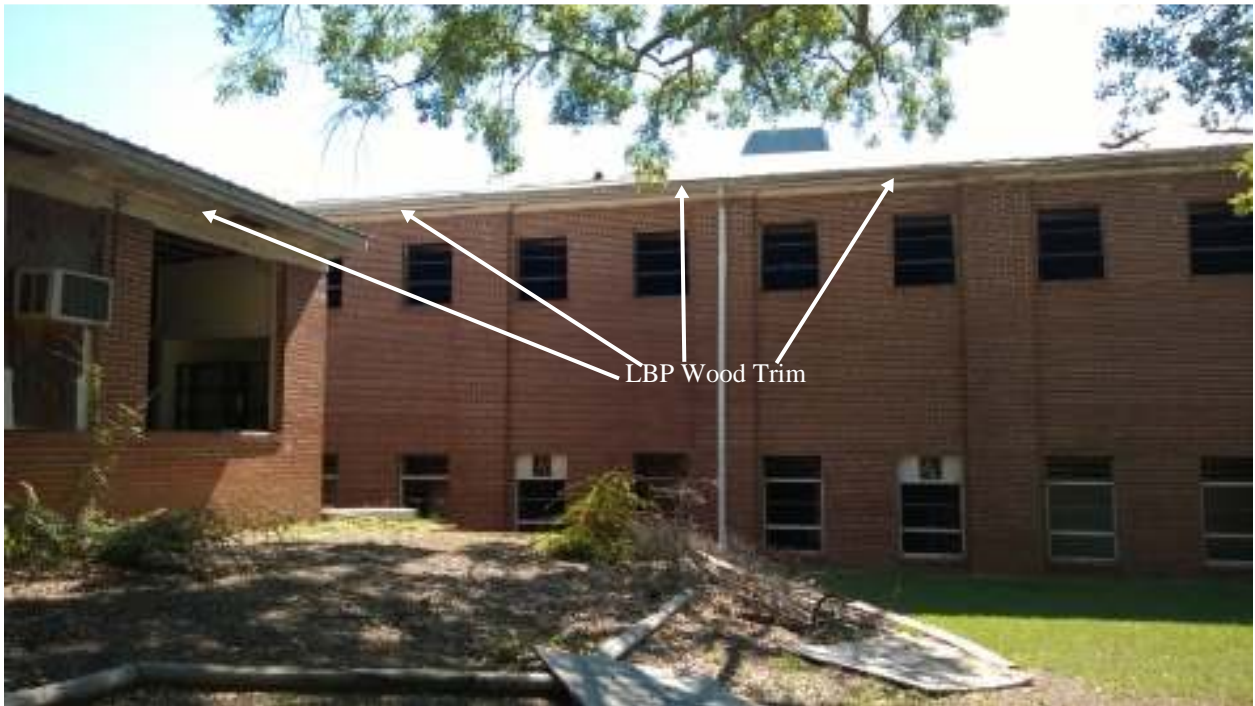
Photo #4: Exterior Side B of Bldg. 5010 LBP locations.
