REPORT DATE: November 30, 2023
MID-ATLANTIC PROJECT #: R3950.00

NESHAP ASBESTOS SURVEY REPORT

THE ALIBI GAME ROOM

1615 Ward Boulevard, Wilson, Wilson County, North Carolina

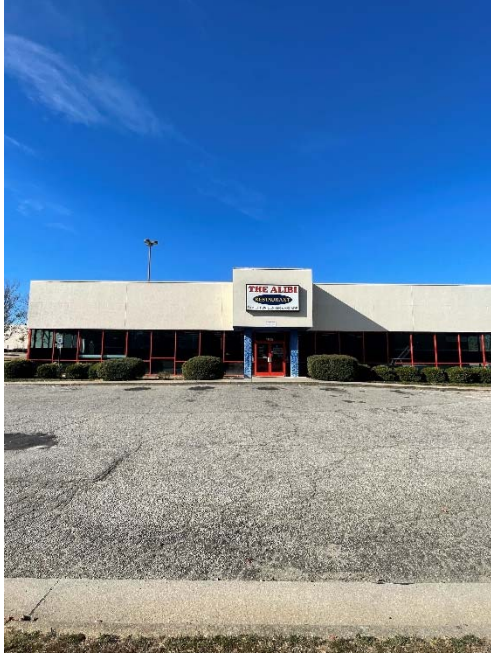
General view of the Subject Property

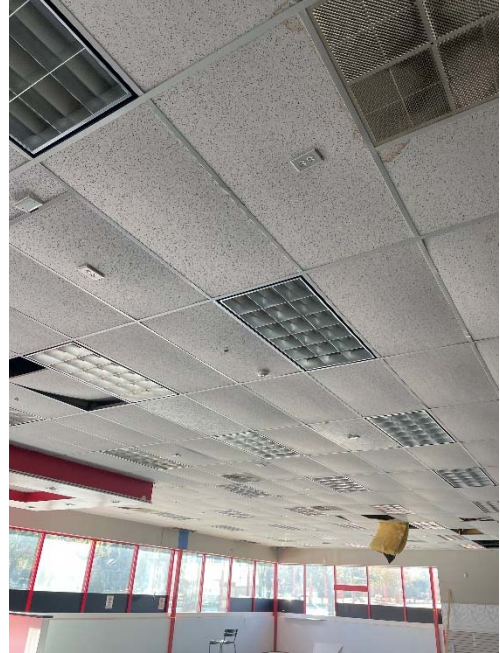
General view of the interior of the commercial structure on the Subject Property

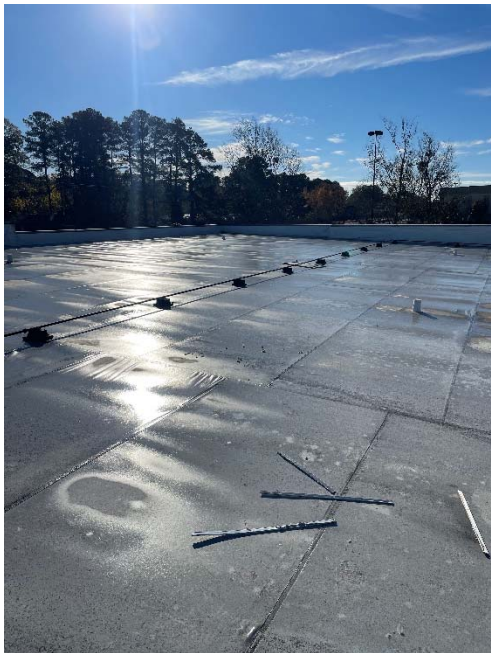
General view of the roof of the commercial structure on the Subject Property
