**Subject: Exterior Lead-Based Paint Survey**  
San Antonio Elementary School  
650 Carne Road  
Ojai, CA 93023  
*FCG Job Code: OUSD-63*

# Attachment 1

## Site Plan for San Antonio Elementary School (with areas of LBP noted)

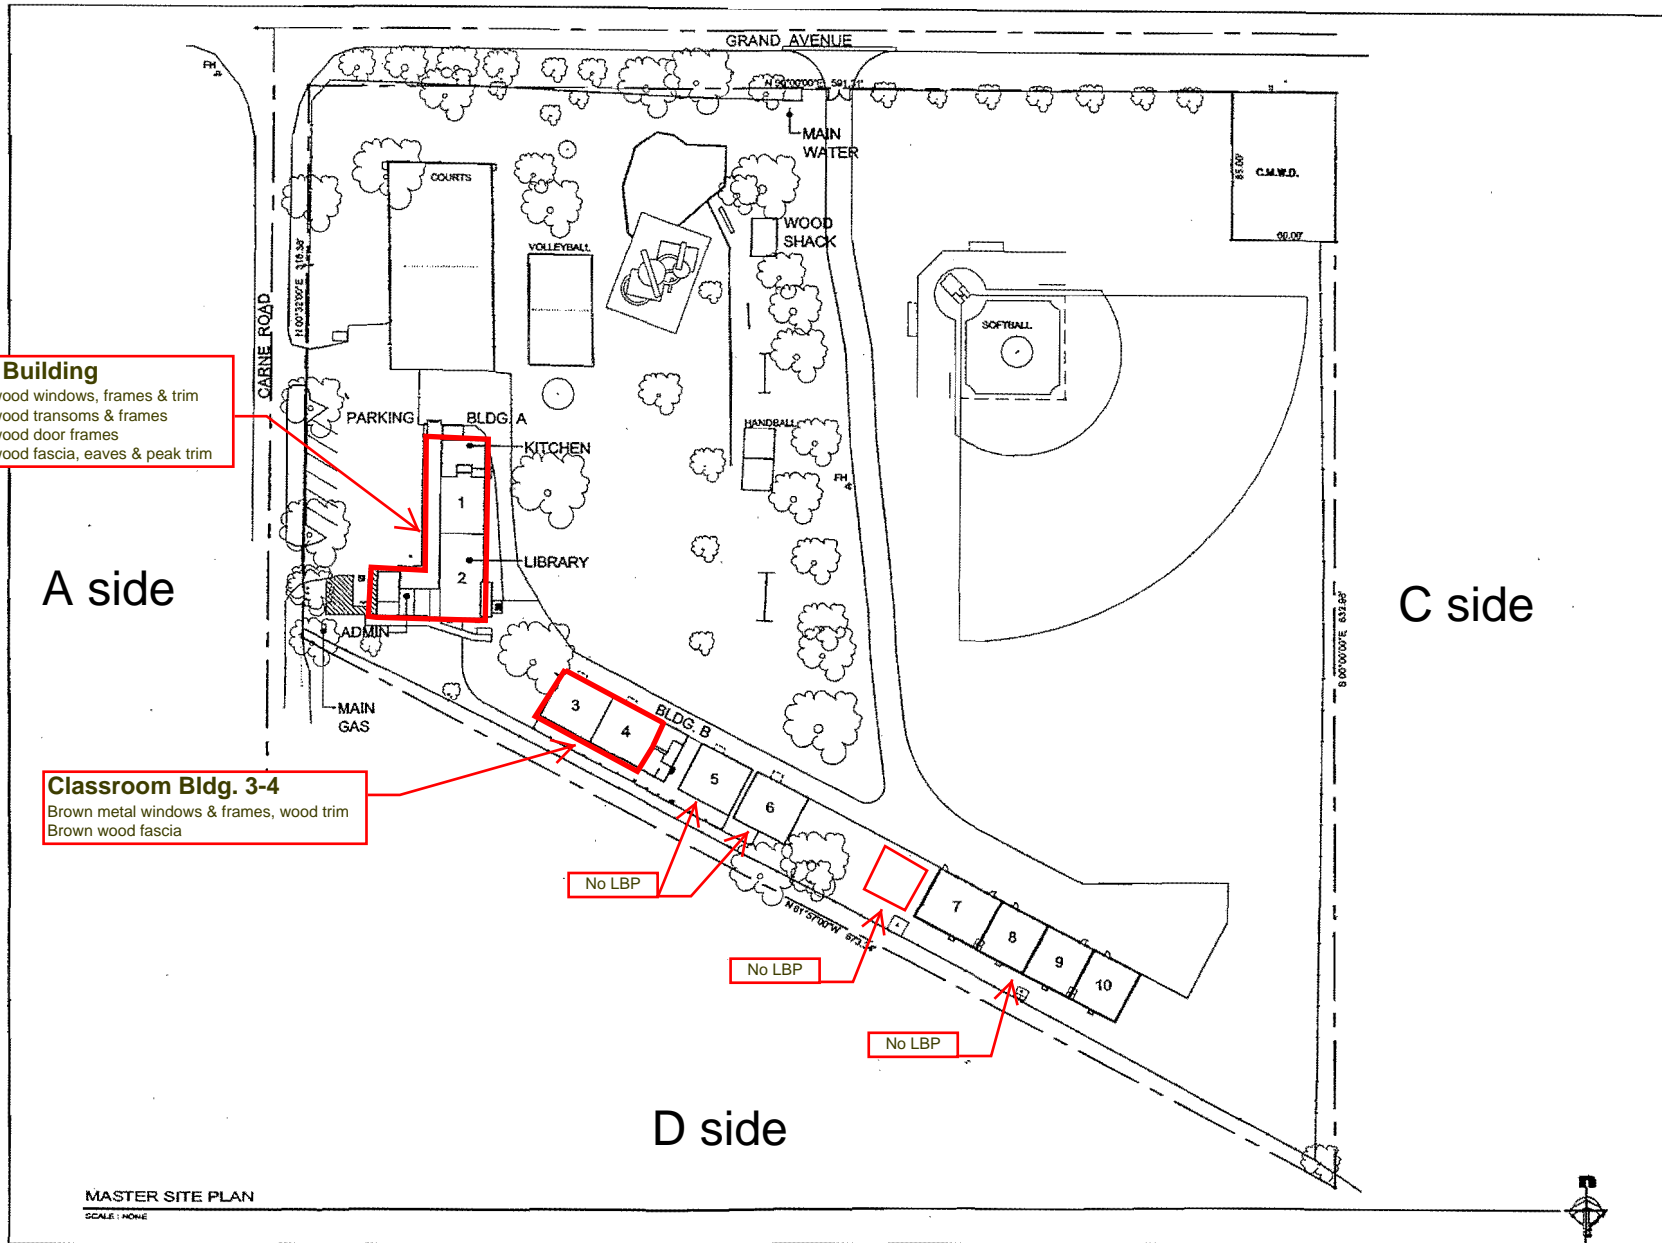
**MASTER SITE PLAN**  
 SCALE: 1"=40'

No LBP was detected on the exteriors of Classroom Building 5-6, Classroom Building 7-10 or the Restroom Building. Refer to the attached data tables for a summary of all XRF readings and the locations of lead-based materials. The A side noted on the tables is the west (Carne Rd. side) of the subject site and the B, C and D sides continue clockwise around the site.

**Main Building**  
 Brown wood windows, frames & trim  
 Brown wood transoms & frames  
 Brown wood door frames  
 Brown wood fascia, eaves & peak trim

**Classroom Bldg. 3-4**  
 Brown metal windows & frames, wood trim  
 Brown wood fascia

No LBP

1. The painted materials listed on Page 2 of this report meet the definition of Lead-Based Paint (LBP) with lead concentrations above the 1.0 mg/cm<sup>2</sup> regulatory level by XRF screening methods. These materials will require the implementation of lead-safe work practices per EPA's Renovation Repair & Painting Rule and CA Title 17 as part of future renovations and painting activities.
