REPORT DATE: October 16, 2023
MID-ATLANTIC PROJECT #: R4446.00

NESHAP ASBESTOS SURVEY REPORT

WILSON RESIDENTIAL ASSEMBLAGE

1419 Corbett Avenue, 927 & 929 Carolina Street, and 209 Maplewood Avenue,
Wilson, Wilson County, North Carolina

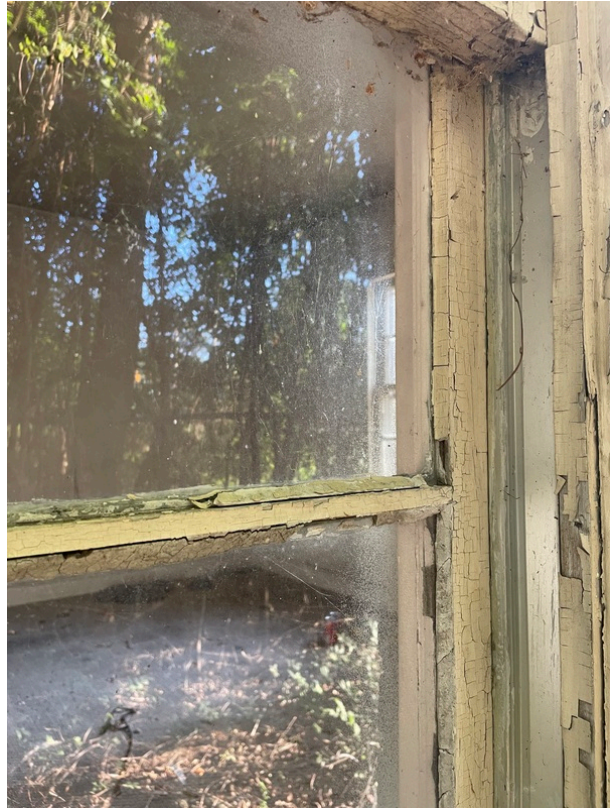
- White Exterior Window Glazing (≤1%)
- White Sink Coating
- Black Chimney Tar

View of trace asbestos-containing White
Exterior Window Glazing (HA 1419-1)

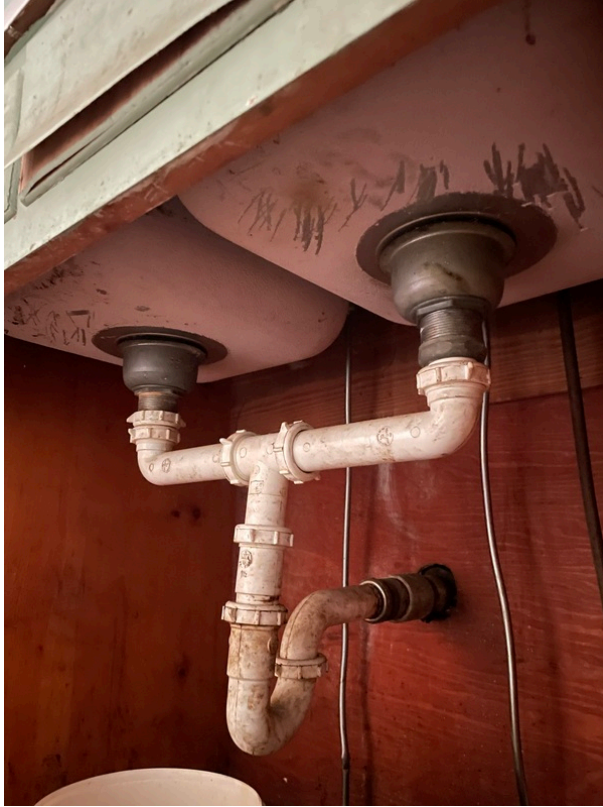
View of asbestos-containing White Sink Coating (HA 1419-5)

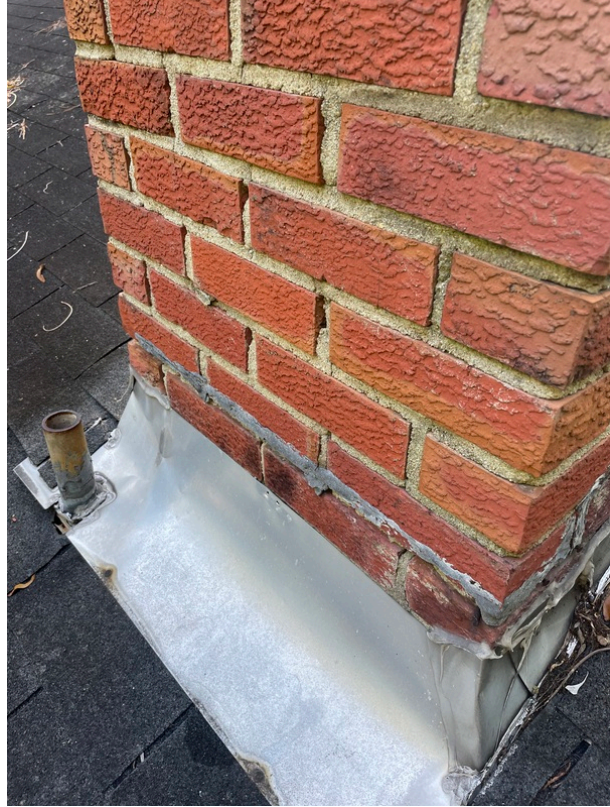
View of asbestos-containing Black Chimney Tar (HA 1419-7)

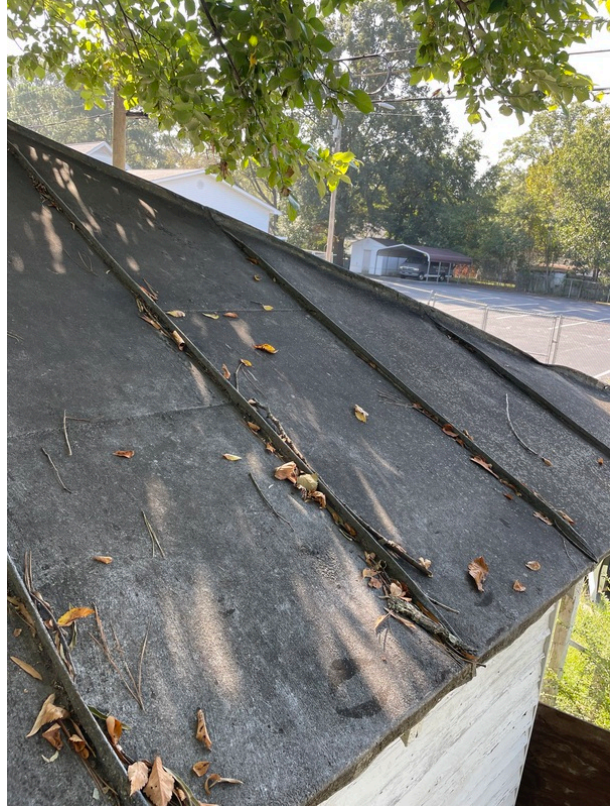
- Silver Paint Coating

View of asbestos-containing Silver Paint
Coating (HA 927-3)

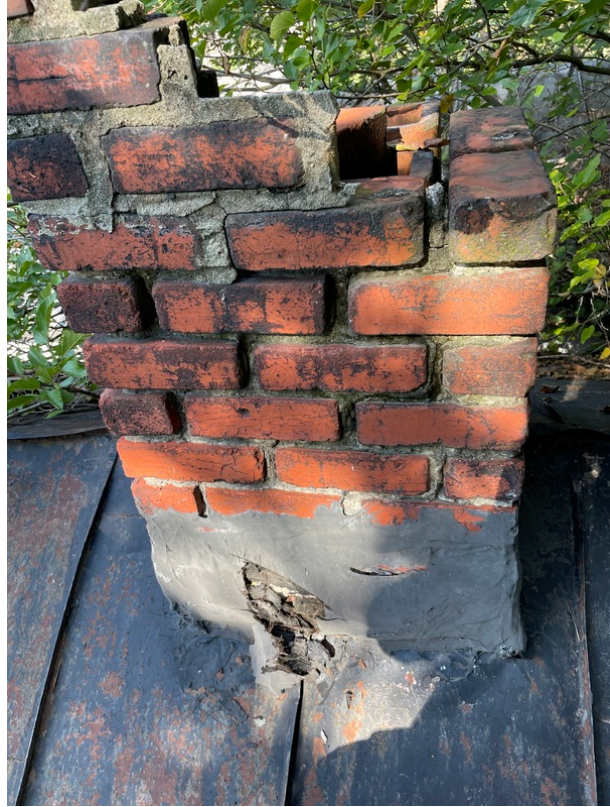
- Black Chimney Tar

View of asbestos-containing Black Chimney Tar (HA 929-3)

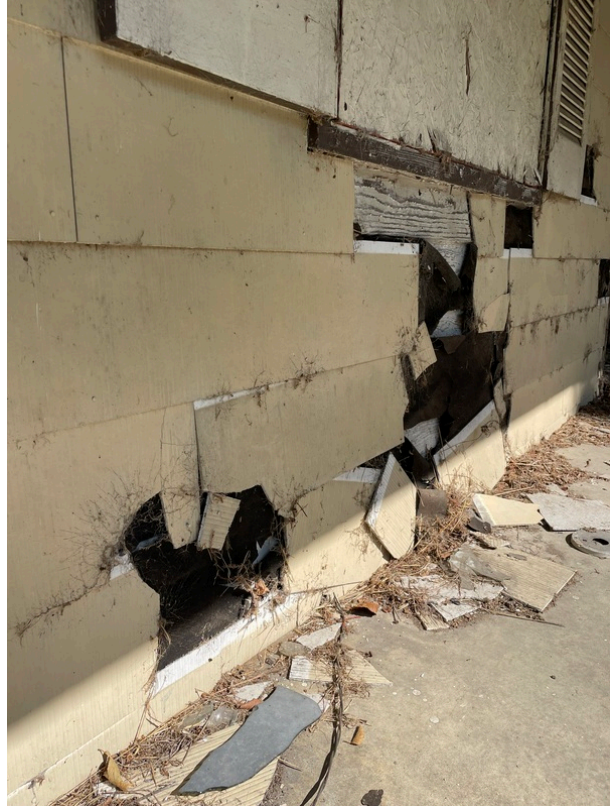
- Transite Siding
- White Exterior Window Glazing (≤1%)
- 12" x 12" Tan Floor Tile
- Tan Floor Tile beneath Parquet Flooring and Off-White Floor Tile
- Gray/Black Chimney Tar

View of asbestos-containing Transite
Siding (HA 209-1)

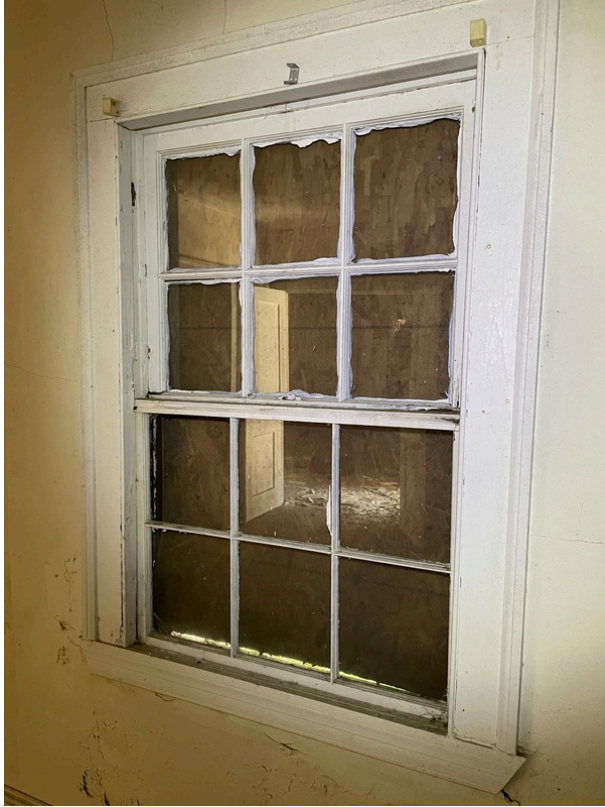
View of trace asbestos-containing White Exterior Window Glazing (HA 209-4)

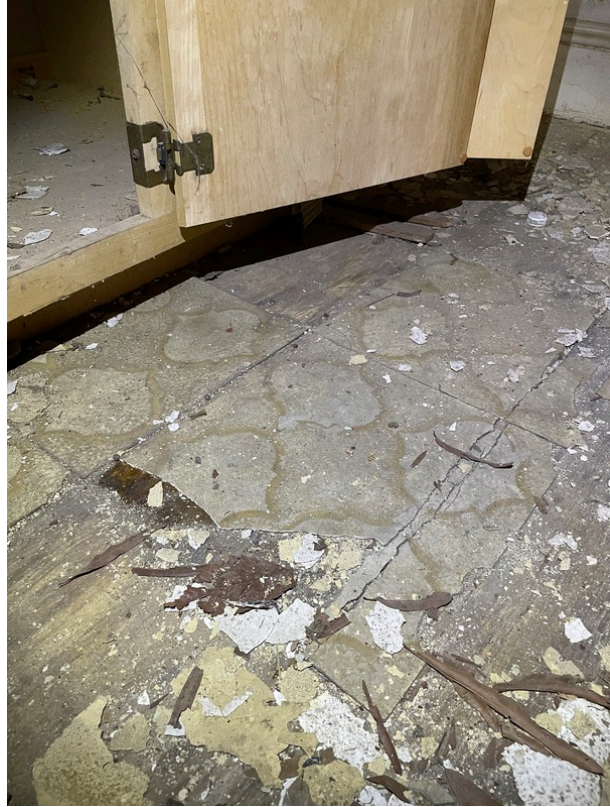
View of asbestos-containing 12" x 12" Tan Floor Tile (HA 209-5)

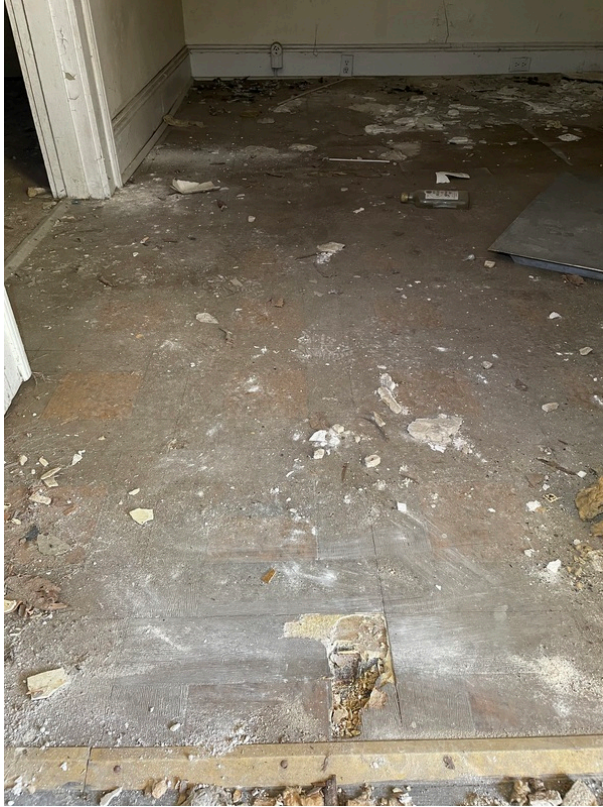
General view of asbestos-containing Tan Floor Tile (HA 209-6)

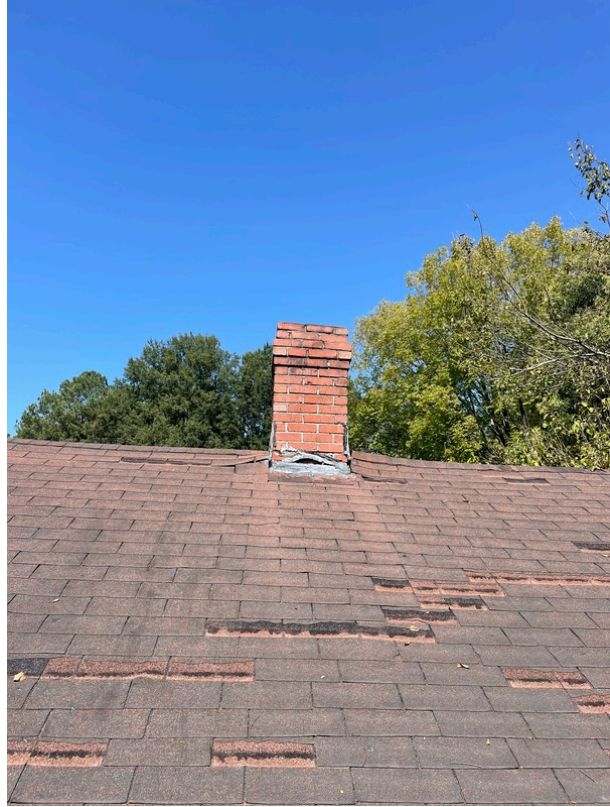
View of asbestos-containing Gray/Black Chimney Caulk (HA 209-9)
