**ASBESTOS PROJECT DESIGN
REGARDING
VACANT BUILDING
419 HAMPTON STREET
WALTERBORO, SOUTH CAROLINA**

Date of Design: October 08, 2019

**ASBESTOS SURVEY
REGARDING
VACANT BUILDING
419 HAMPTON STREET
WALTERBORO, SOUTH CAROLINA**

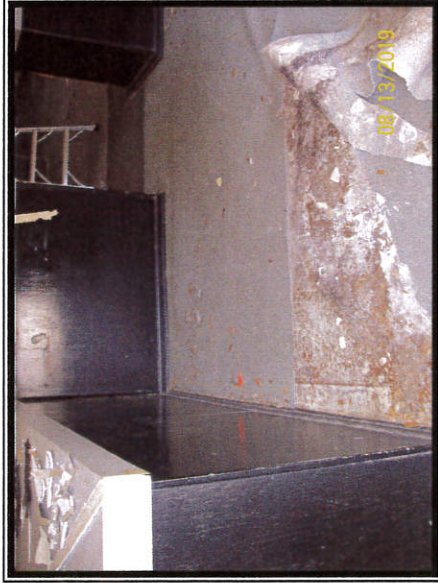
Photo #2
Asbestos Detected at >1% in Parquet Flooring;
No Asbestos Detected in Mottled Gray Flooring

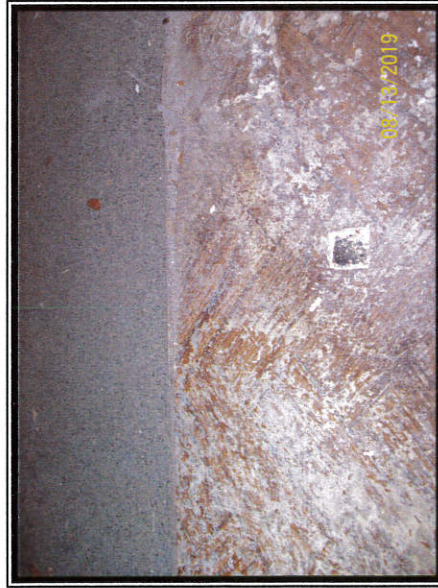
Photo #3
Asbestos Detected at >1% in Tan Floor Tiles
under Parquet Sheet Flooring at Counter Area

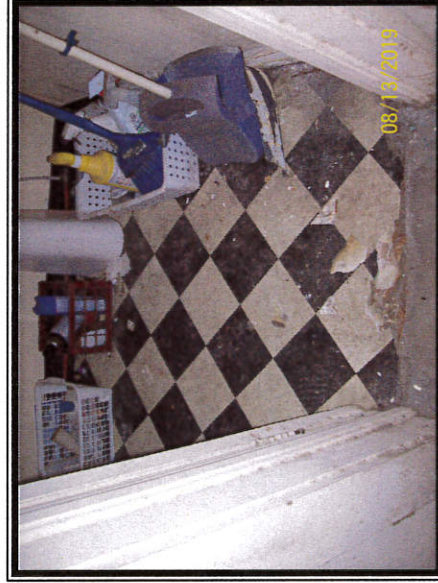
Photo #4
Parquet Sheet Flooring under non-asbestos
containing Checkerboard Sheeting in BR 2

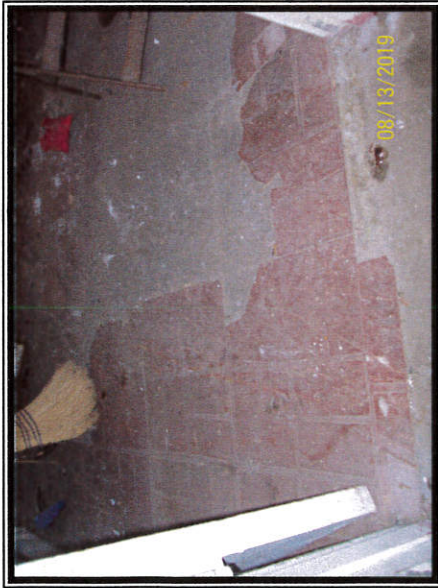
Photo #5

Asbestos Detected at >1% in Brick-patterned Flooring Squares in Room 1

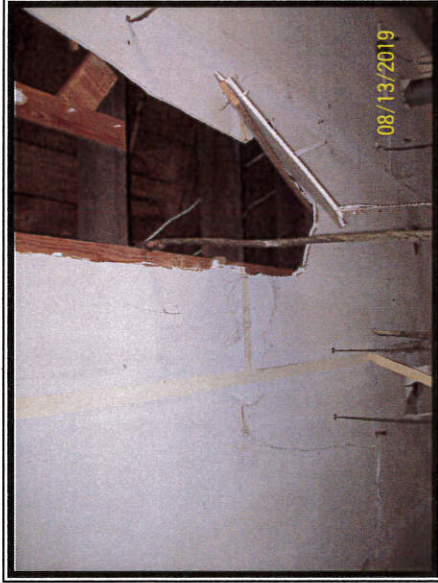
Photo #6

Asbestos Detected at >1% in Sheetrock with Joint Compound Systems

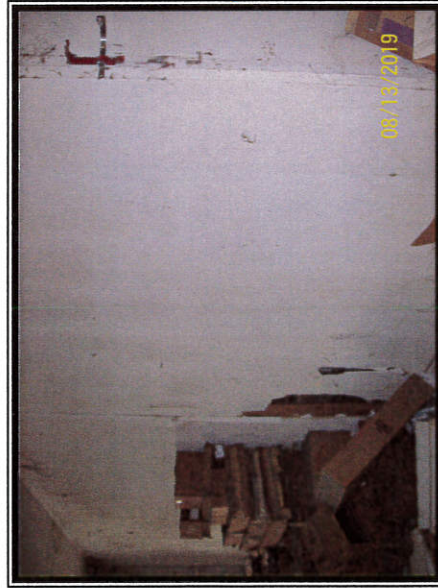
Photo #7

View of Sheetrock Wall System with Joint Compound in Area 3

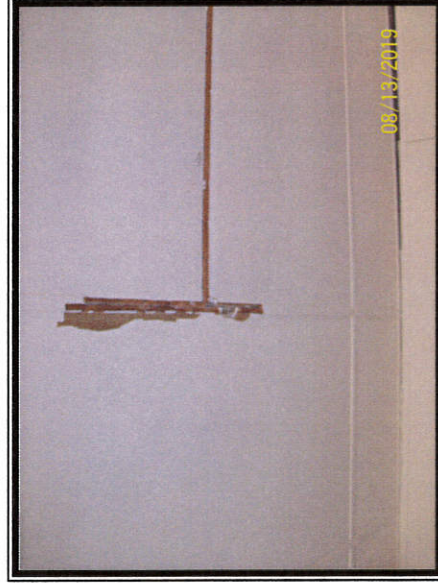
Photo #8

Asbestos Detected at >1% in Joint Compound of Sheetrock with Furring Strips Systems

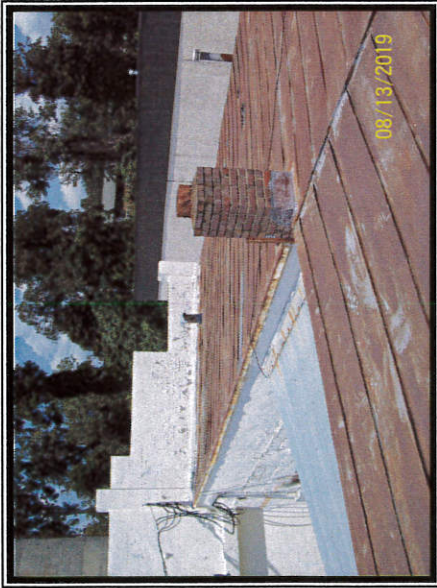
Photo #9
Northeast-facing view of Sheet Metal Roofing
System over Areas 1 & 2 (Rusted)

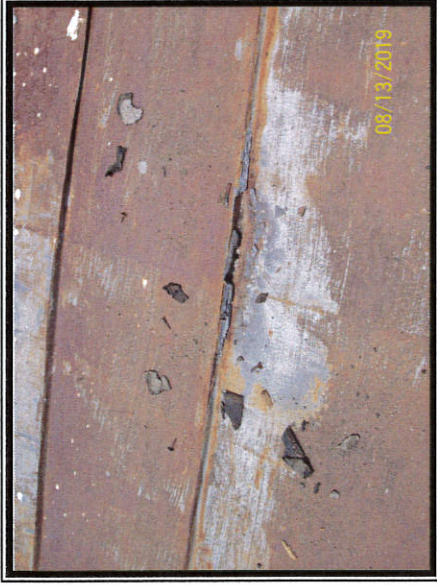
Photo #10
Asbestos Detected at >1% in Metal Roof Seam
Caulk of Areas 1 & 2

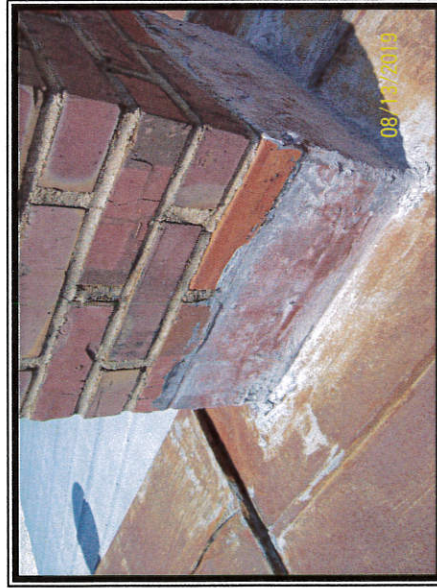
Photo #11
Asbestos Detected at >1% in Silver Roof
Sealant Material as Seen on Chimney

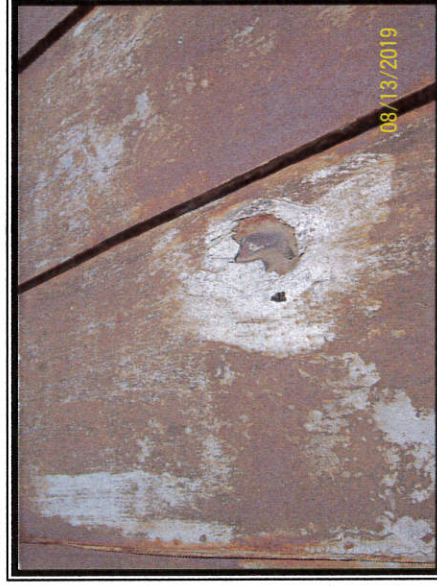
Photo #12
View of Silver Roof Sealant Material on Sheet
Metal Panel

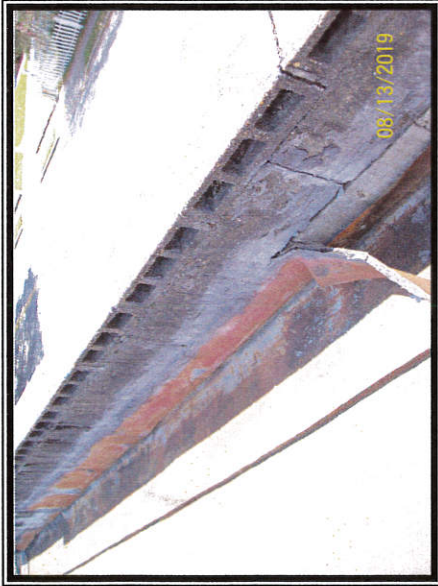
Photo #13

Asbestos Detected at >1% in Area 1 & 2 Roof Parapet Flashing Sealant Materials

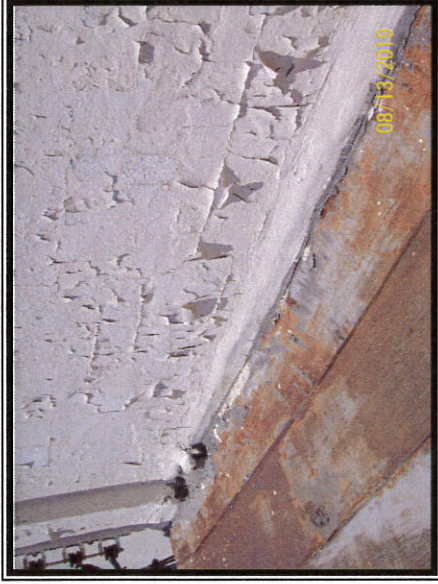
Photo #14

View of Flashing Sealant Materials at North End of Area 2 Roof

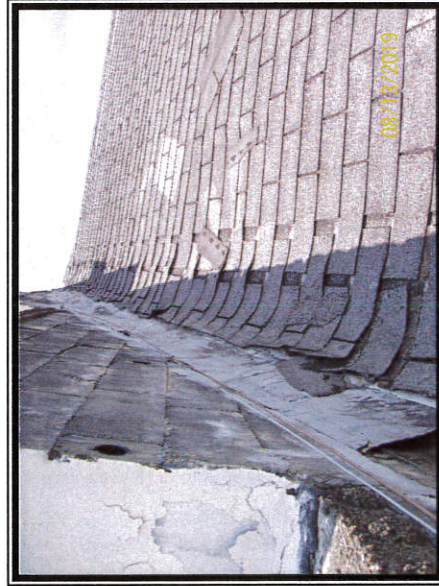
Photo #15

Asbestos Detected at >1% in Area 3 Parapet Flashing Materials; No Asbestos in Shingles/Felt

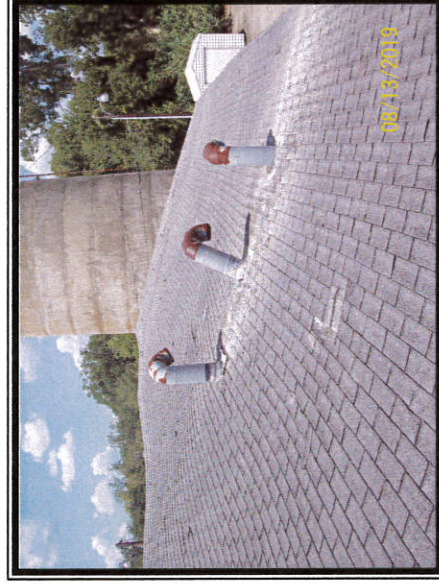
Photo #16

View of Area 3 Roof Vent Pipe with Asbestos-containing Sealant Material

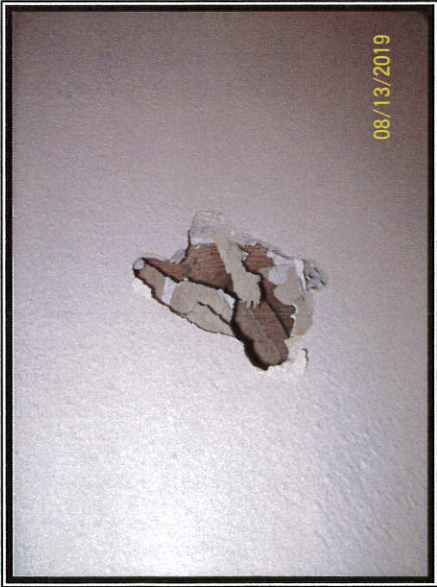
Photo #17
No Asbestos Detected in Cementitious Board
and Sheetrock Combination Wall System

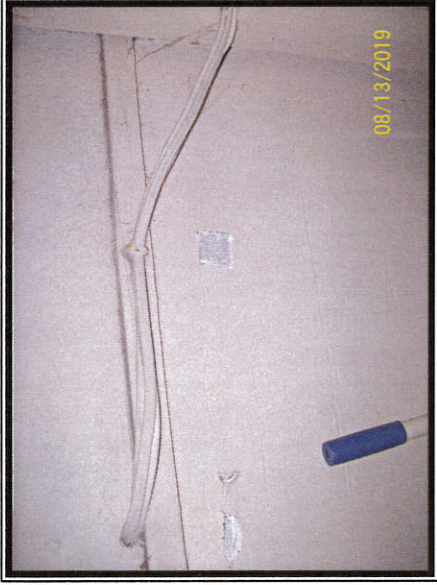
Photo #18
No Asbestos Detected in Simulated Tile Wall
Surfacing in Bathrooms

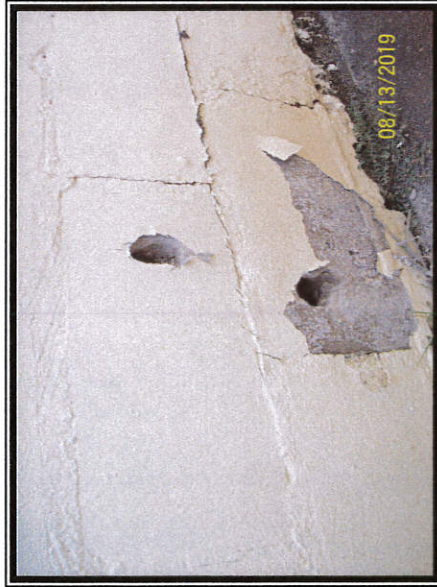
Photo #19
No Vermiculite in CMU; No Asbestos Detected
in Exterior Paint or Block Fill Materials

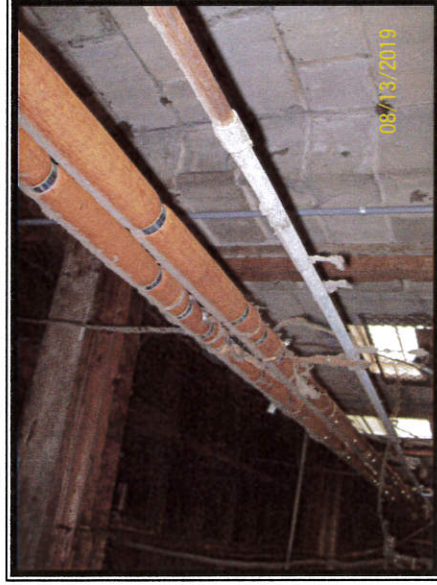
Photo #20
No Asbestos Detected in Any Pipe Wrap
Materials
