## **Pre-Demolition Limited Regulated Hazardous Materials Survey Report**

**Residential Home, Arlington County  
1212 S. Irving Street  
Arlington, VA 22204**

**November 28, 2020**

**JSK Project Number JSK-2020-86**

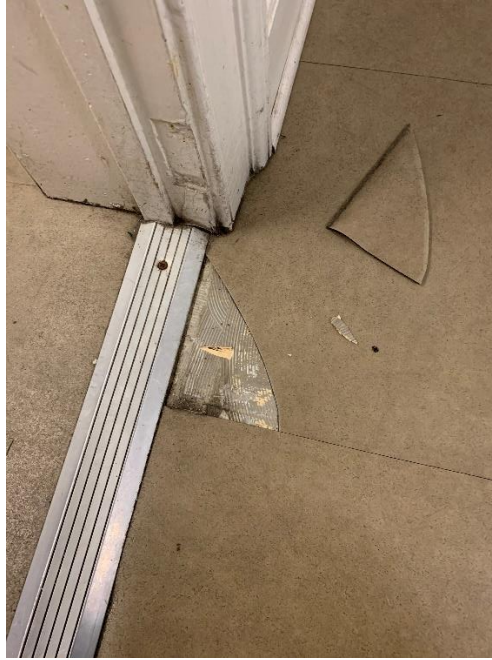
Homogeneous Material No. 1 – Non-ACM Tan 18” by 18” VFT with Cream Mastic located in the Kitchen and Laundry Area

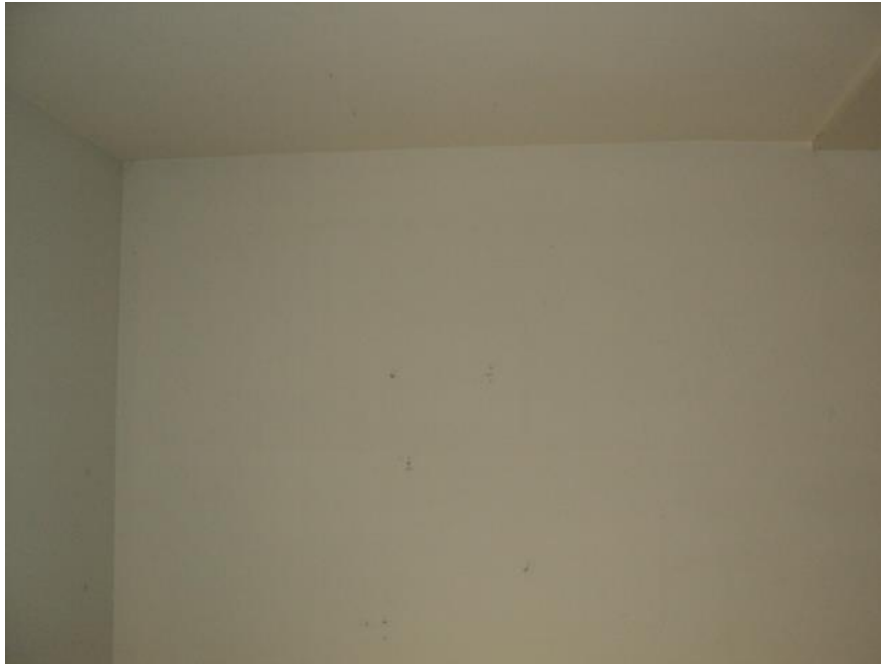
Homogeneous Material No. 2 – Non-ACM White Wall DW and Associated White JC located Throughout the Building including Dining Room, Bedroom 2-2 and Bedroom 3-2

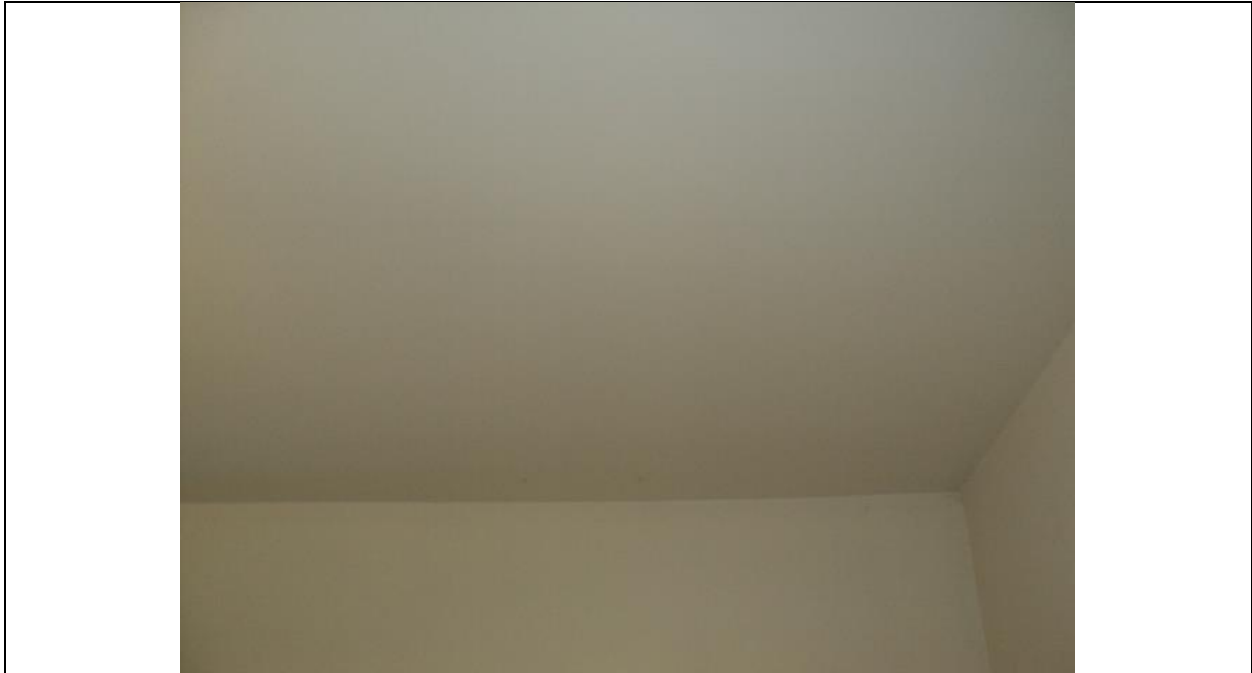
Homogeneous Material No. 3 – Non-ACM White Ceiling DW and Associated White JC located Throughout the Building including Dining Room, Bedroom 2-2 and Bedroom 3-2

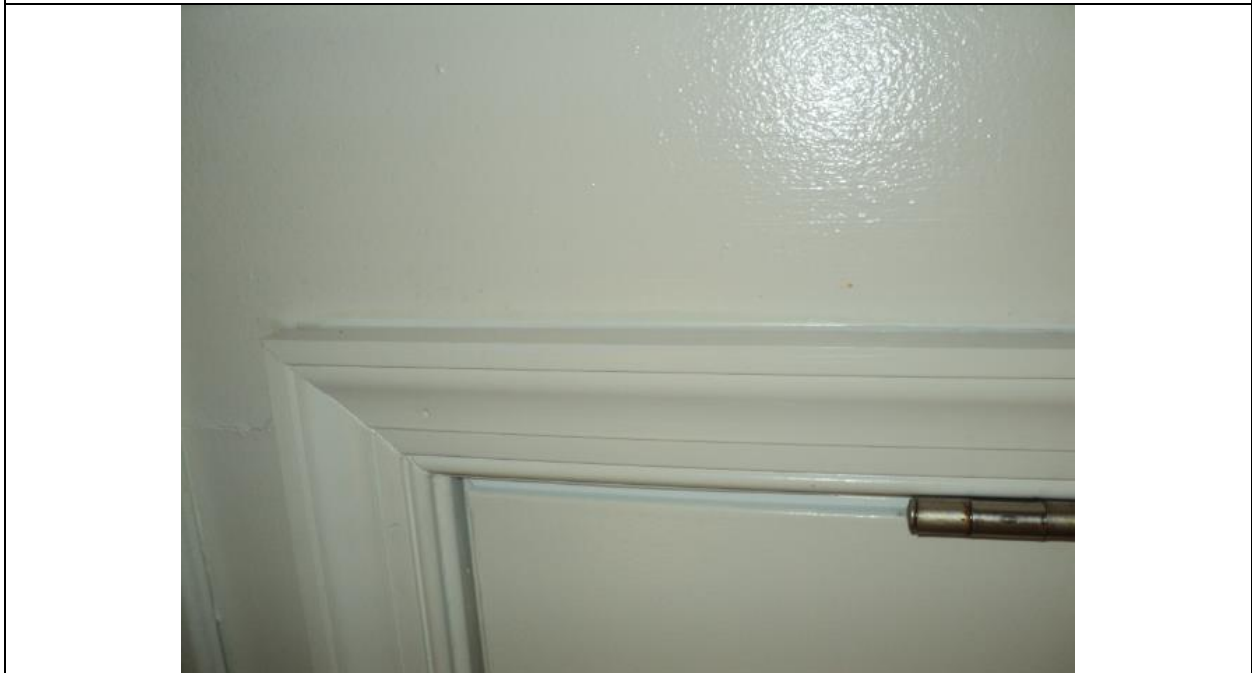
Homogeneous Material No. 4 – Non-ACM White Interior Door Caulk located in the Kitchen and Bedroom 1-3

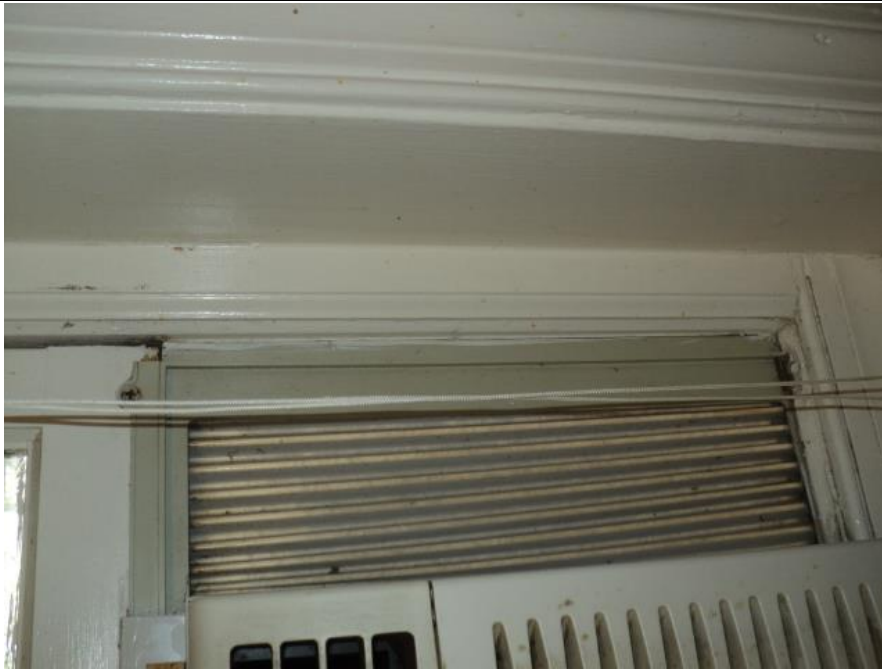
Homogeneous Material No. 5 – Non-ACM White Interior Window Caulk located in the Kitchen and Bedroom 1-3

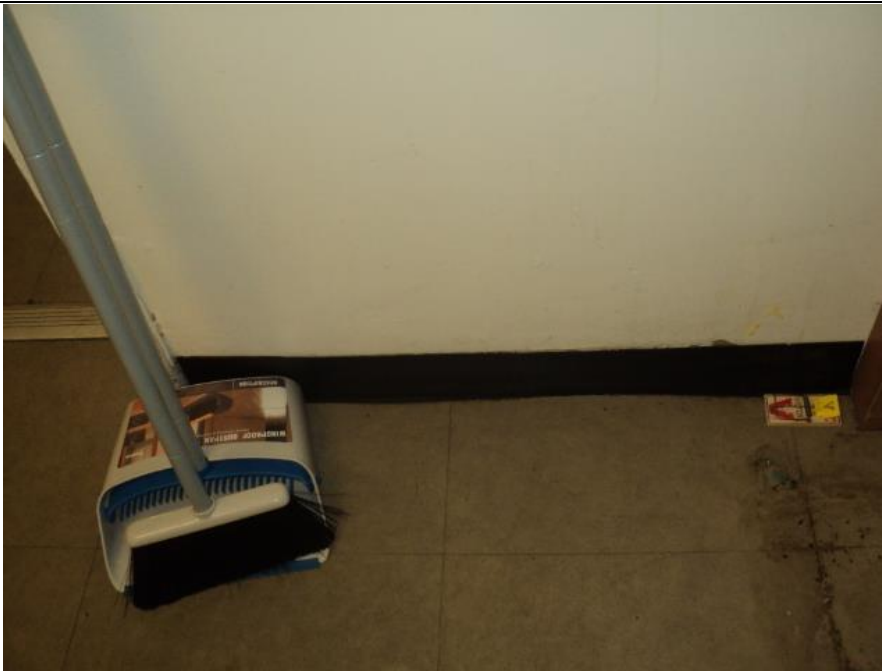
Homogeneous Material No. 6 – Non-ACM 4" Black Vinyl Cove Base with Cream Mastic Located in the Kitchen

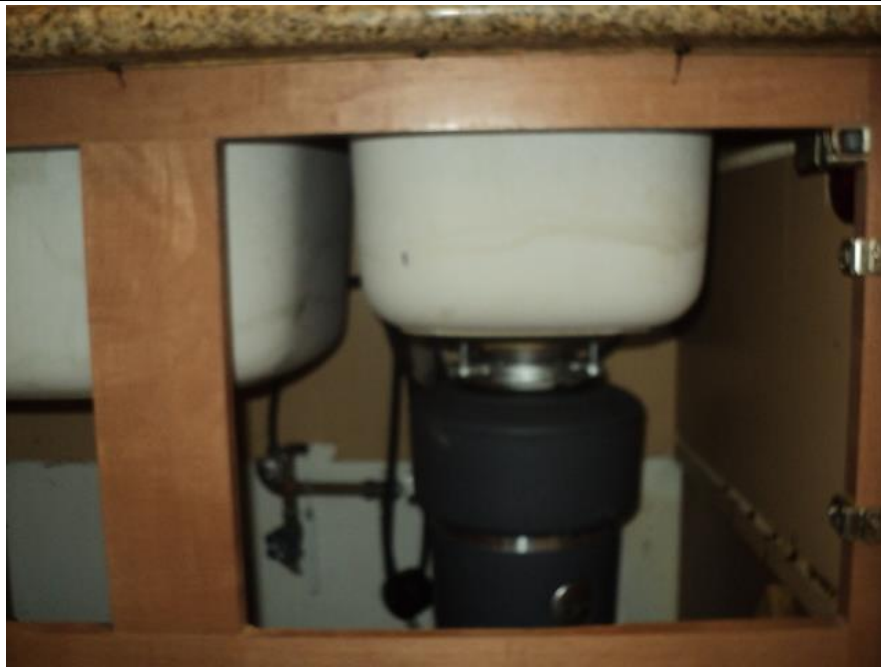
Homogeneous Material No. 7 – Non-ACM Light Gray Under Sink Bowl Coating located in the Kitchen

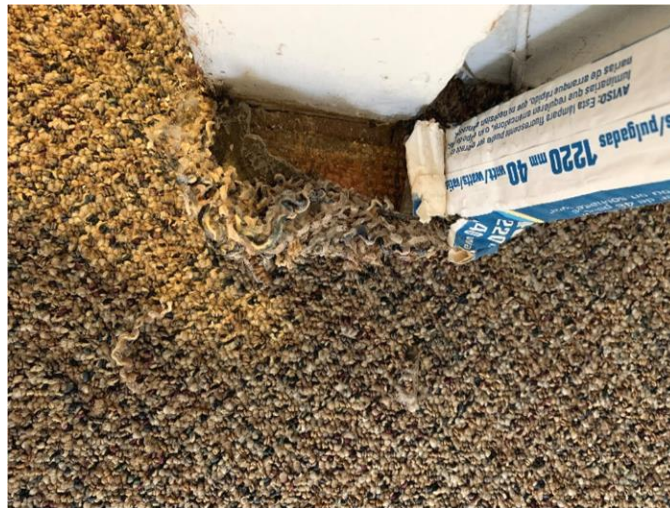
Homogeneous Material No. 8 – Non-ACM Black and Brown Carpet with Tan Carpet Glue located in the Living Room and Office Space

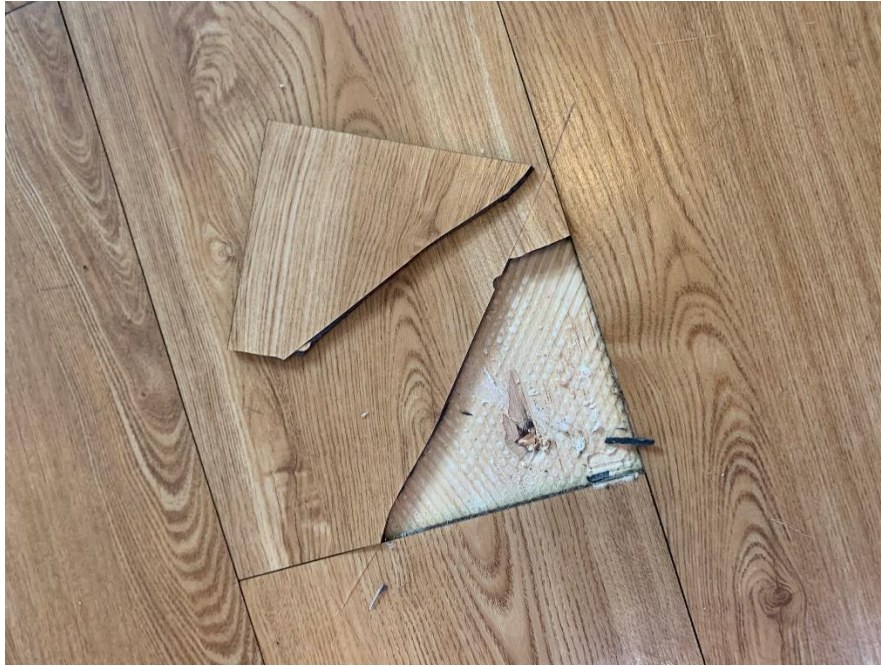
Homogeneous Material No. 9 – Non-ACM Tan Faux Wood Pattern Vinyl Plank Flooring with Cream Mastic located in Bedroom 1-2 and Bedroom 1-3

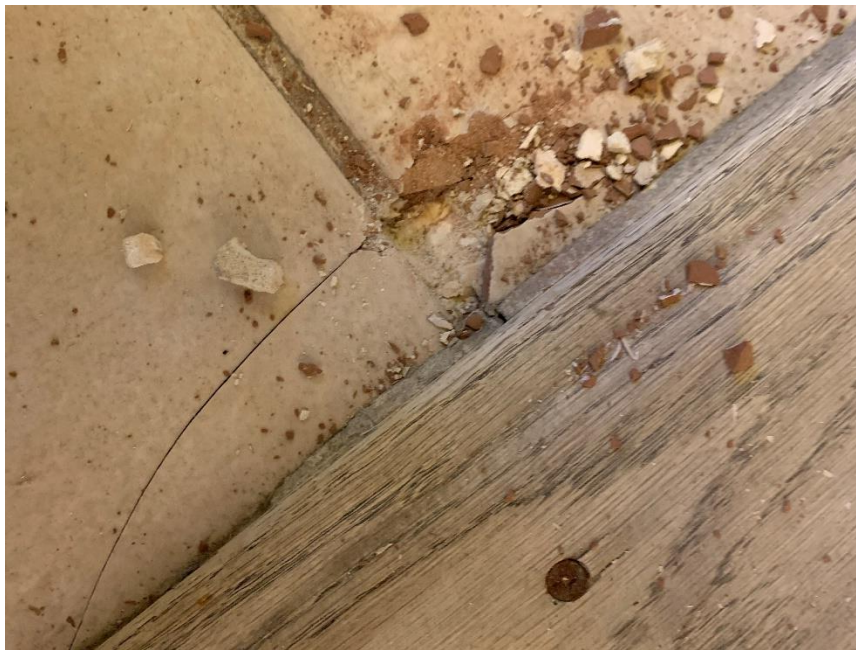
Homogeneous Material No. 10 – Non-ACM Mottled Pink CT with Light Gray Grout and White Setting Base located in the Bathroom on the 1<sup>st</sup> Floor

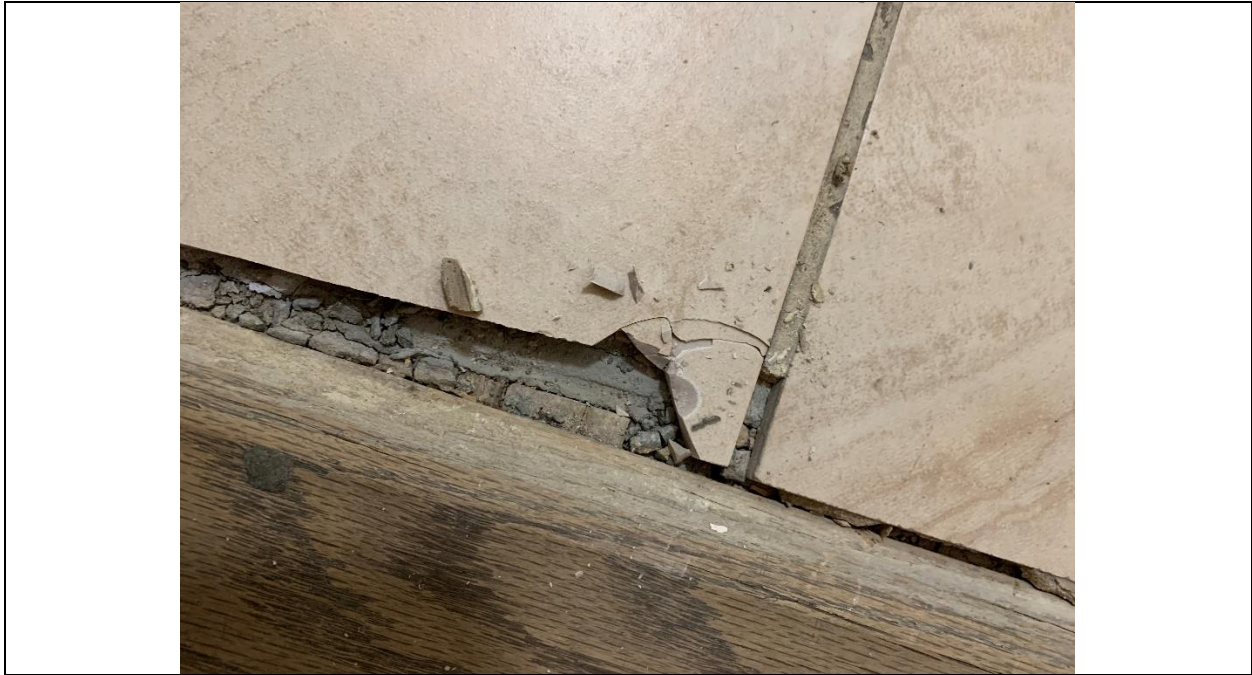
Homogeneous Material No. 11 – Non-ACM Pinkish Gray CT with Gray Grout and Gray Setting Base located in the Shower Room on the 1<sup>st</sup> Floor

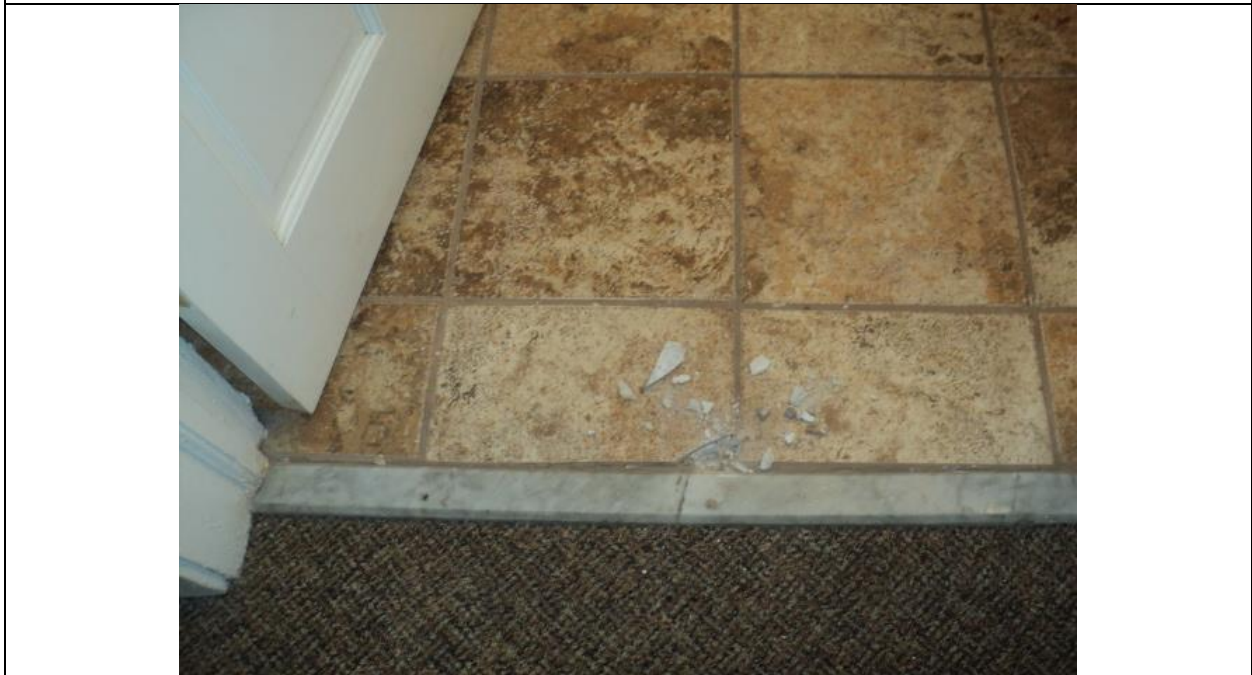
Homogeneous Material No. 12 – Non-ACM Mottled Dark Brown CT with Tan Grout and White Setting Base located in Bathroom 2-1

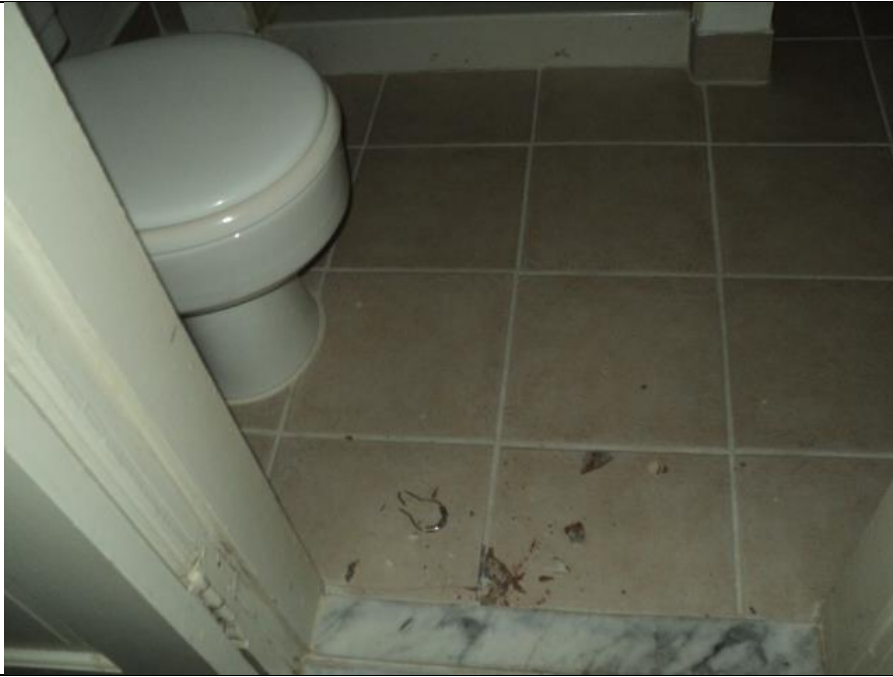
Homogeneous Material No. 13 – Non-ACM Creamish White CT with Cream Grout and White Setting Base located in the Bathroom on the 3<sup>rd</sup> Floor

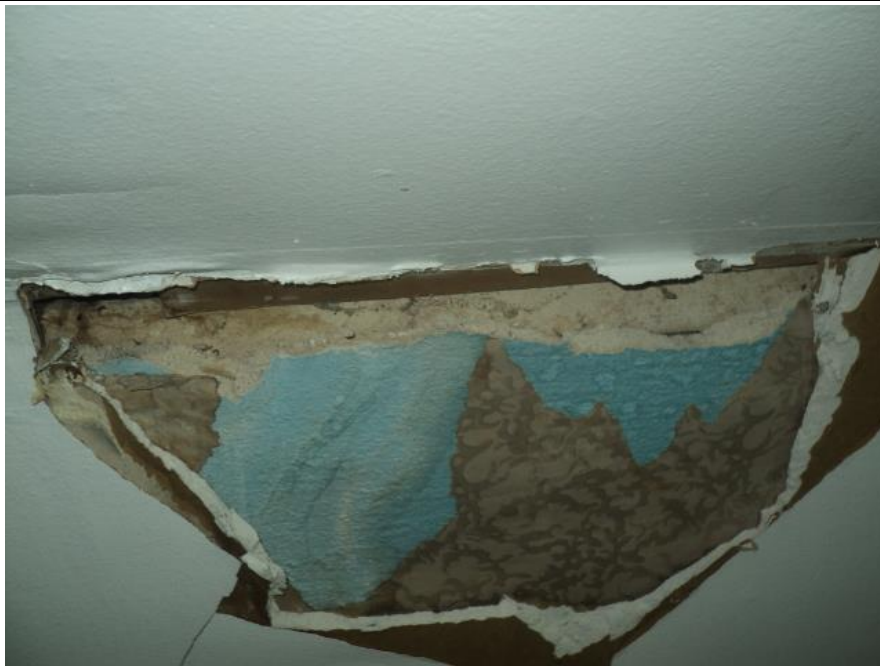
Homogeneous Material No. 14 – Non-ACM Tan Ceiling Plaster located in Bedrooms 3-1 and 3-2

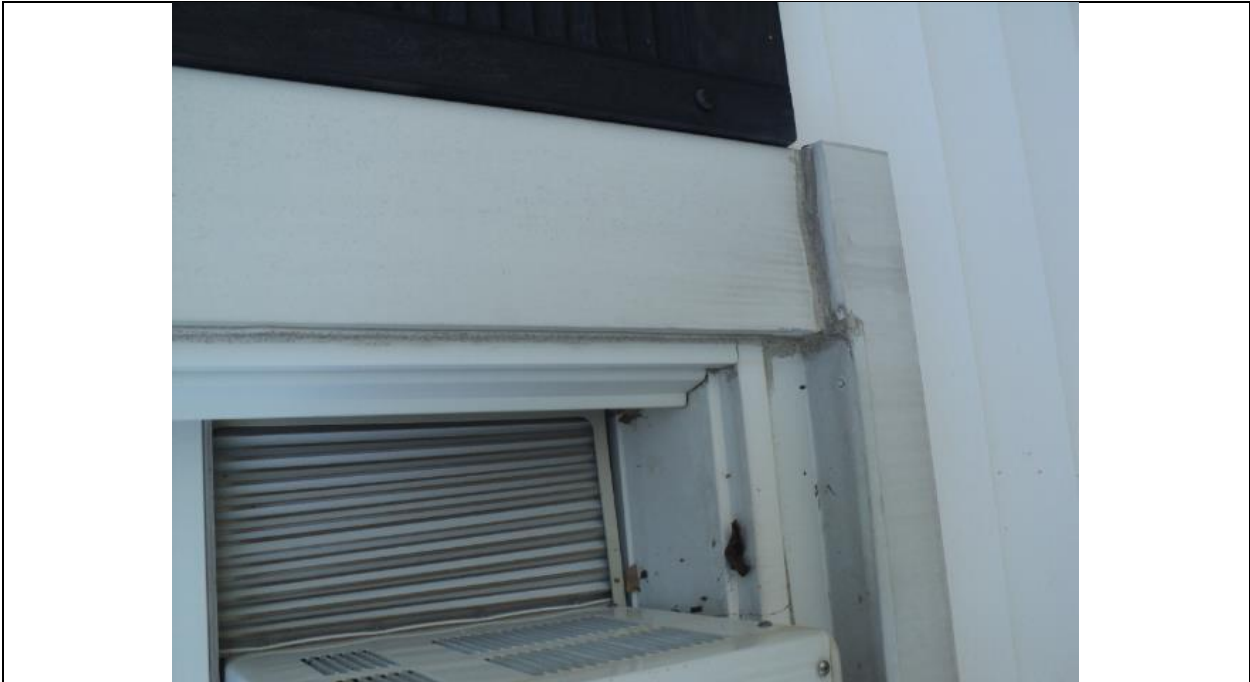
Homogeneous Material No. 15 – Non-ACM White Exterior Window Caulk located in the Exterior Windows

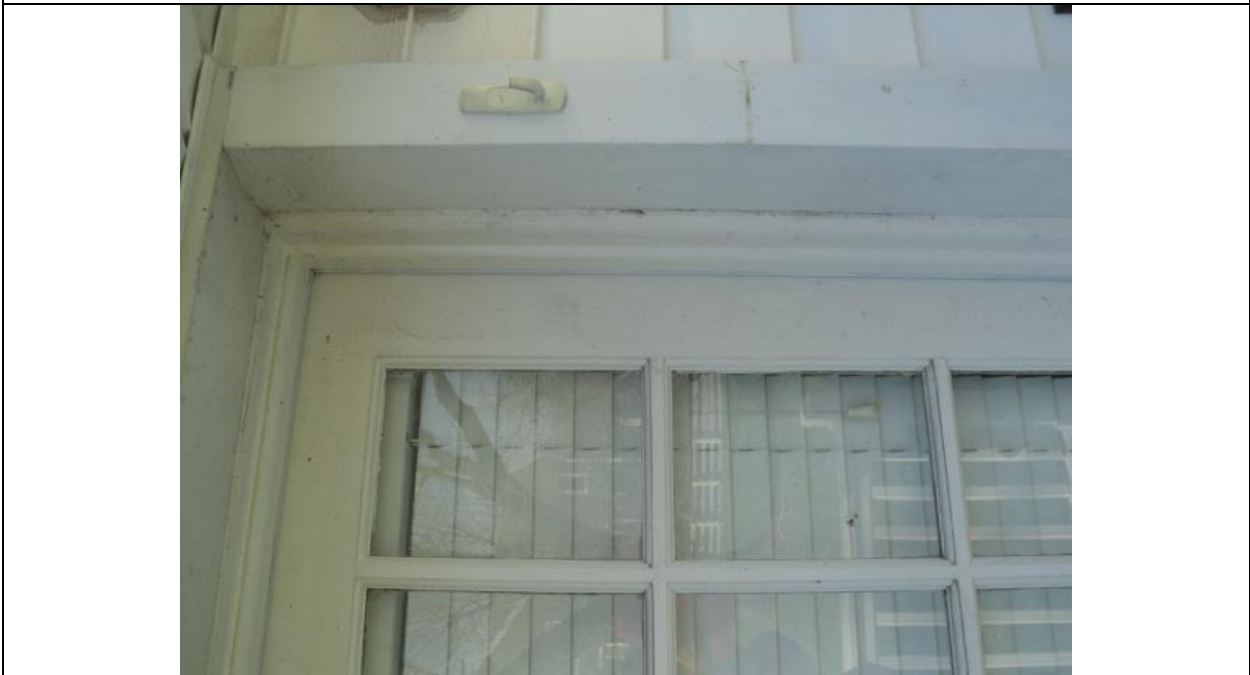
Homogeneous Material No. 16 – Non-ACM White Exterior Door Caulk located on the Exterior Door

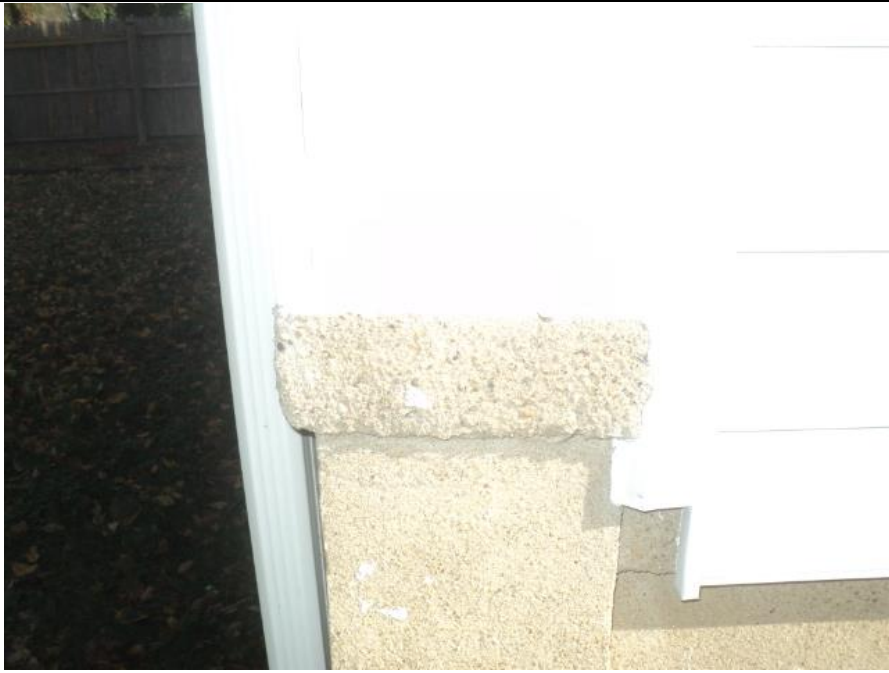
Homogeneous Material No. 17 – Non-ACM White Vinyl Siding Seam Caulk located on the Exterior Siding

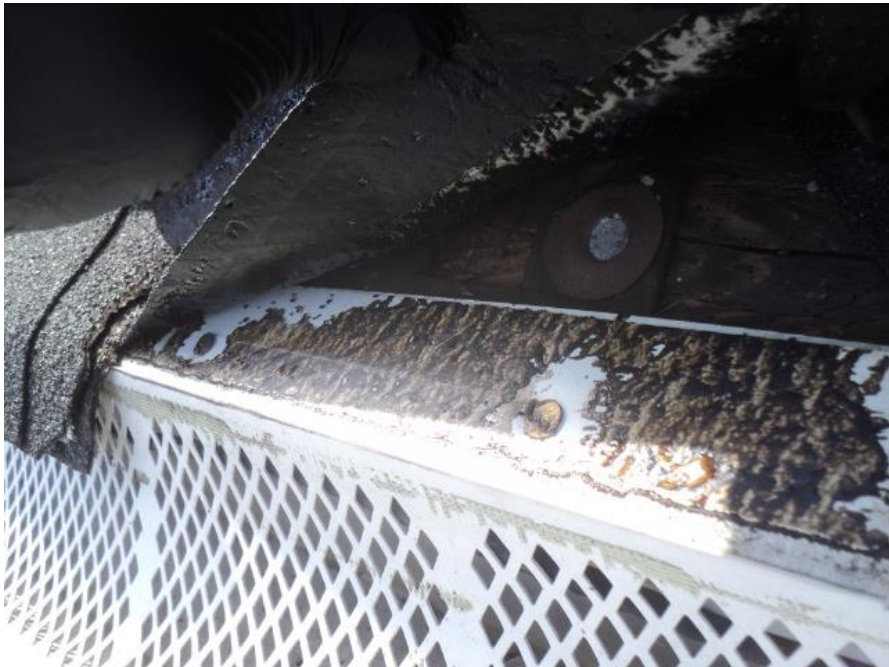
Homogeneous Material No. 18 – Non-ACM Black asphalt roof shingle with Black Asphalt Ice Shield and Black Felt Paper located on the Roof

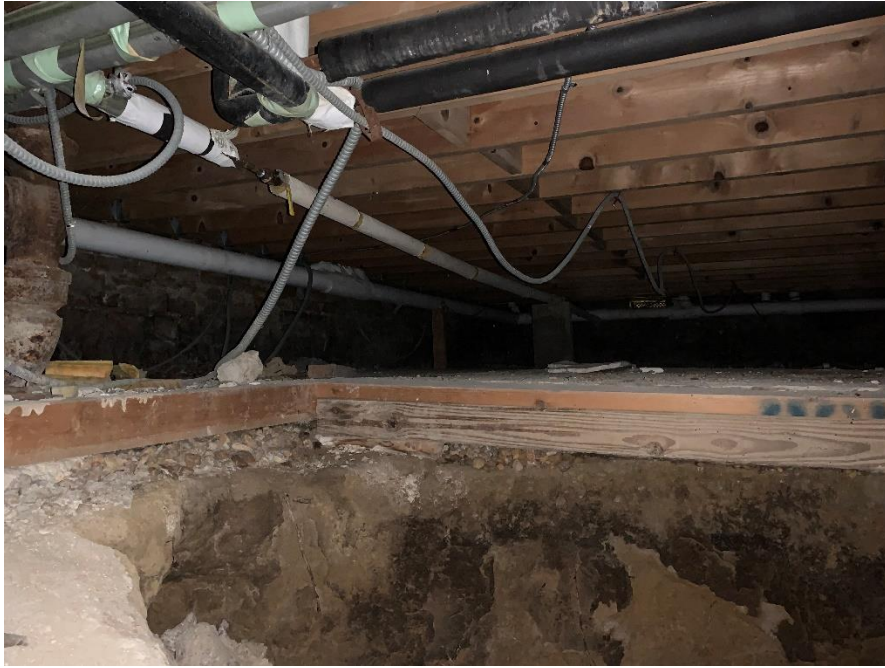
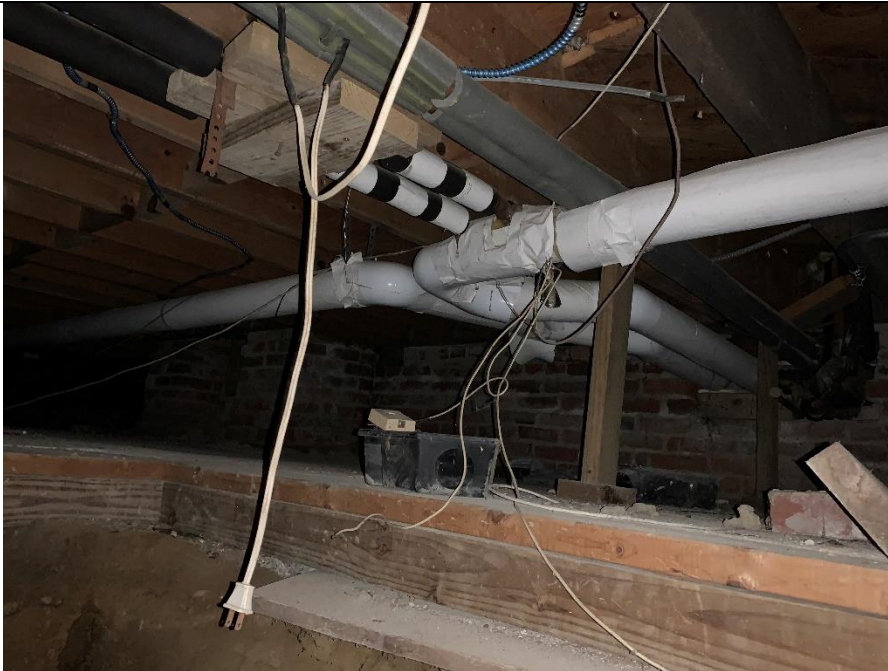
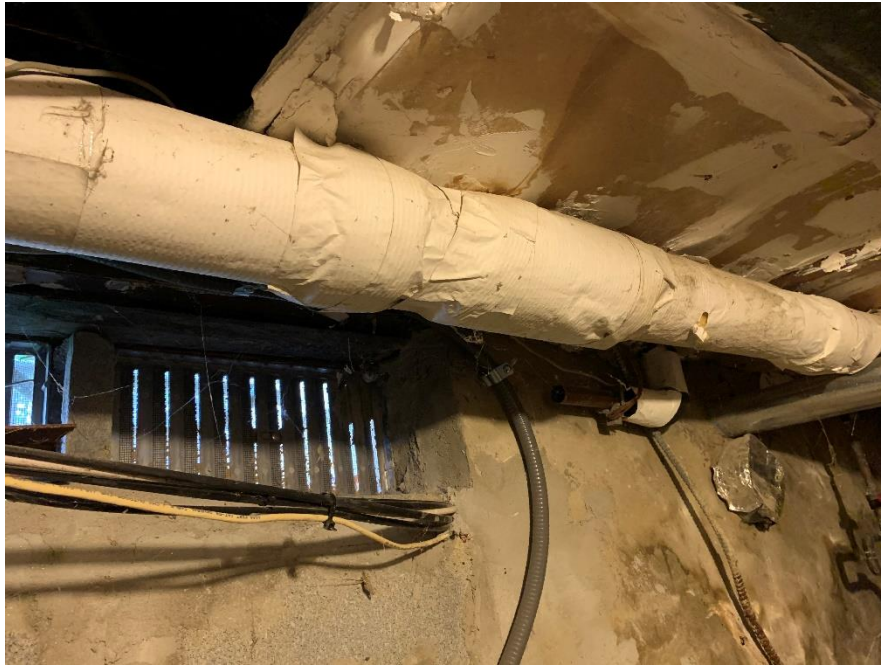
Non-ACM Fiberglass Insulation on Piping in Basement

Another View of Non-ACM Fiberglass Insulation on Piping in Basement

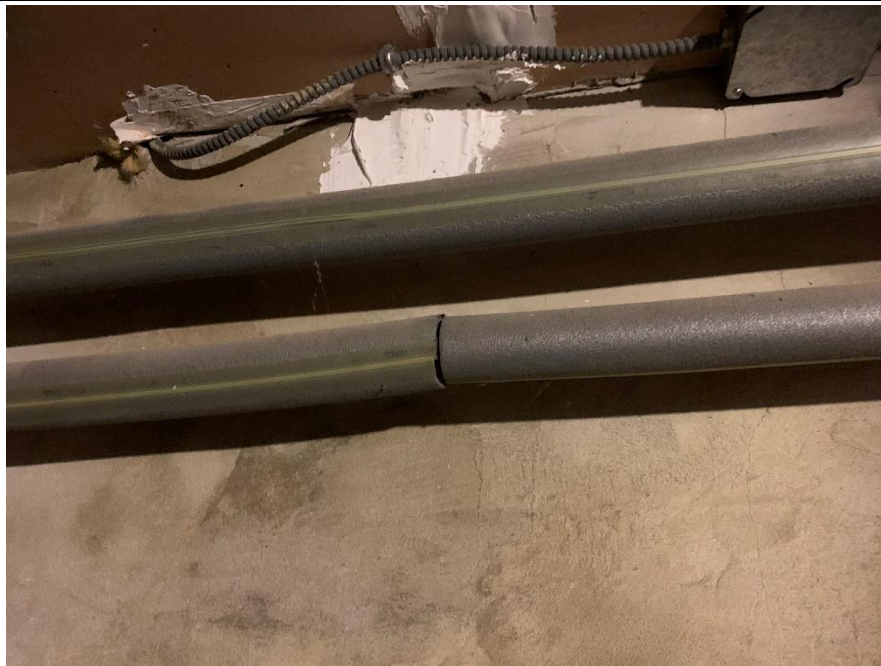
Non-ACM Foam Insulation on Piping in Basement

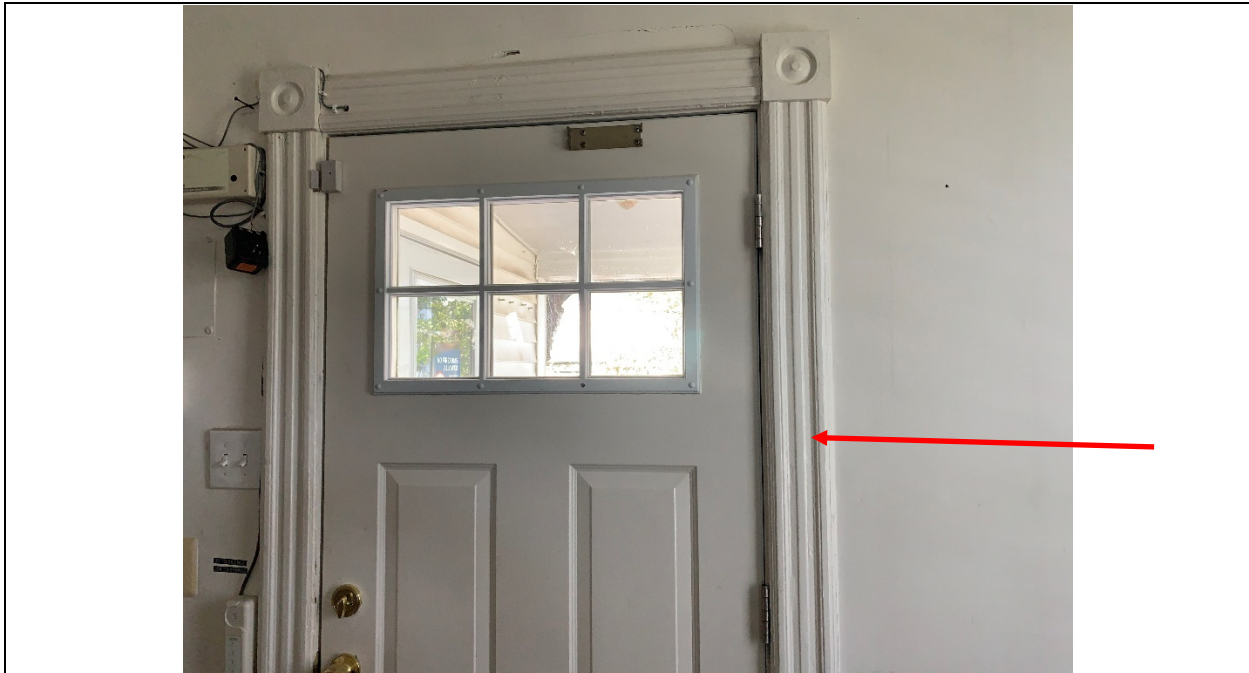
LBP-1: Lead-Based Paint on Living Room Door Casing

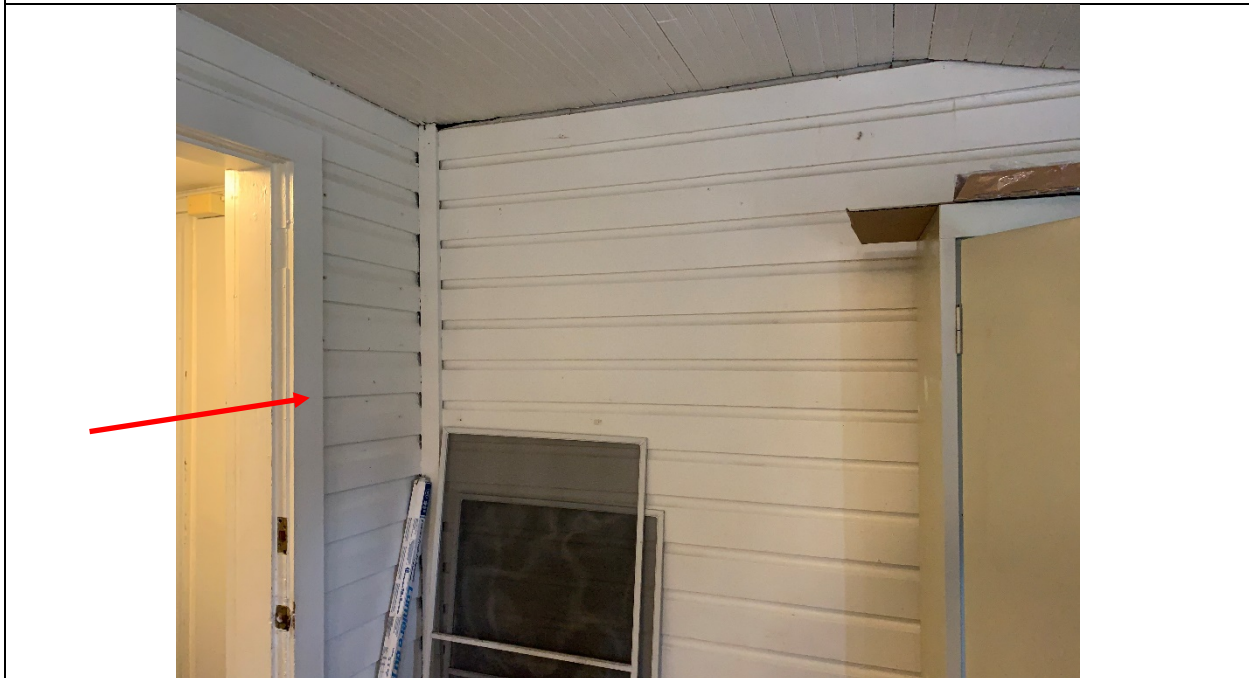
LBP-2: Lead-Based Paint on Casing on Door Leading to Office from Living Room/Dining Room

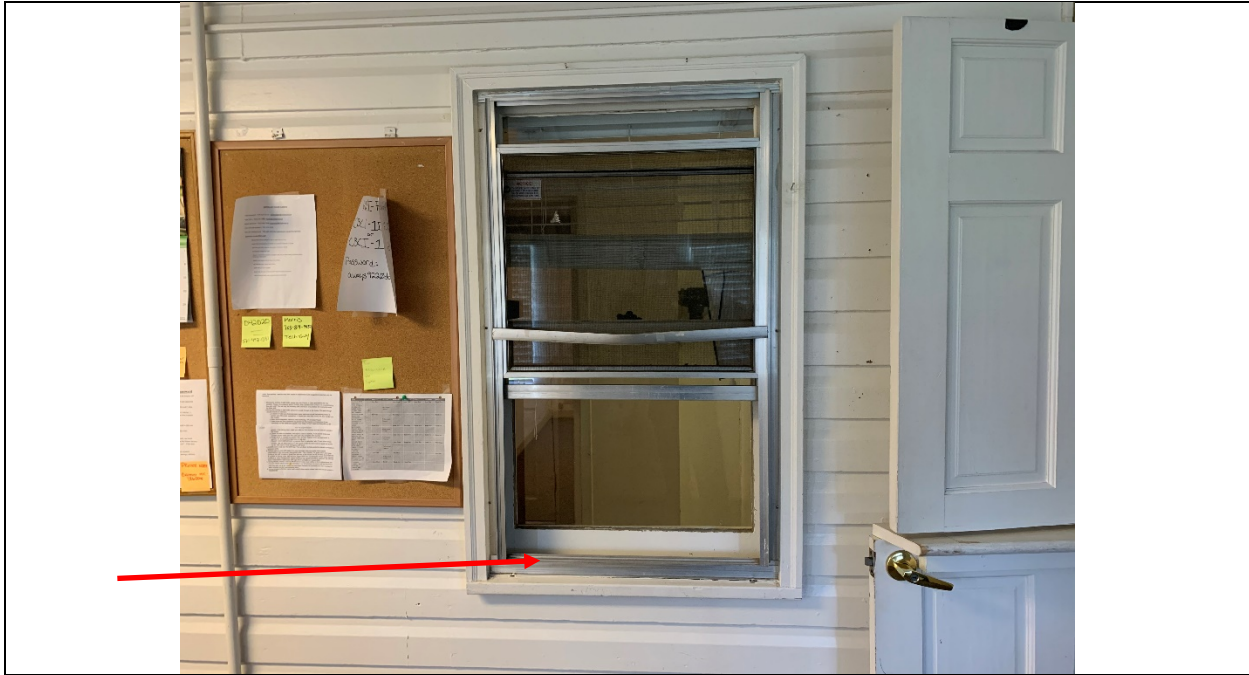
LBP-3: Lead-Based Paint on Window Sash, Window Casing, Windowsill & Window Trough in the Office

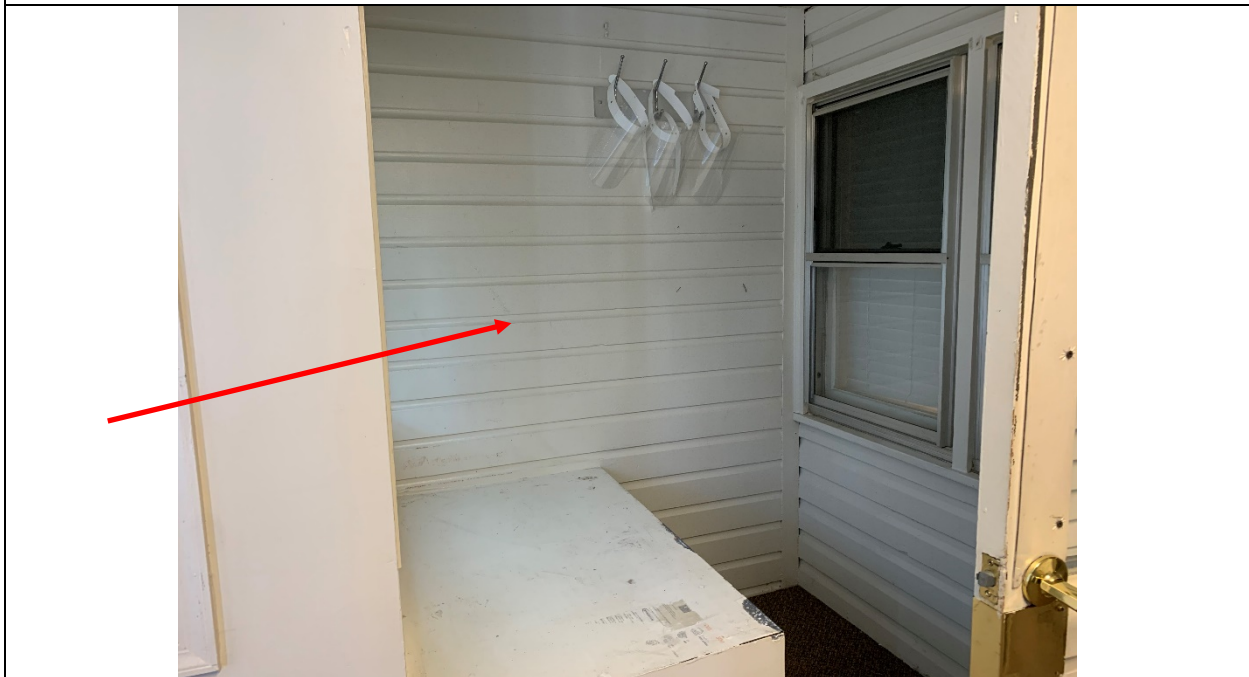
LBP-4: Lead-Based Paint on Siding/Paneling in the Office Area

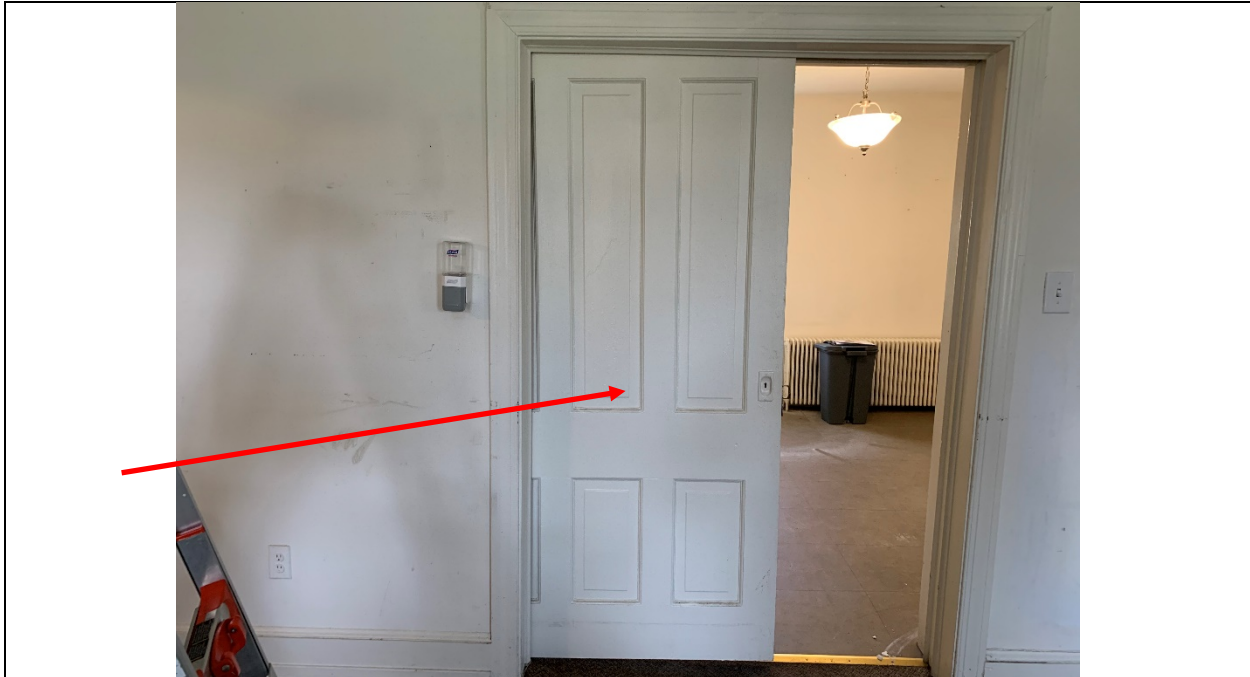
LBP-5: Lead-Based Paint on Pocket Door Separating Living Room and Dining Room

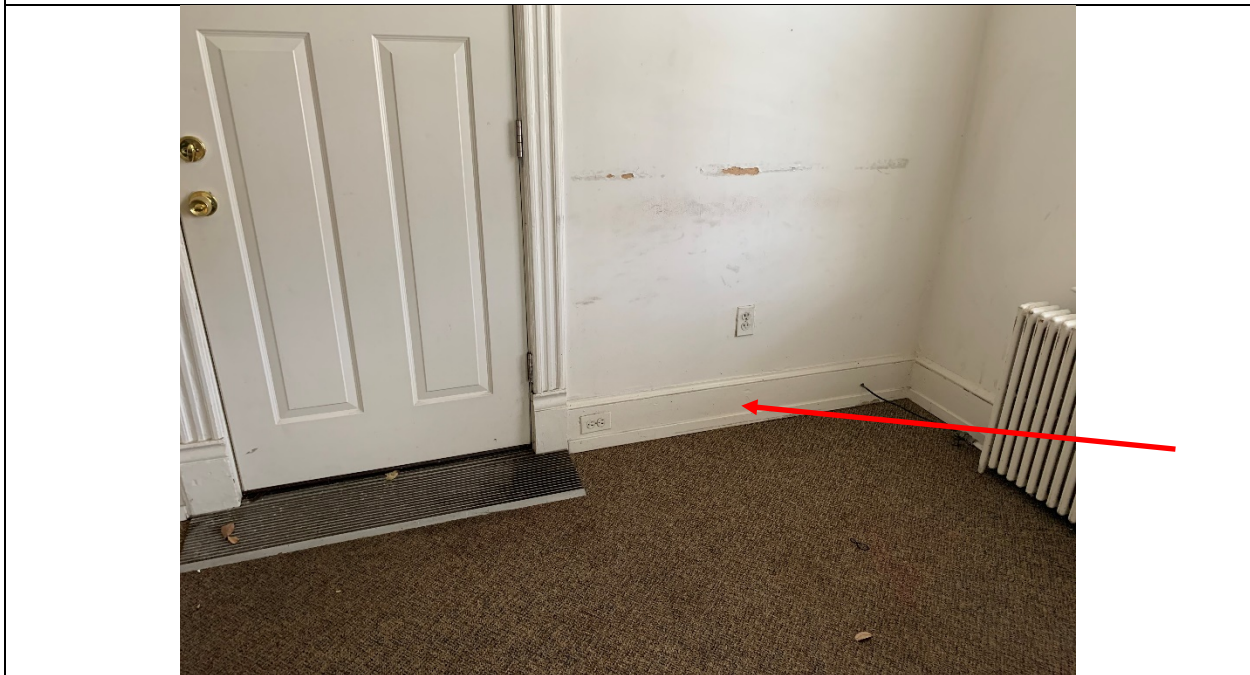
LBP-6: Lead-Based Paint on Baseboard in Living Room

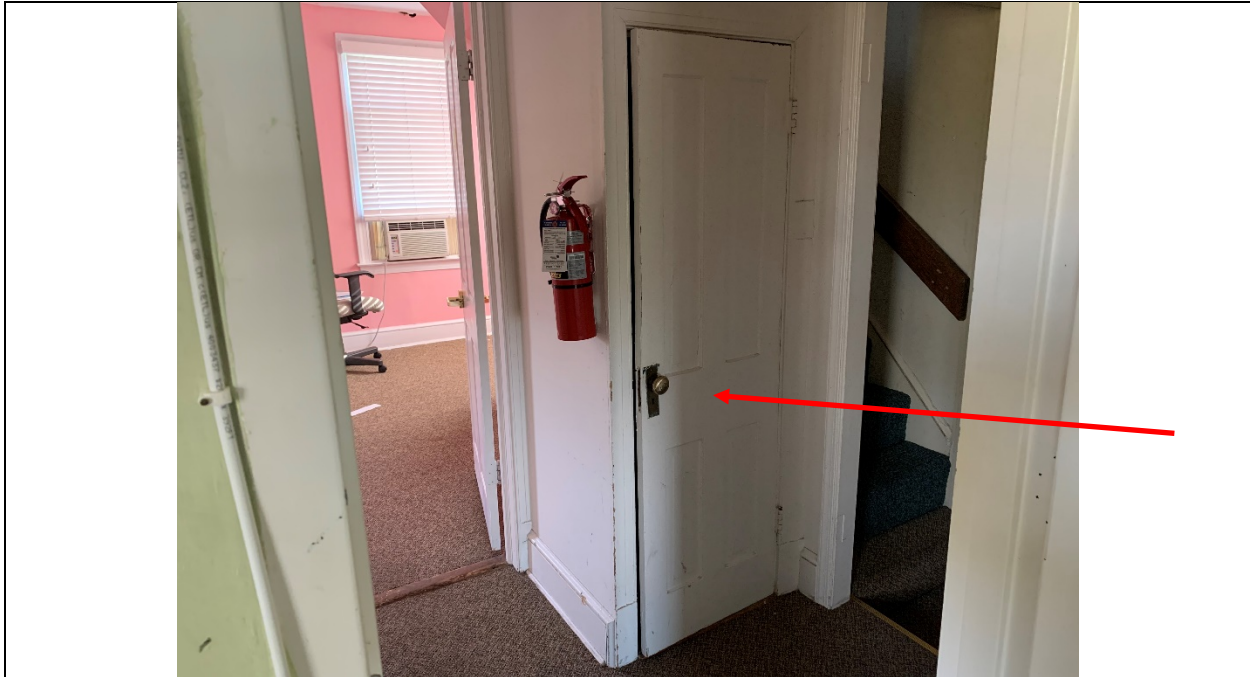
LBP-7: Lead-Based Paint on Closet Door in Landing Area (2<sup>nd</sup> Floor)

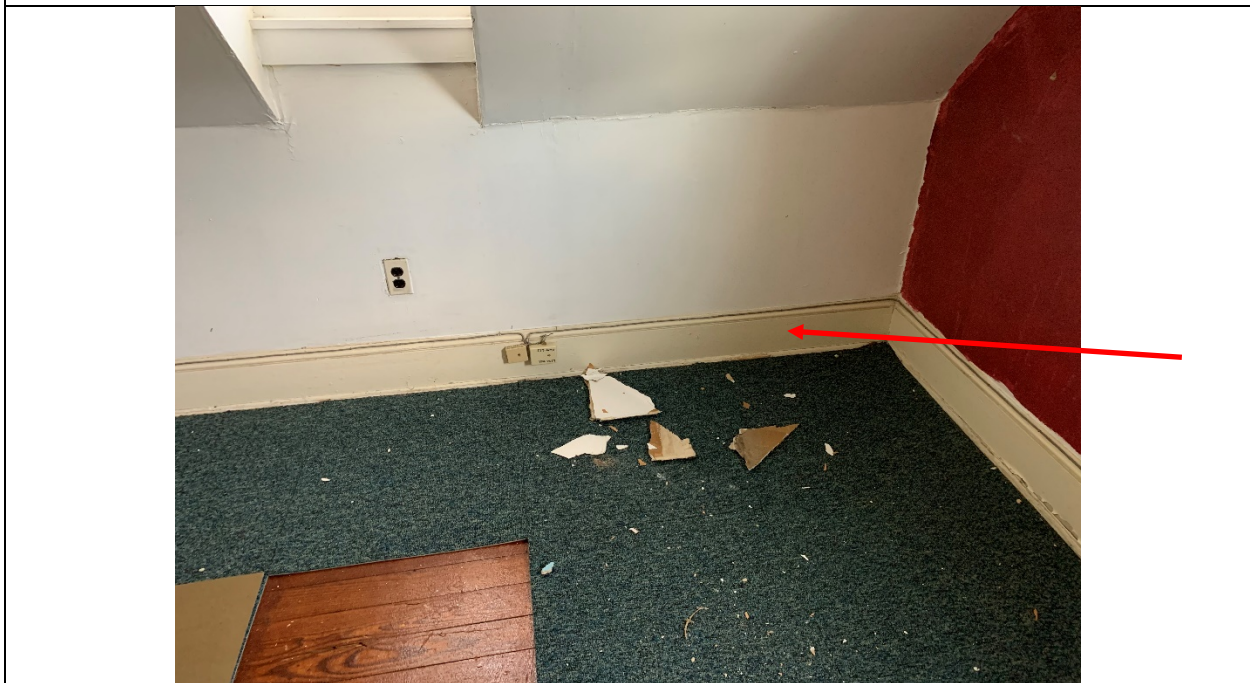
LBP-8: Lead-Based Paint on Baseboard in Bedroom 3-2 (3<sup>rd</sup> Floor)

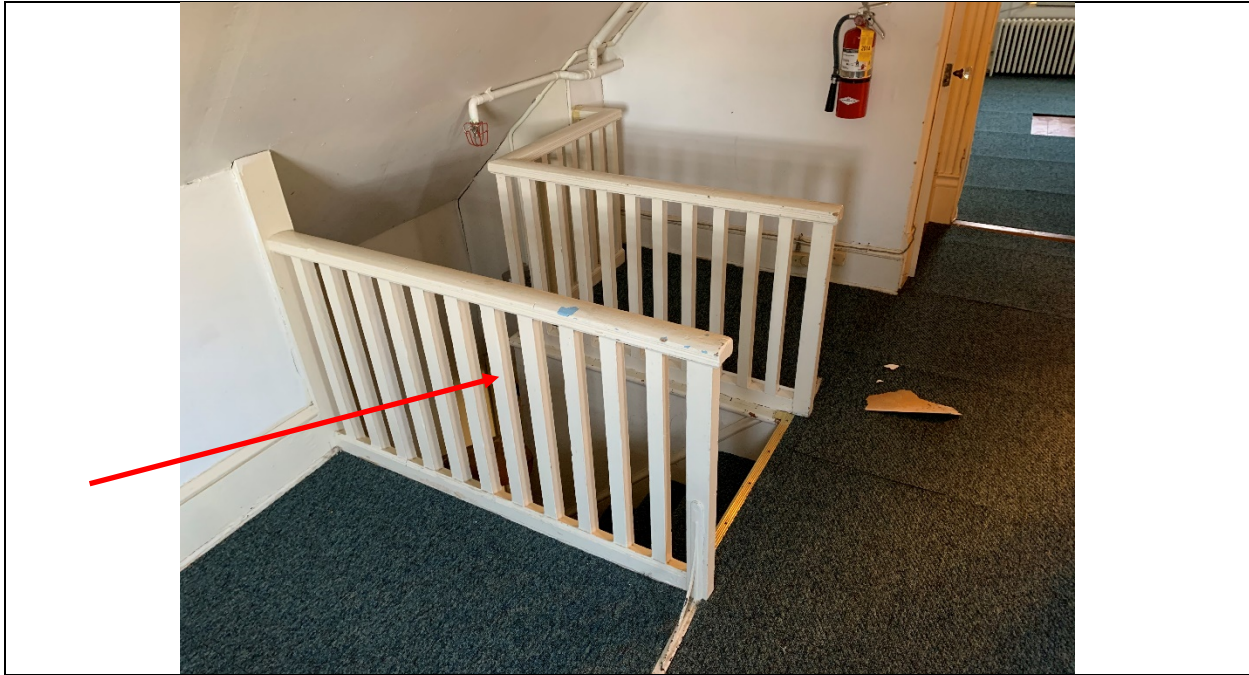
LBP-9: Lead-Based Paint on Handrail and Rail Spindle, Stairway to 3<sup>rd</sup> Floor Area

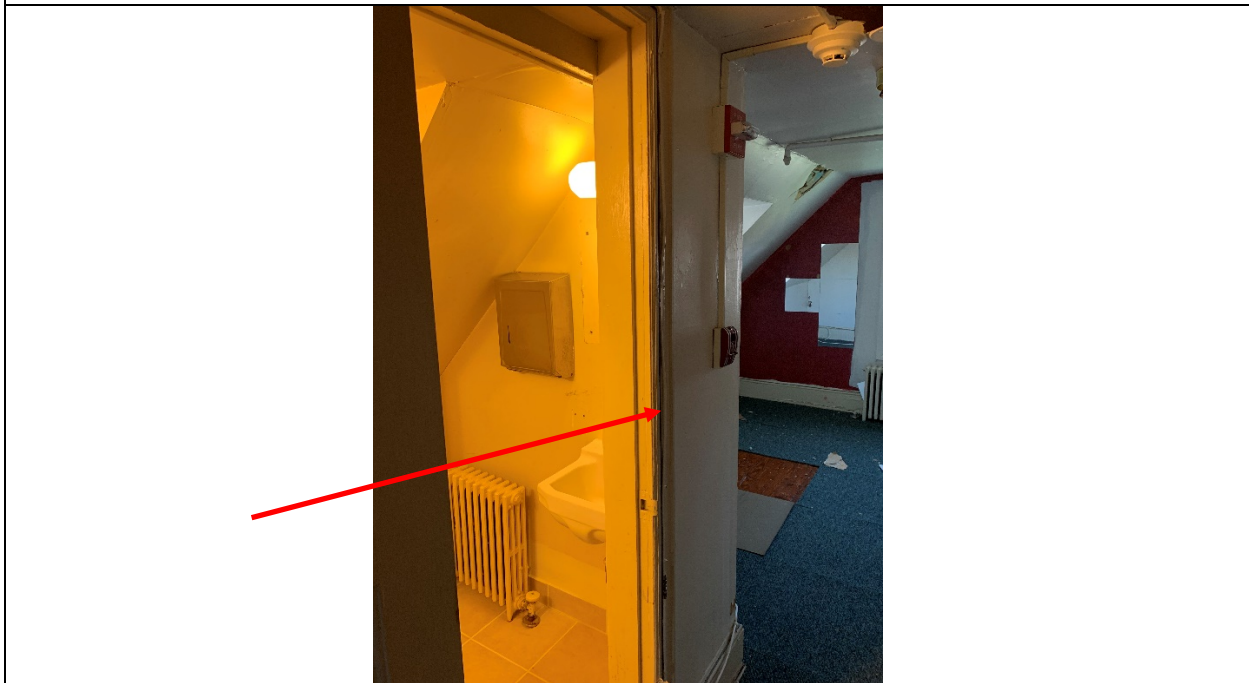
LBP-10: Lead-Based Paint on Door Casing in Bathroom on 3<sup>rd</sup> Floor
